RE: 7 Aviles Street

Re: 7 Aviles Street - Evaluation

AES Project: #326-085

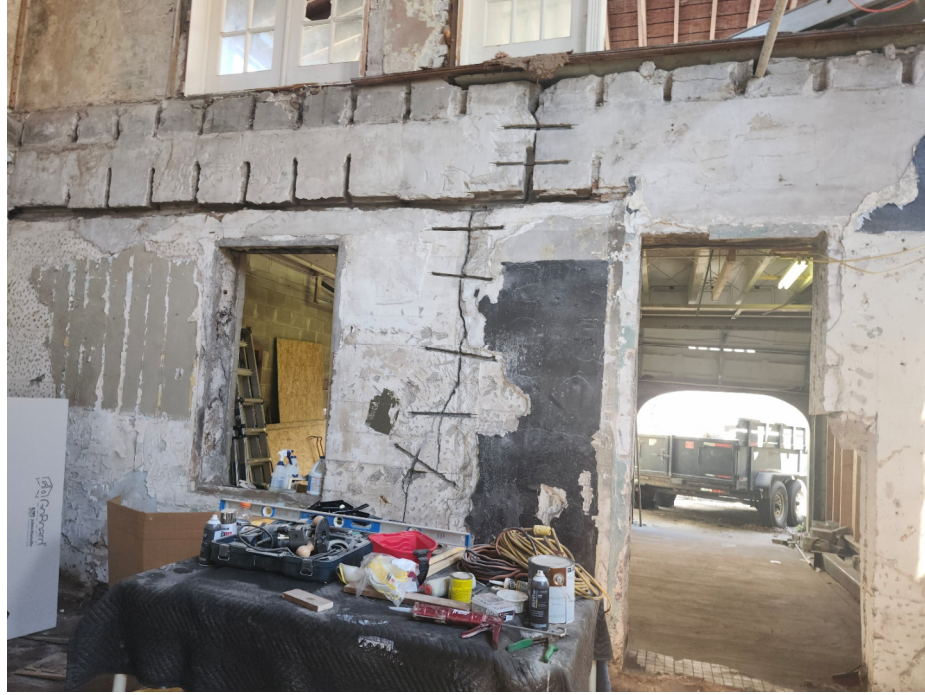
1. The first-floor coquina walls are unreinforced, cracked, and have several modifications. The walls have visible settlement. It is likely these walls do not have foundations (see Photographs 1, 2 and 3).

Photograph 1 - Cracked Coquina Wall

1. It may be possible to save the coquina walls, however, the walls will require significant strengthening as follows:
 - a. Underpin the walls with deep foundations such as helical piers to arrest the settlement.
 - b. Crack stitch the walls with stainless steel plates set in epoxy. The thickness of the walls requires more significant reinforcing than round dowels.
 - c. Fill the cracks with an epoxy grout or with a non-shrink cementitious grout.
 - d. Fill in the areas that have been cut out with reinforced coquina concrete doweled to the existing walls.

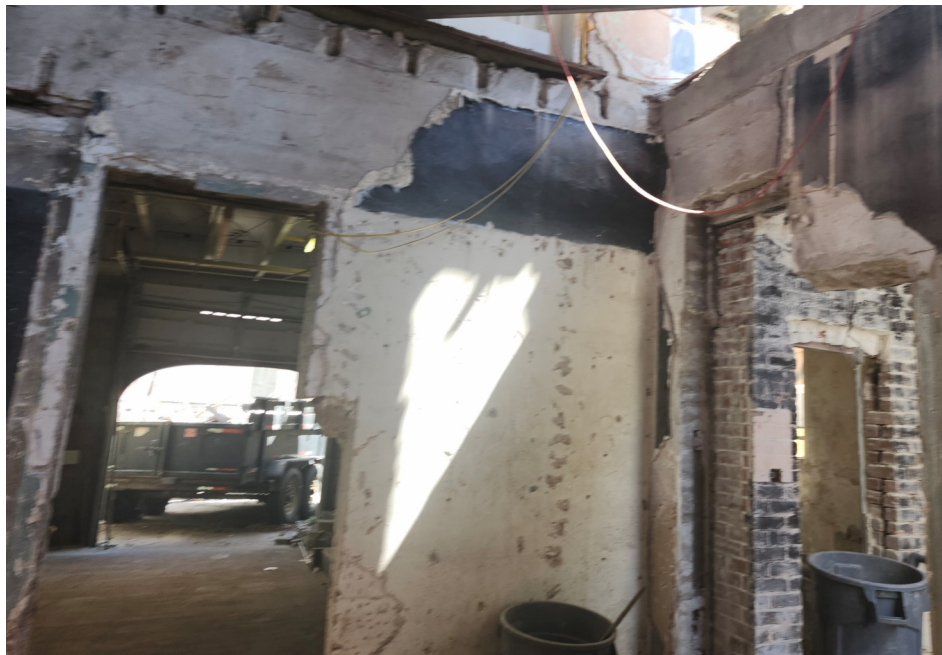
Photograph 2 - Modified Coquina Walls

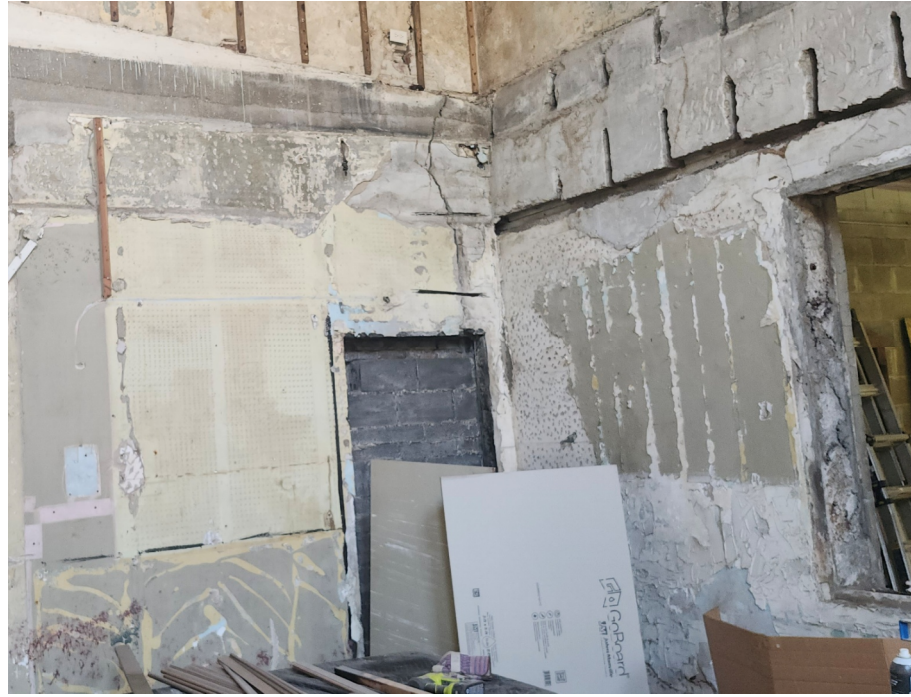
Photograph 3 - Cracked Coquina Wall

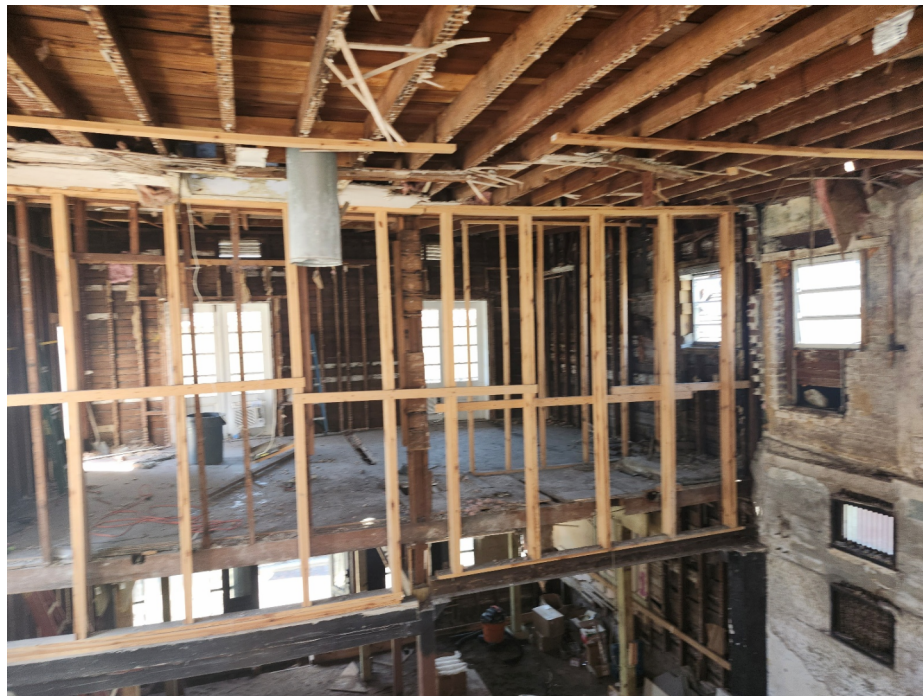
2. The second-floor framing has been removed at the coquina area. The roof framing was still in place but is only supported with temporary shoring (see Photograph 4).

Photograph 4 - Temporary Shoring Supporting Roof Framing

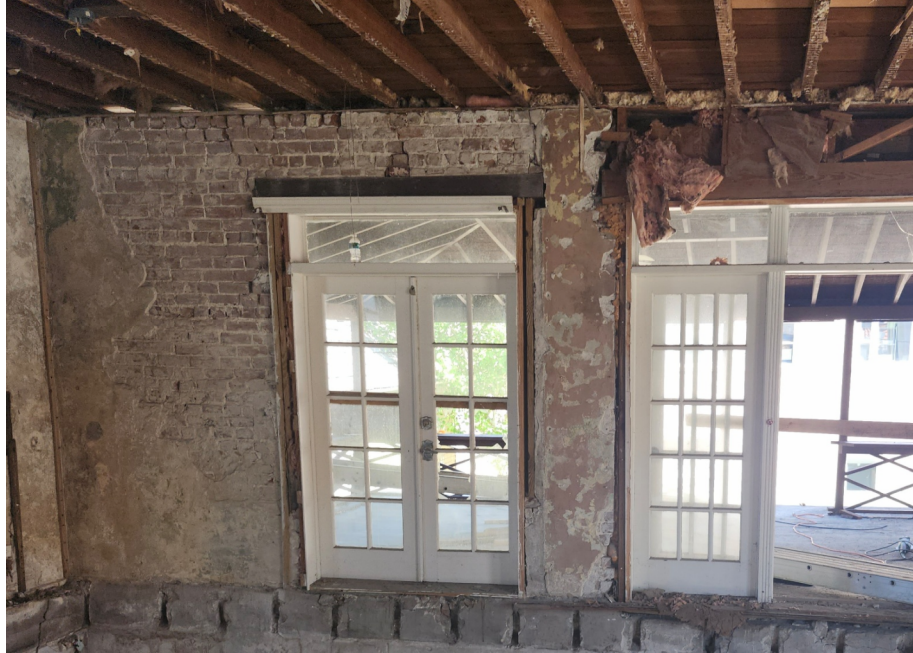
3. The second-floor brick walls are unreinforced, load-bearing walls. The walls are cracked and the mortar is deteriorating. The wall openings typically had wood lintels (see Photographs 5 and 6).

Photograph 5 - Damaged/Deteriorated Brick Wall

2. The second-floor masonry walls supported by the coquina walls are in poor condition. Further investigation of these walls is required. The walls have been weakened by the deteriorated mortar and modifications that cut holes in the walls. At a minimum, the walls will require significant reinforcing, re-pointing, and infilling of the areas that have been modified.
3. The west two-story addition is in poor condition and unsafe. The brick façade is unstable and is in danger of failing. The wall on both the north and south walls have visibly buckled, with significant movement at the north wall. The wood-framed walls are deteriorated beyond repair.

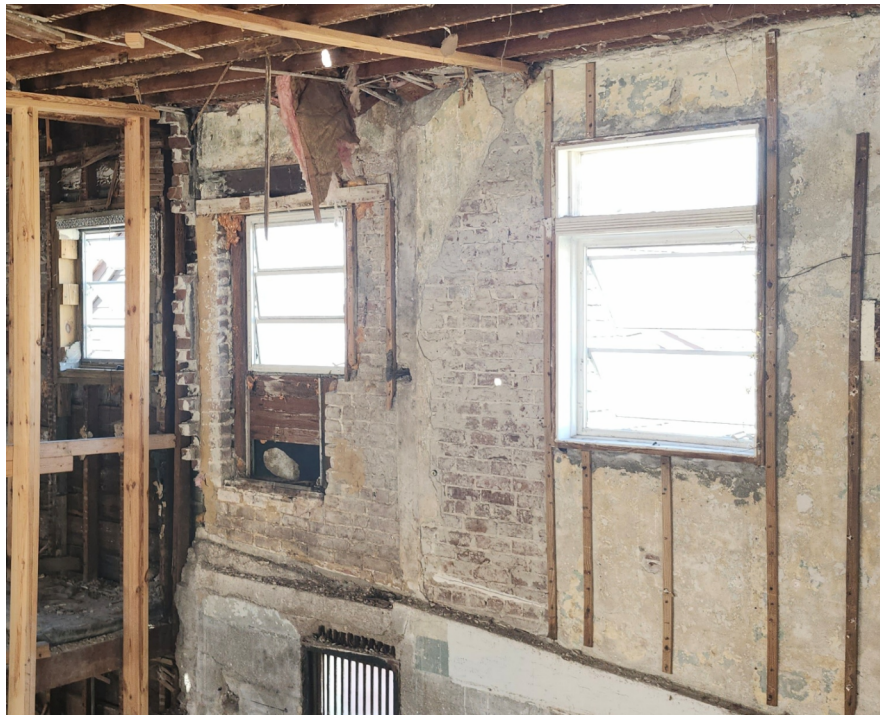
Photograph 6 - Damaged/Deteriorated Brick Wall

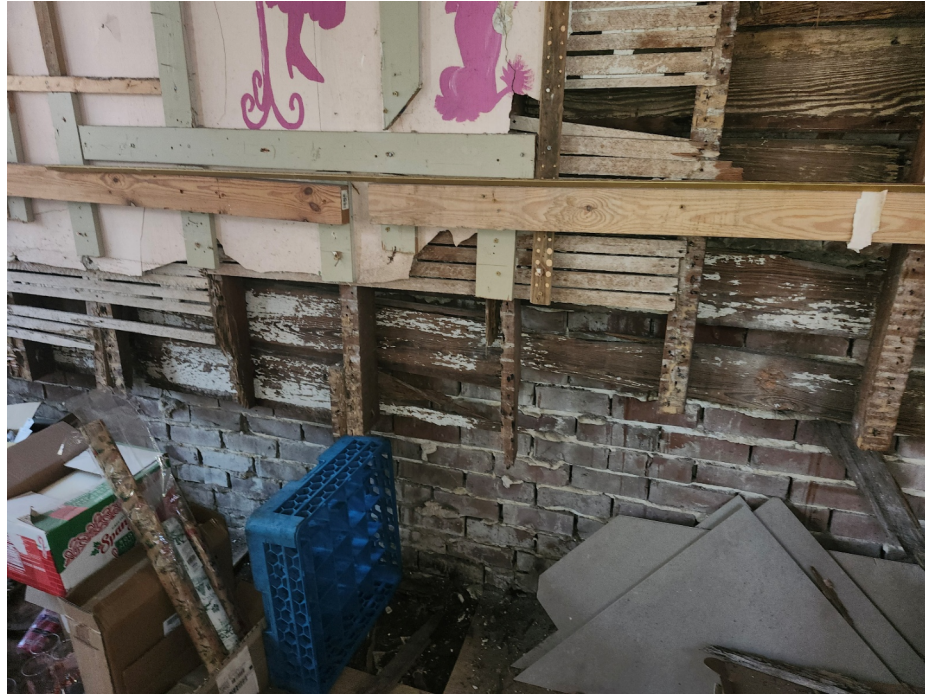
4. The west addition is in very poor condition. The exterior wall studs and sheathing are severely deteriorated. The contractor has installed temporary shoring to support the roof (see Photographs 7 and 8).

Photograph 7 - Deteriorated Brick Veneer and Stud Wall

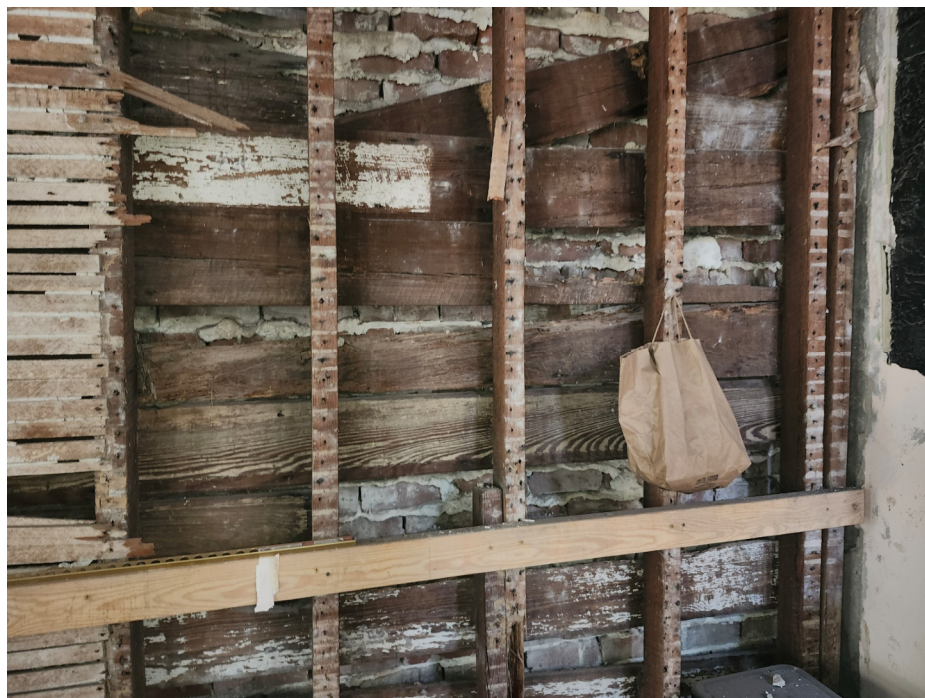
Photograph 8 - Deteriorated Brick Veneer and Stud Wall

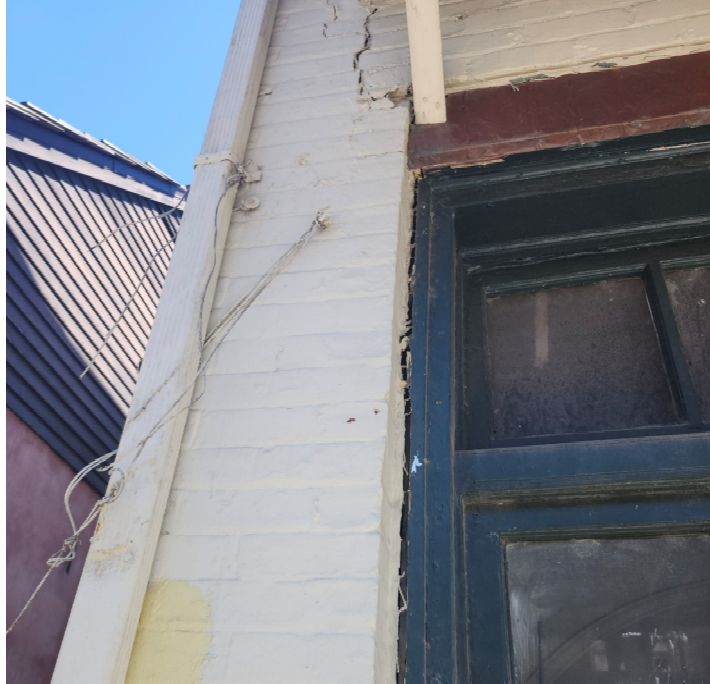
5. The brick veneer at the west addition has no ties anchoring the brick back to the structure. The mortar is severely deteriorated and many of the bricks were loose. The brick is buckling on both the north and south faces of the building. The north face has significant visible movement at the northwest corner of the building (see Photographs 9 and 10).

Photograph 9 - Brick Separating at Northwest Corner

In conclusion, the west addition exterior walls and façade are in poor condition. The brick façade is in poor condition and in danger of failing. These walls are danger to life and property. AES has provided the contractor with a temporary bracing plan to stabilize the brick veneer.

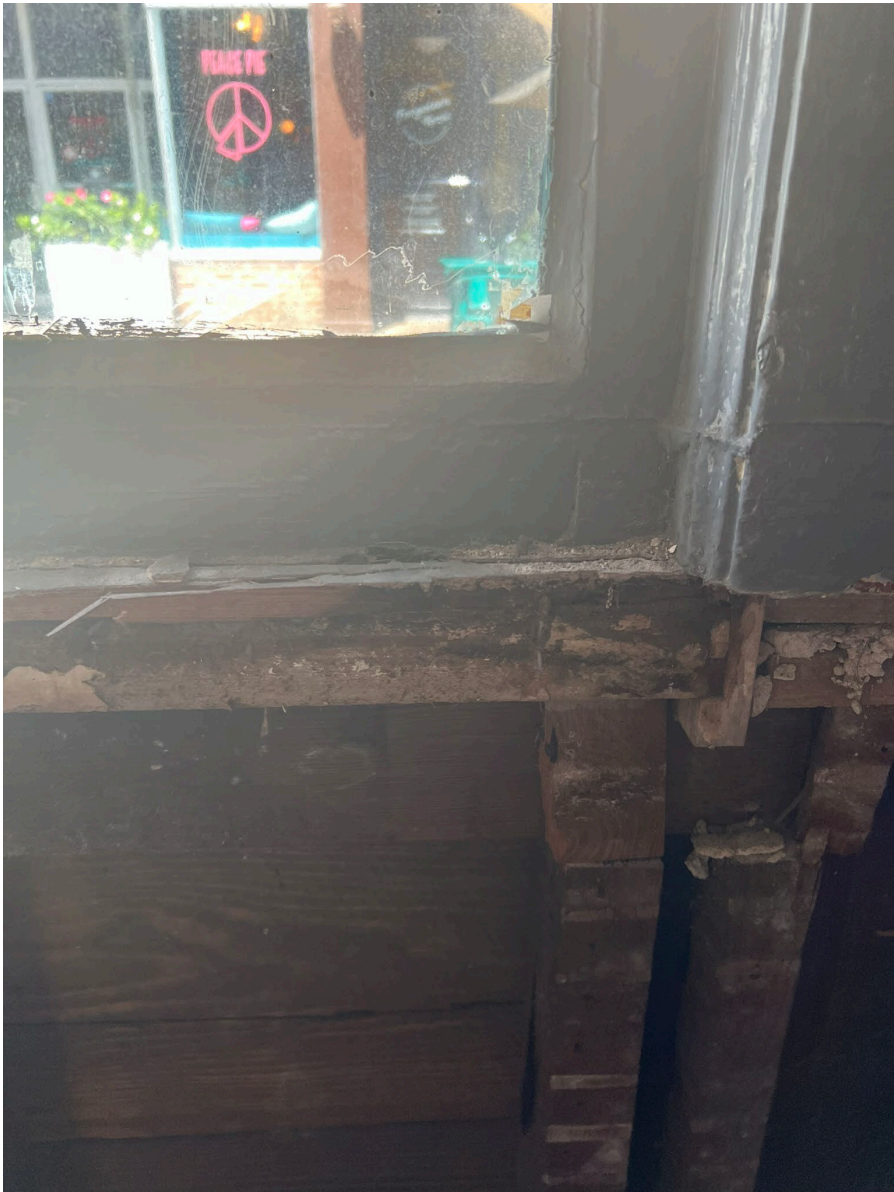
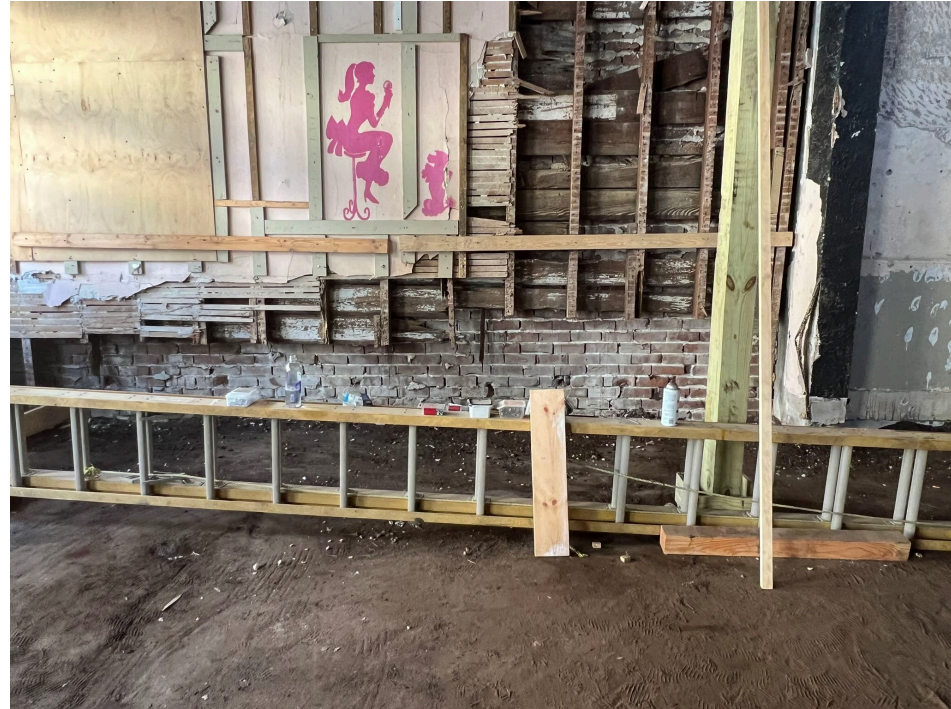
Interior, Sill Damage and Brick
