# City of St. Augustine

## Historic Architectural Review Board

### A G E N D A

**Thursday, July 18, 2019 1:00 p.m. \*Amended**

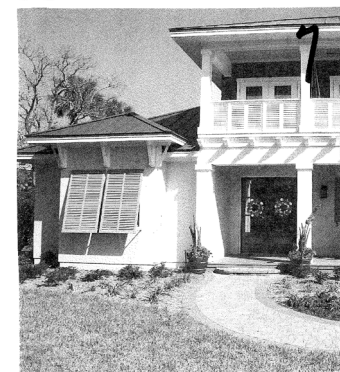
Proposed Shutter Style

- No historical photographs could be found that show the home having shutters historically. Shutters are appropriate to use on Bungalow Style homes, however.
- Bahama shutters are rarely used in Florida.
- Based on the application, the shutters will only be placed on the southern elevation, which is a side and non-character defining elevation. Installing the shutters will not have a negative impact on the character of the structure.
- The proposed color for the shutters is on the pre-approved color list.
- The applicant should consider a more compatible material for the shutters such as wood.

1. **Approve** the shutters if the applicant can prove that such shutters have been used in St. Augustine or on the home
- Or
2. **Approve** the use of shutters with the condition that the applicant uses a more traditional style.

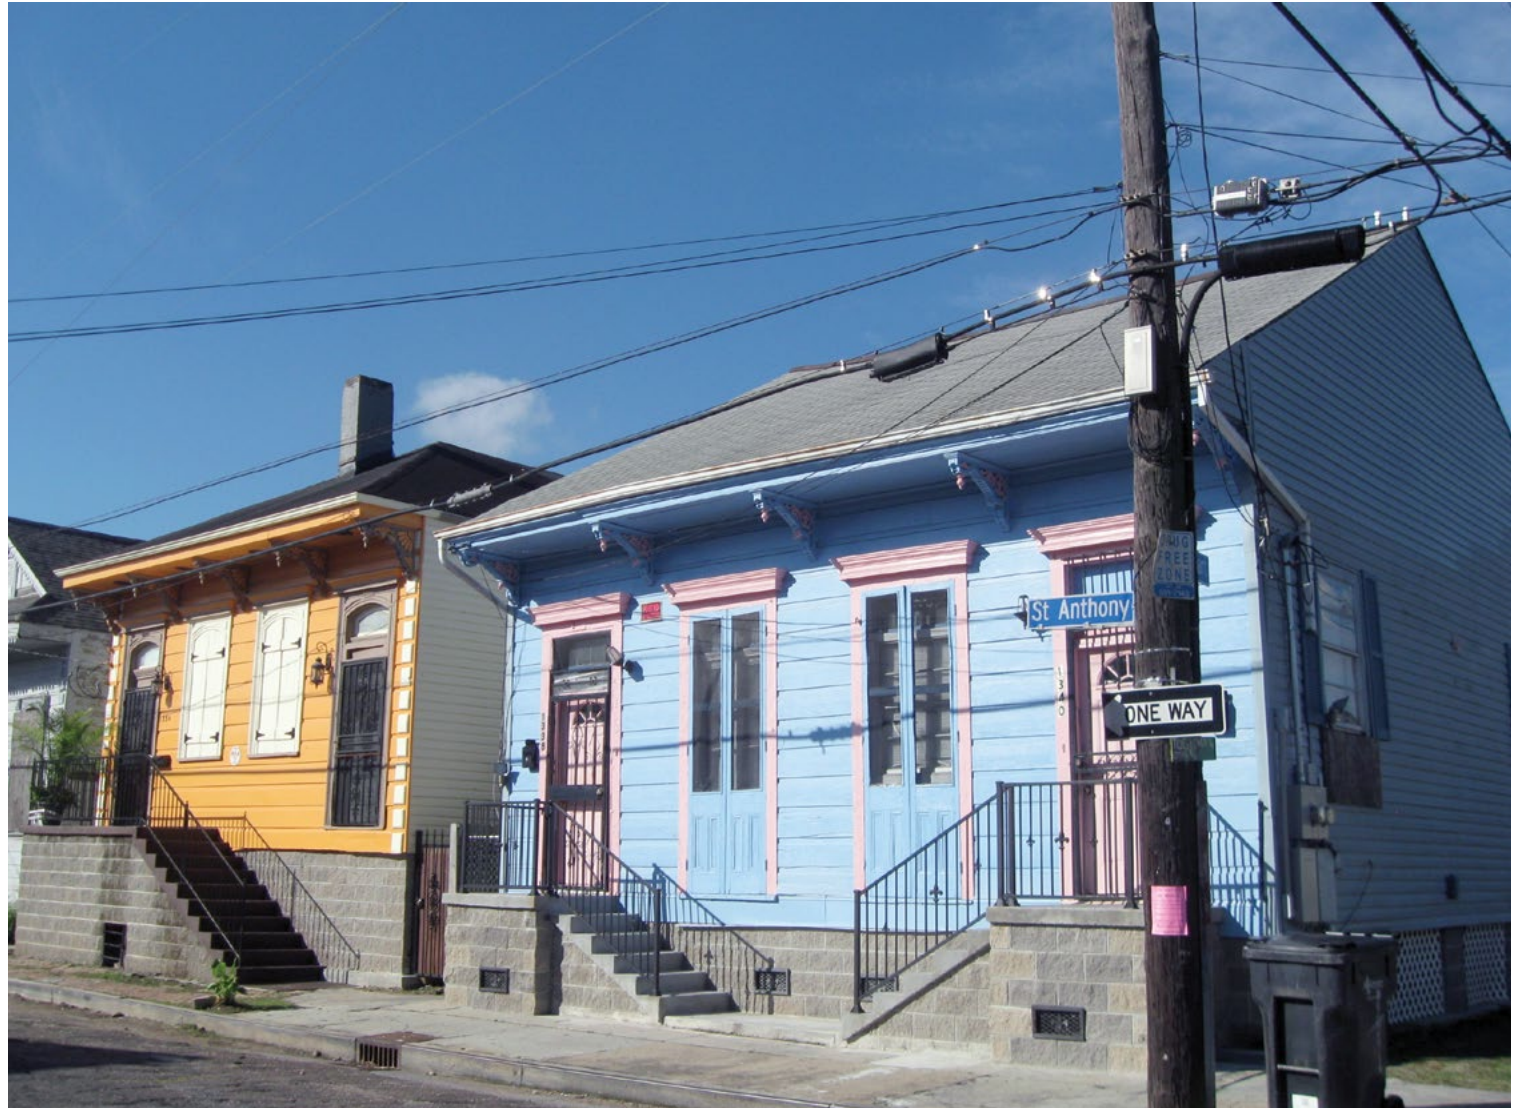
[60] In some instances, it may be necessary to elevate a historic building located in a floodplain to protect it. But this treatment is appropriate only if elevating the building will retain its historic character, including its relationship to the site, and its new height will be compatible with surrounding buildings if in a historic district. The house on the right, which has been raised only slightly, has retained its historic character. The house on the left has been raised several feet higher, resulting in a greater impact on the historic character of the house and the district.

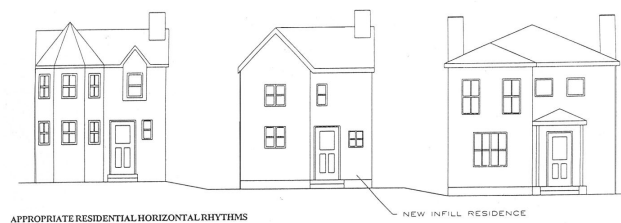
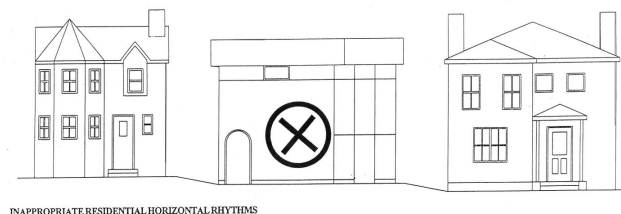
Figure 7

### Residential Horizontal Rhythms

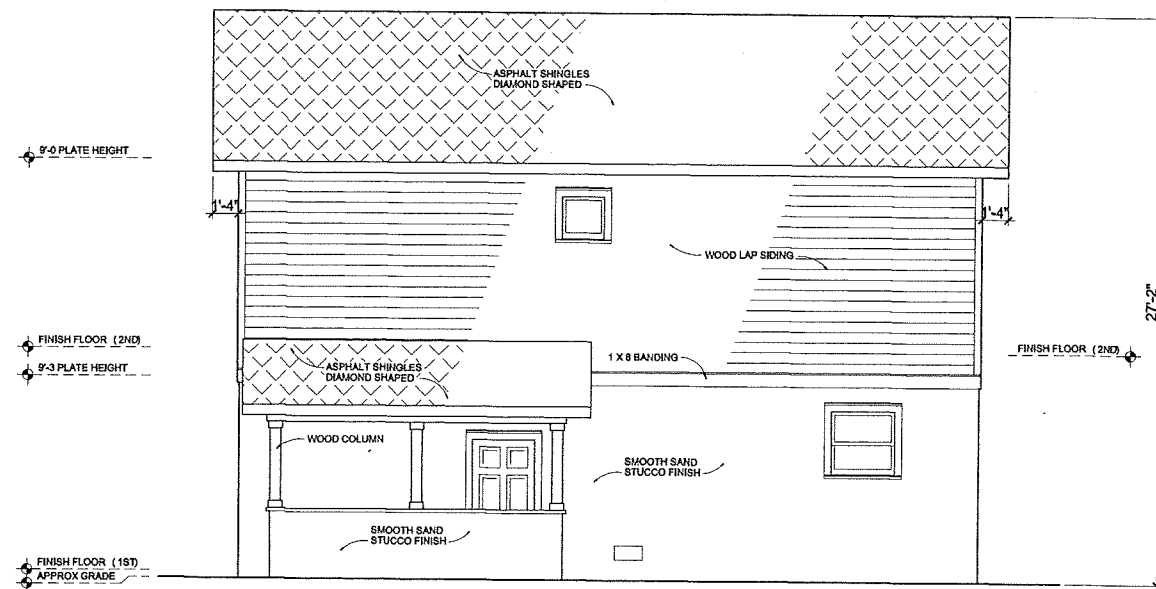
## EAST ELEVATION

SCALE: 1/4" = 1'-0

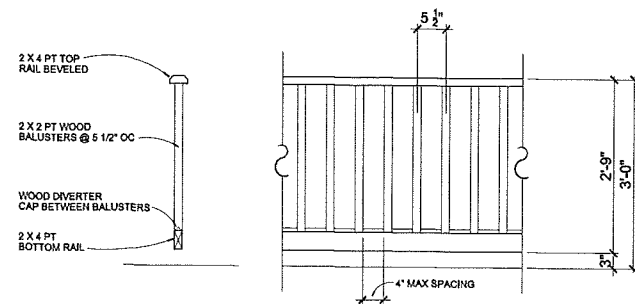
## RAILING DETAIL

SCALE: 3/4" = 1'-0

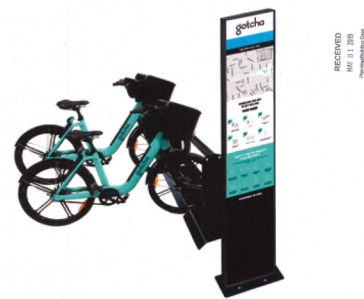
Proposed Bike Rack and Sign

- Overall, the design of the sign and of the bike racks are the same as what was previously approved in the Opinion of Appropriateness. This includes the colors and the font on the signs. The location of the proposed racks also appear to be in the same locations.
- No major changes appear to have been made to the design since the Opinion was approved.
- The applicant provided a rendering for one of the stops to show the sign and the stop in context. The dimensions of the rack and the signs were also provided but material information was not included in the application.
- Subsurface construction, especially excavation on city property, may require an A14 Archaeological Review Application.
