# City of St. Augustine

## Historic Architectural Review Board

### A G E N D A

HISTORIC ARCHITECTURAL REVIEW BOARD  
STAFF REPORT AND RECOMMENDATION  
Prepared for August 15, 2019 Meeting

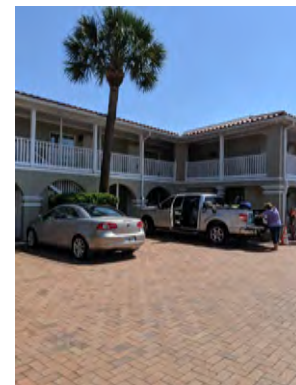
Location of Proposed Walkway

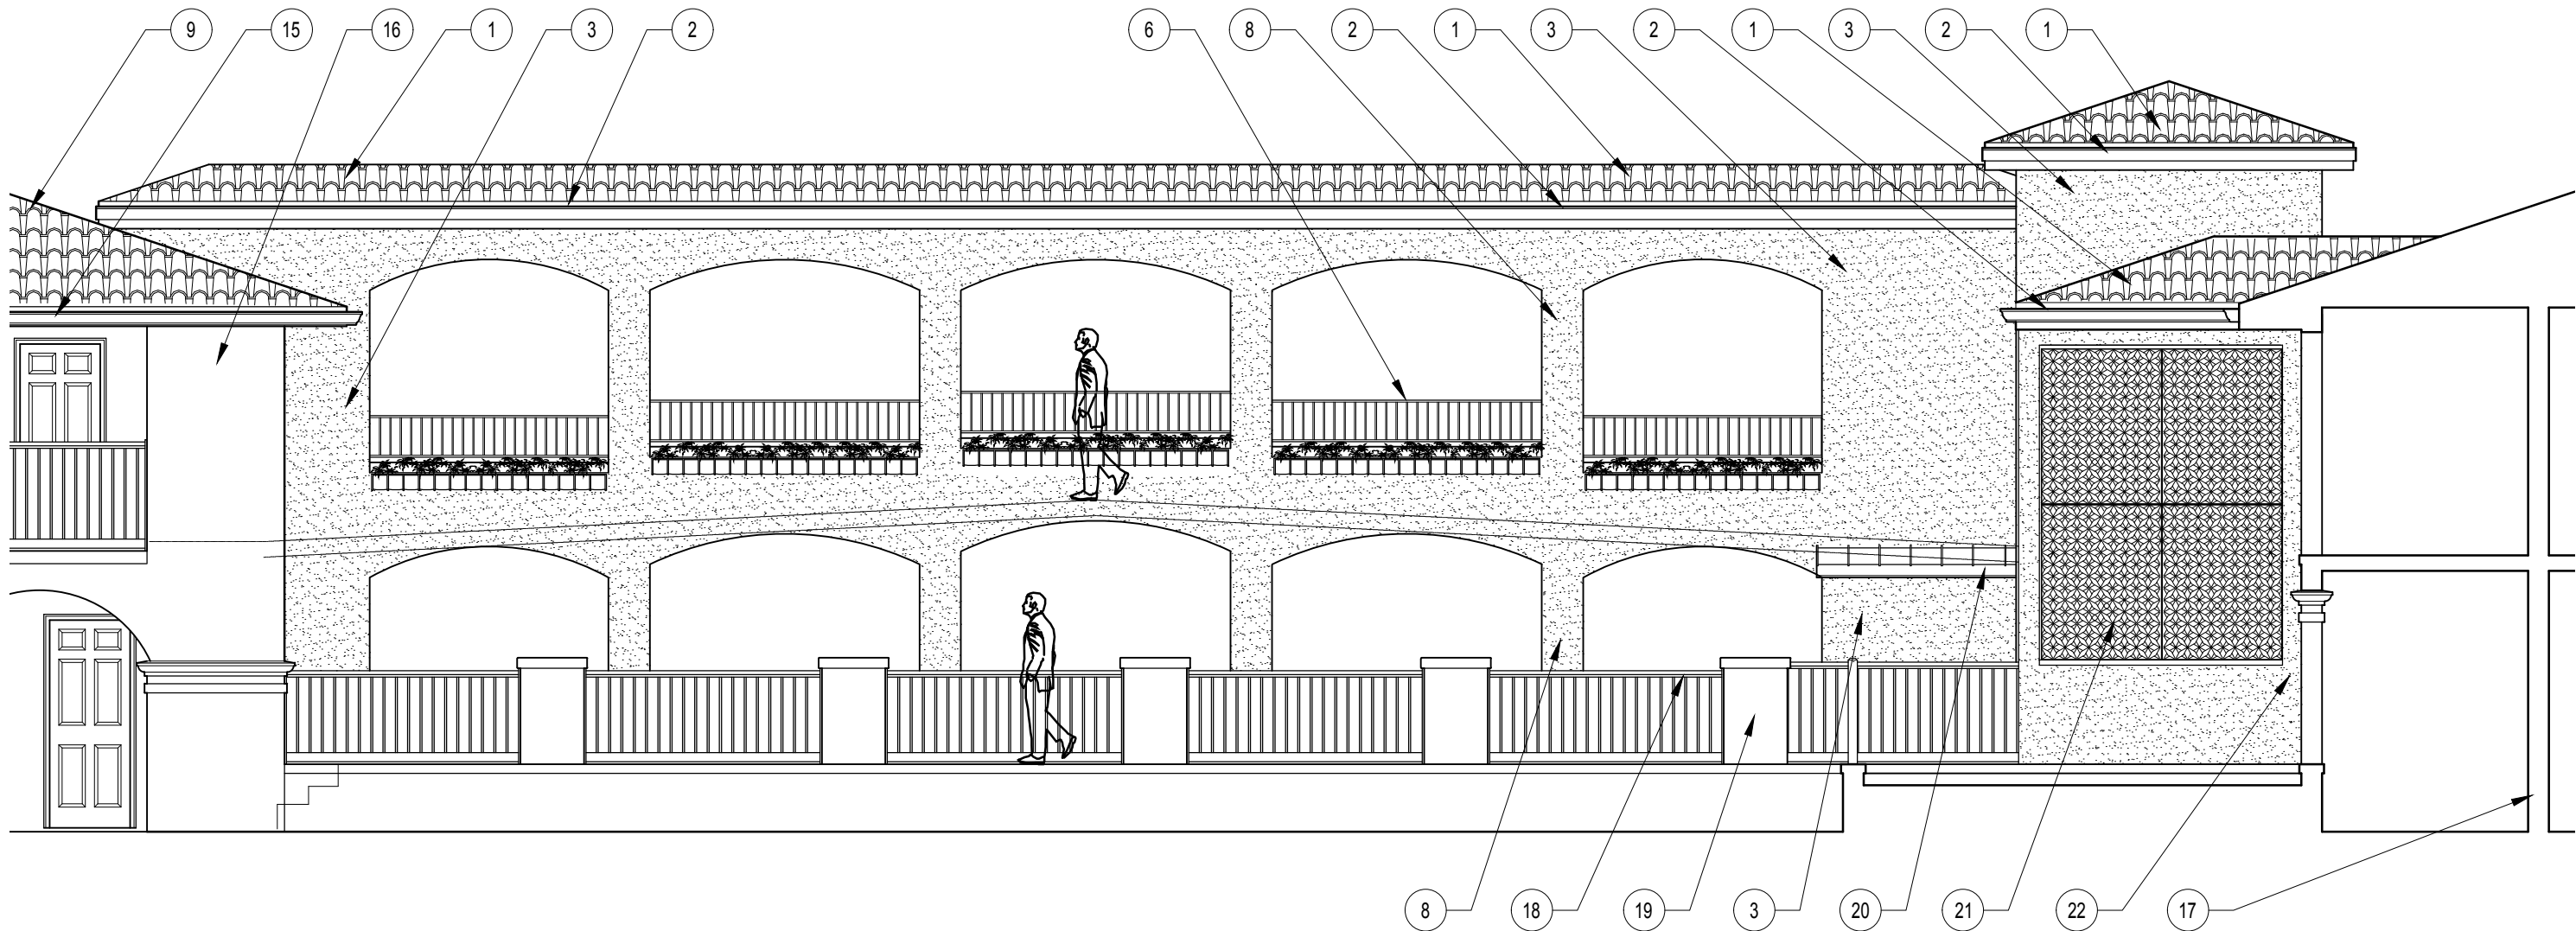
SOUTH (POOL) ELEVATION

- Sheet 1 - Updated 'Pool side' elevator elevations
- Sheet 2 - Updated 'Stair' elevator elevations
- Sheet 3 - Updated Section through the stair with canopy
- Sheet 4 - Updated renderings
- Sheet 5 - Metal panel company information

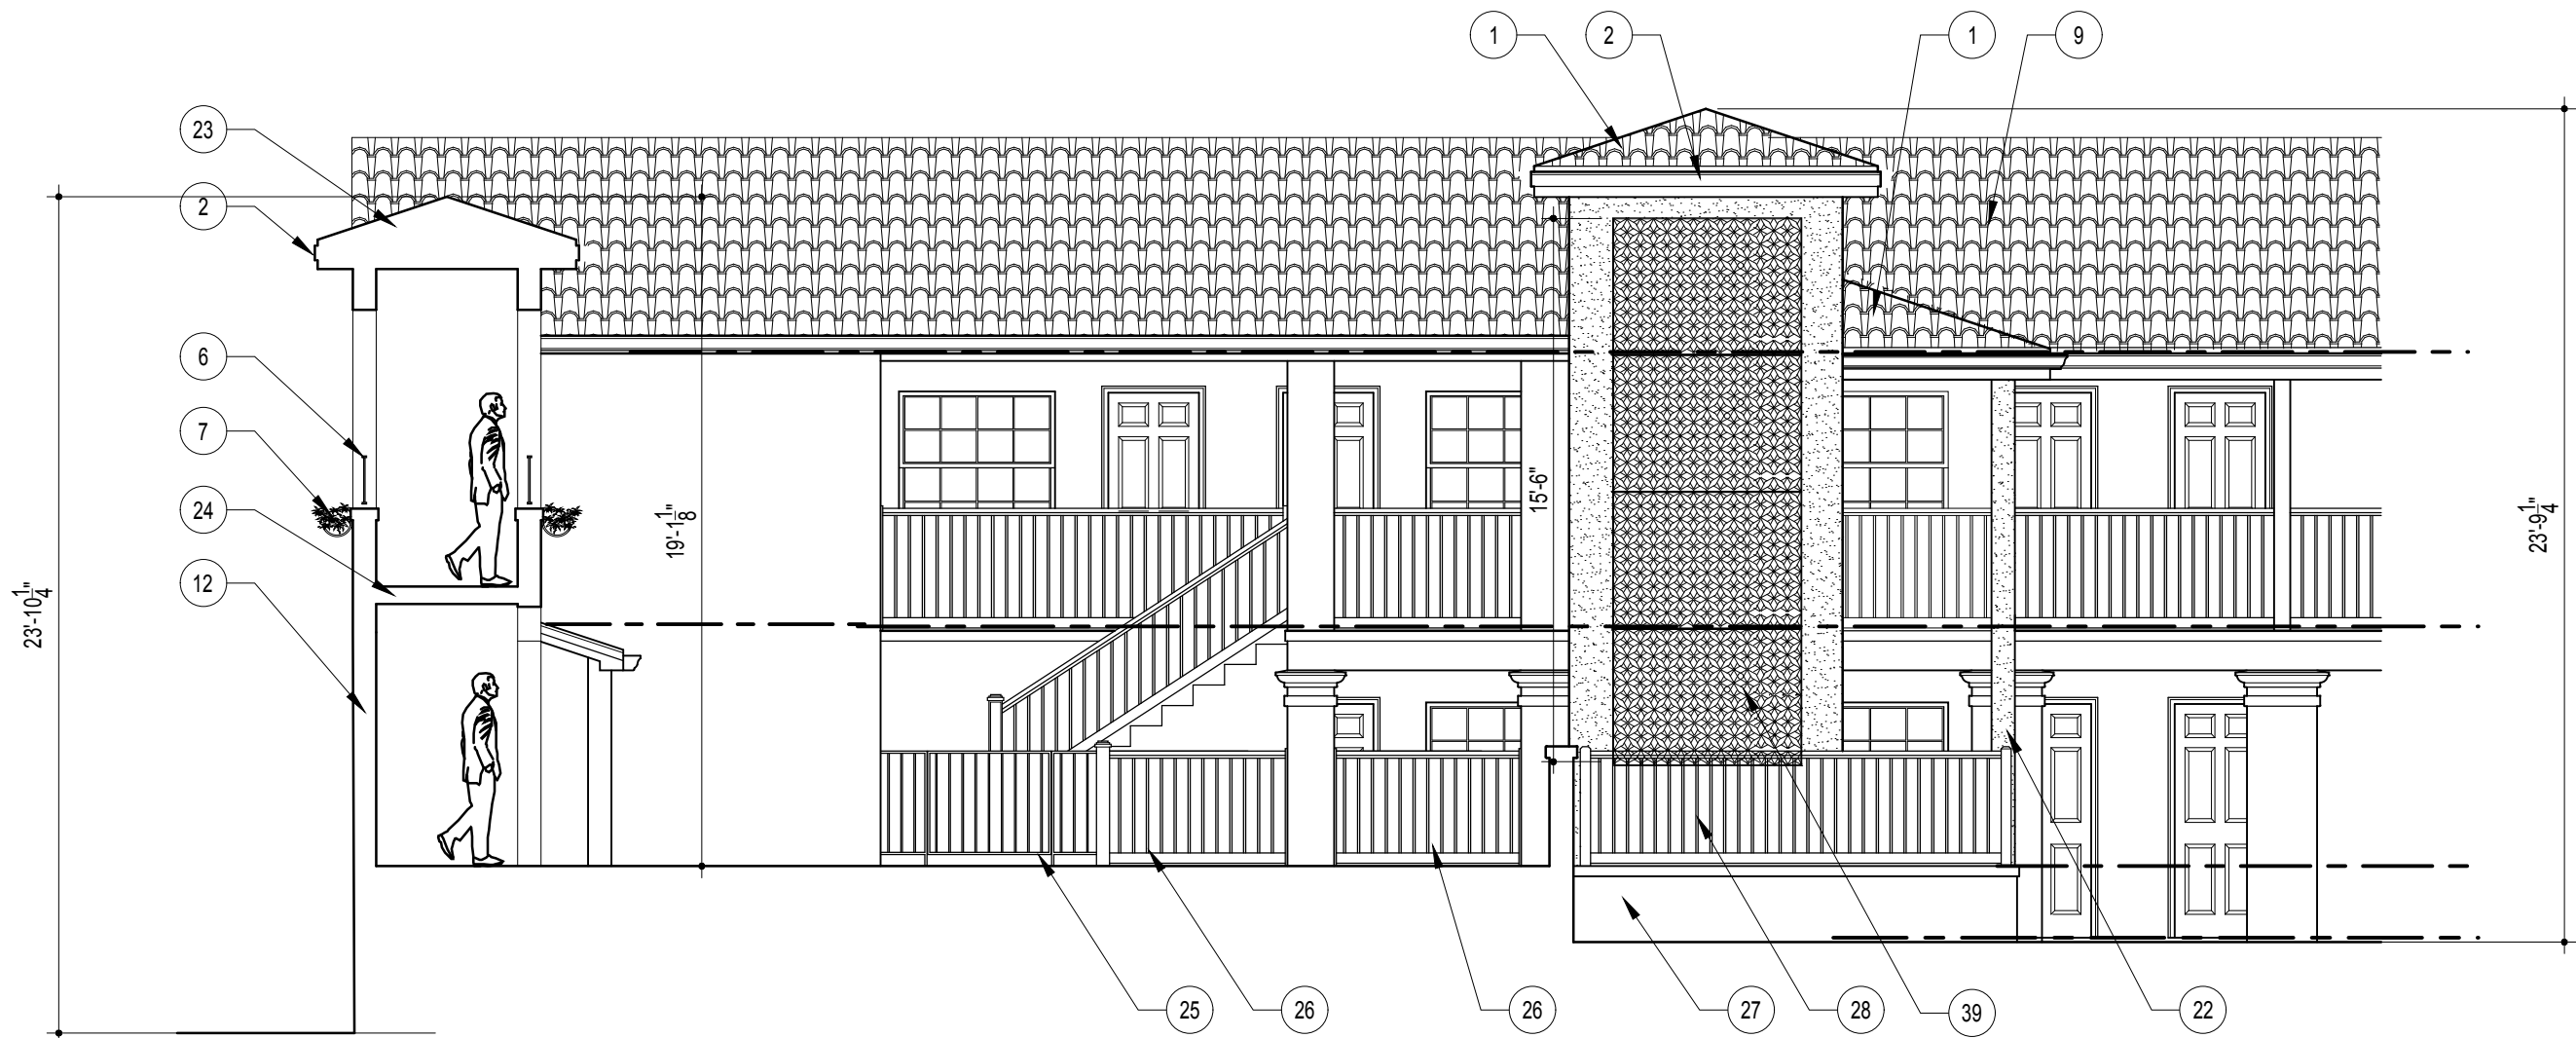
WEST (POOL) ELEVATION

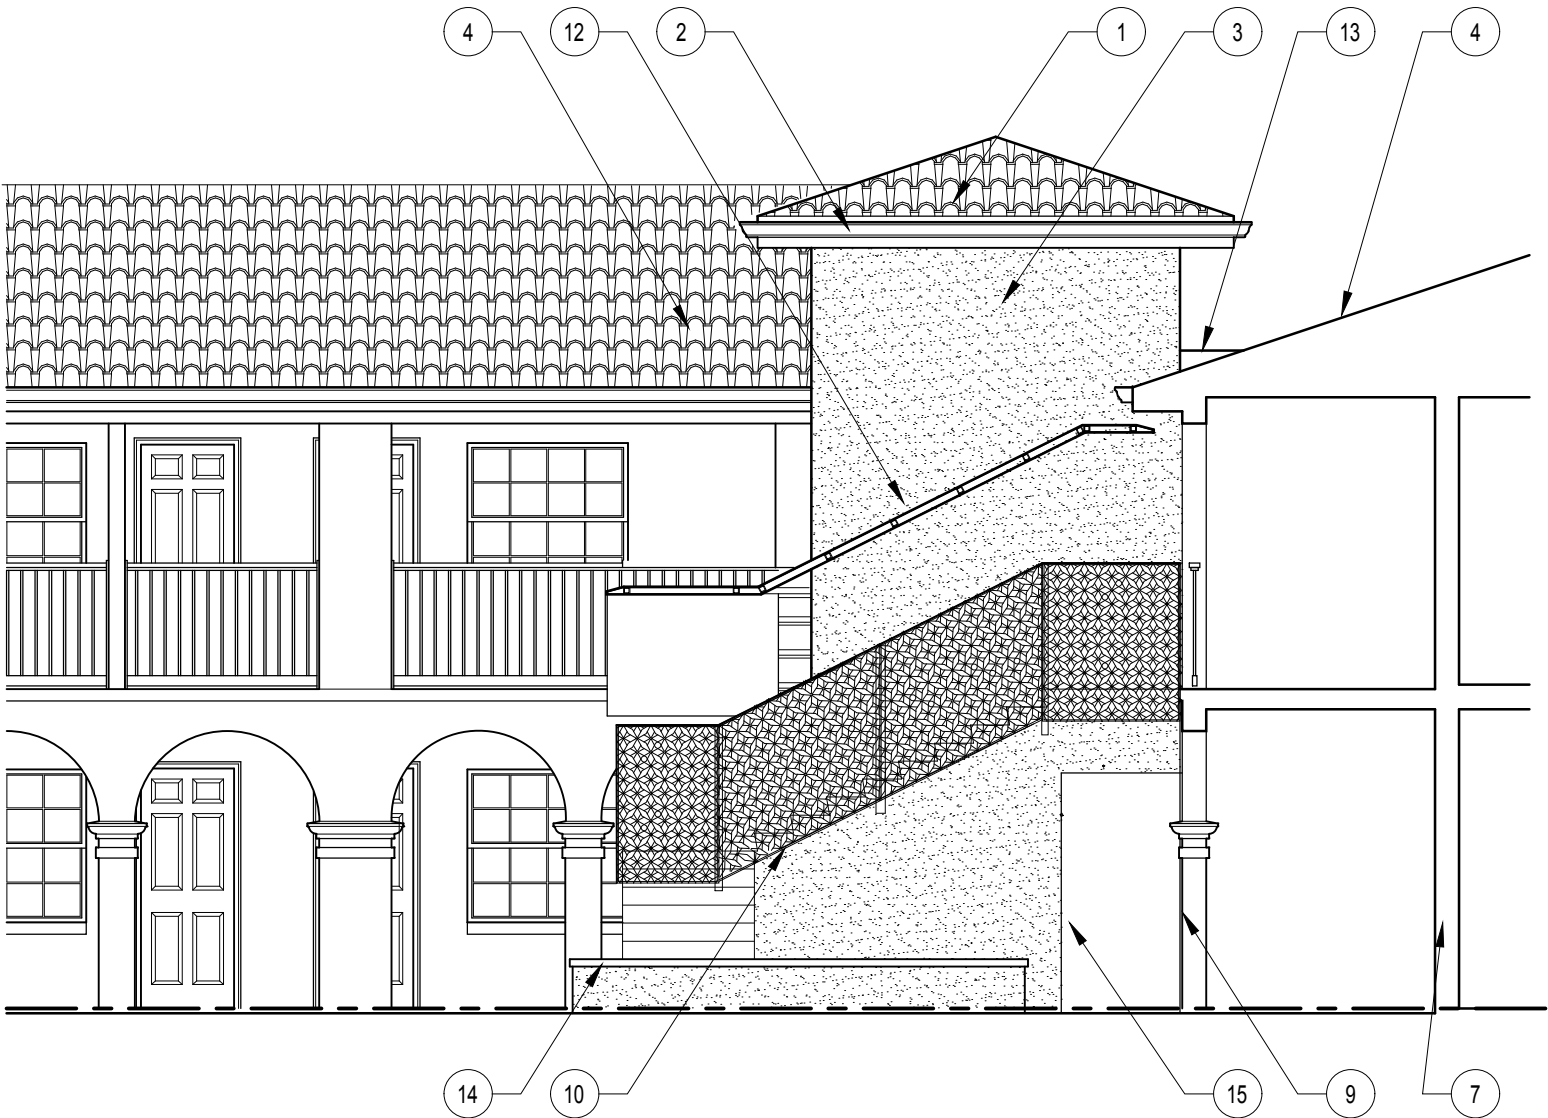
WEST (CORNER) ELEVATION

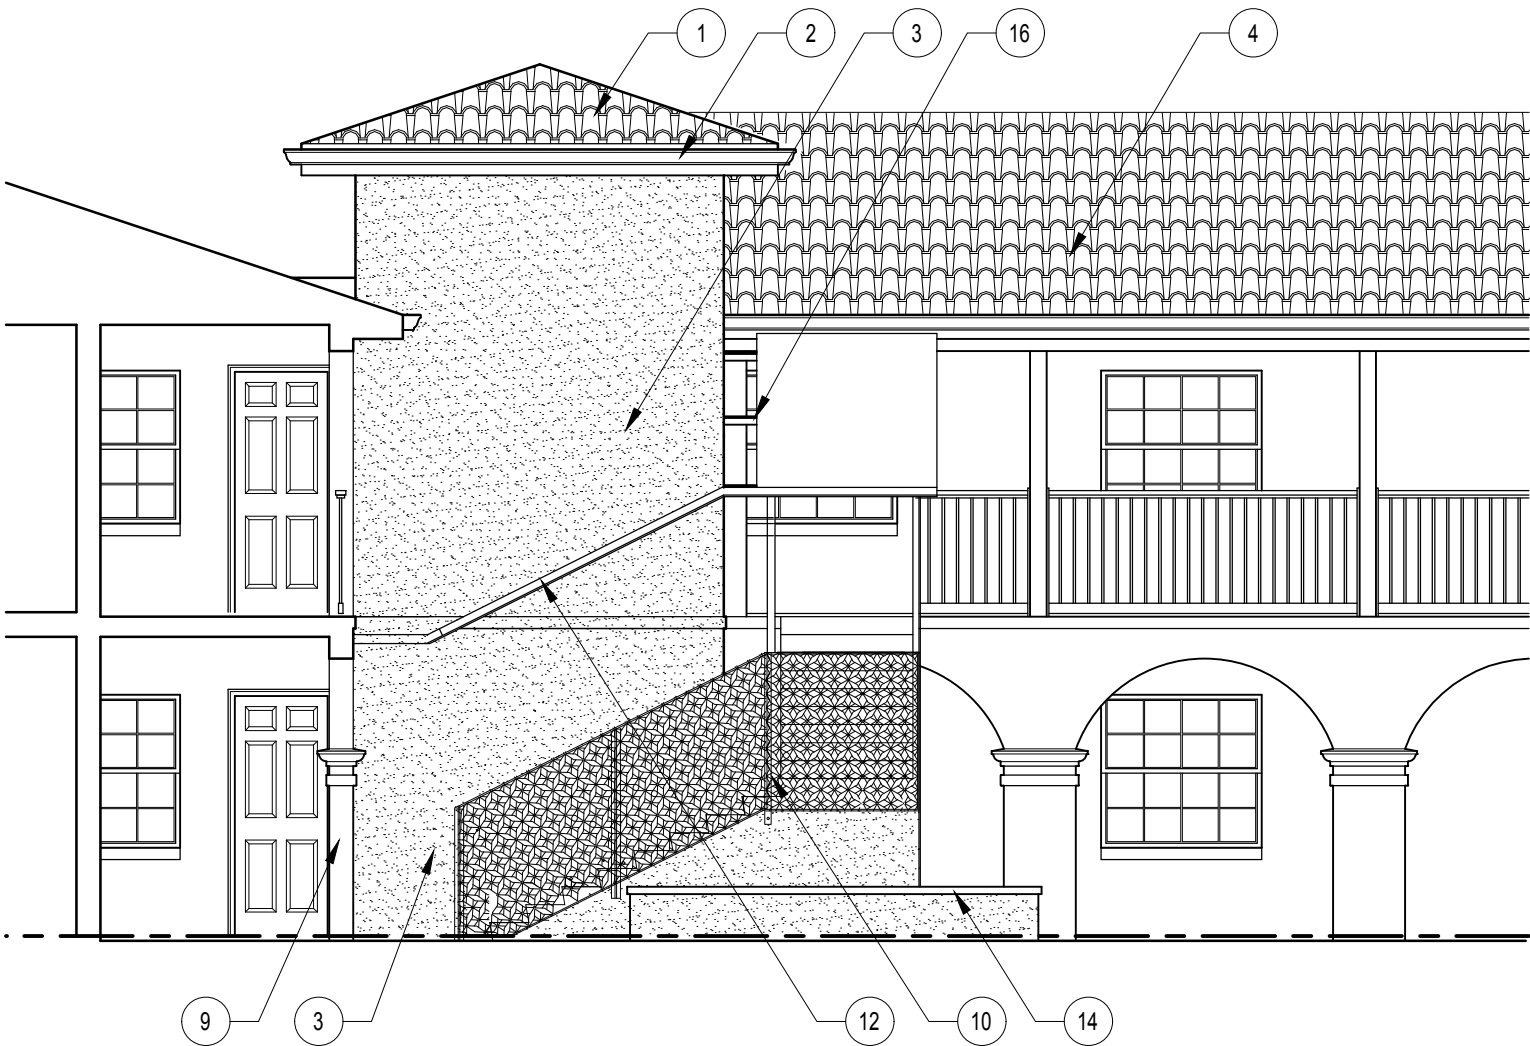
NORTH (CORNER) ELEVATION

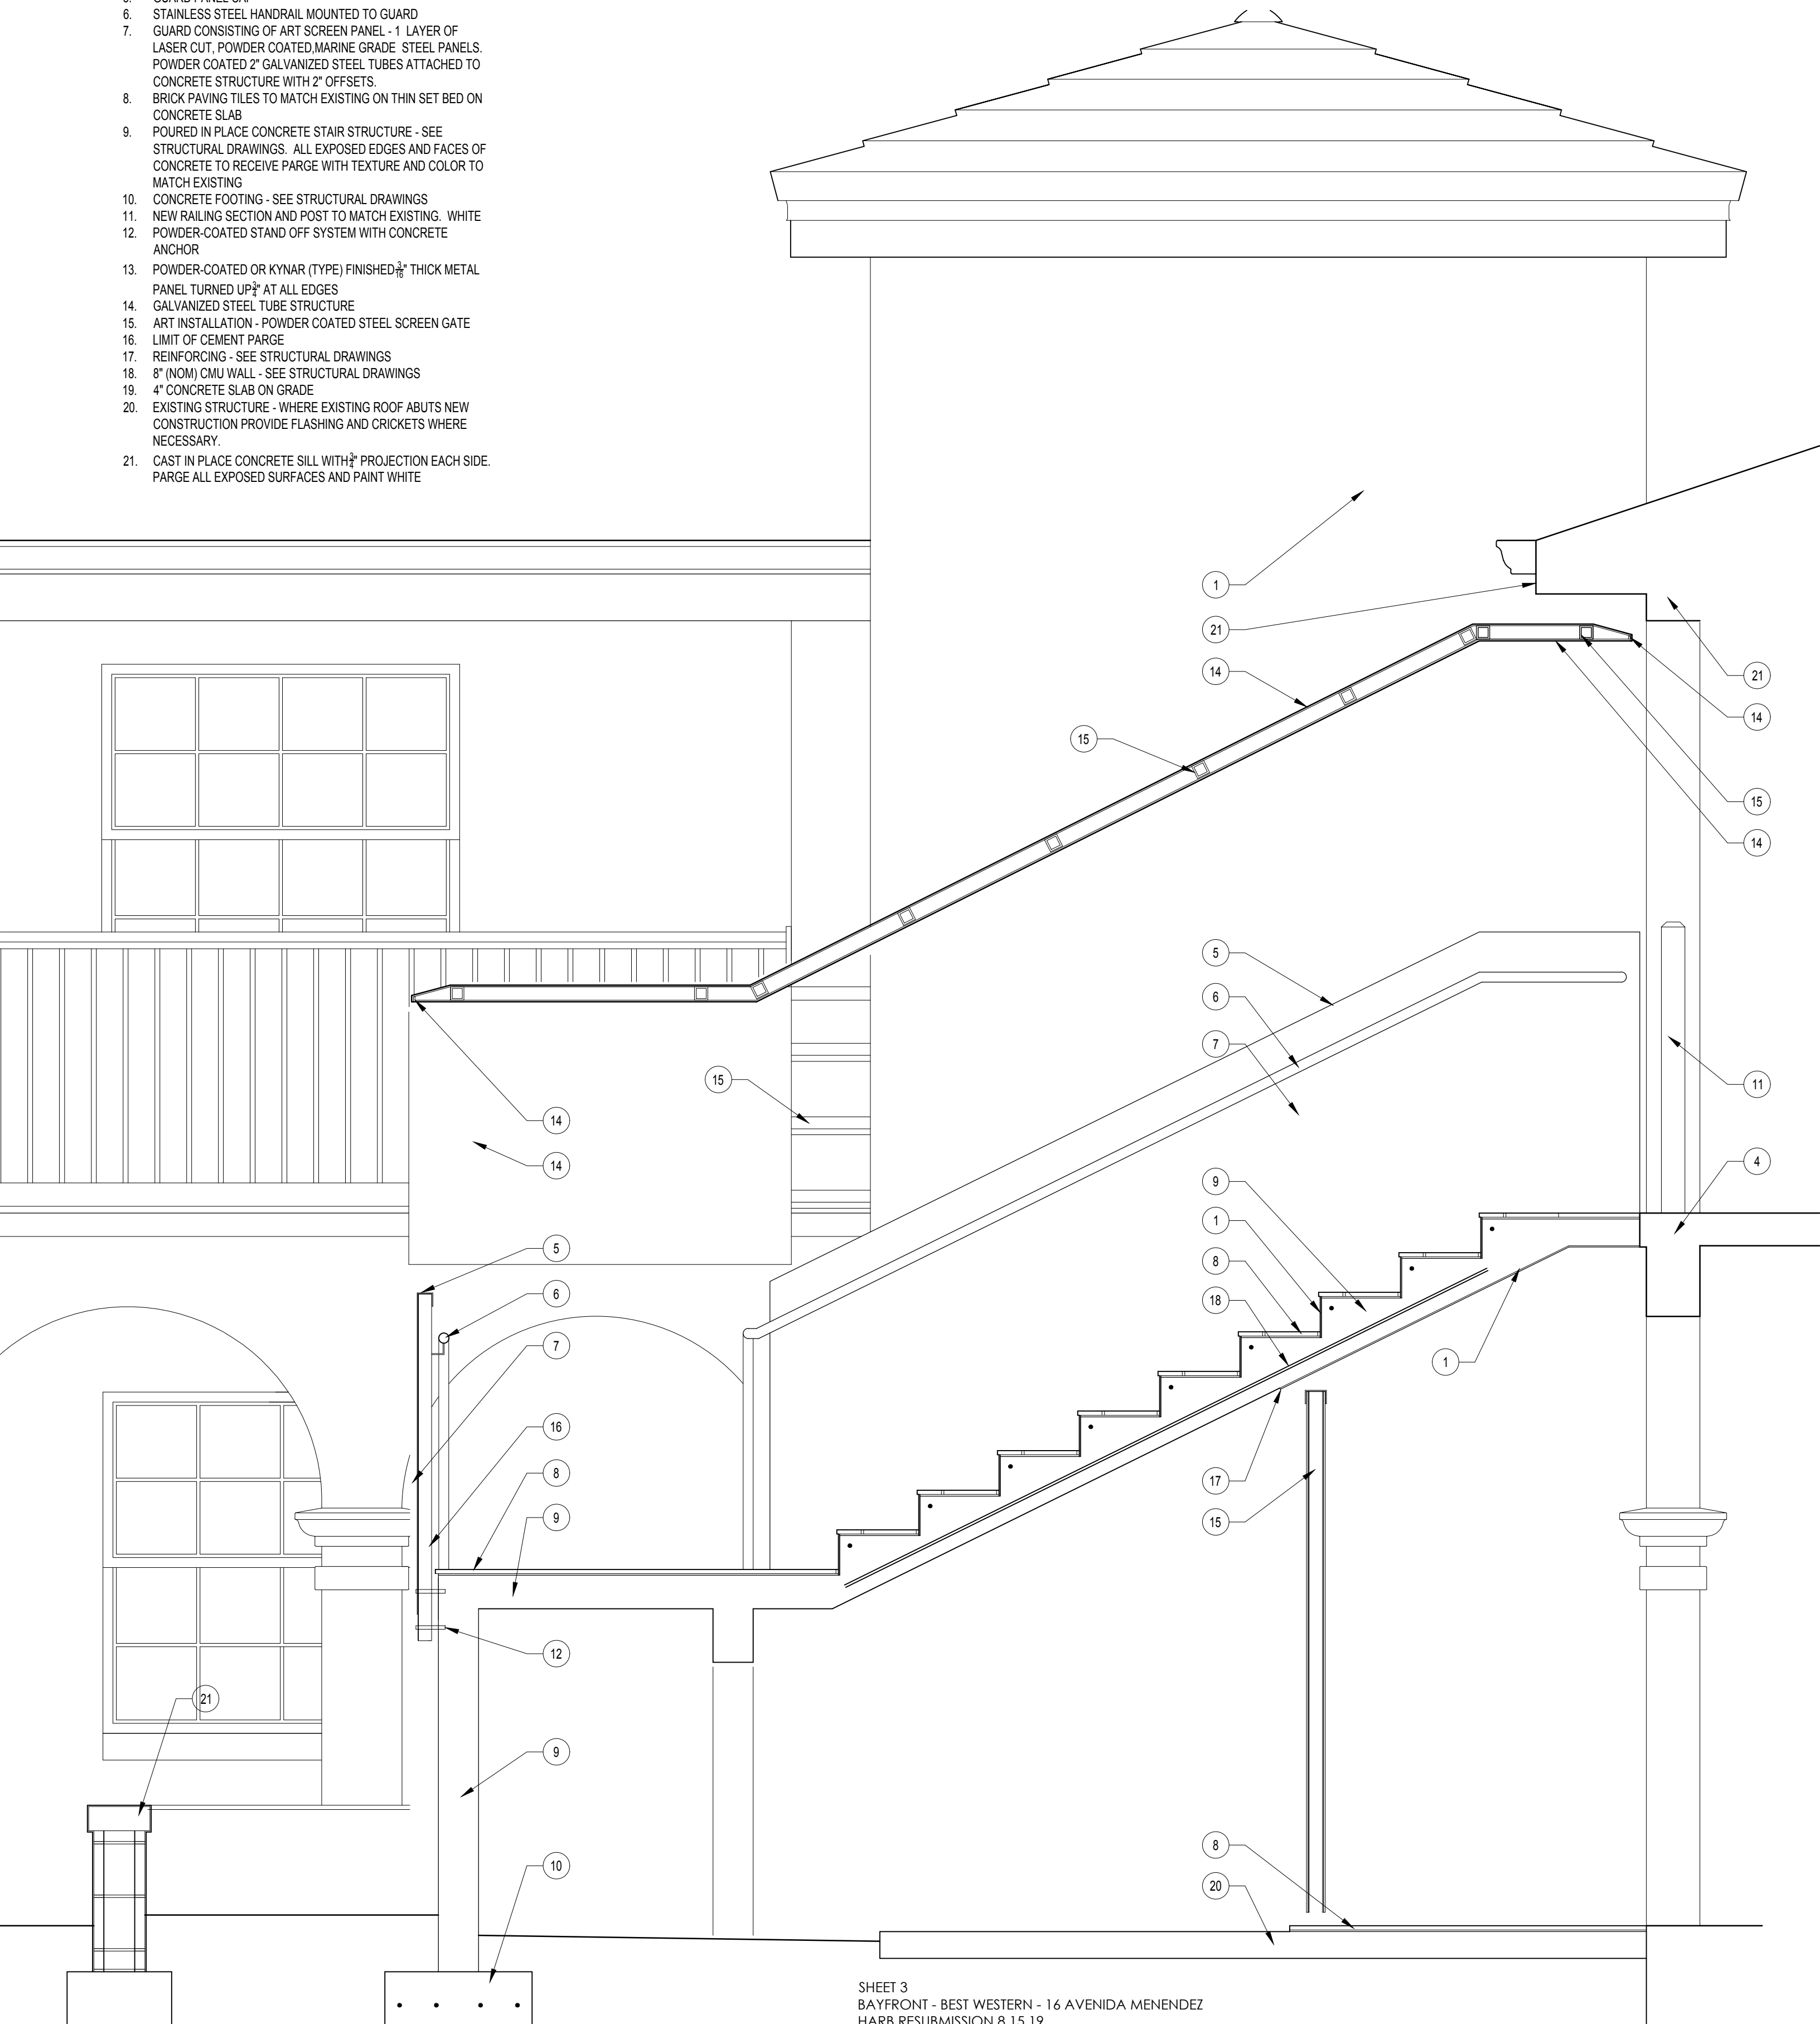
SHEET 3  
BAYFRONT - BEST WESTERN - 16 AVENIDA MENENDEZ  
HARB RESUBMISSION 8.15.19  
SARAH RYAN ARCHITECT, LLC

3. EXISTING WOOD RAILING
4. EXISTING CONCRETE FLOOR STRUCTURE
5. GUARD PANEL CAP
6. STAINLESS STEEL HANDRAIL MOUNTED TO GUARD
7. GUARD CONSISTING OF ART SCREEN PANEL - 1 LAYER OF LASER CUT, POWDER COATED, MARINE GRADE STEEL PANELS. POWDER COATED 2" GALVANIZED STEEL TUBES ATTACHED TO CONCRETE STRUCTURE WITH 2" OFFSETS.

15. ART INSTALLATION - POWDER COATED STEEL SCREEN GATE
16. LIMIT OF CEMENT PARGE
17. REINFORCING - SEE STRUCTURAL DRAWINGS
18. 8" (NOM) CMU WALL - SEE STRUCTURAL DRAWINGS

19. 4" CONCRETE SLAB ON GRADE
20. EXISTING STRUCTURE - WHERE EXISTING ROOF ABUTS NEW CONSTRUCTION PROVIDE FLASHING AND CRICKETS WHERE NECESSARY.
21. CAST IN PLACE CONCRETE SILL WITH  $\frac{3}{4}$ " PROJECTION EACH SIDE. PARGE ALL EXPOSED SURFACES AND PAINT WHITE

## SECTION AT NEW STAIR AND ELEVATOR

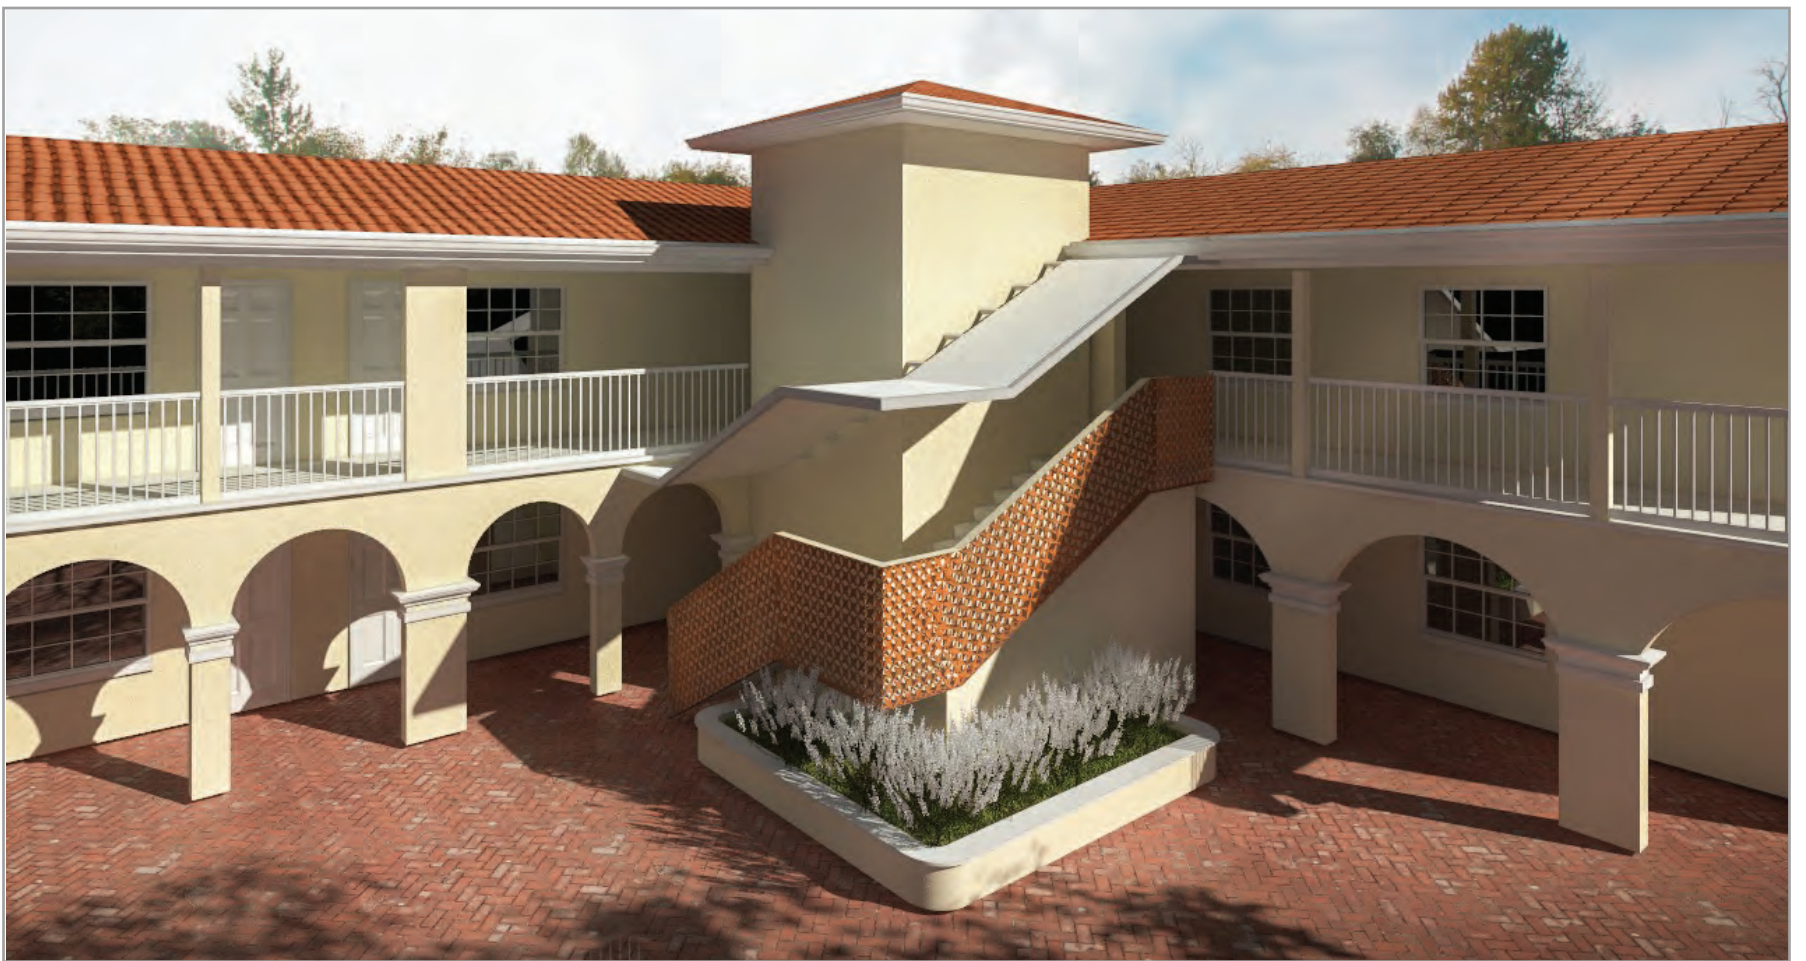
16 Avenida Menendez - Proposed Corner Elevator and Stair View

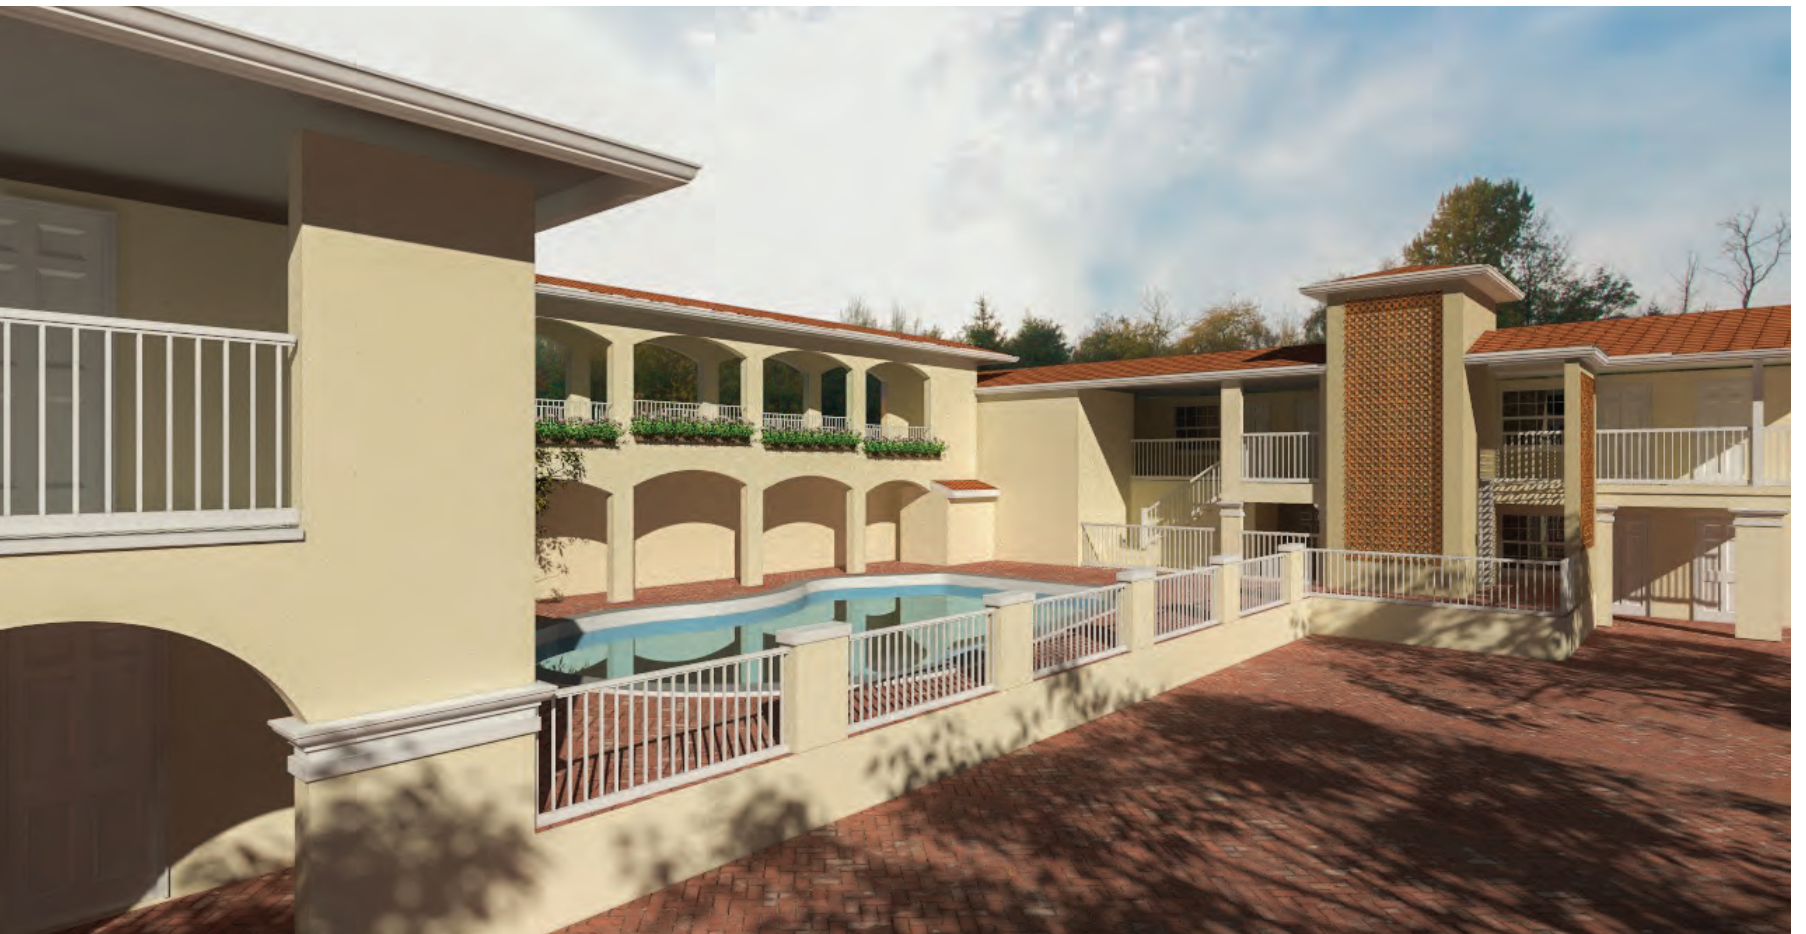
16 Avenida Menendez - Proposed Pool Side Elevator and Walkway View

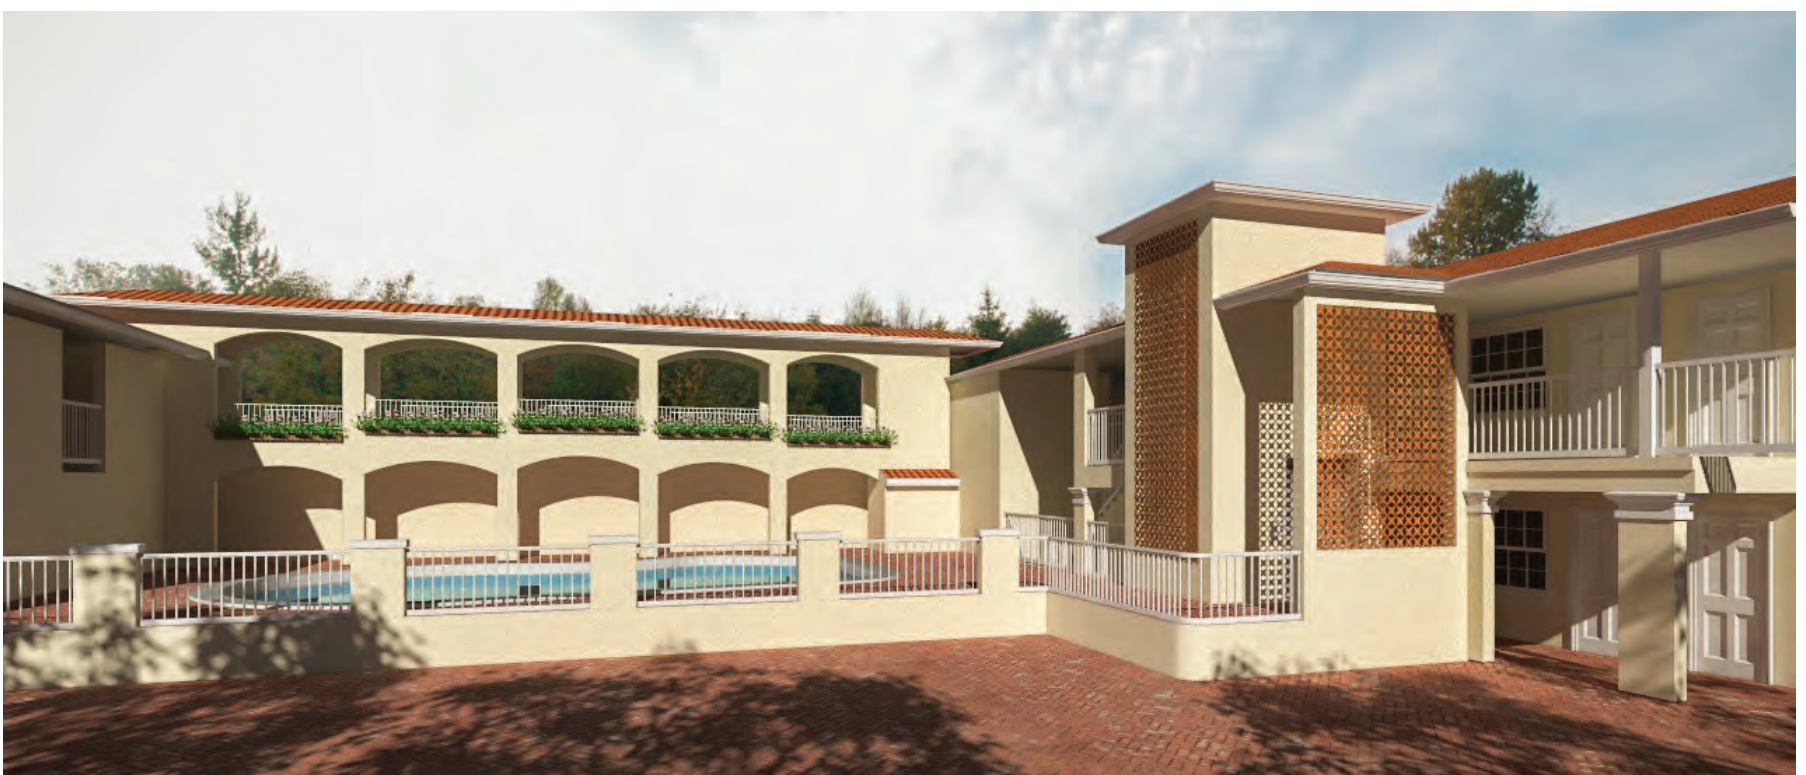
16 Avenida Menendez - Proposed Pool Side Elevator and Walkway View

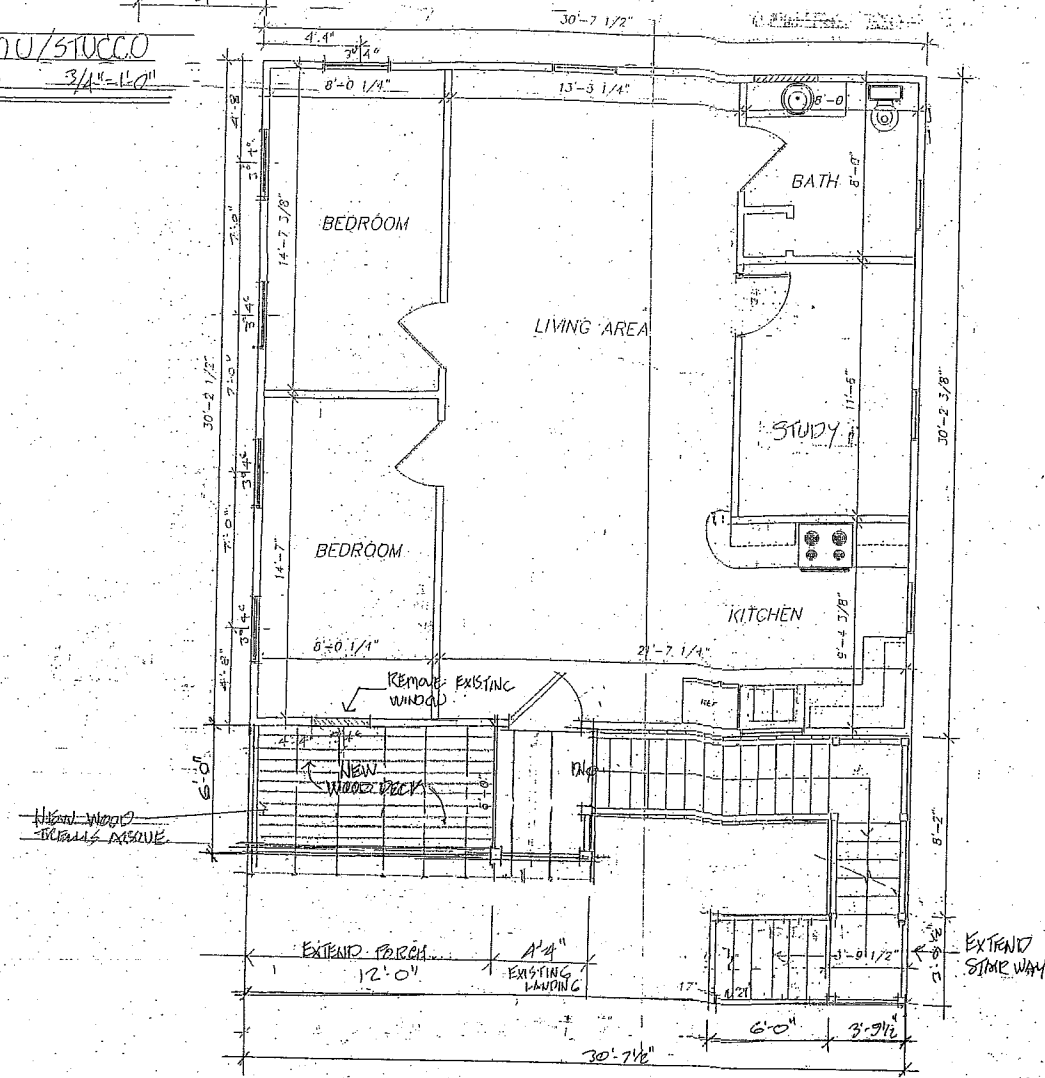
PROPOSED 2nd FLOOR  
SCALE 1/4"=1'-0"

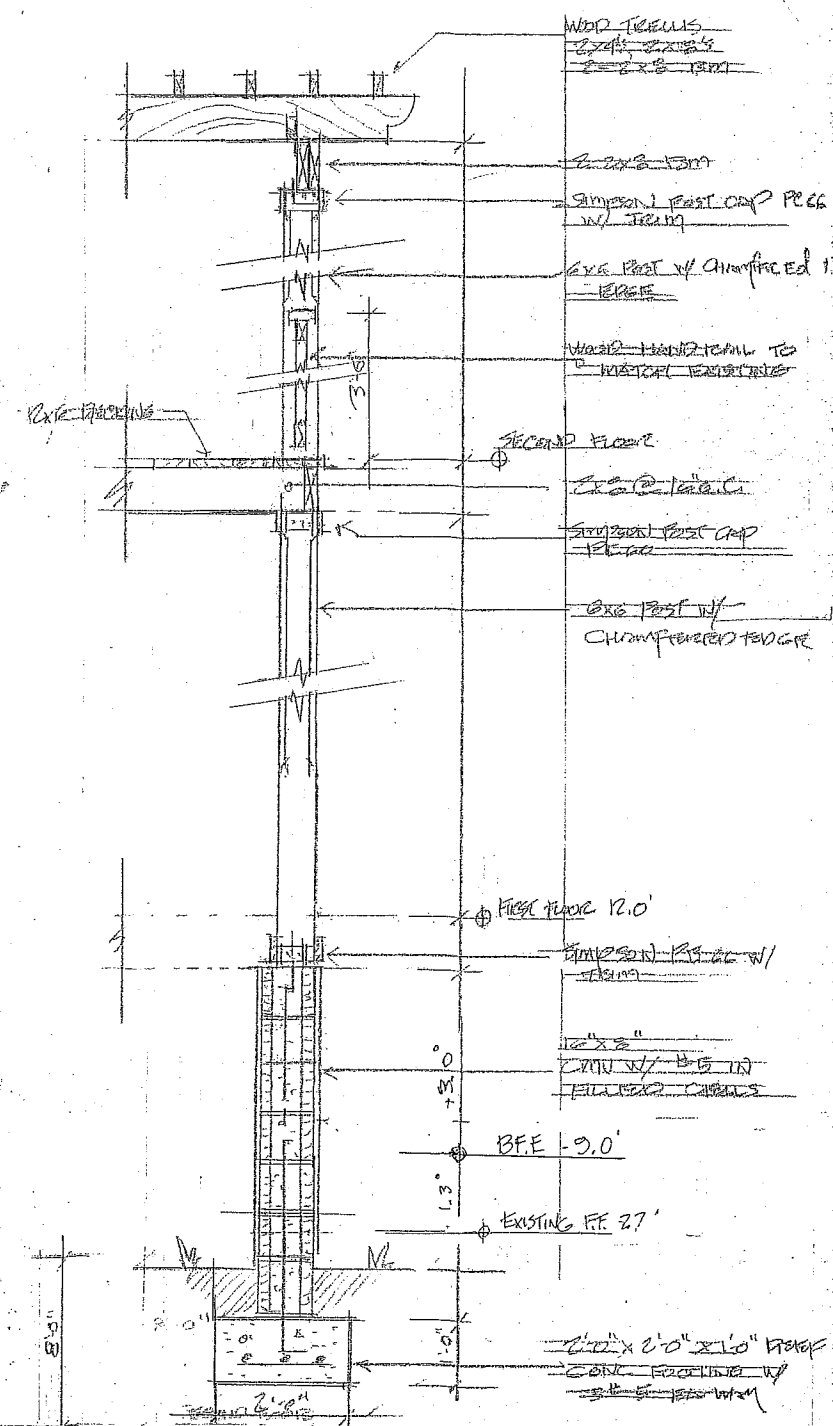
TYPICAL SECTION @  
NEW DECK AND TRELLIS 34'-10"
