# City of St. Augustine

## Historic Architectural Review Board

### A G E N D A

HISTORIC ARCHITECTURAL REVIEW BOARD  
STAFF REPORT AND RECOMMENDATION  
Prepared for August 15, 2019 Meeting

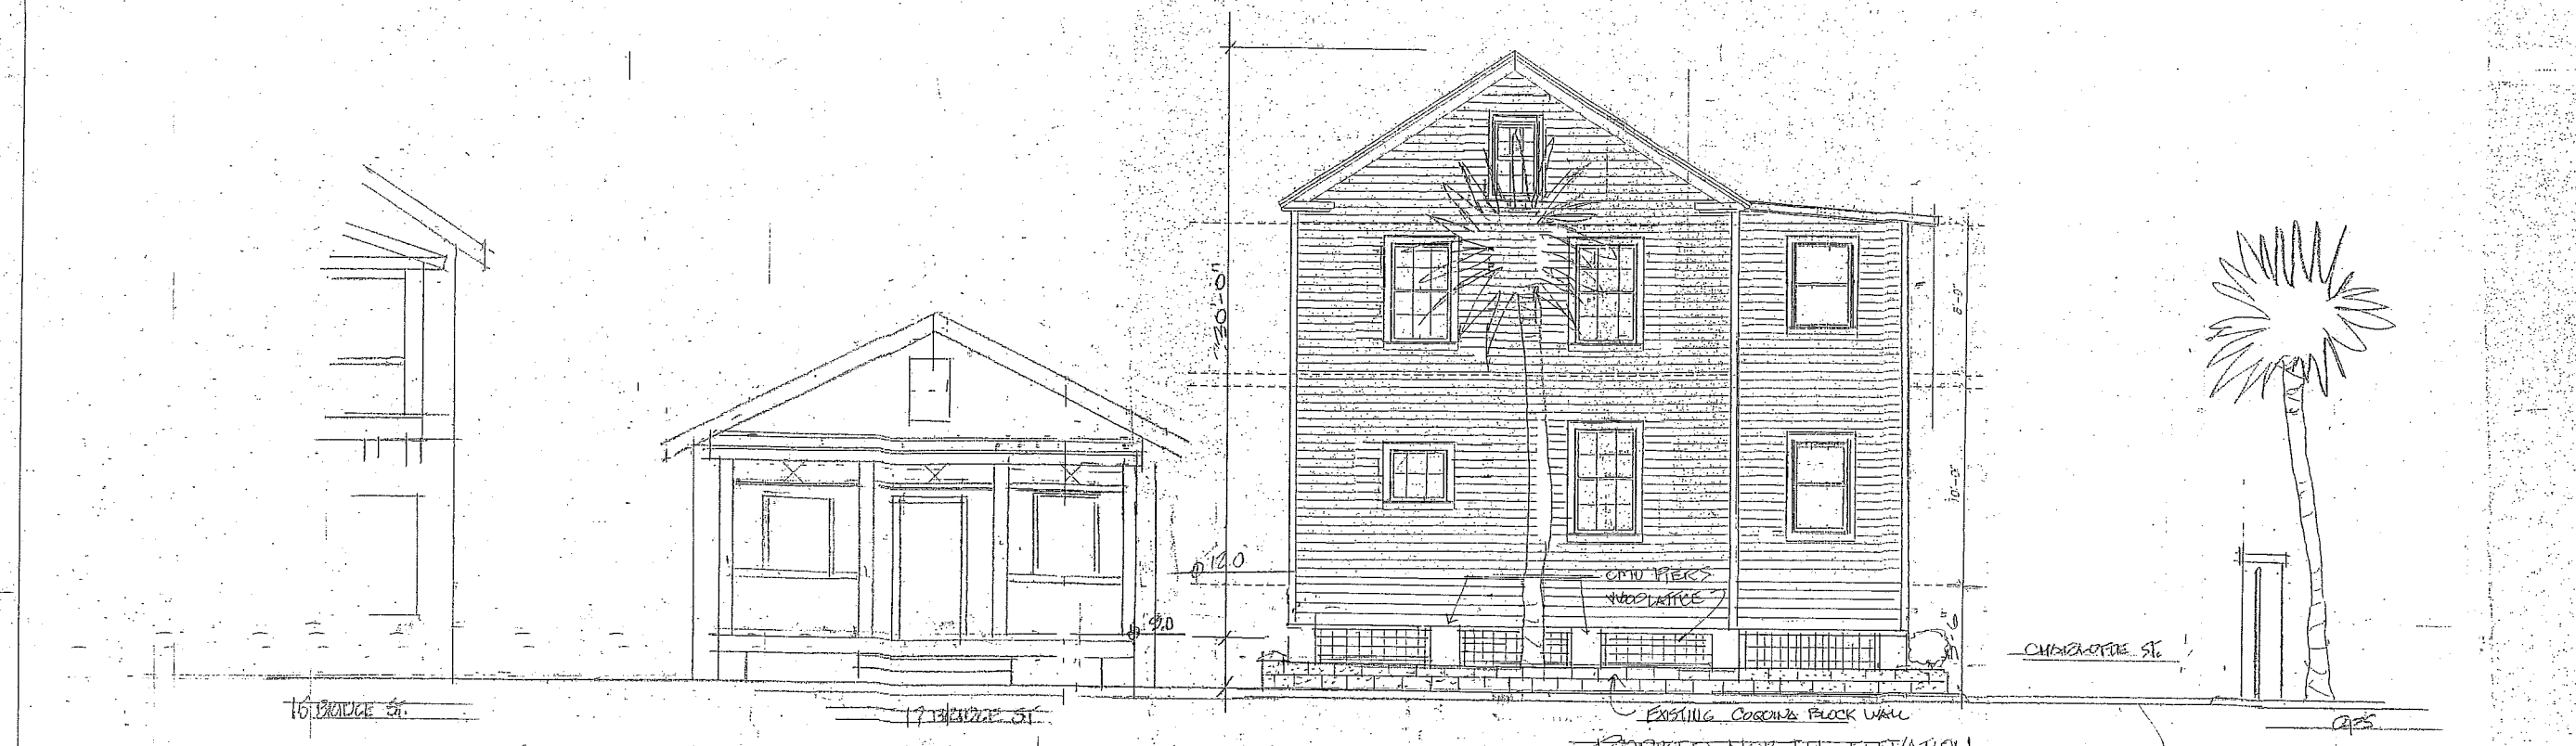
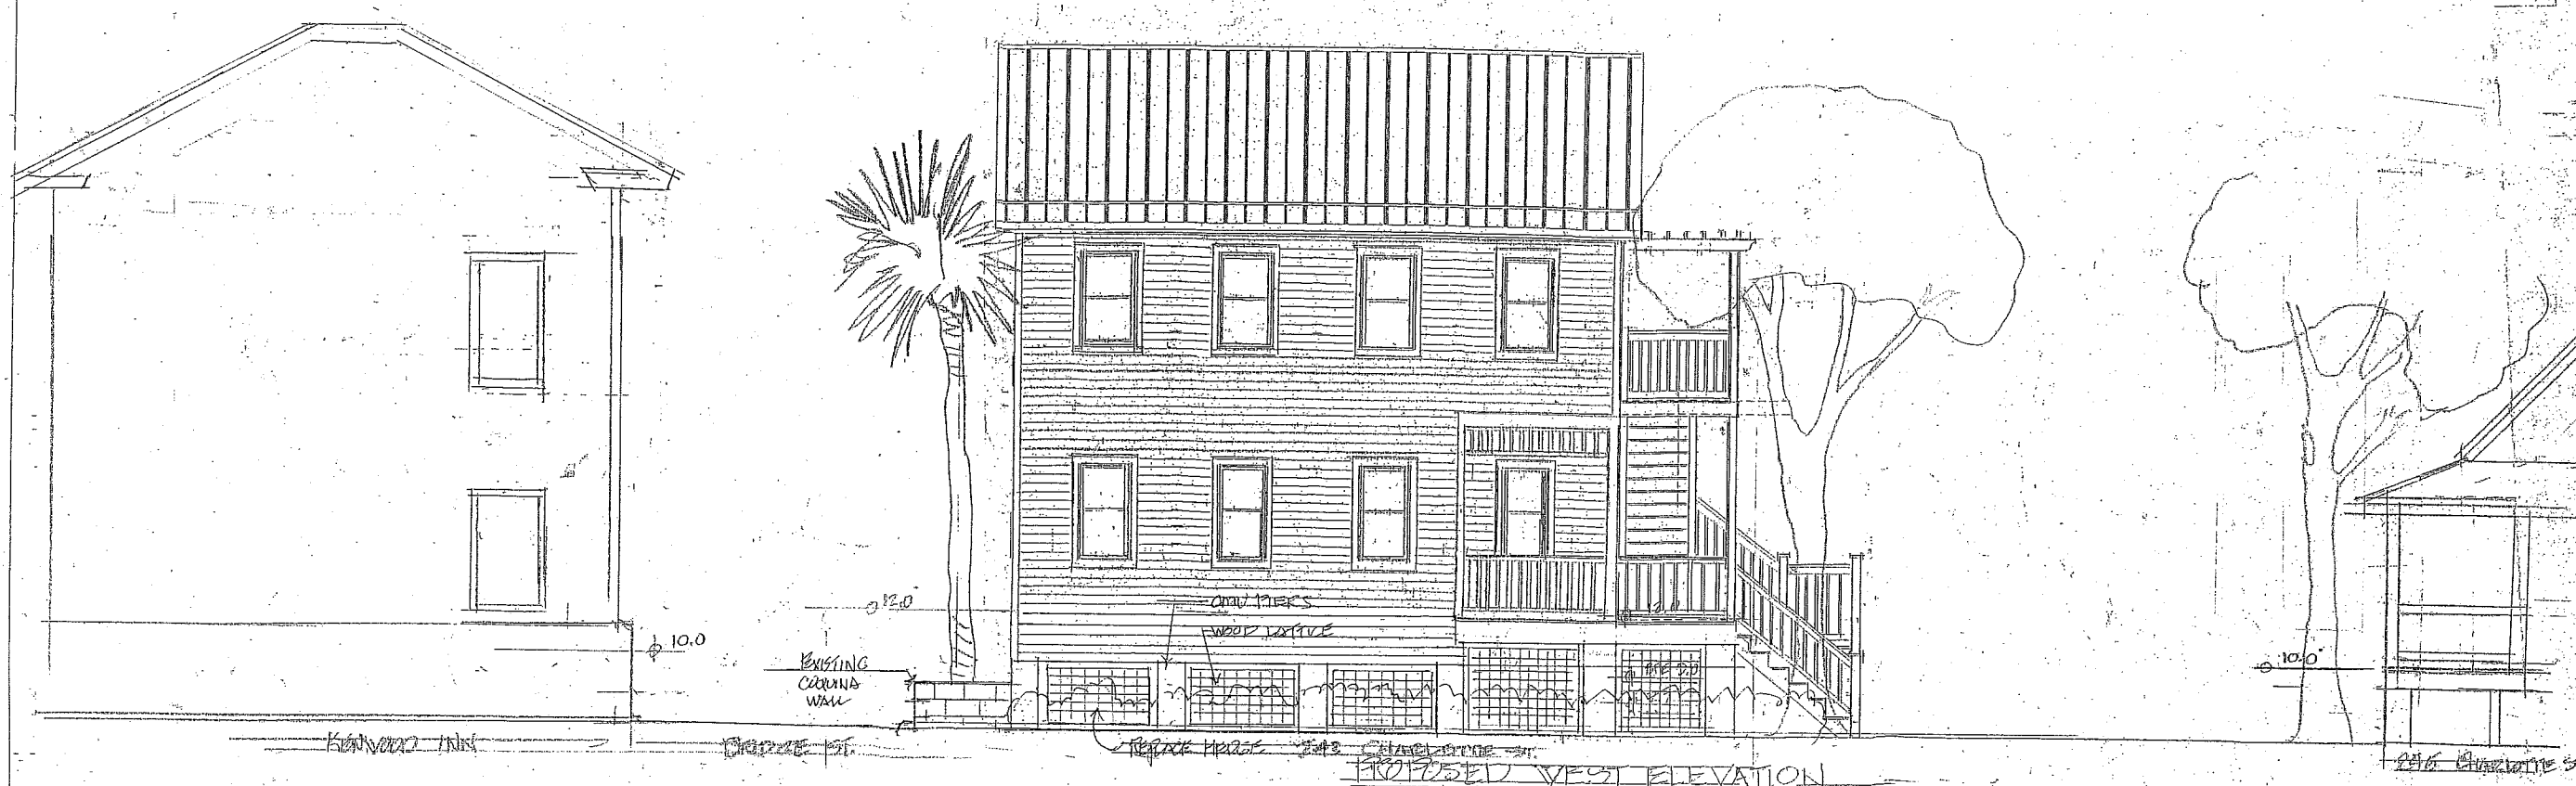
DATE: 6-20-19  
SCALE: AS NOTED  
DWG: DWG/243CHAR  
SHEET  
A-2

NEW STAIRCASE AT:  
243 CHARLOTTE ST.  
SAINT AUGUSTINE, FL 32084
