# City of St. Augustine

## Historic Architectural Review Board

### A G E N D A

**Thursday, September 26, 2019 1:00 p.m.**

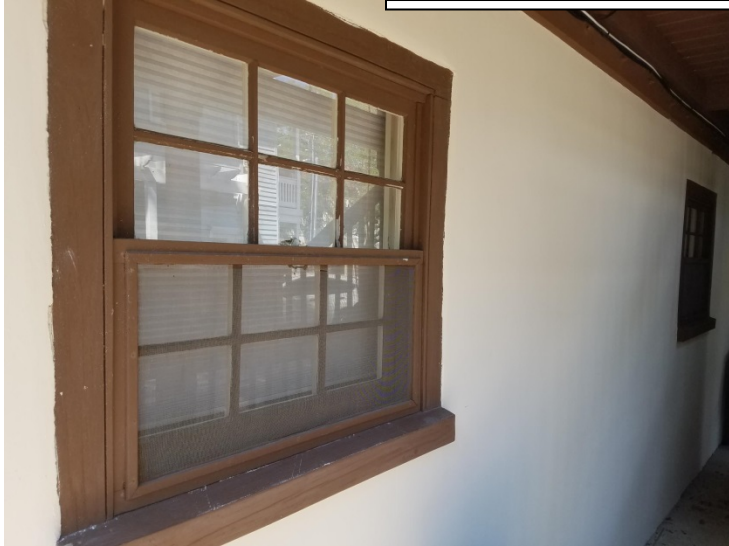
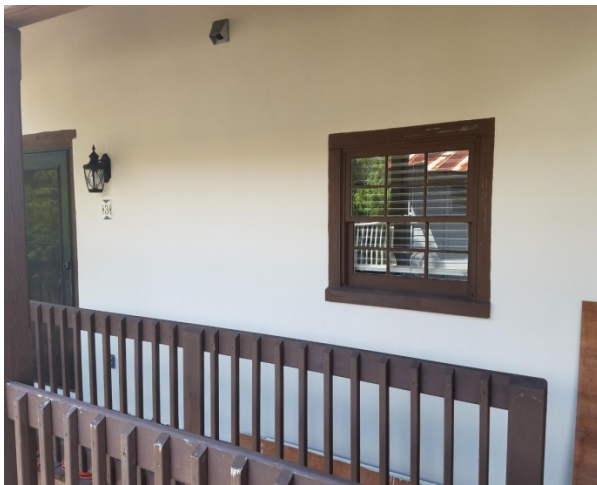
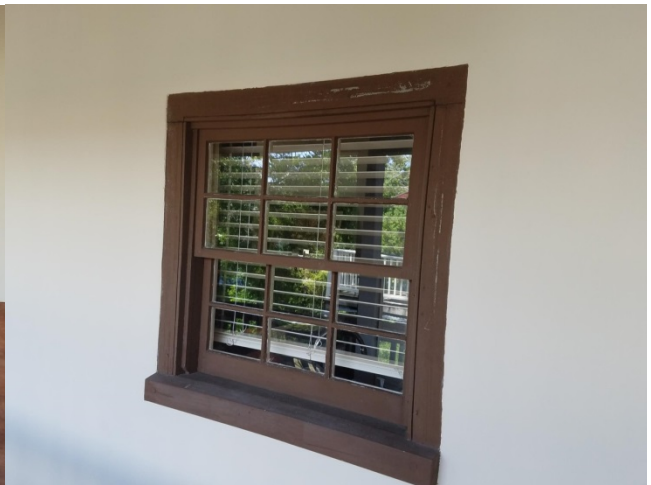
North Side of home, not visible from the road, faces the homes private parking. Least damage but windows don't function properly.

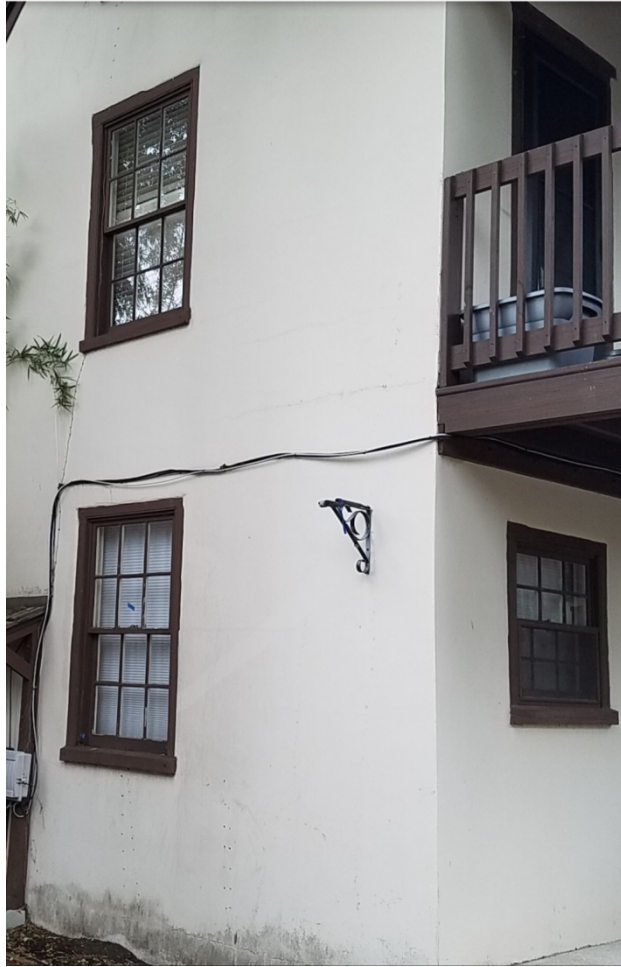
East Side of home, not seen from road, facing the rear of the property into the homes private parking. Significant damage to both windows.

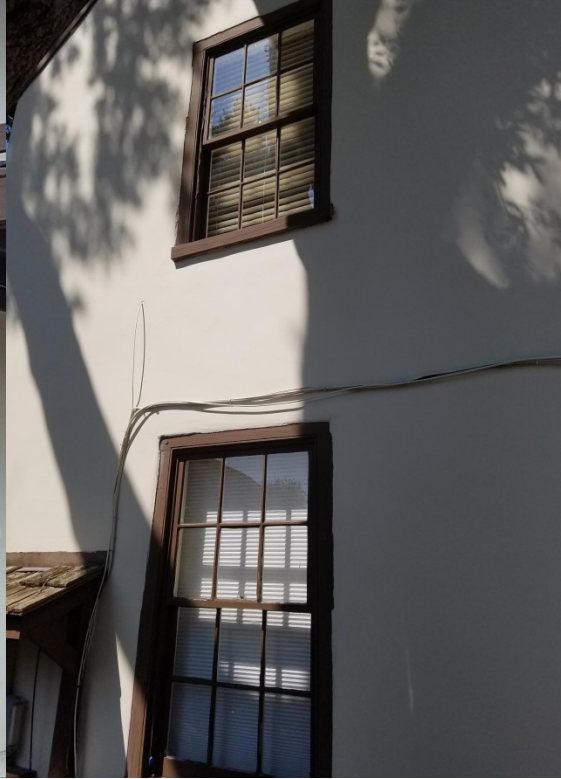
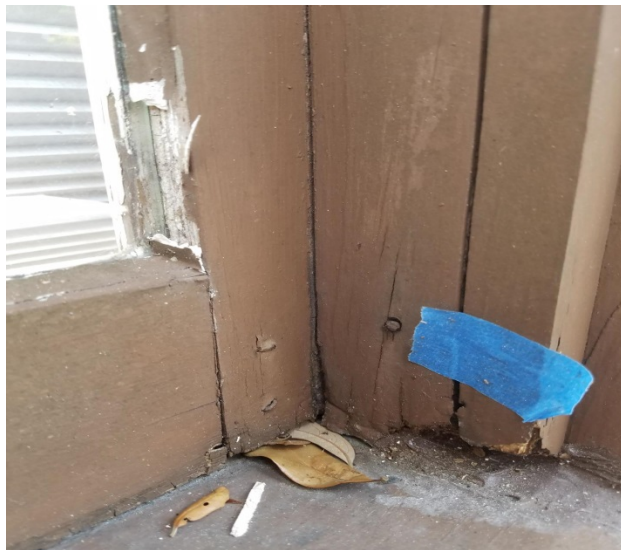
South facing portion of home, not seen from road, windows face neighbor's house. Both windows have significant damage.

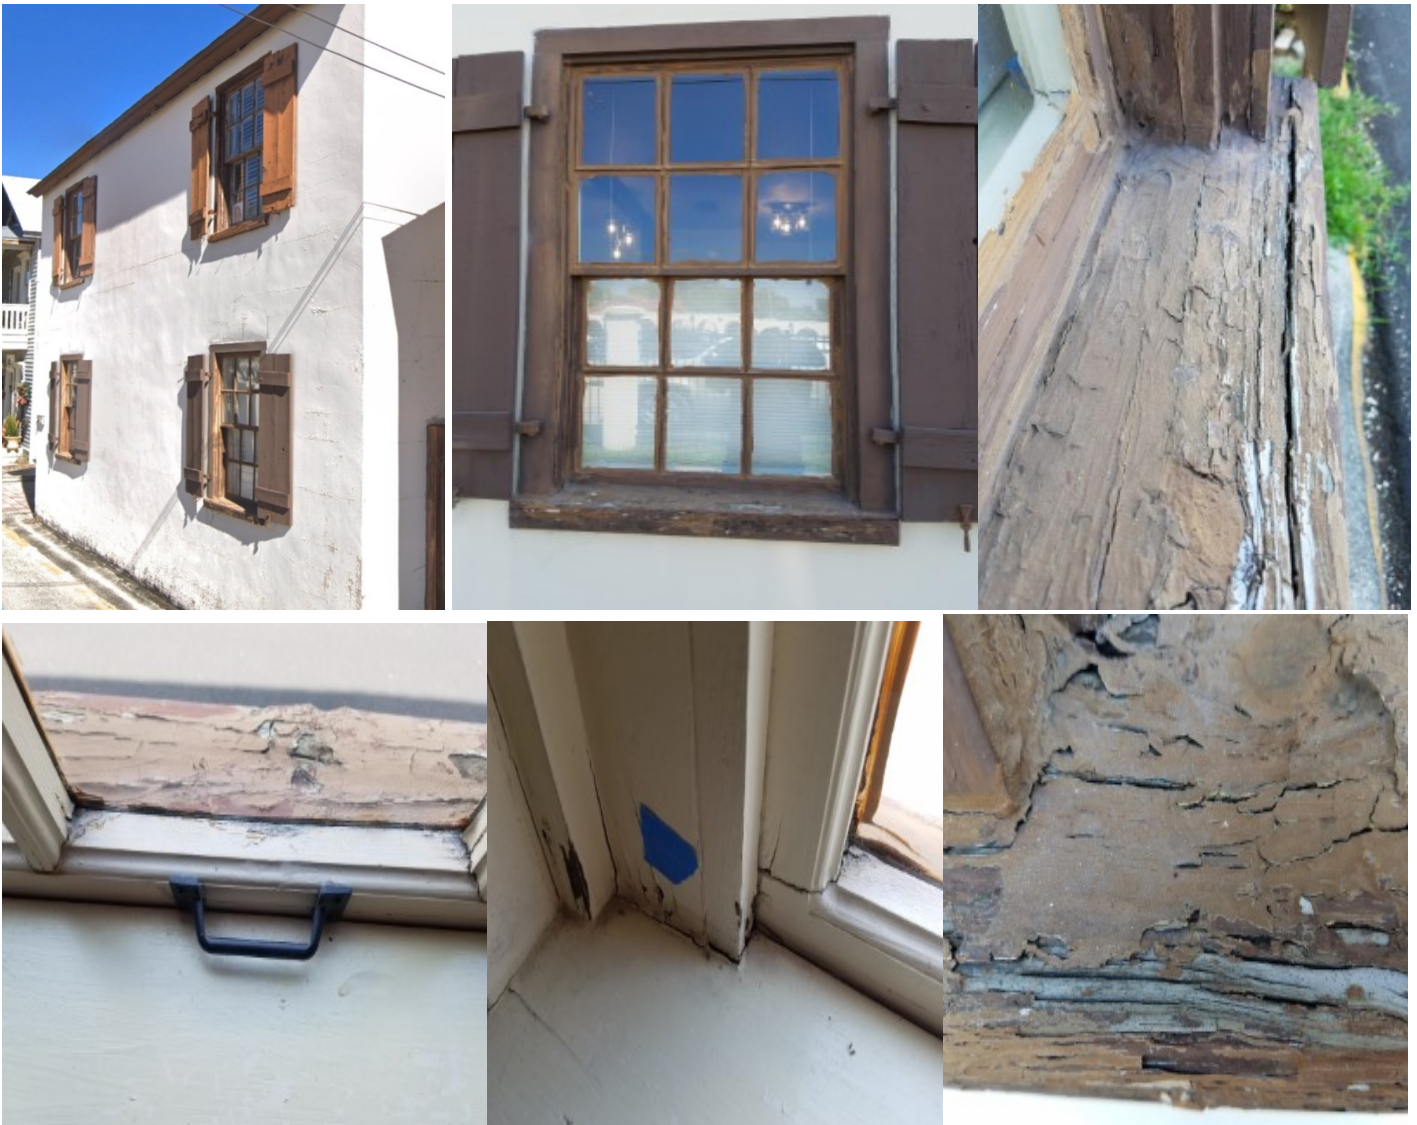
Bottom right front window showing significant sun and weather damage . This side of the building has the most exposure to the elements ,especialy sun most of the day.

While some attempt has been made to improve the appearance using filler and paint, the condition of the windows remains completely ineffectve for their intended purpose.

They DO NOT prevent insects and other unwanted pest from entering.

They DO NOT open.

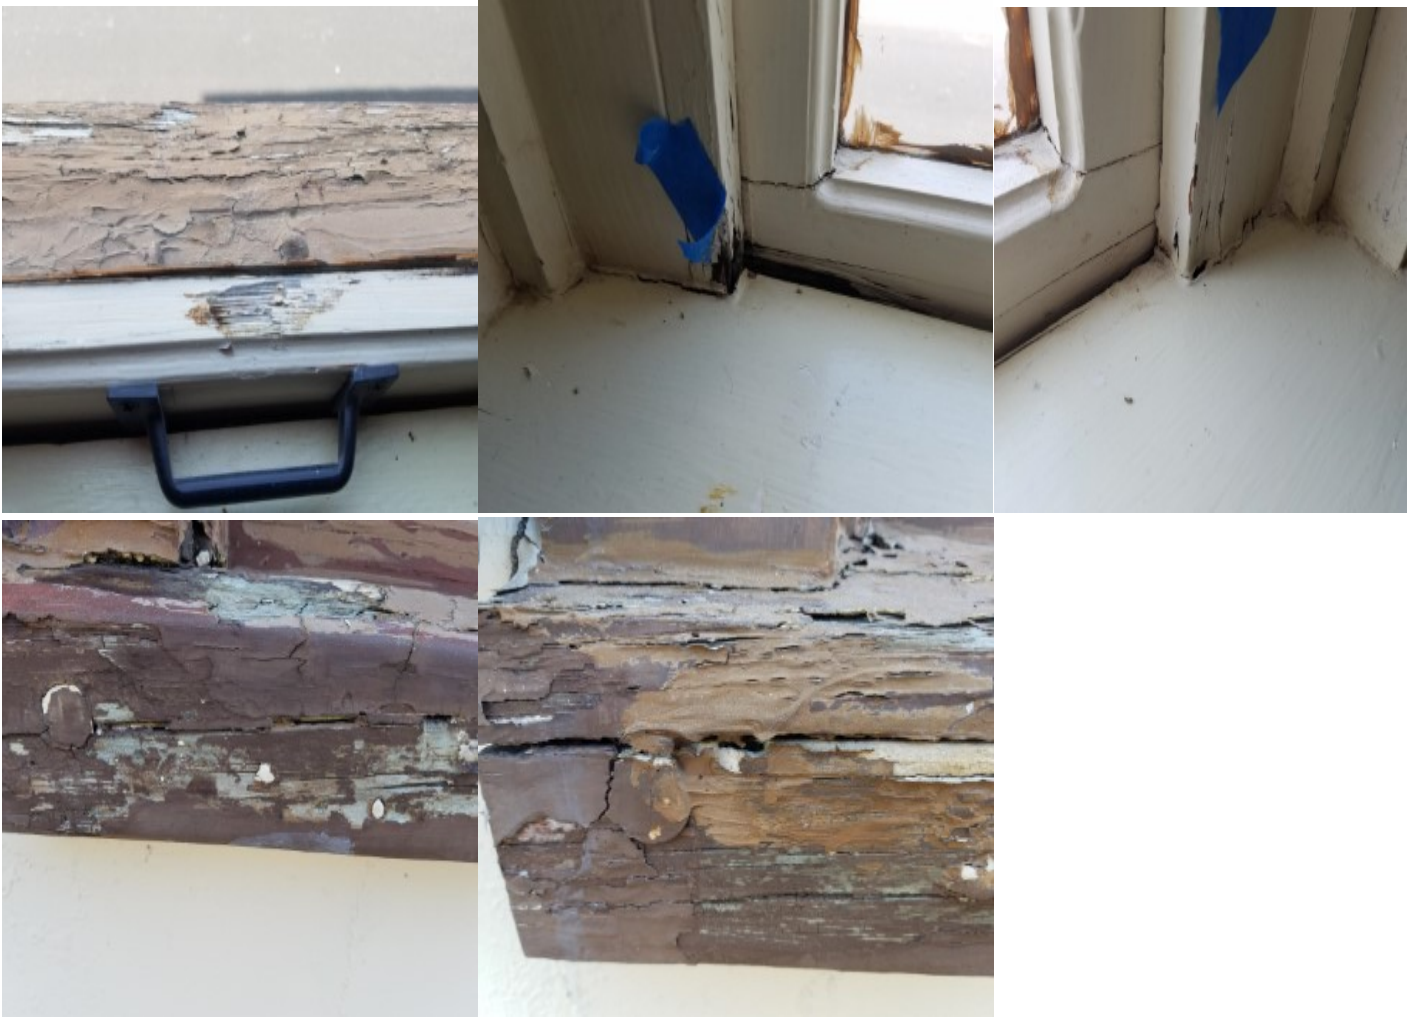
Bottom left front window showing significant sun and weather damage . This side of the building has the most exposure to the elements ,especialy sun most of the day.

While some attempt has been made to improve the appearance using filler and paint, the condition of the windows remains completely ineffectve for their intended purpose.

They DO NOT prevent insects and other unwanted pest from entering.

They DO NOT open.

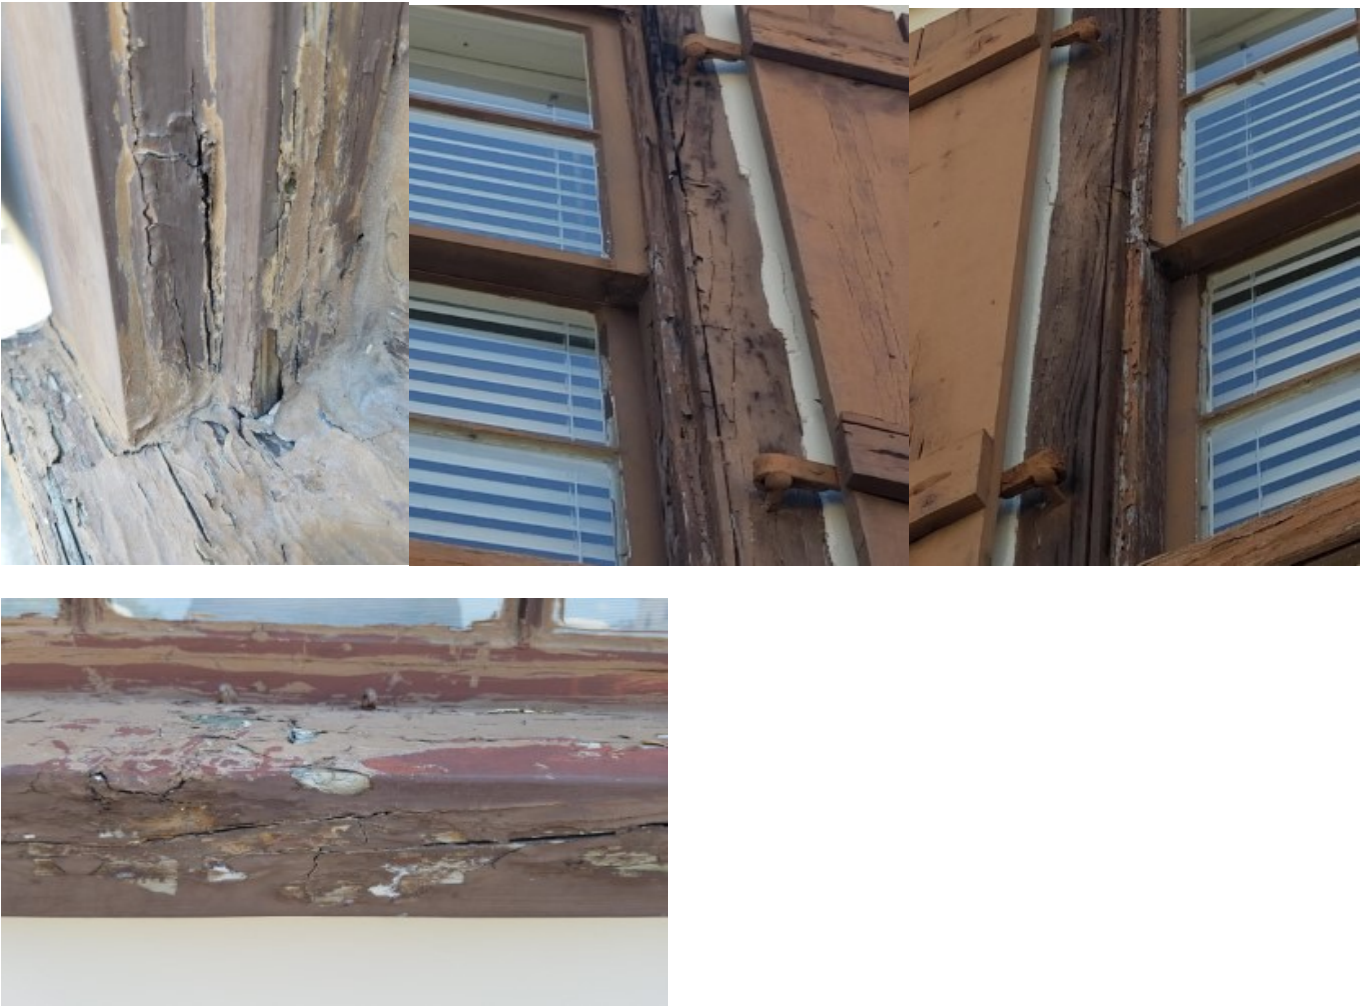
Upper right front window showing significant sun and weather damage . This side of the building has the most exposure to the elements ,especialy sun most of the day.

While some attempt has been made to improve the appearance using filler and paint, the condition of the windows remains completely ineffectve for their intended purpose.

They DO NOT prevent insects and other unwanted pest from entering.

They DO NOT open.

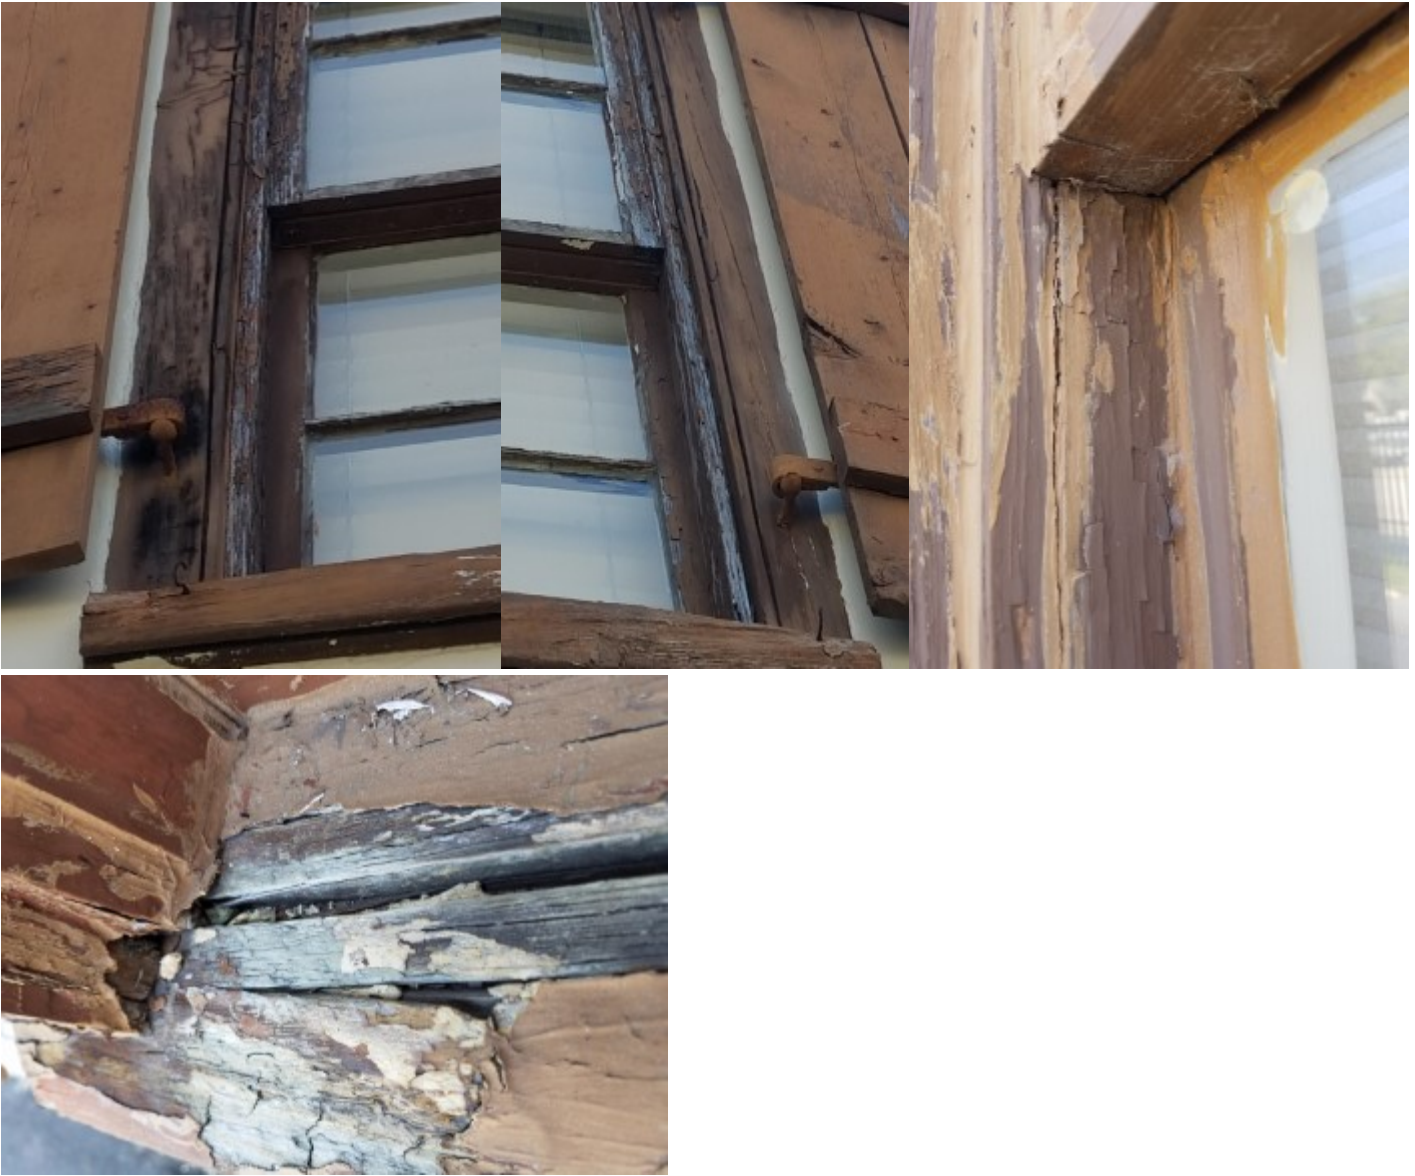
Upper left front window showing significant sun and weather damage . This side of the building has the most exposure to the elements ,especialy sun most of the day.

While some attempt has been made to improve the appearance using filler and paint, the condition of the windows remains completely ineffectve for their intended purpose.

They DO NOT open.

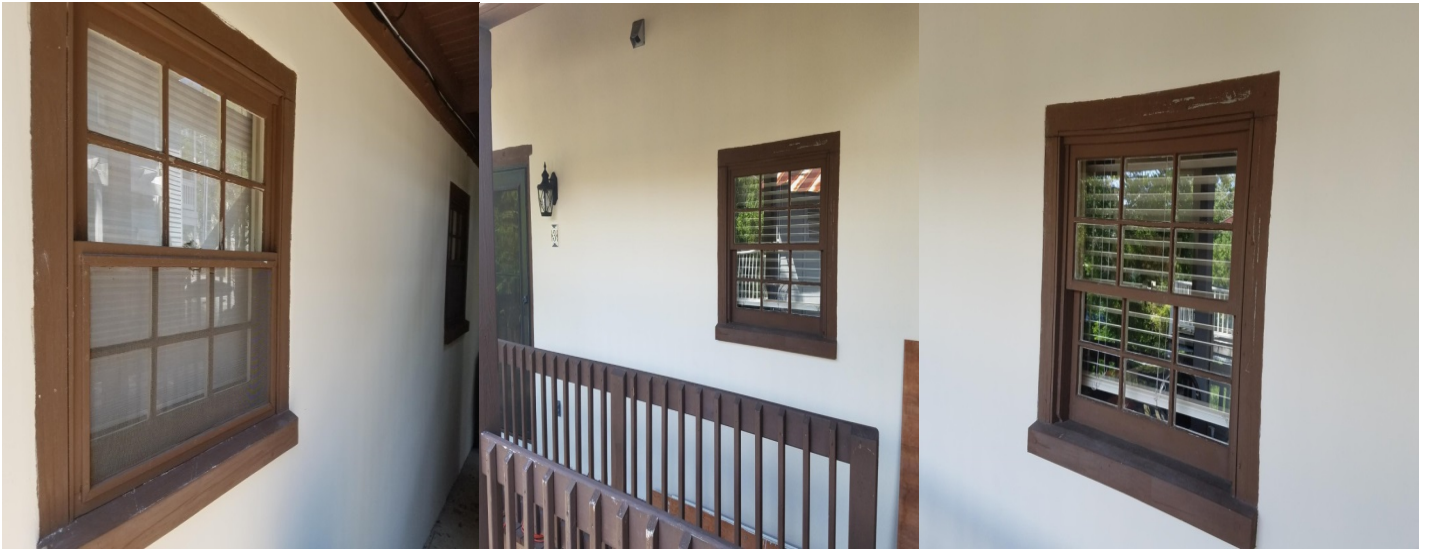
North Side of home, faces the homes private parking. Least damage but windows don't function properly.

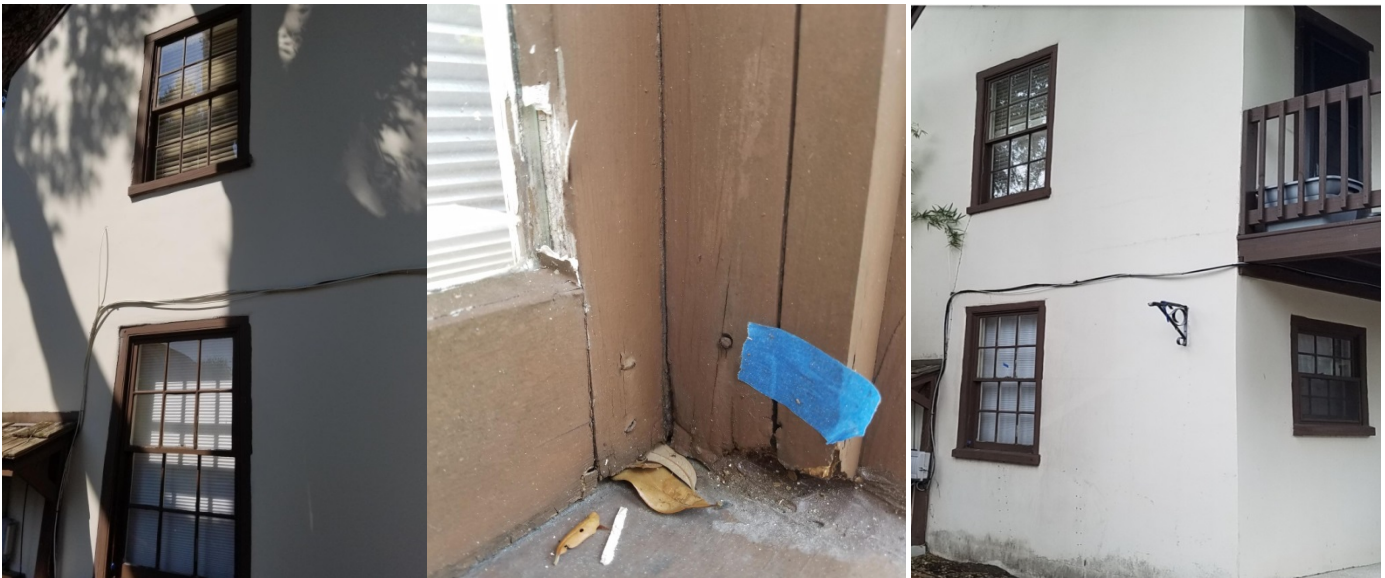
East side of home, not visible from the road, faces the homes private parking. Least damage but windows don't function properly and have water intrusion due to wood rot and insect damage. Due to large tree, windows on this side are shaded all day which promotes detreating of the wood and mold and mildew growth.

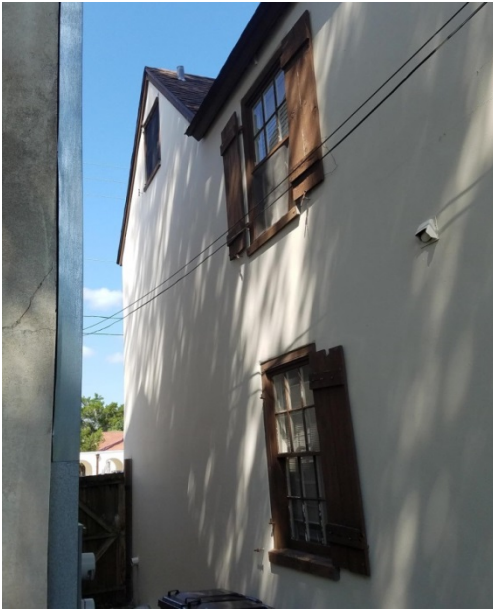
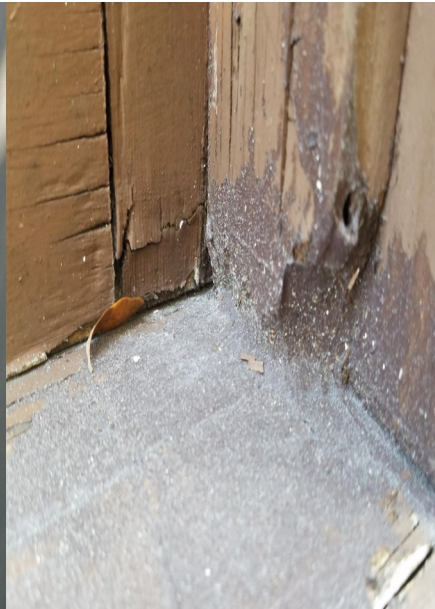
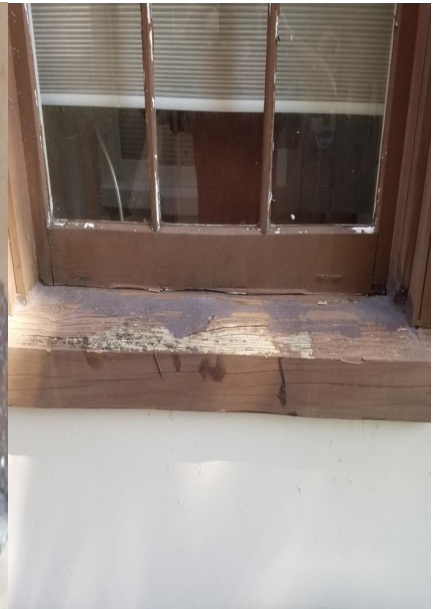
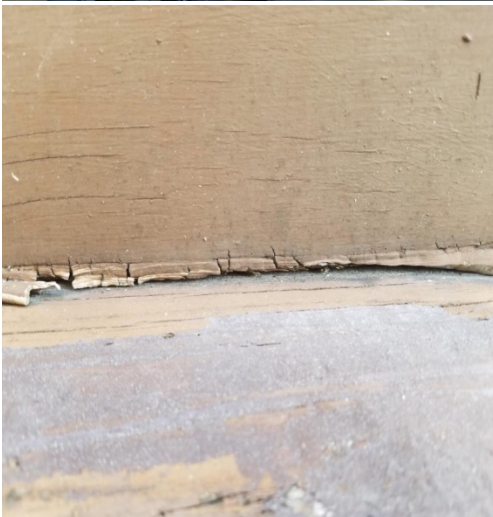
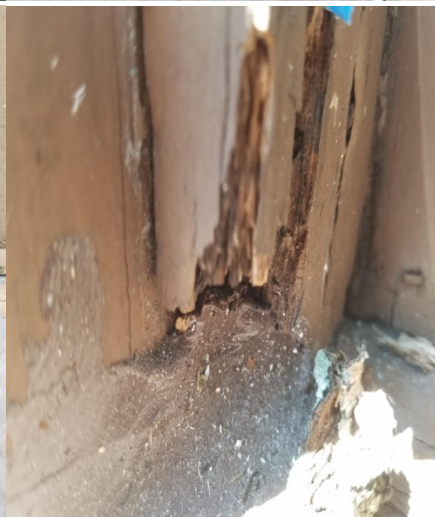
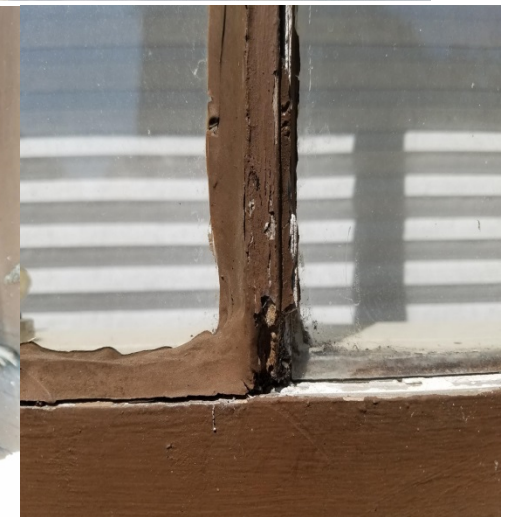
South facing portion of the home, windows face neighbor's house. Both windows have significant damage.

Inoperable with water and insects intrusion.

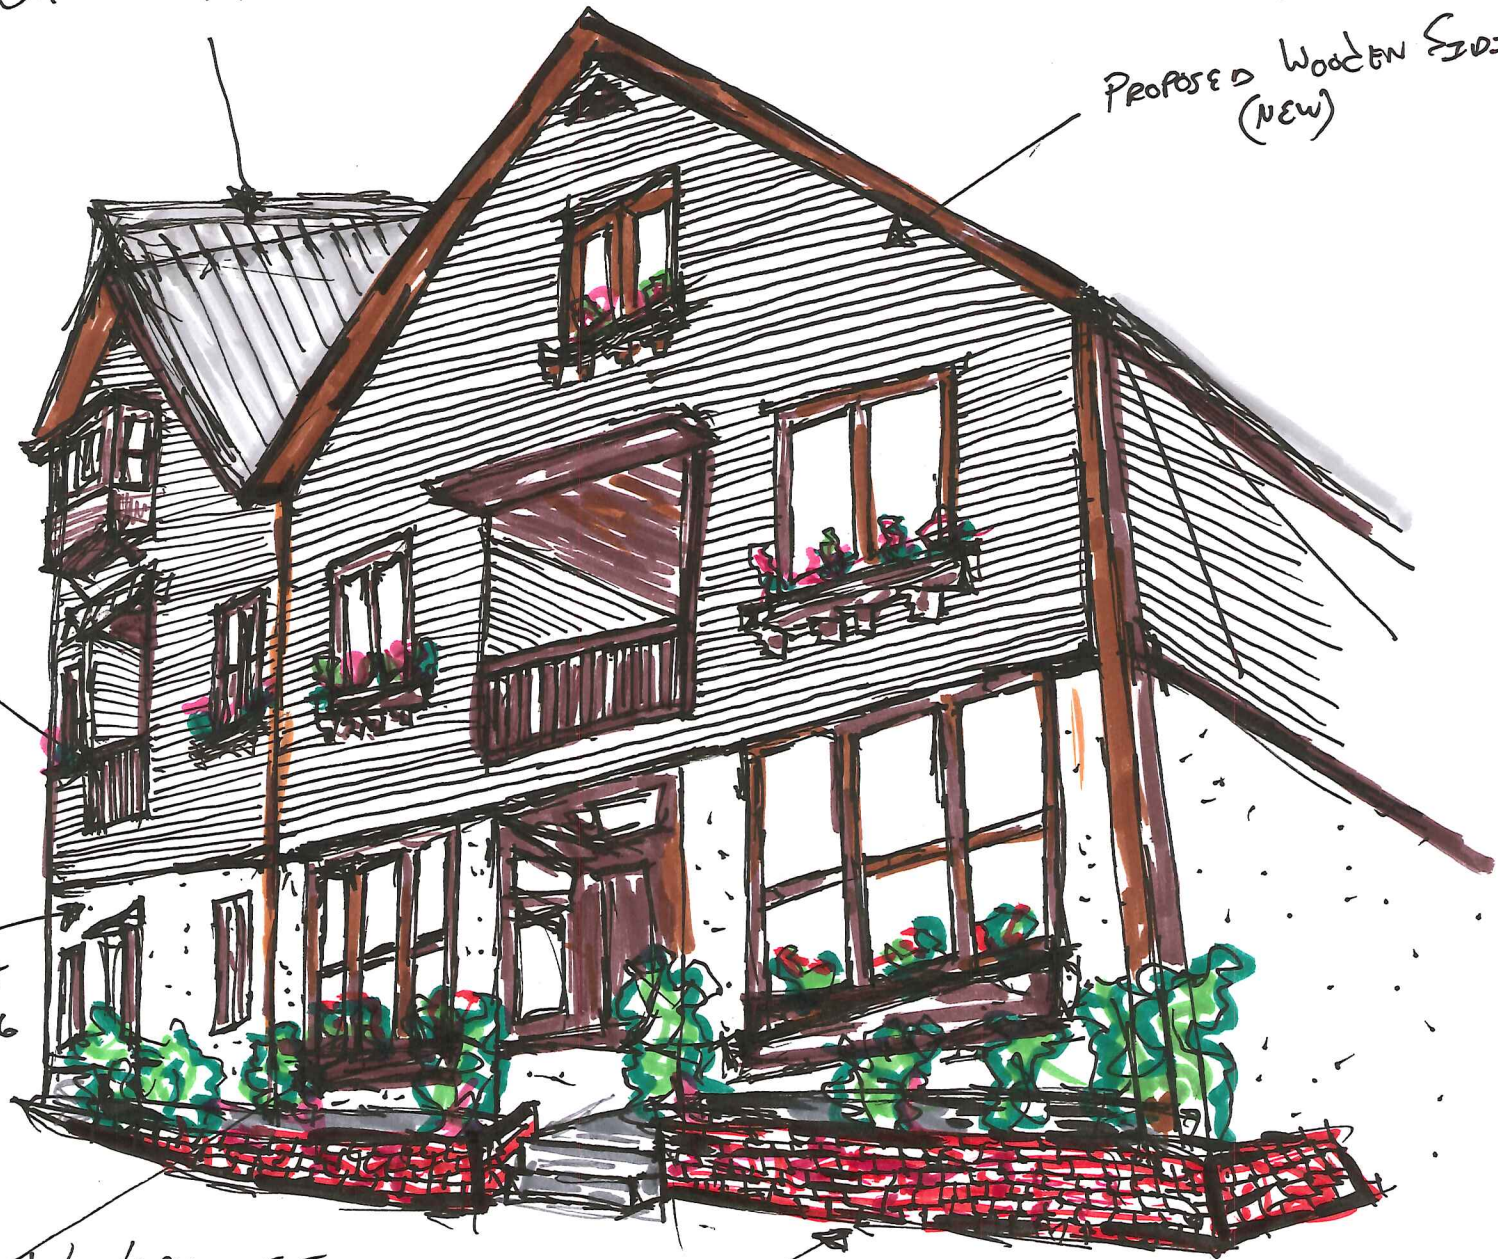
EX 7

PROPOSED INSTALLATION/REPLACEMENT  
OF PLANTER BOXES

PROPOSED CLEANING  
OF EXISTING BRICK WALL

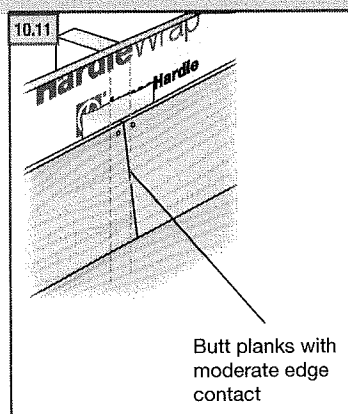
Butt joints in HardiePlank lap siding should always land on a stud. Butt joints between studs are not recommended and should be avoided. Whenever possible, factory-finished ends should be used at butt joints.

Butt planks with  
moderate edge  
contact

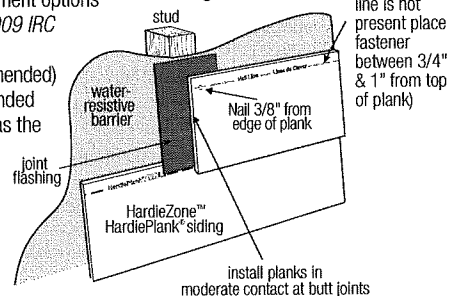
Figure 2

- Joint Flashing (James Hardie recommended)
- Caulking\* (Caulking is not recommended for ColorPlus for aesthetic reasons as the Caulking and ColorPlus will weather differently. For the same reason, do not caulk nail heads on ColorPlus products.)
- "H" jointer cover

Nail line (if nail line is not present place fastener between 3/4" & 1" from top of plank)

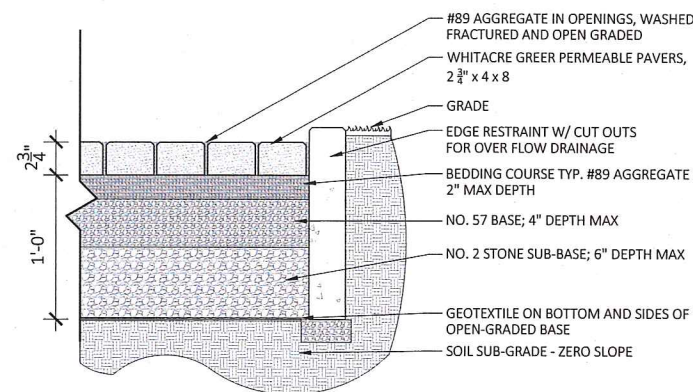
3 WHITACRE GREER PERVIOUS PAVERS

#89 AGGREGATE IN OPENINGS, WASHED FRACTURED AND OPEN GRADED  
WHITACRE GREER PERMEABLE PAVERS, 2 3/4" x 4 x 8  
GRADE  
EDGE RESTRAINT W/ CUT OUTS FOR OVER FLOW DRAINAGE  
BEDDING COURSE TYP. #89 AGGREGATE 2" MAX DEPTH  
NO. 57 BASE; 4" DEPTH MAX  
NO. 2 STONE SUB-BASE; 6" DEPTH MAX  
GEOTEXTILE ON BOTTOM AND SIDES OF OPEN-GRADED BASE  
SOIL SUB-GRADE - ZERO SLOPE
