## **CITY OF ST. AUGUSTINE HISTORIC ARCHITECTURAL REVIEW BOARD**

### **A G E N D A**

**THURSDAY, DECEMBER 16, 2021 - 1:00 PM**

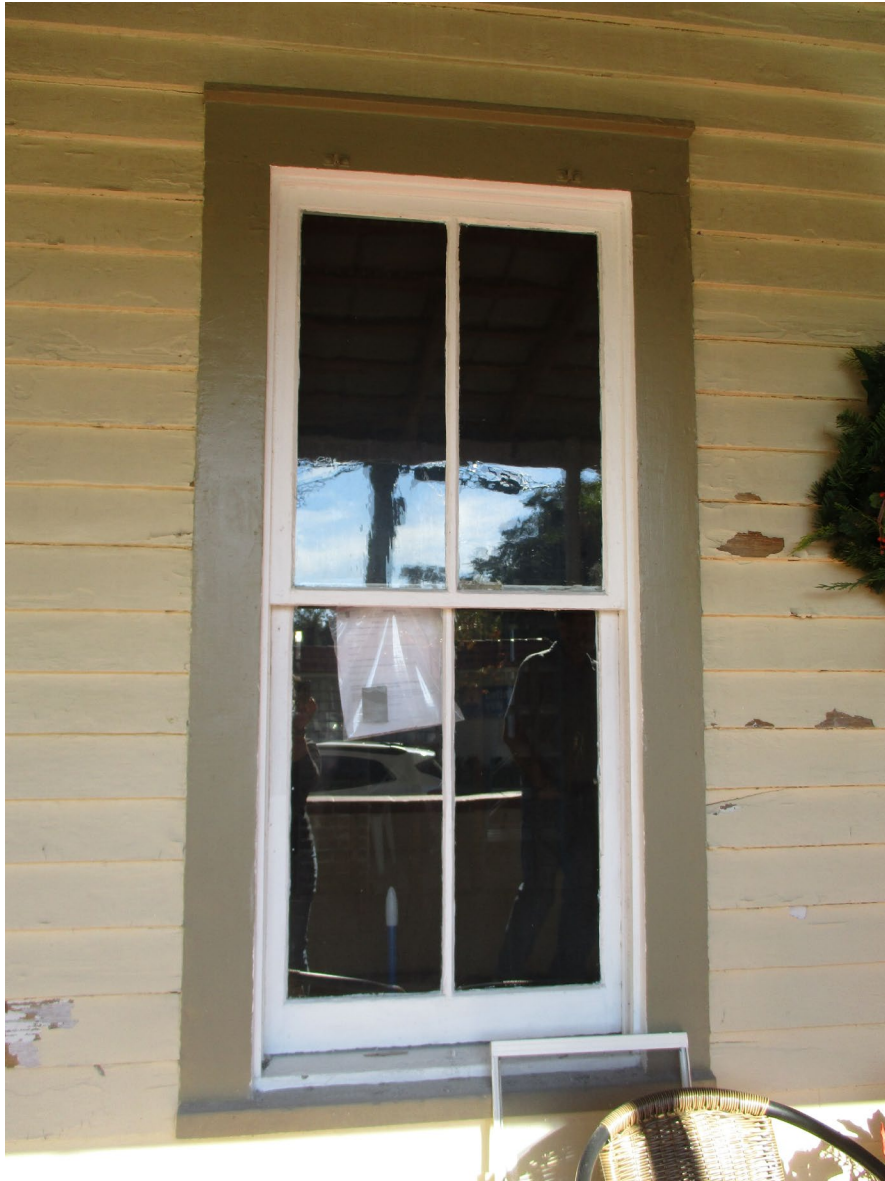
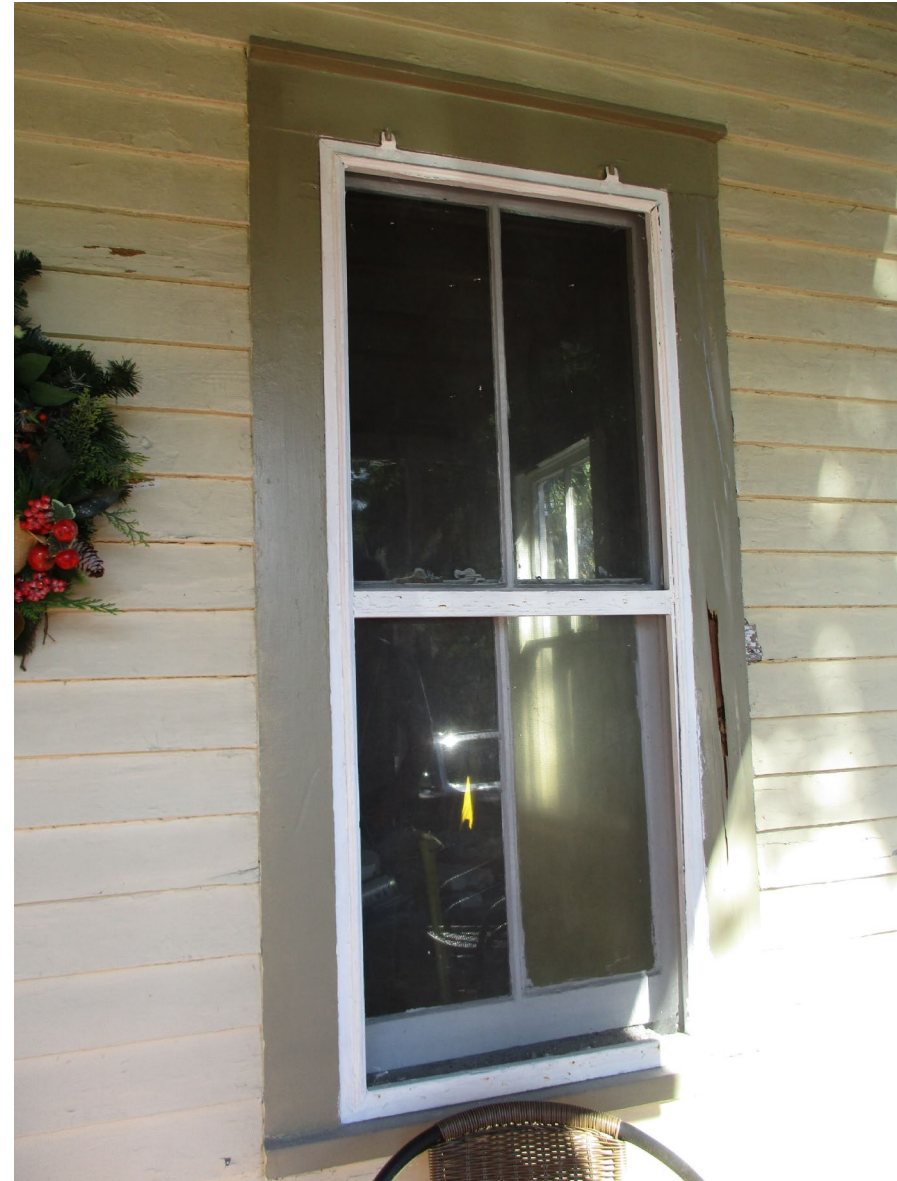
**STAFF PHOTOGRAPHS**  
**120 Bridge Street**

Wood windows proposed to be replaced with vinyl or aluminum in 1/1 pattern: 2/2 aluminum windows would be more compatible

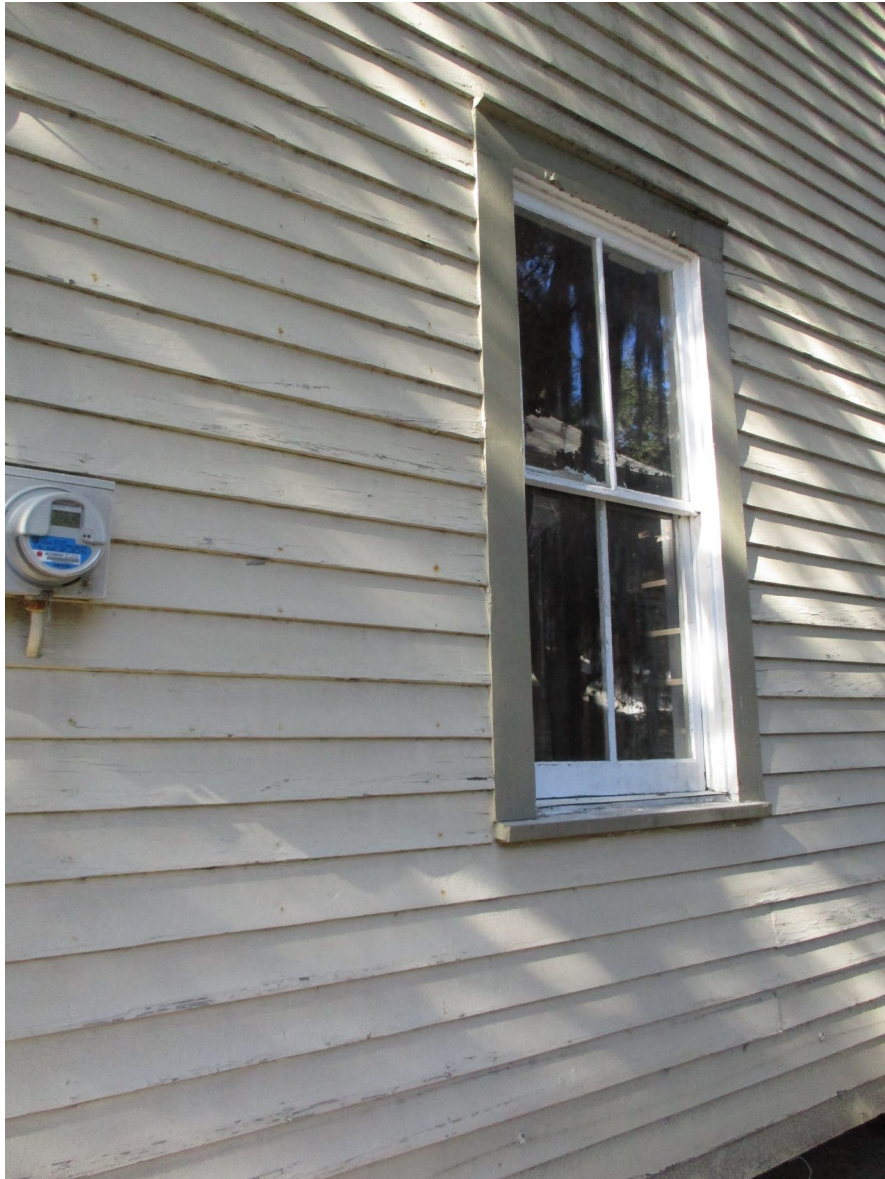
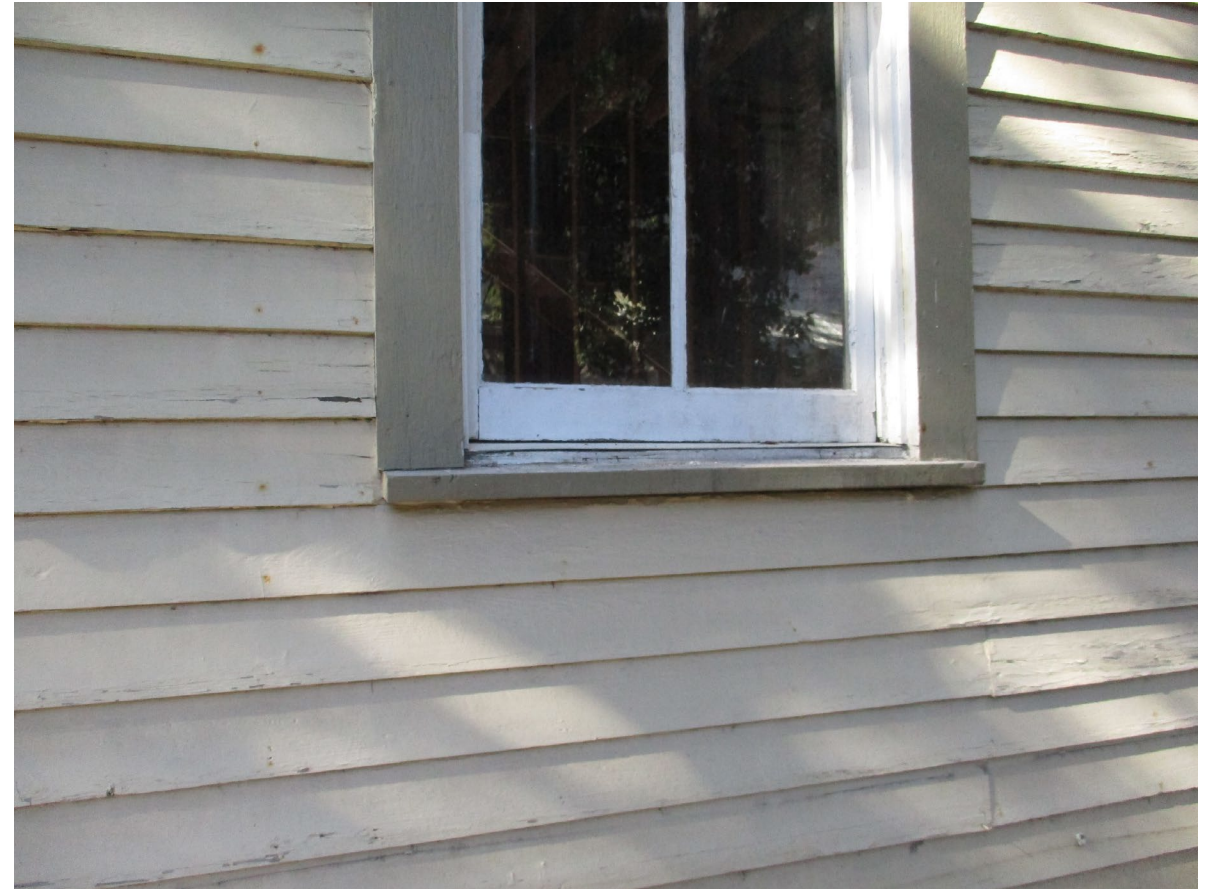
**STAFF PHOTOGRAPHS**  
**120 Bridge Street**

Wood windows proposed to be replaced with vinyl or aluminum in 1/1 pattern: 2/2 aluminum windows would be more compatible

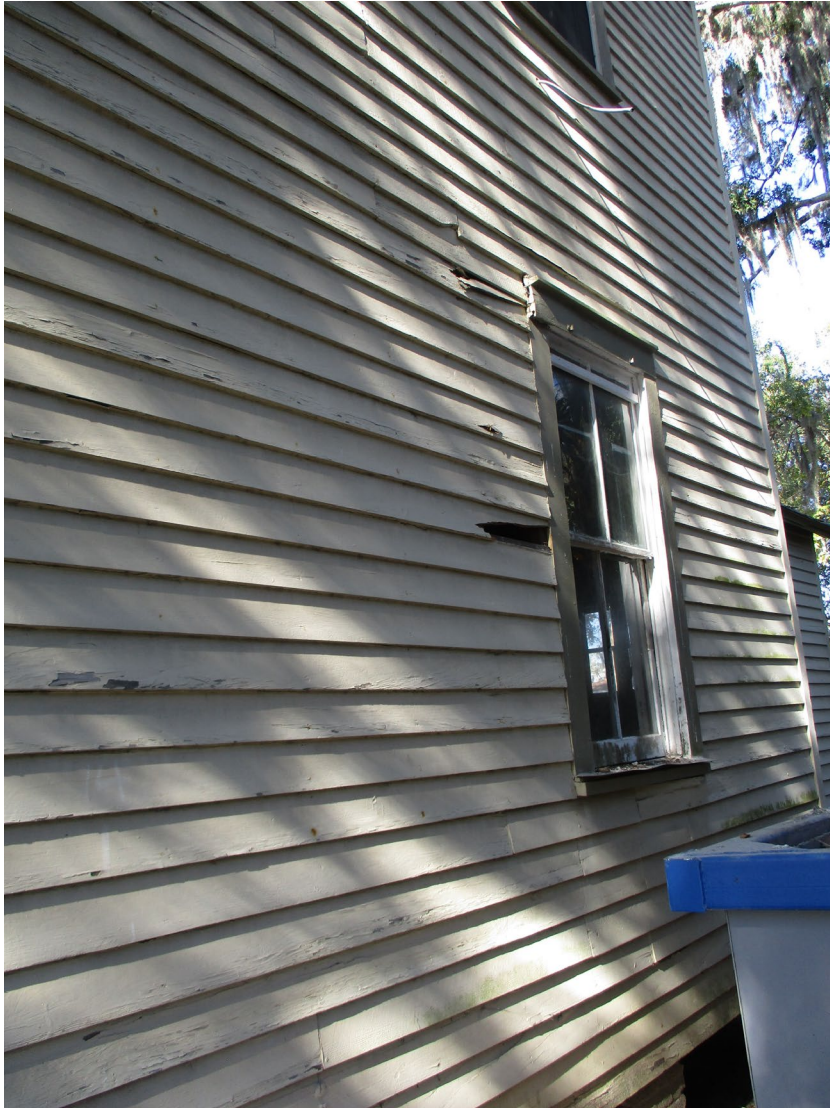
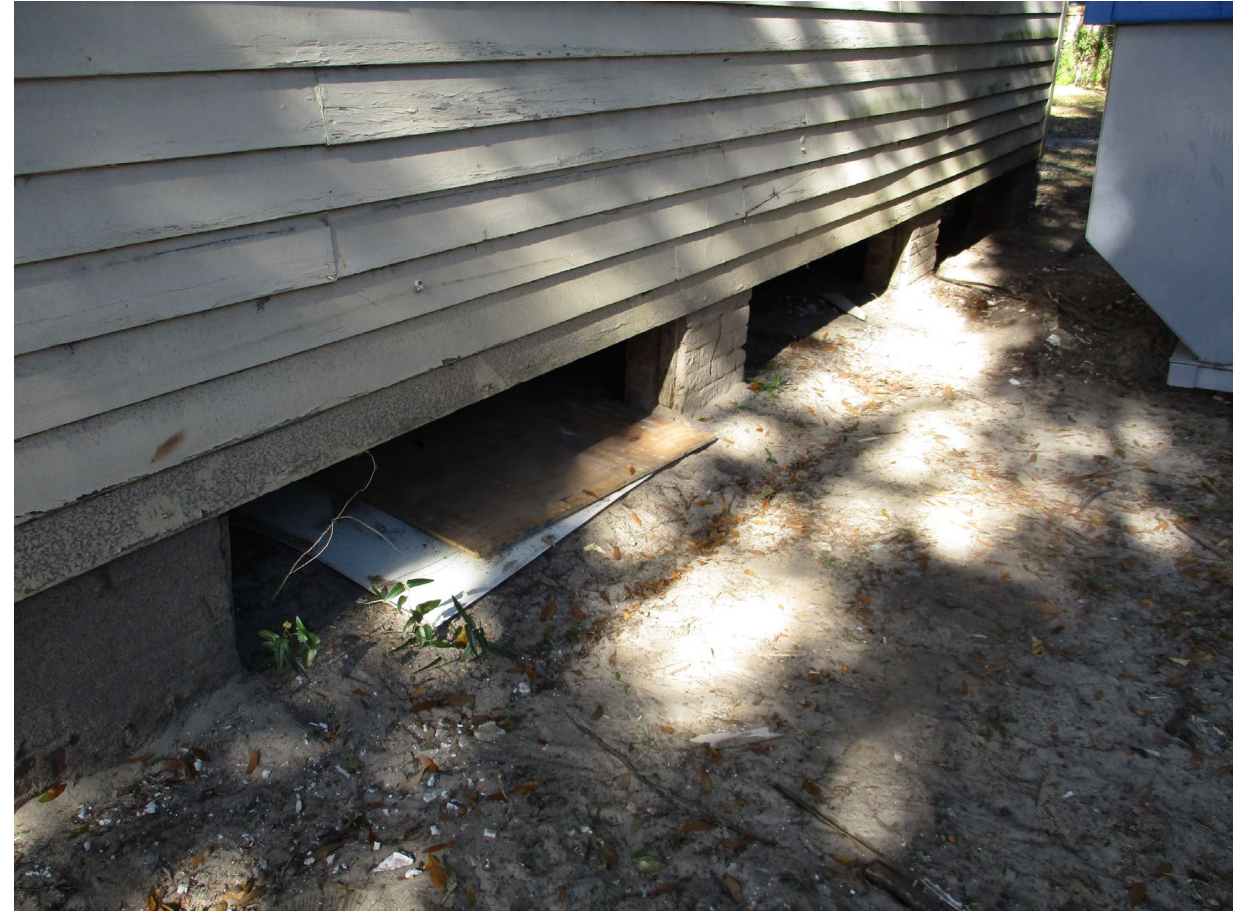
## STAFF PHOTOGRAPHS 120 Bridge Street

Historic wood lap siding proposed to be replaced with Hardie board type siding

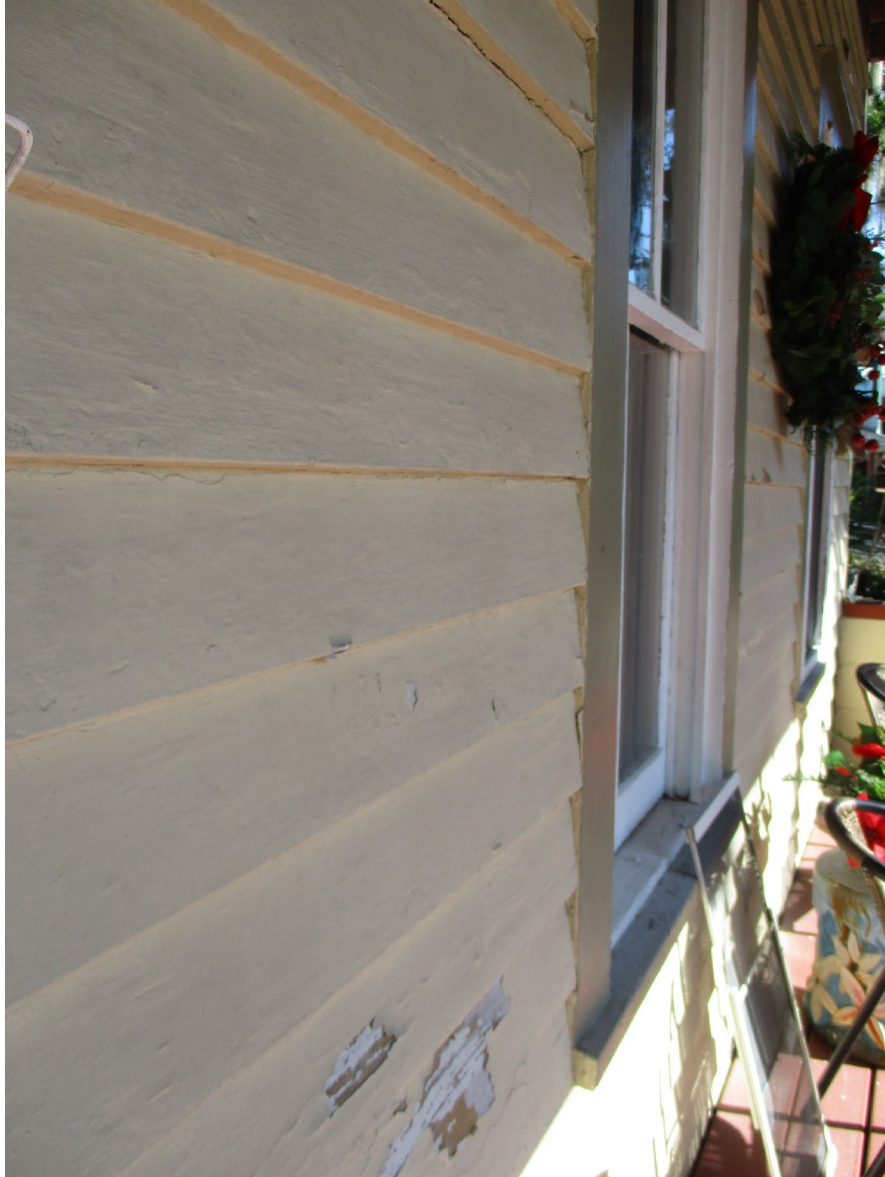
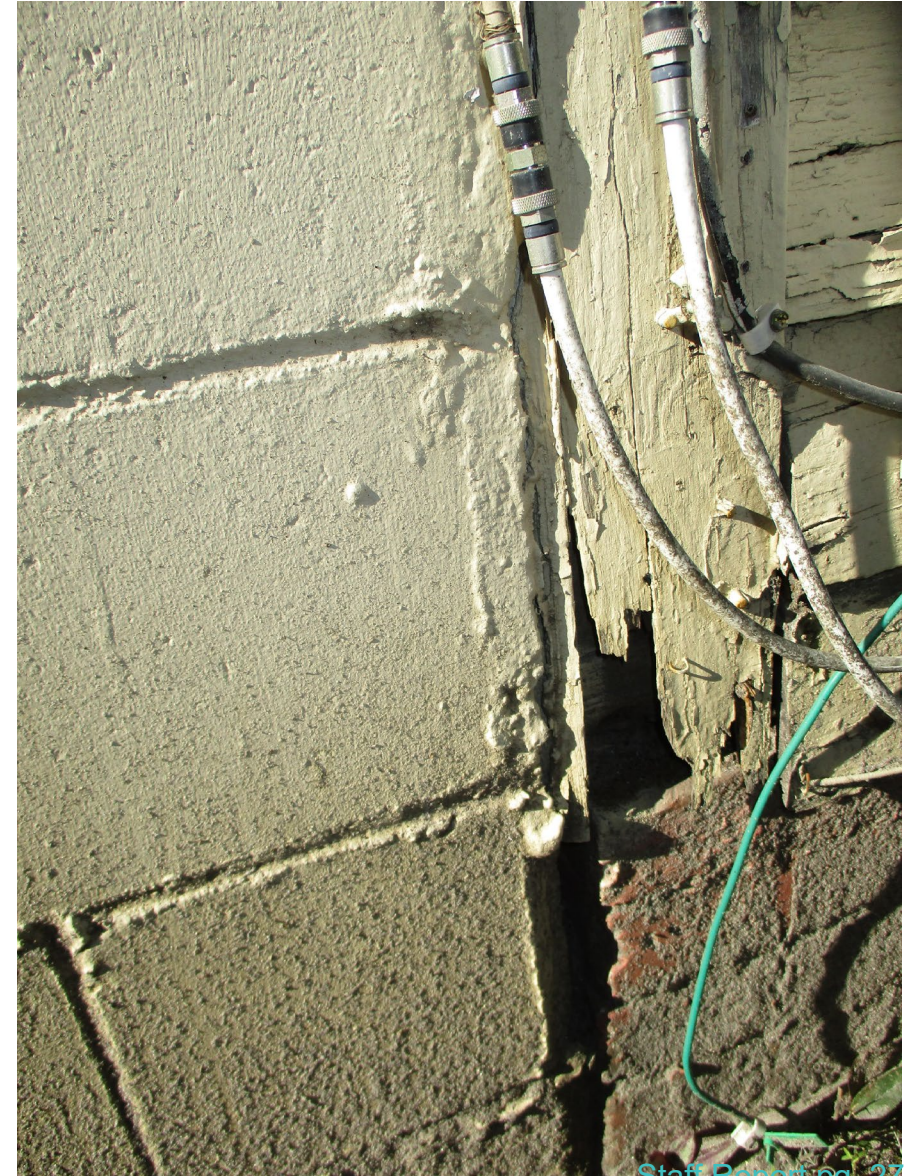
**STAFF PHOTOGRAPHS**  
**120 Bridge Street**

Historic wood lap siding proposed to be replaced with Hardie board type siding

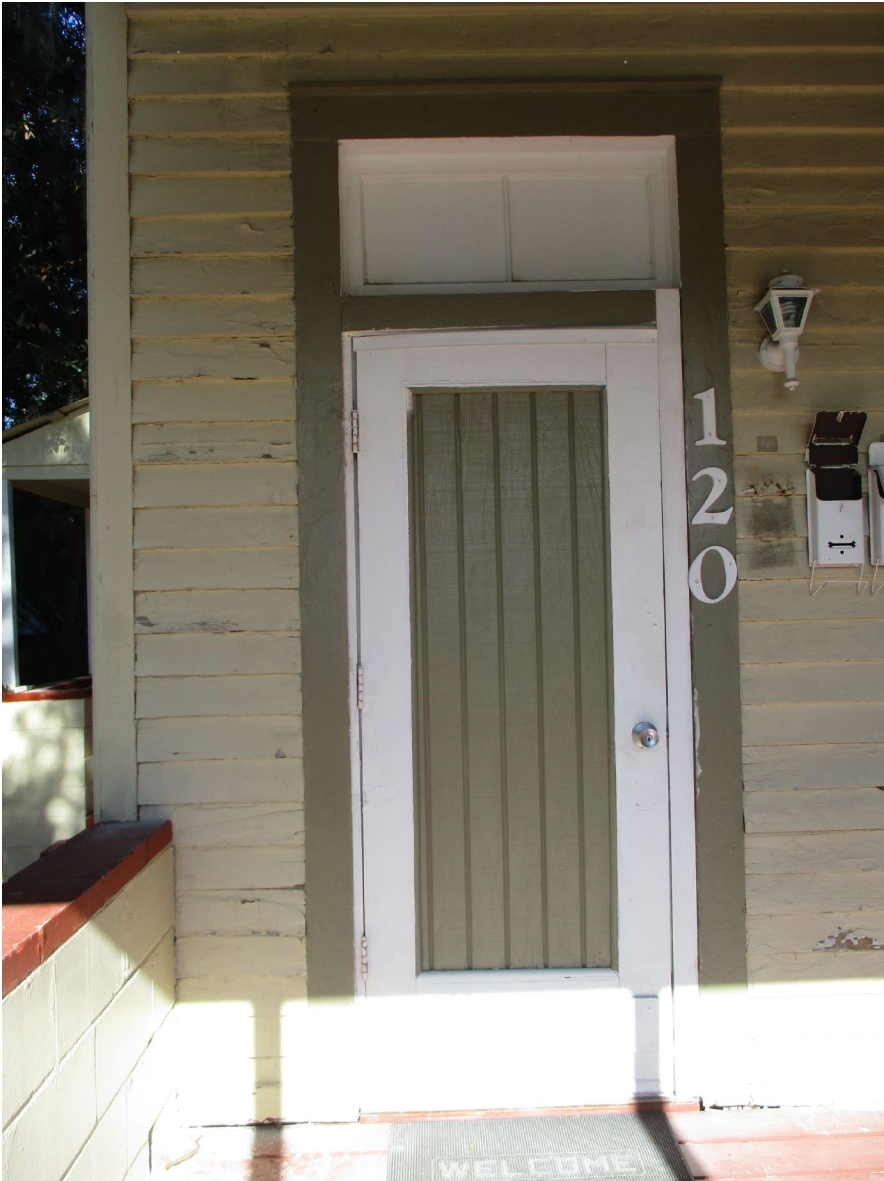
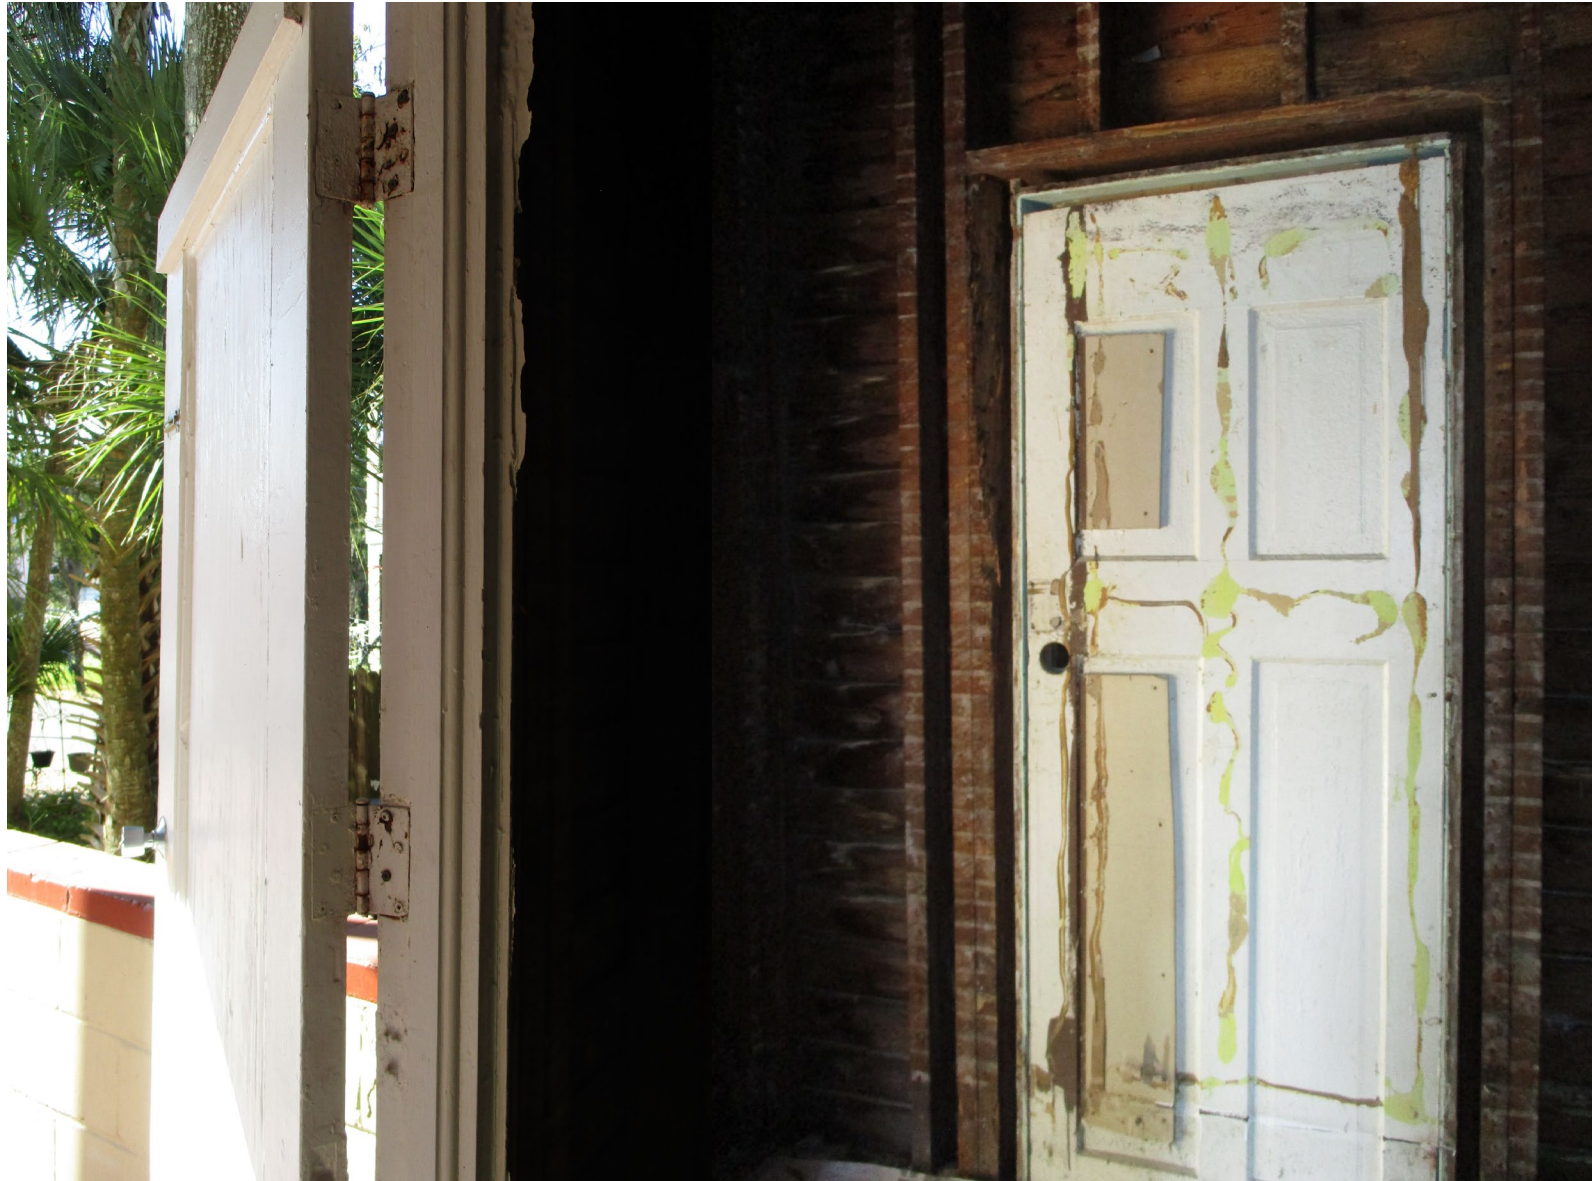
STAFF PHOTOGRAPHS  
120 Bridge Street

Front door proposed to be replaced with new: existing door appears to be an interior door and what may have been the original exterior door is on the interior.

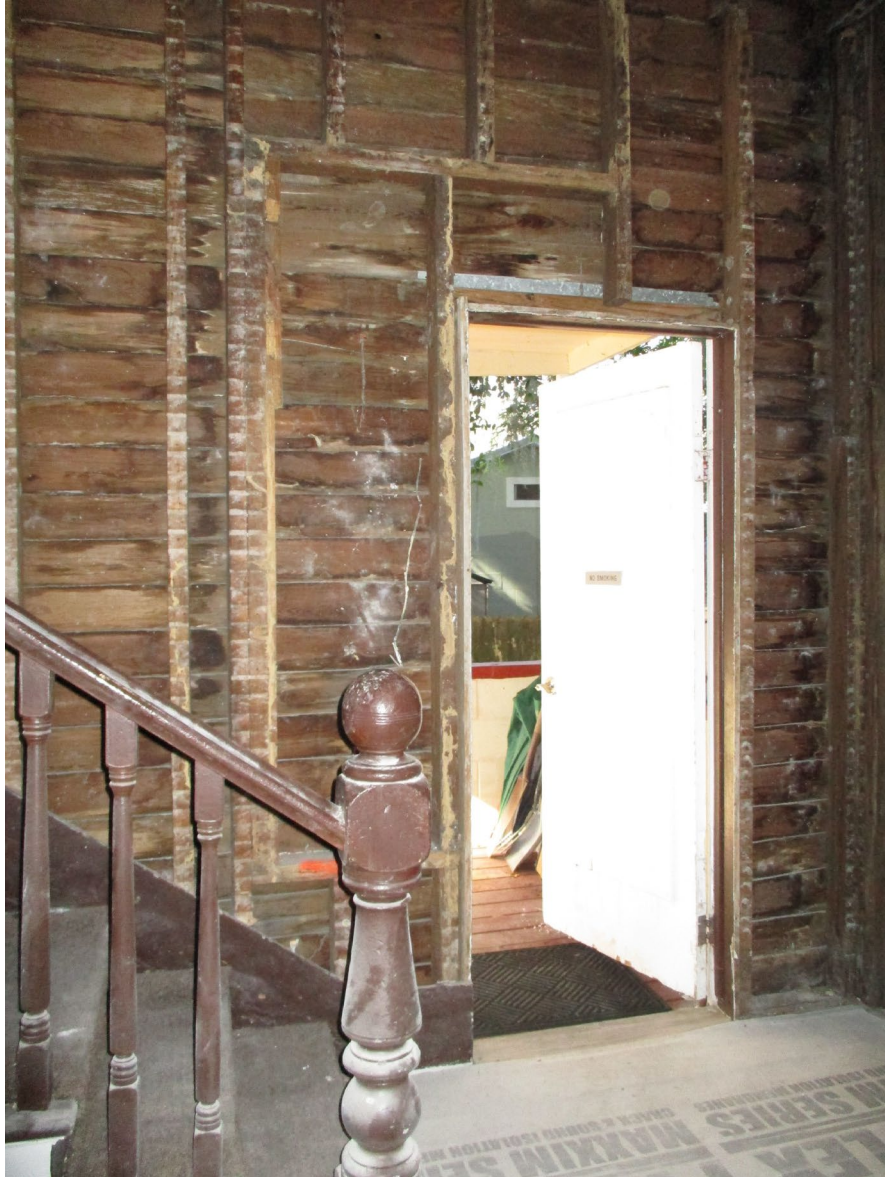
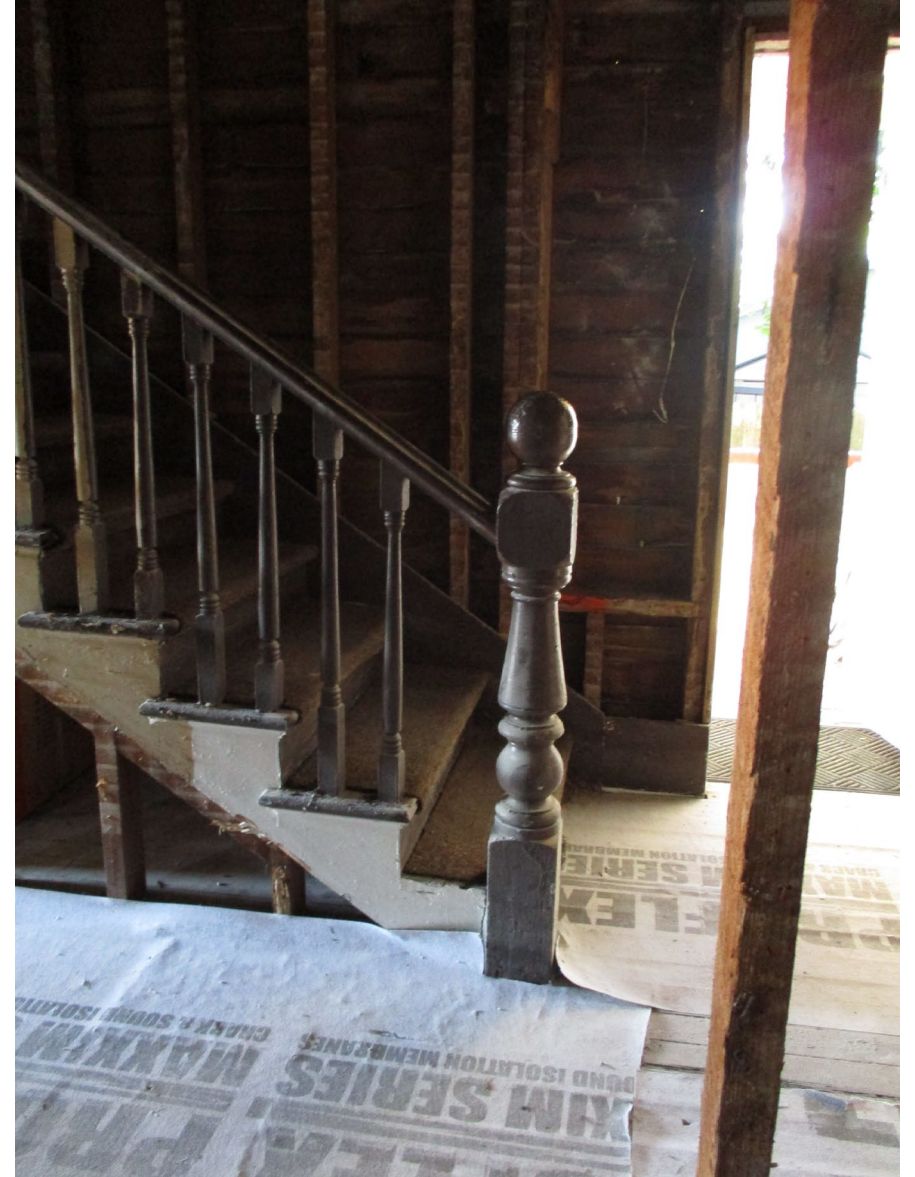
STAFF PHOTOGRAPHS  
120 Bridge Street

Side door proposed to be replaced with new: existing door does not appear to be original

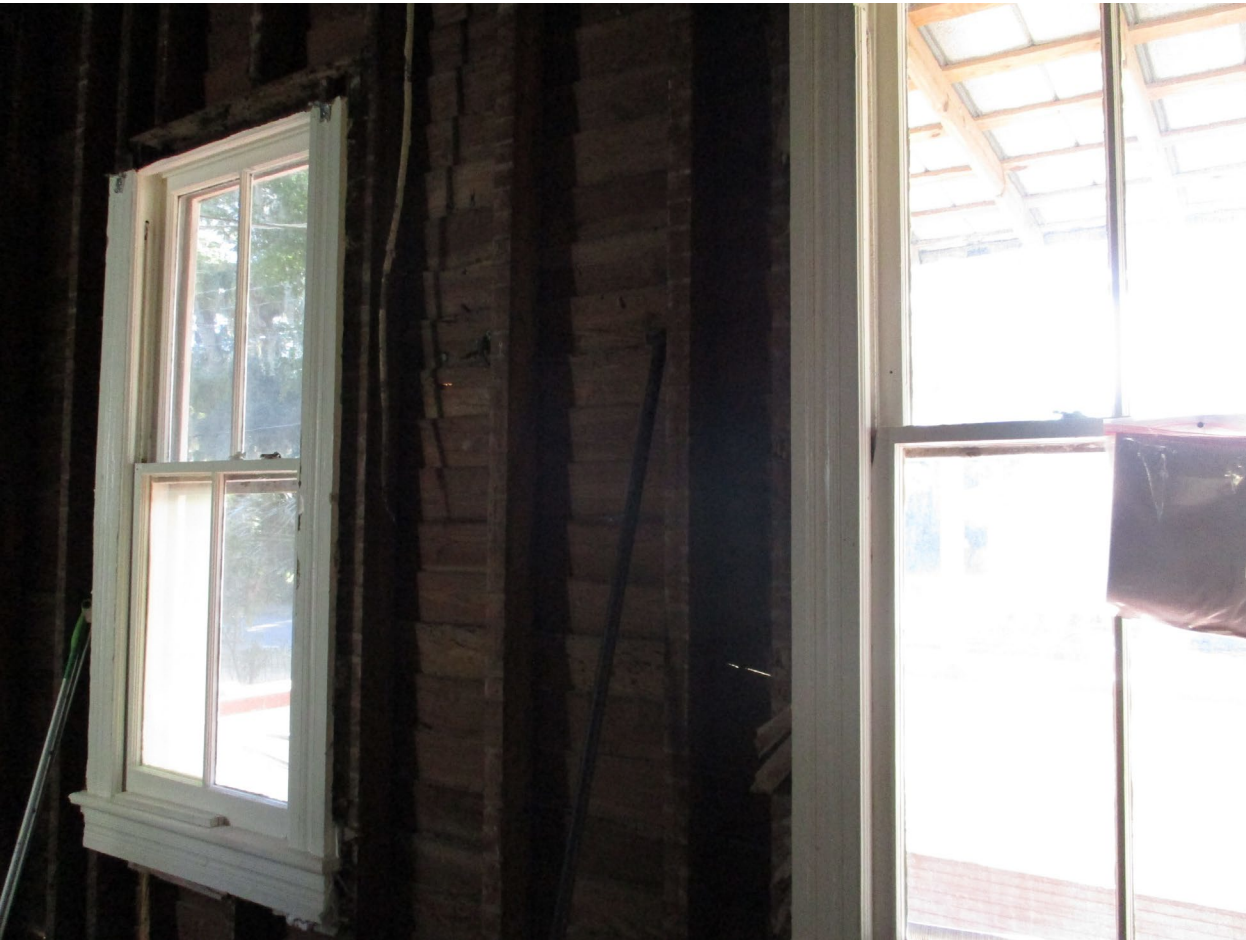
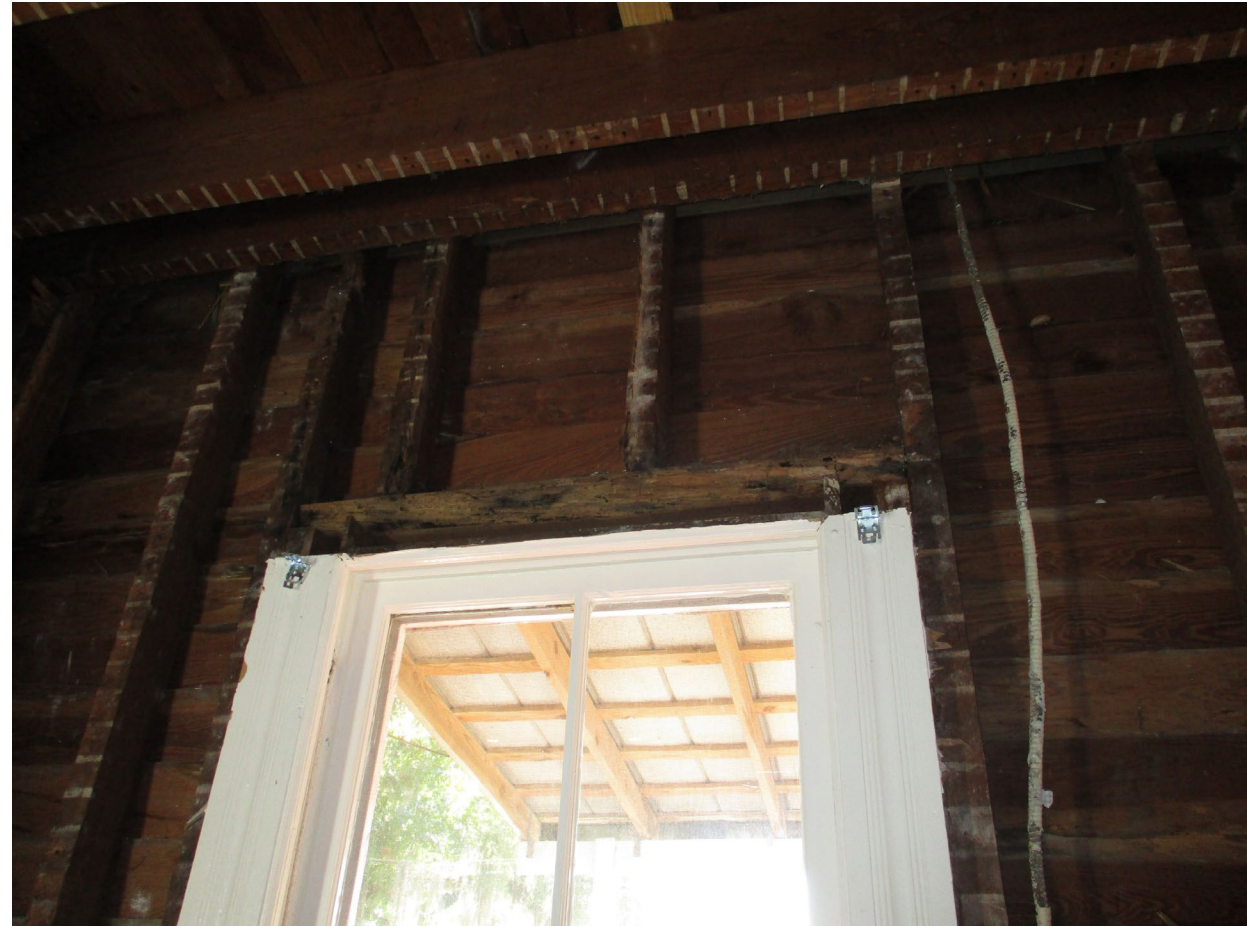
## STAFF PHOTOGRAPHS 120 Bridge Street

Wood windows proposed to be replaced with vinyl or aluminum in 1/1 pattern: 2/2 aluminum windows would be more compatible

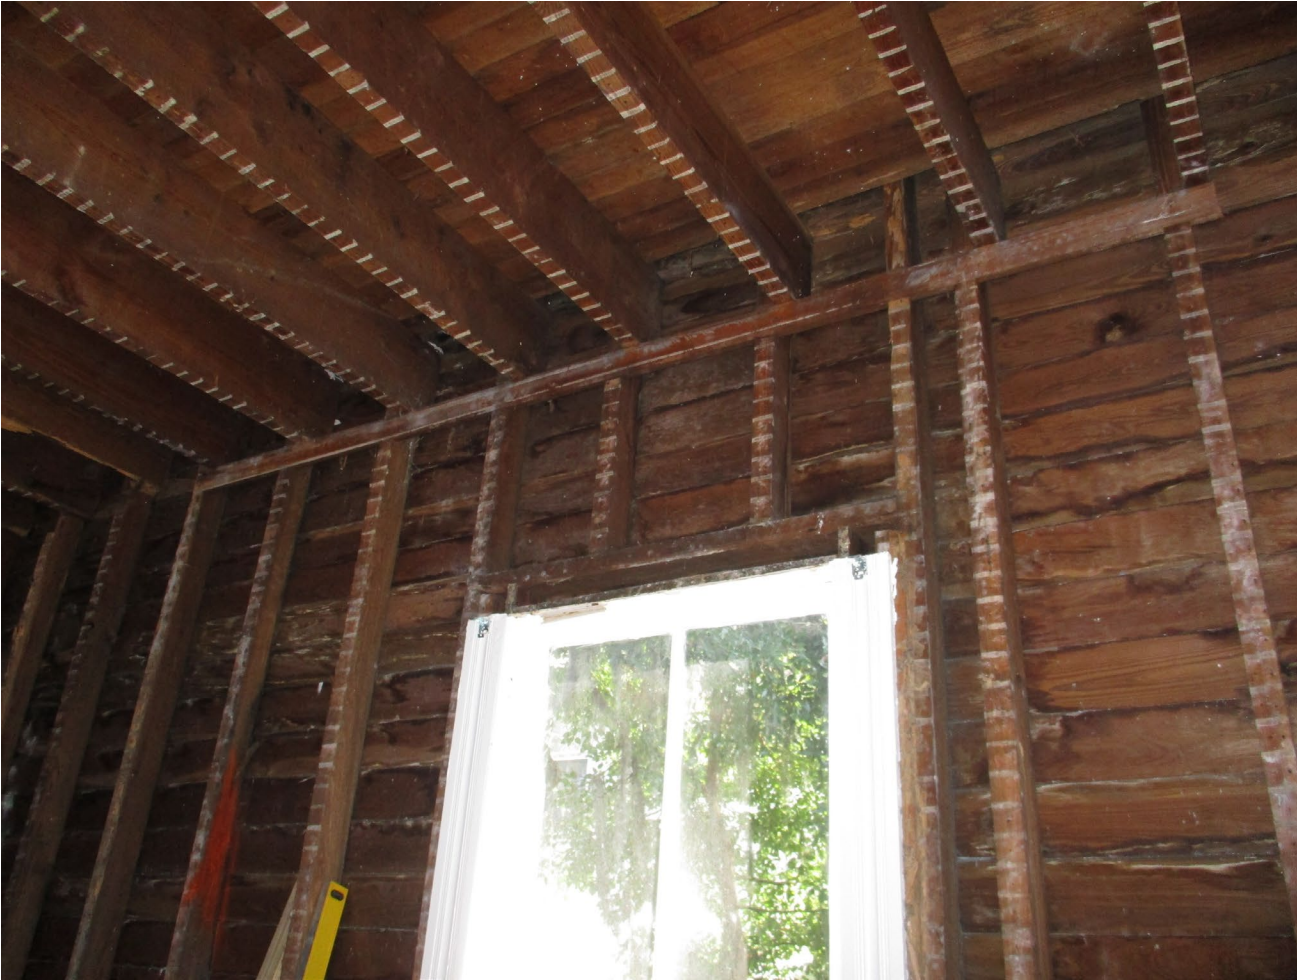
**STAFF PHOTOGRAPHS**  
**120 Bridge Street**

Wood windows proposed to be replaced with vinyl or aluminum in 1/1 pattern: 2/2 aluminum windows would be more compatible

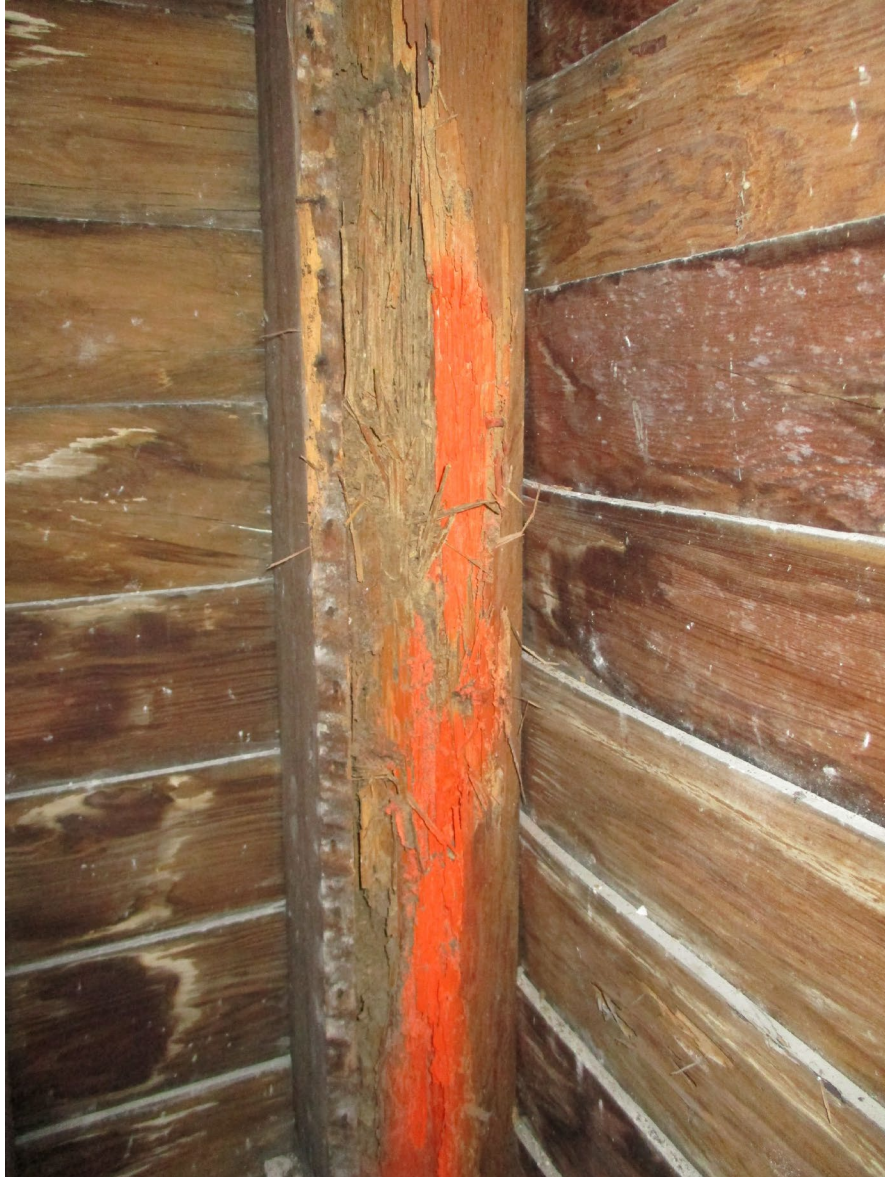
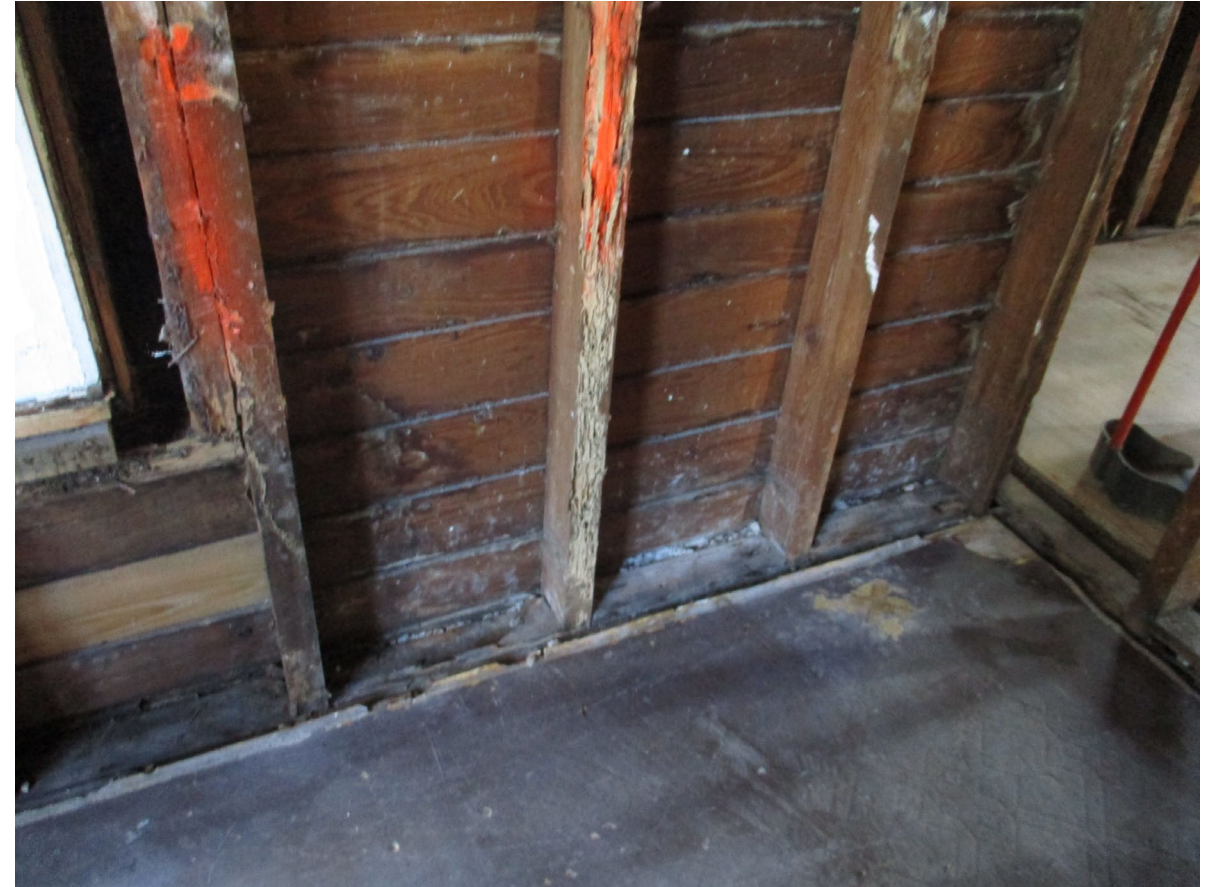
**STAFF PHOTOGRAPHS**  
**120 Bridge Street**

Termite damage sprayed with orange paint

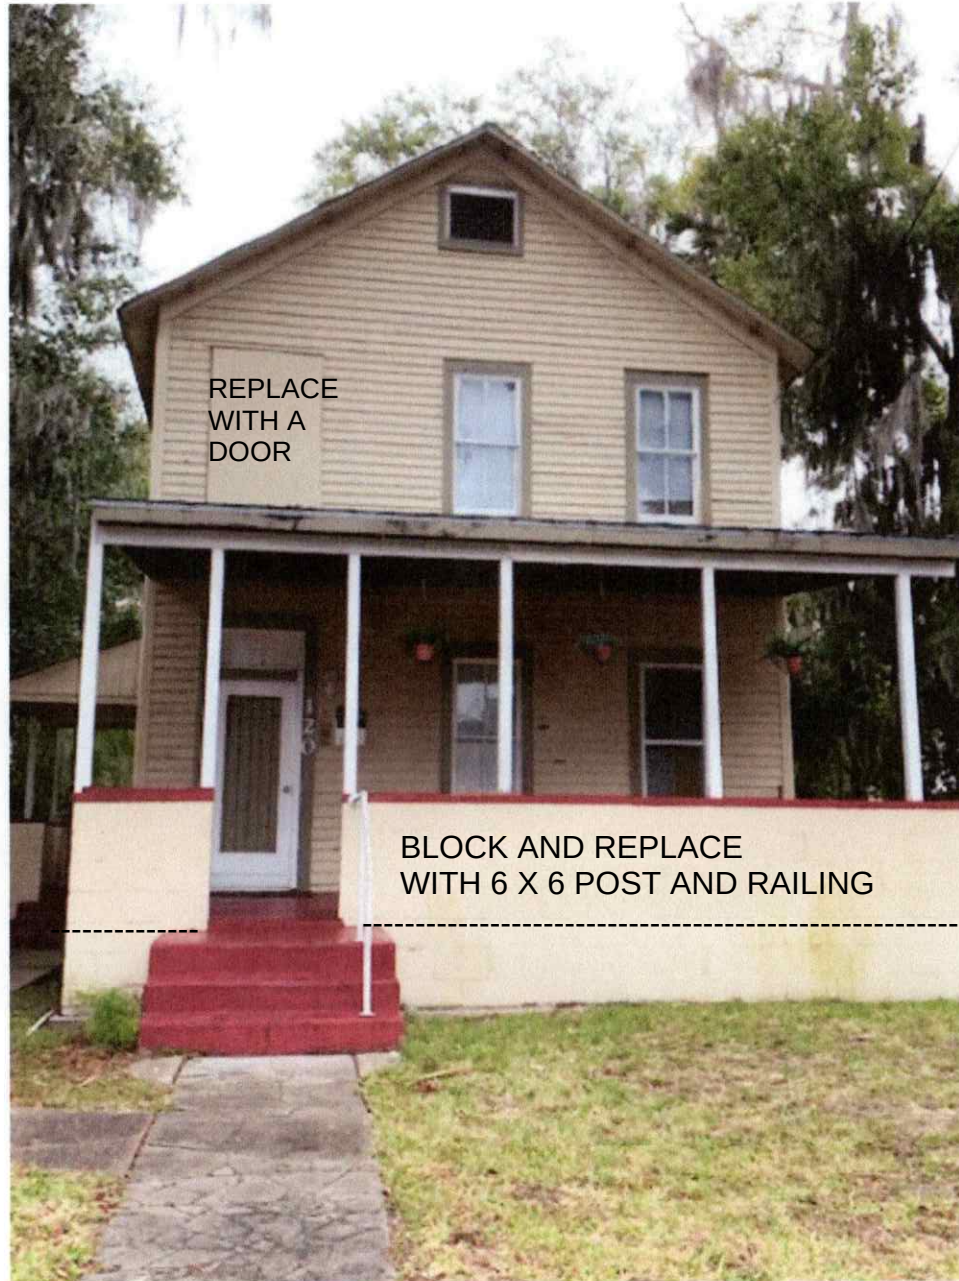
REMOVE CHIMNEY AND REPLACE  
ROOF WITH METAL/ALUMINUM  
ROOFING

REPLACE ALL SIDING WITH  
HARDIE BOARD

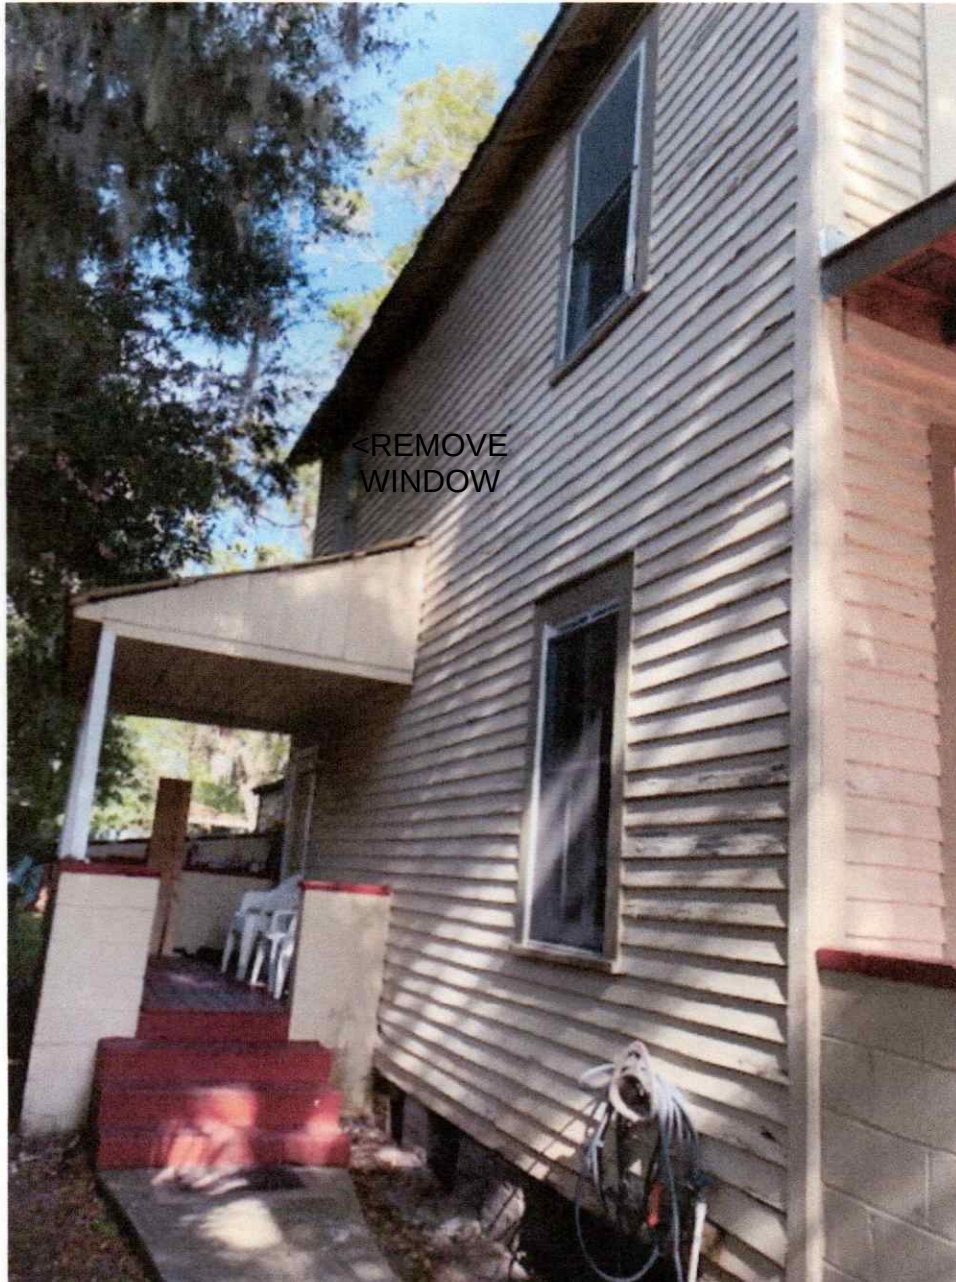
WEST SIDE

REPLACE SIDE DOOR

REPLACE WINDOWS WITH VINYL OR  
ALUMINUM  
WINDOWS

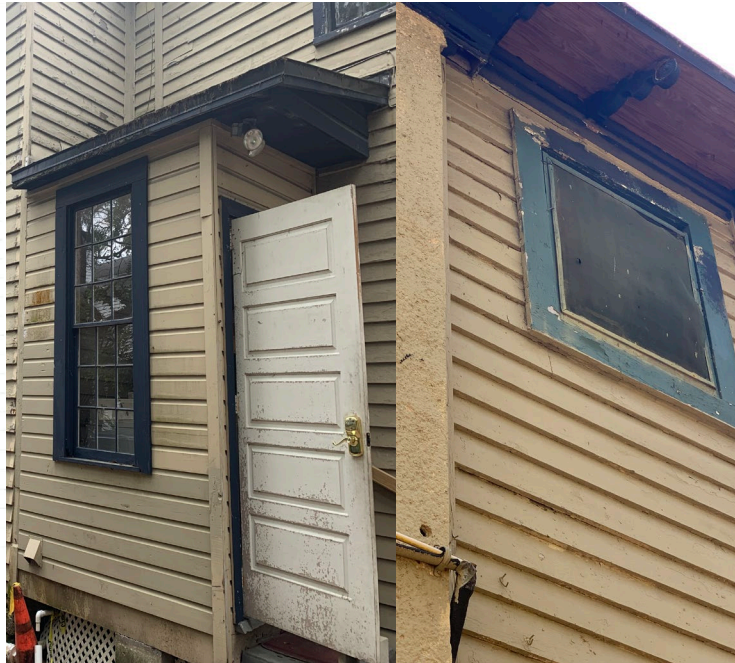
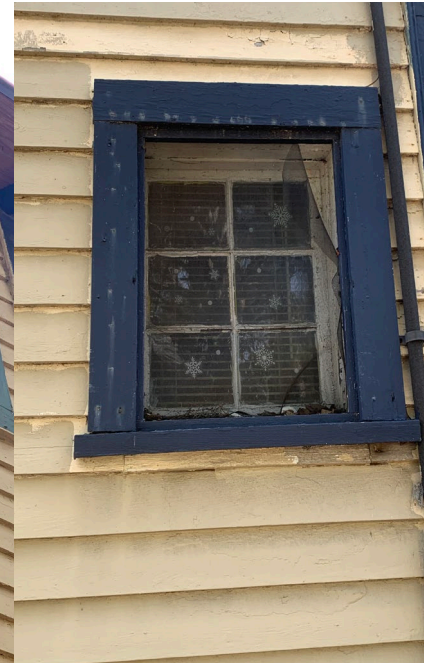
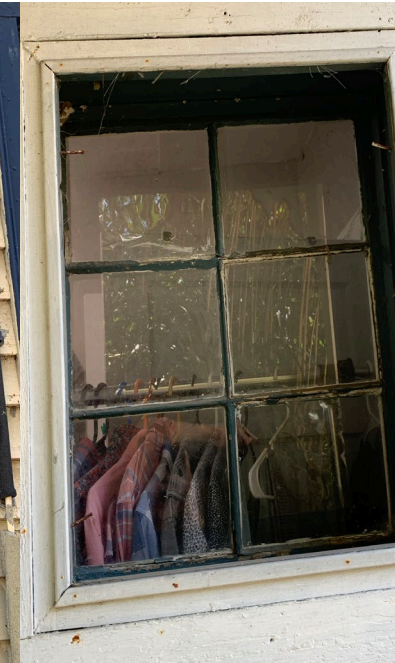
# Windows Continued Two Story Wood Sided Section

- I am proposing to replace the windows in the two story wood sided portions of the building with all wood, raised mutton, 9 over 9 windows to match what appears to have been original to the building and make up the majority of what still exist in this section of the building. I am proposing to keep and restore the two fixed 6 light windows at the front of the clapboard section just behind the 1920s stucco addition, the fixed 6 light window on the 1<sup>st</sup> floor porch on the southern side of the property, the 9 over 9 on the single story, novelty sided side entrance and the eastern most 9 over 9 window on the second floor of the novelty sided gable section of the south facing side of the building. These five windows are either fixed light or not located in living spaces within the property.

-----Proposing to Keep-----

Keep & replace  
Bottom sash with  
9 light from other  
Removed window
