## **CITY OF ST. AUGUSTINE HISTORIC ARCHITECTURAL REVIEW BOARD**

### **A G E N D A**

**THURSDAY, DECEMBER 16, 2021 - 1:00 PM**

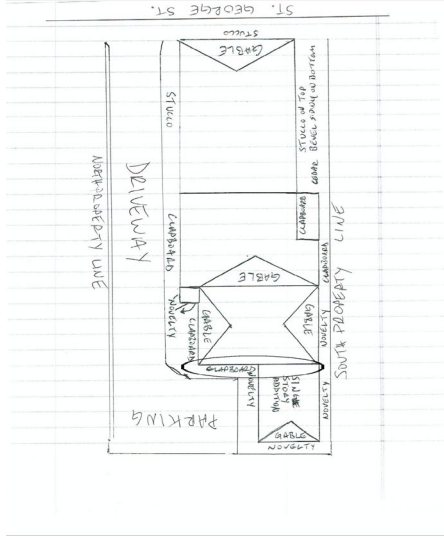
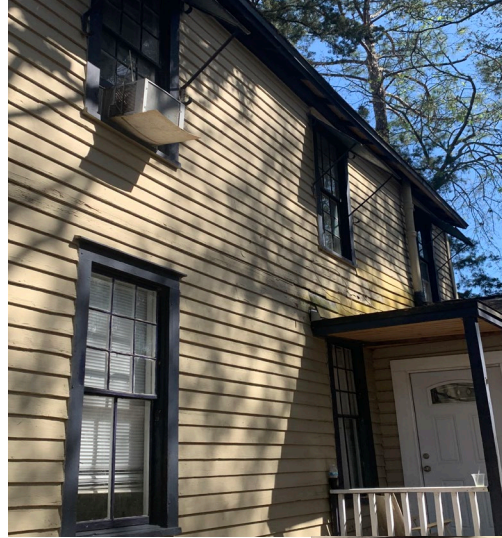
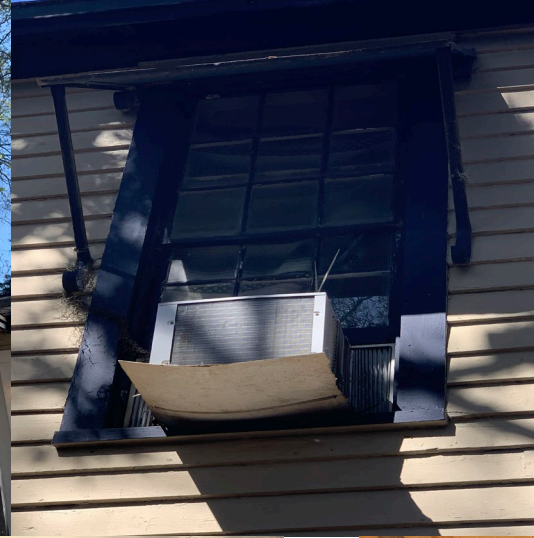
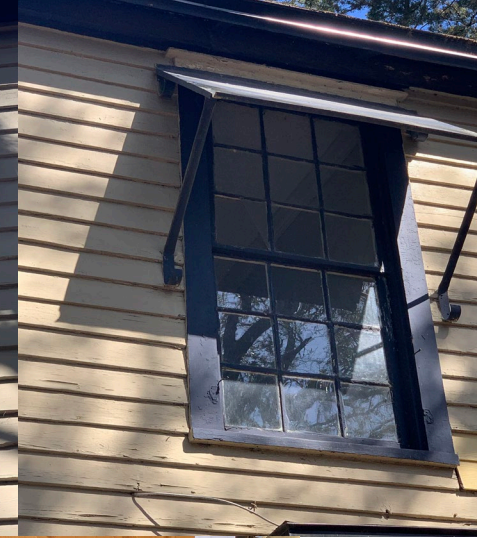
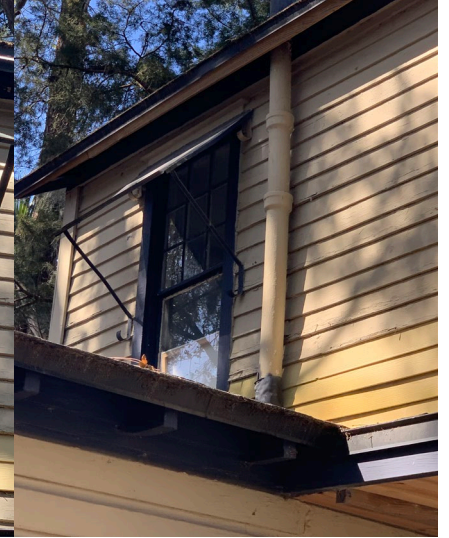
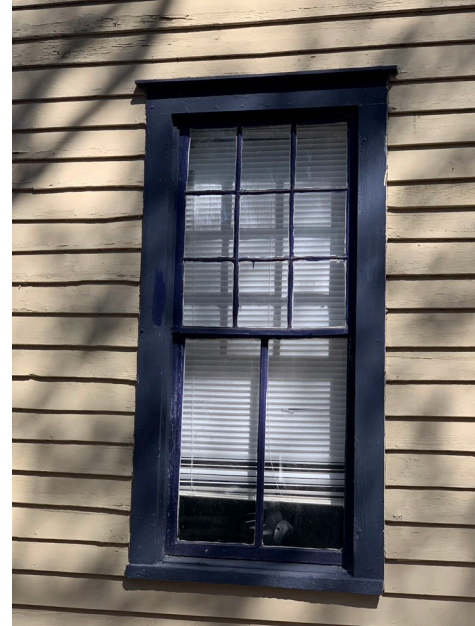
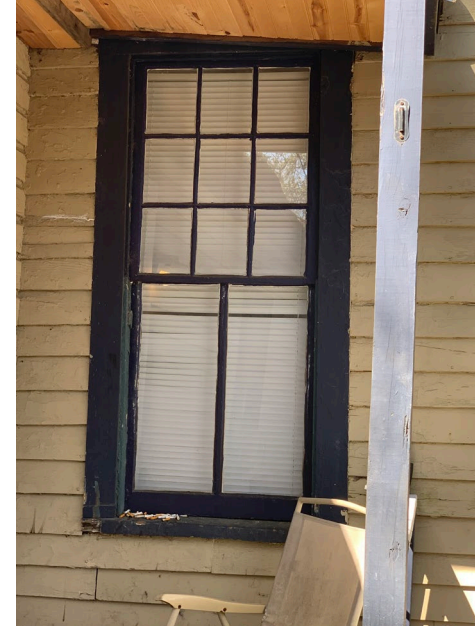
# Rear/West Facing Section

None of these windows have counter balances and these units are occupied

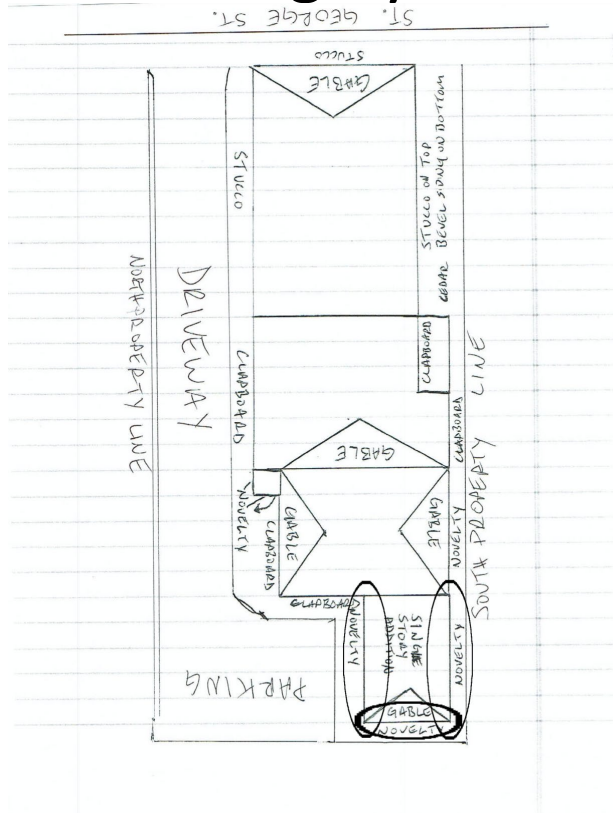
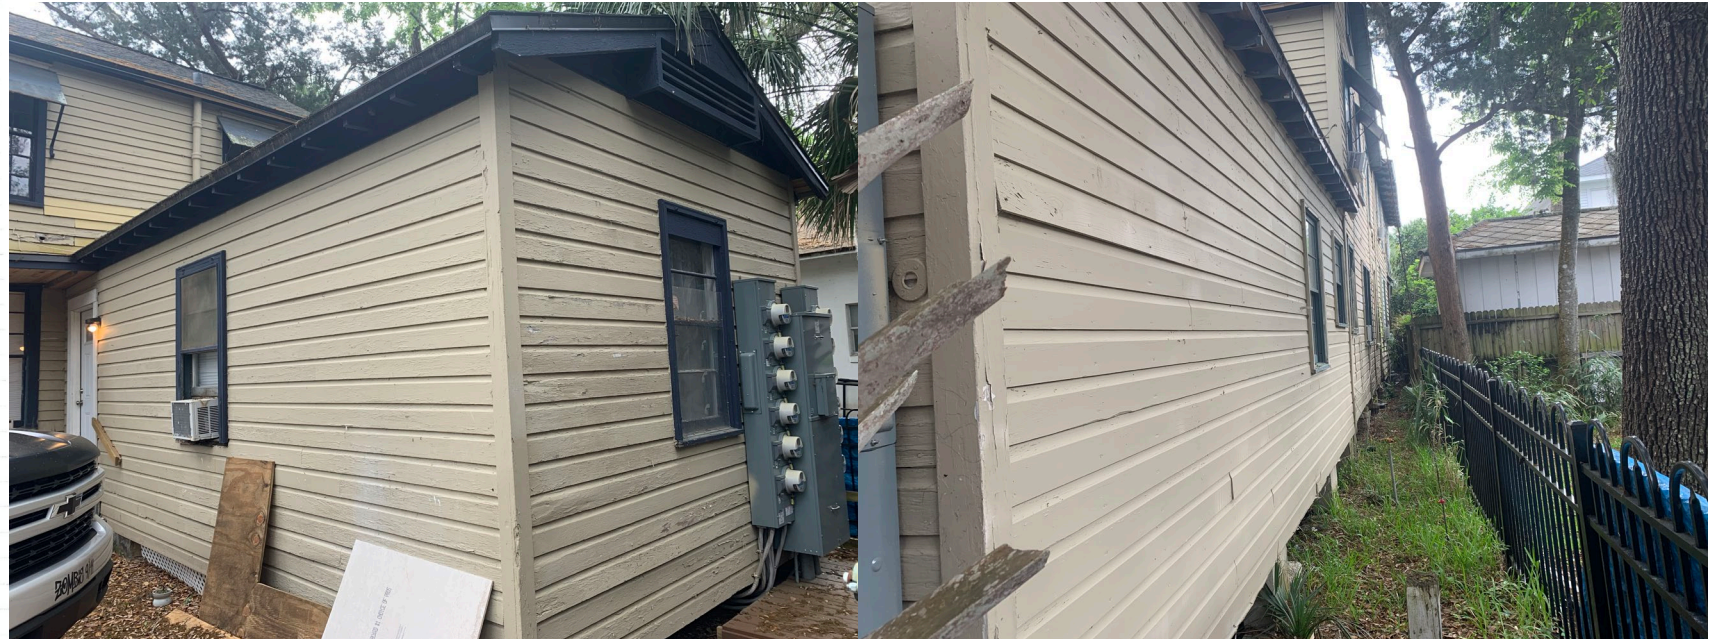
# Siding Continued

- Replace roughly 10-15% of the novelty siding on the one story rear addition with matching novelty siding. This siding is mostly in good shape with the exception of a few boards on the north facing side and roughly 25% of the rear, west facing side.

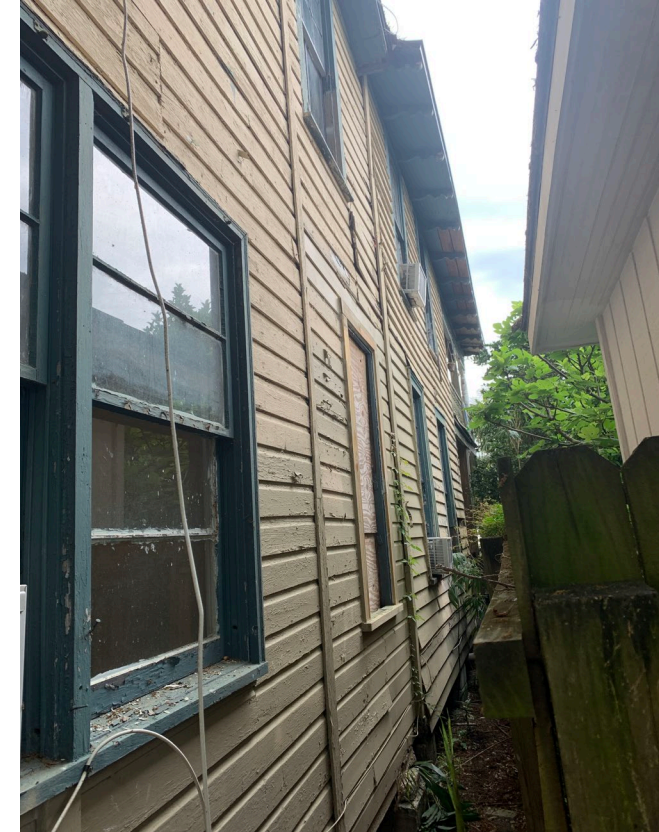
# Siding Continued

- Replace roughly 50-75% of the novelty siding on the south facing gable section of the property just east (in front of) the one story addition at the rear of the property with matching novelty siding. This section of the property is in very bad condition. It is separating from the framing members and is very brittle and rotted.

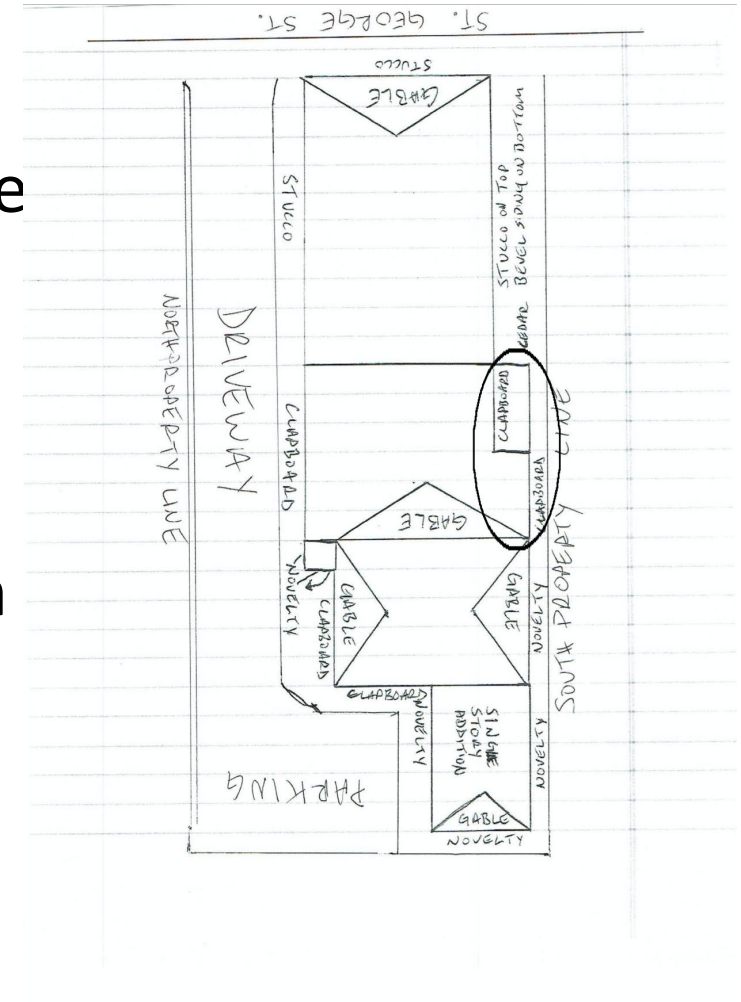
# Siding Continued

- Replace roughly 50-75% of the clapboard siding on the porch section that is immediately behind the stucco section on the south facing side of the property and the 16 foot section between the porch and the novelty sided gable section with new wood clapboard siding to match. This section is in very bad shape with several rotten boards, several boards that have separated from the framing members and some boards that appear to have separated completely and fallen off the side of the building.

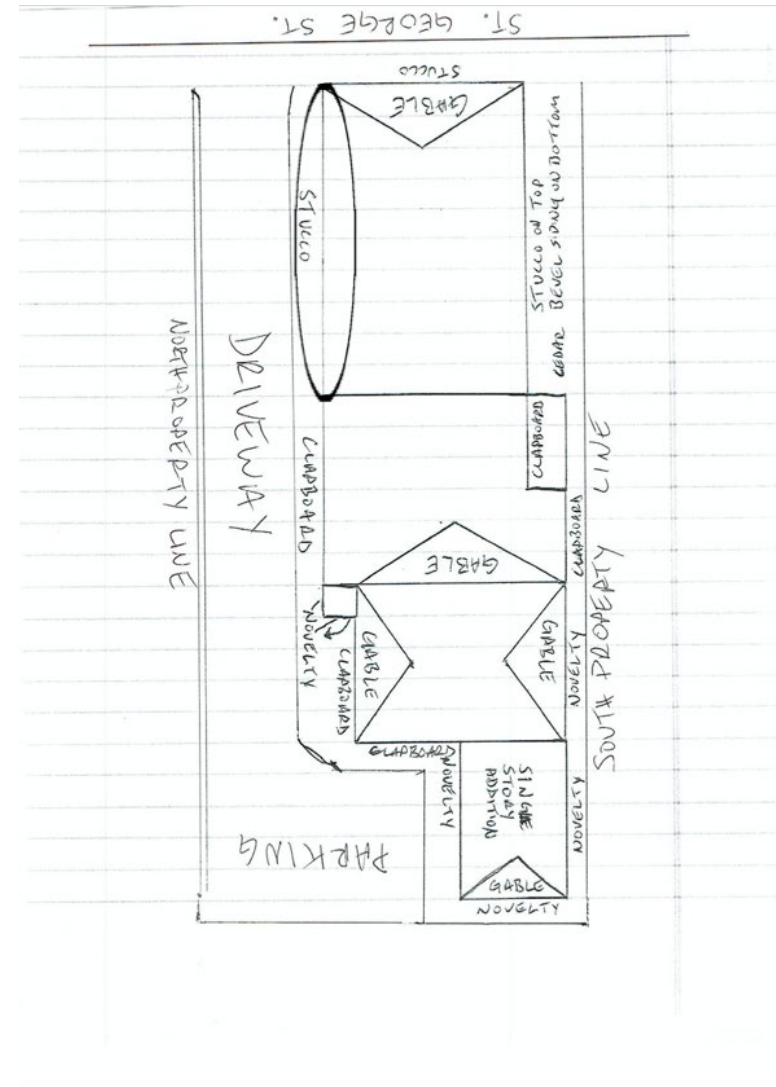
# North Elevation 1920s Stucco Section

- The stucco section of the north Elevation consists of thirteen 2 over 2 windows that were replaced of windows disapproved of by the board in the November 2021 HARB meeting. I am proposing to replace these with the Jeld-Wen windows with the same 2 over 2, vertical muntin pattern they originally had.

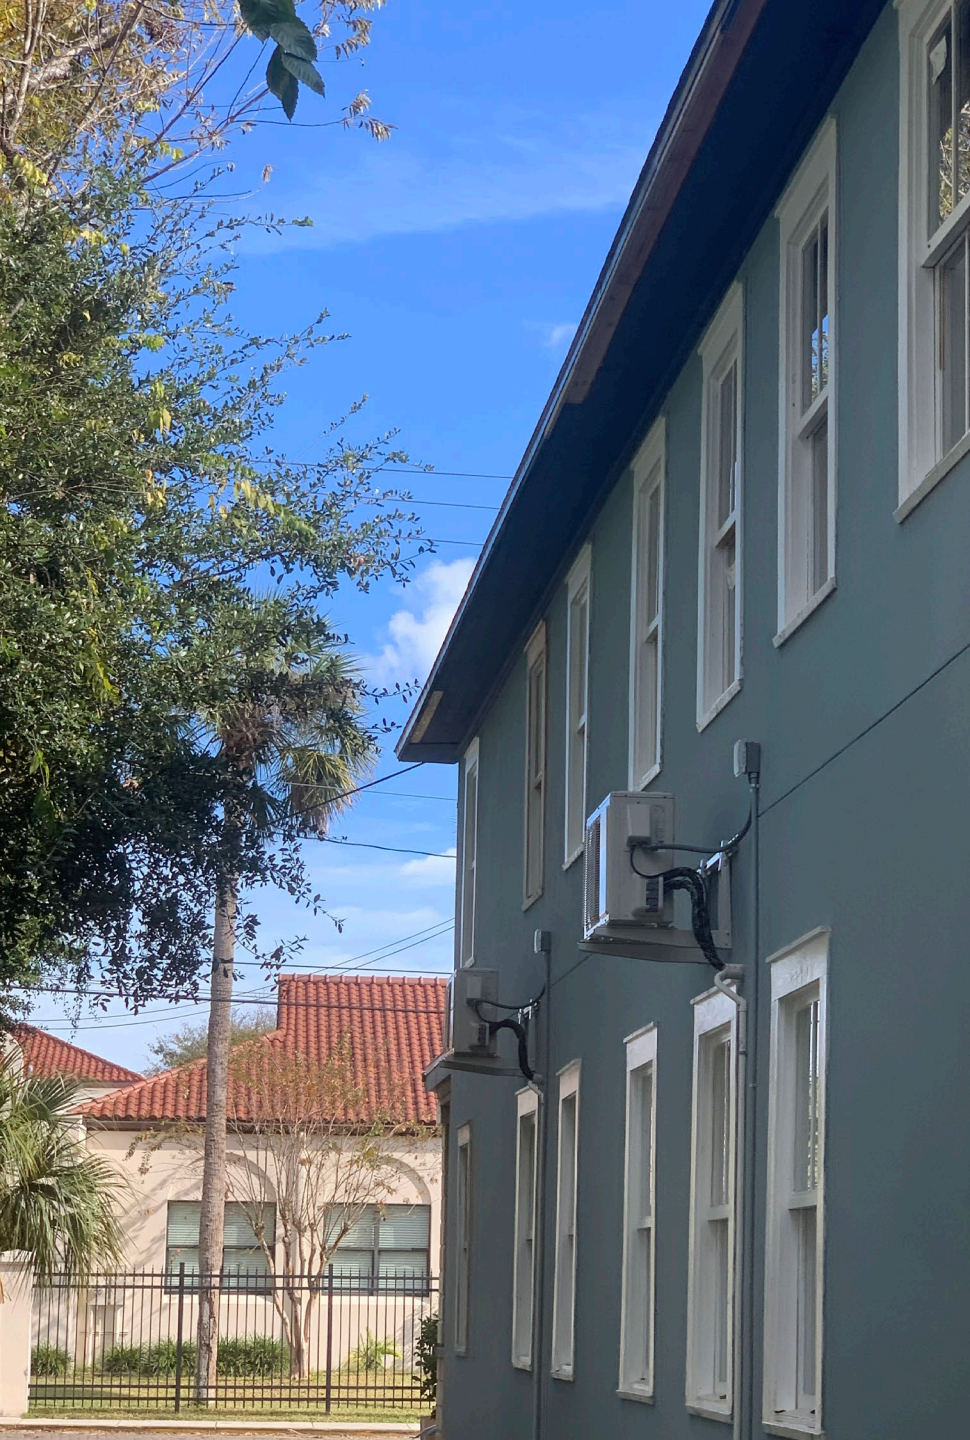
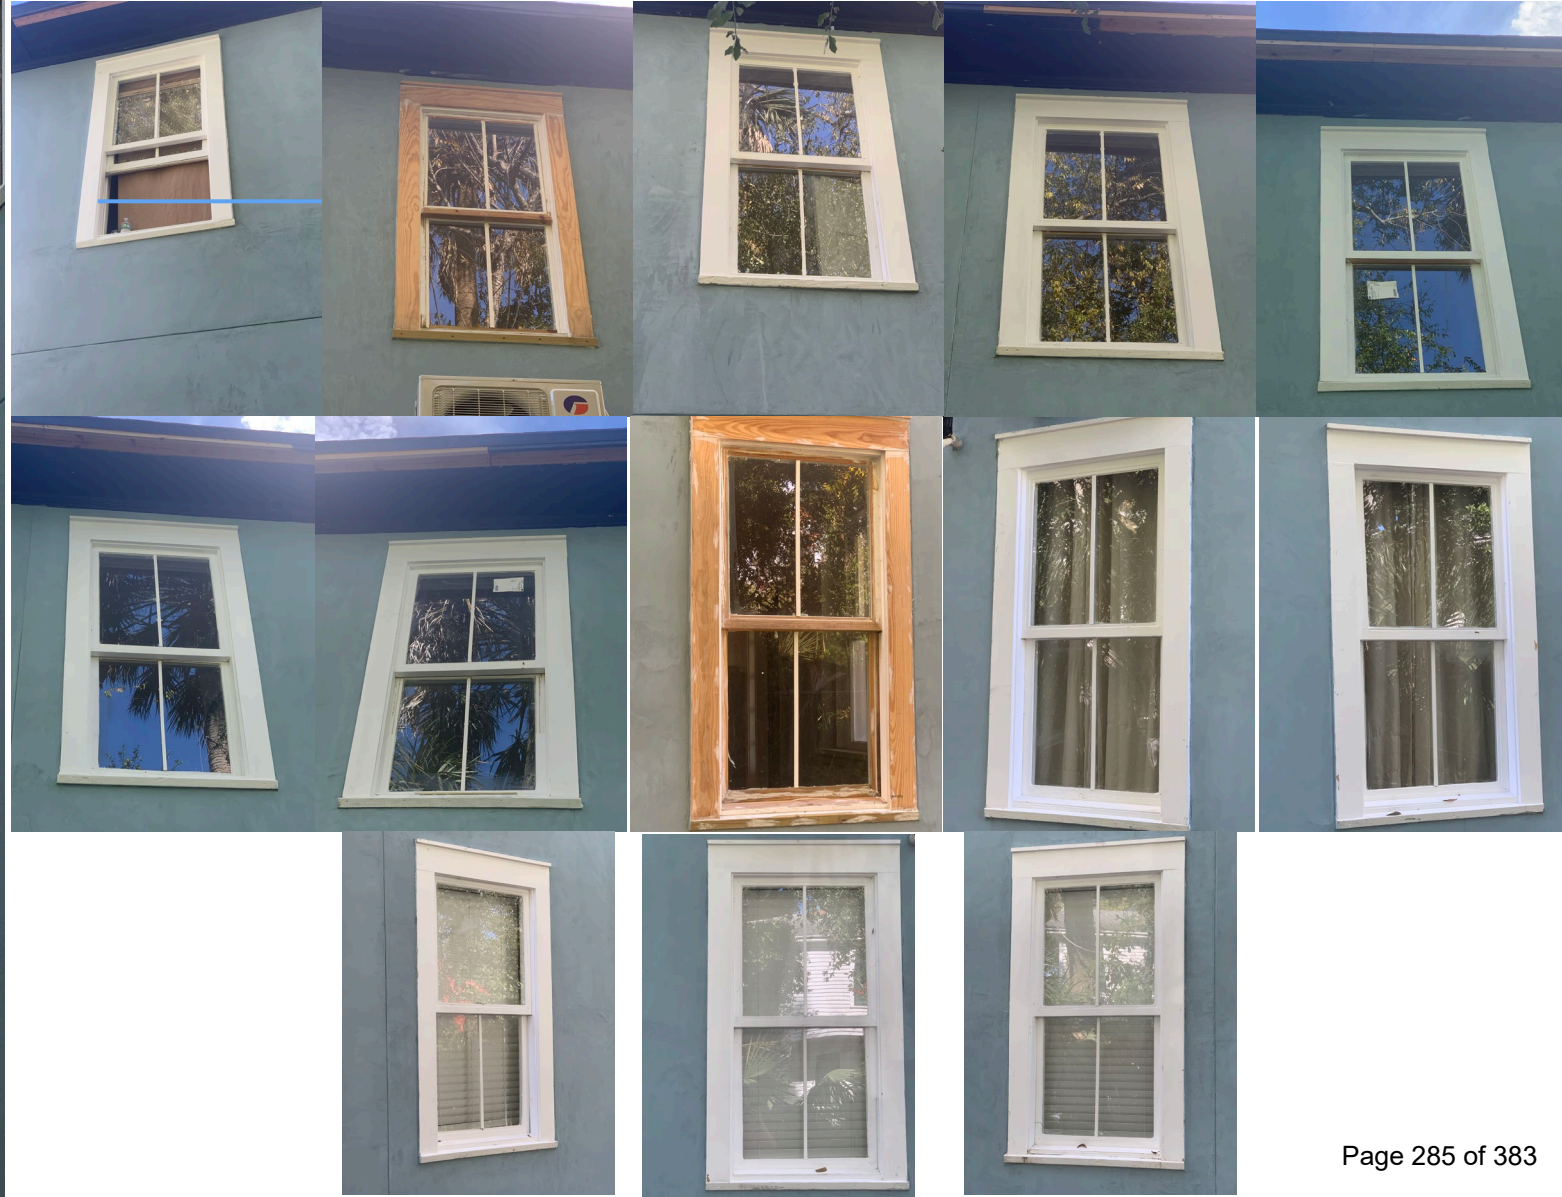
# North Elevation Window Photos

In order of left to right, top to bottom

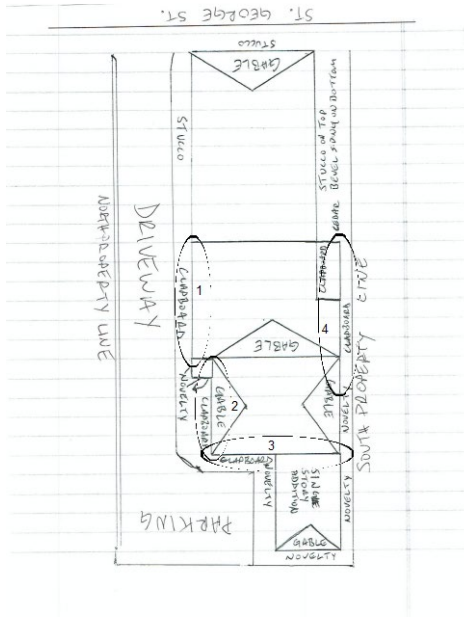
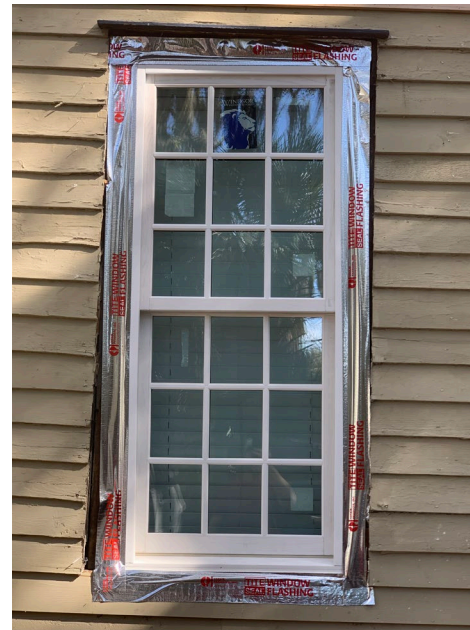
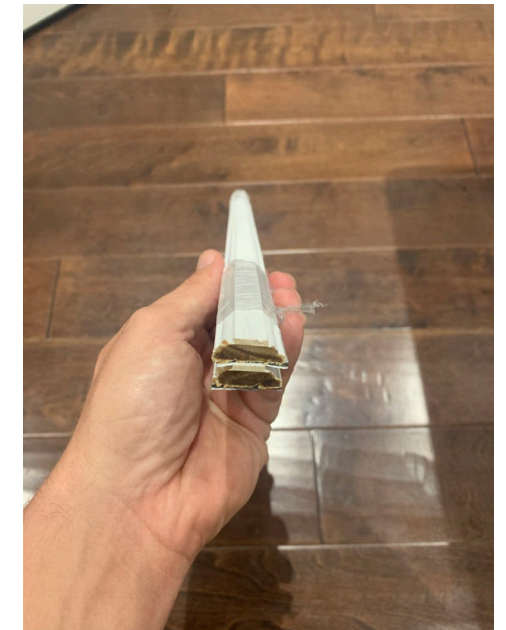
9 over 9 windows approved in the April 2021 HARB meeting.

- The replacement windows for this section of the building were approved in the April HARB meeting, however, the muntins on the windows that were delivered were not wood. We have since had the manufacturer deliver wood muntins to install.

The circled sections in the left image above represent the areas of the building that were previously replaced with the Windsor windows as approved in the April meeting. The center image is of the Windsor window as currently installed and the wood muntins in the right image above are to be installed to meet the wood muntin requirements

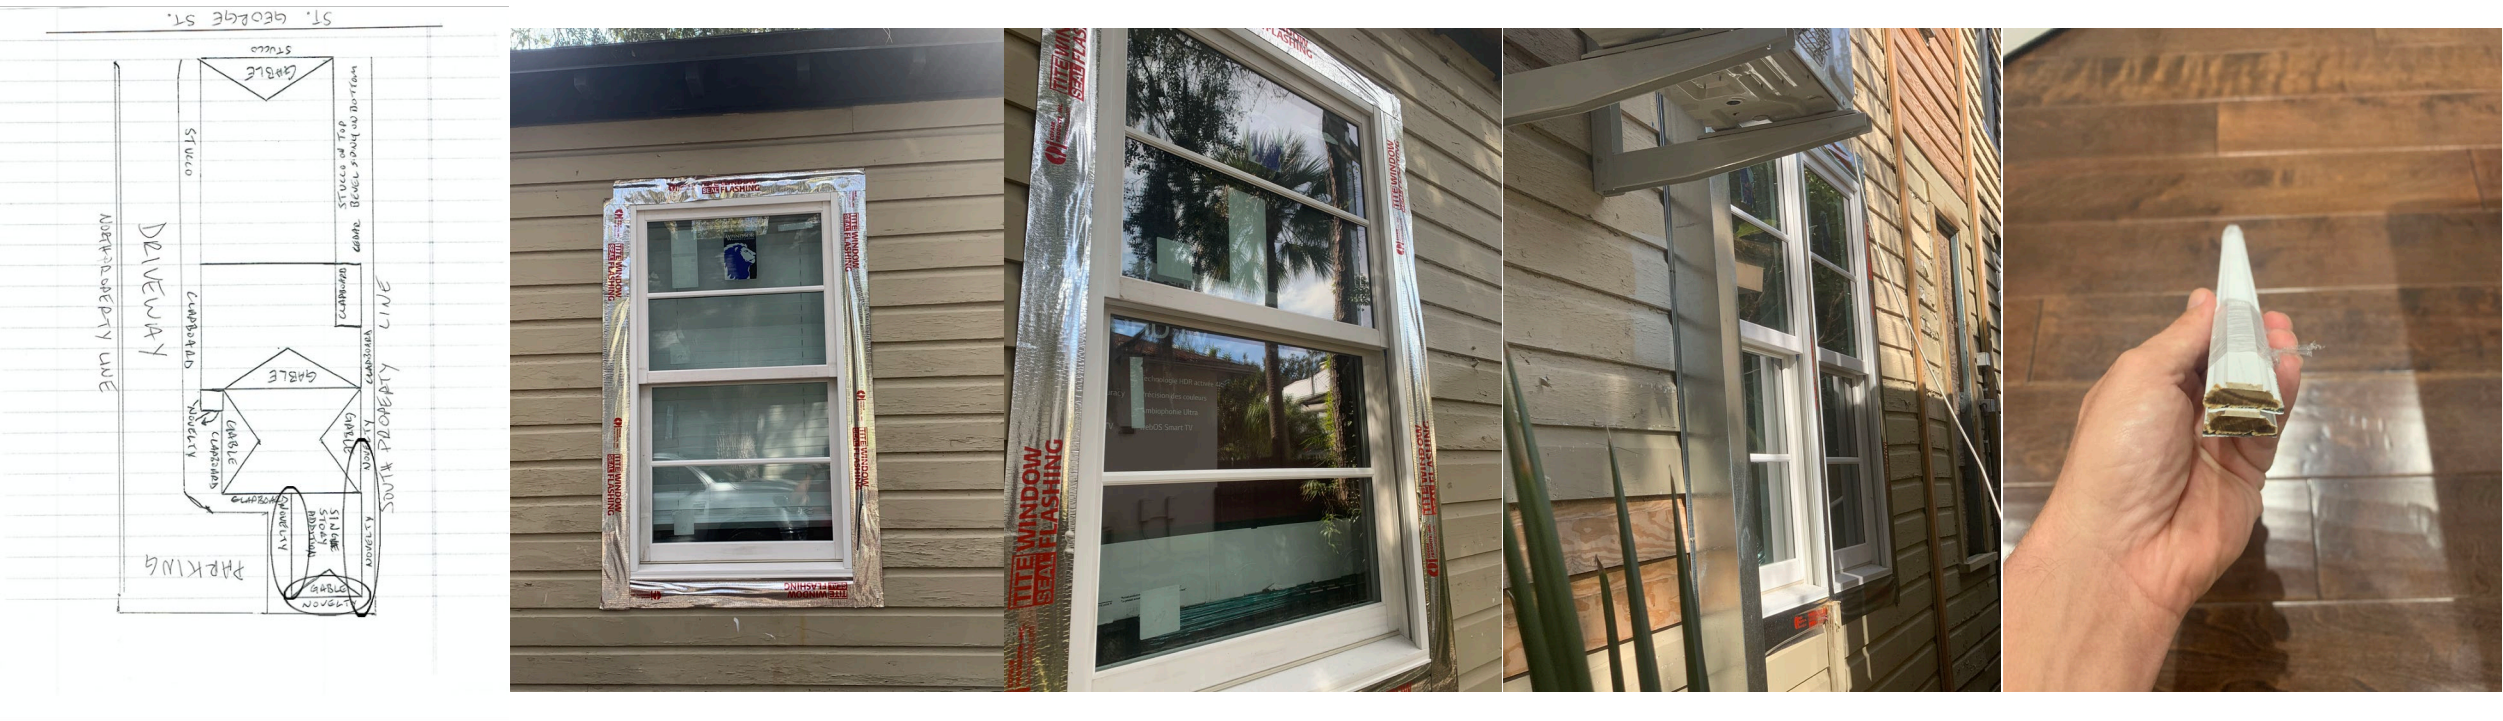
2 over 2 windows approved in the April 2021 HARB meeting.

- The replacement windows for this section of the building were approved in the April HARB meeting, however, the muntins on the windows that were delivered were not wood. We have since had the manufacturer deliver wood muntins to install.

The circled sections in the left image above represent the areas of the building that were previously replaced with the Windsor windows as approved in the April meeting. The middle there images are of the Windsor window as currently installed and the wood muntins in the right image above are to be installed to meet the wood muntin requirements

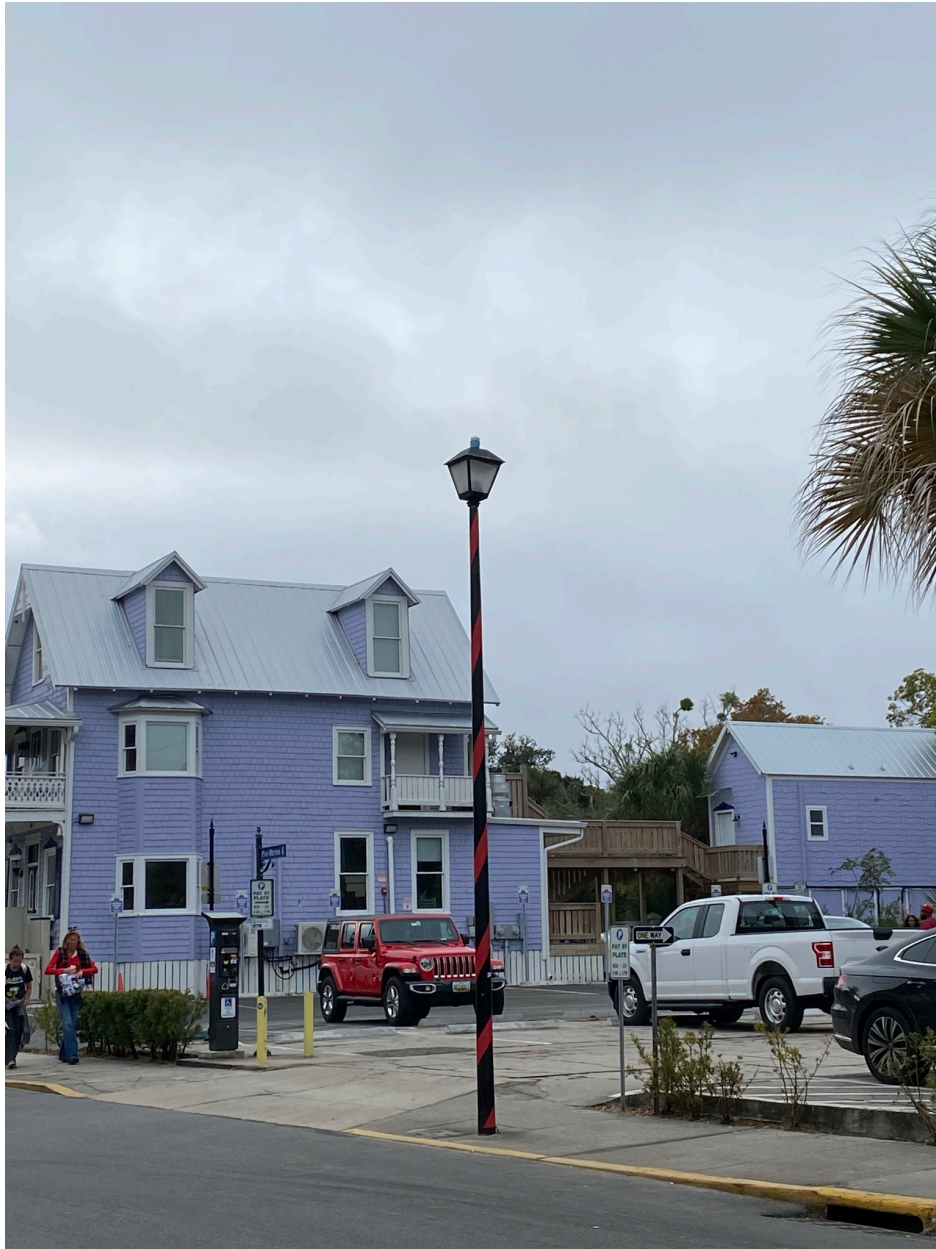
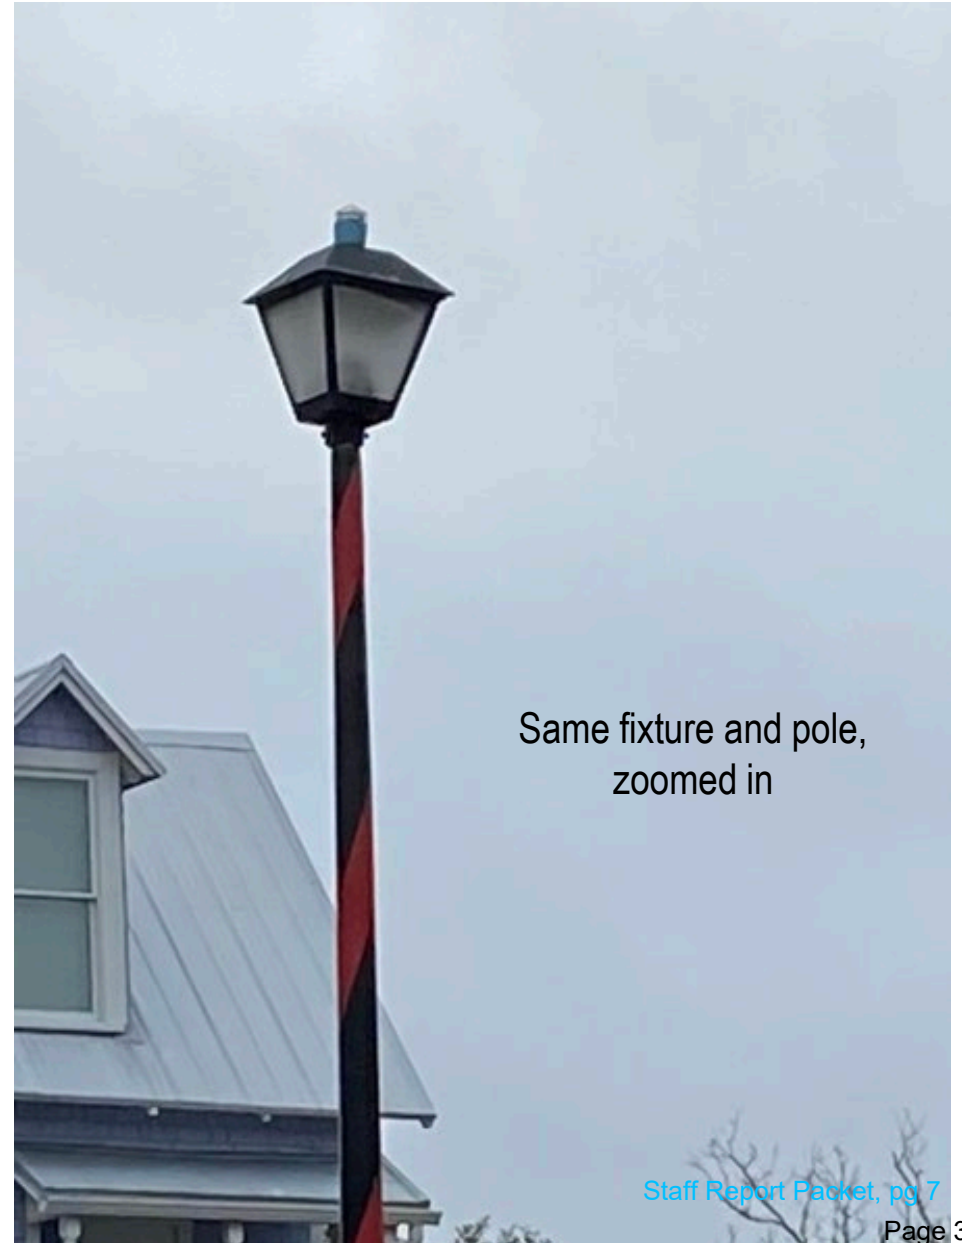
## STAFF PHOTOGRAPHS

### St. Augustine/FPL Lighting Fixture Replacement: Existing 4-panel light fixtures on metal poles

Same fixture and pole,  
zoomed in

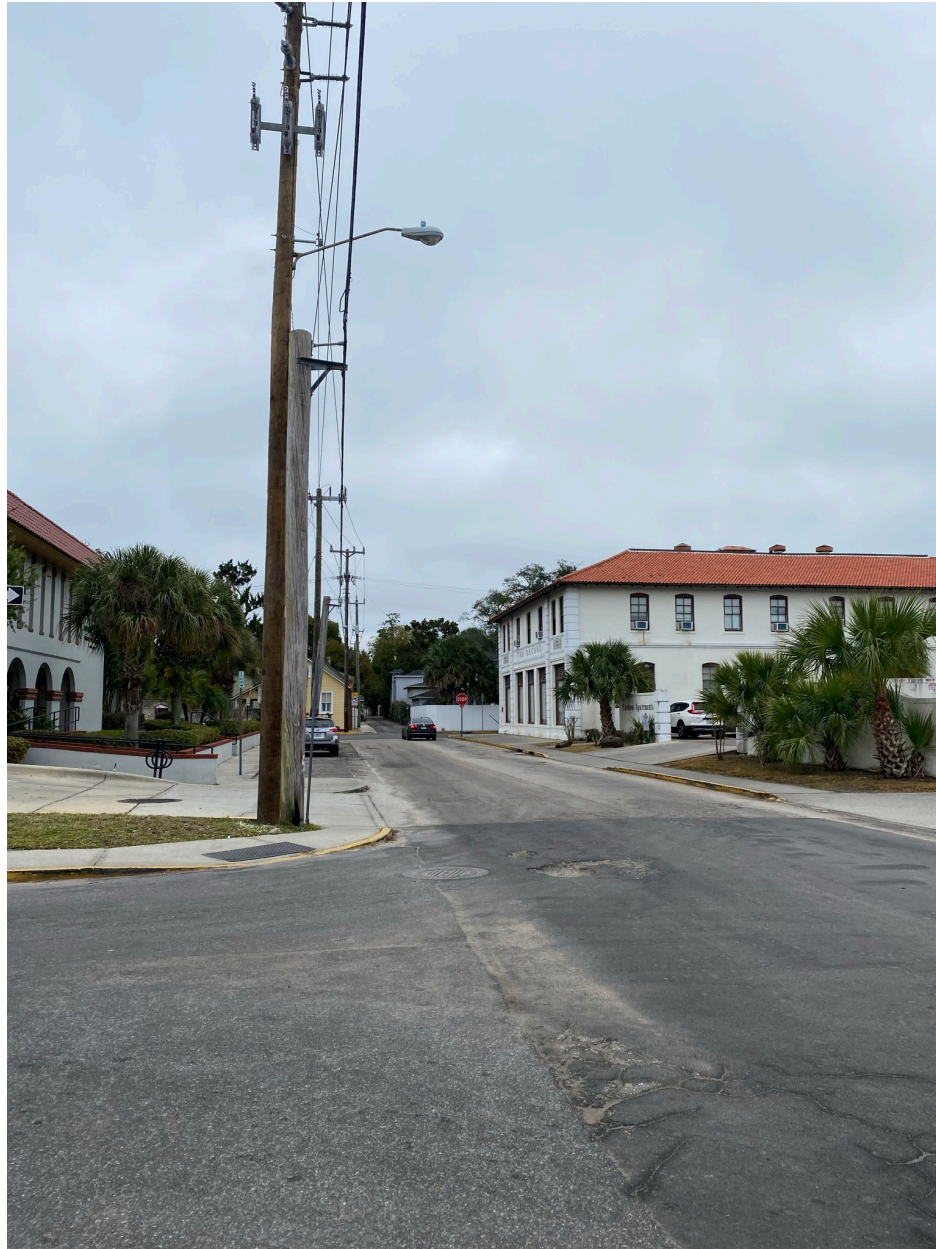
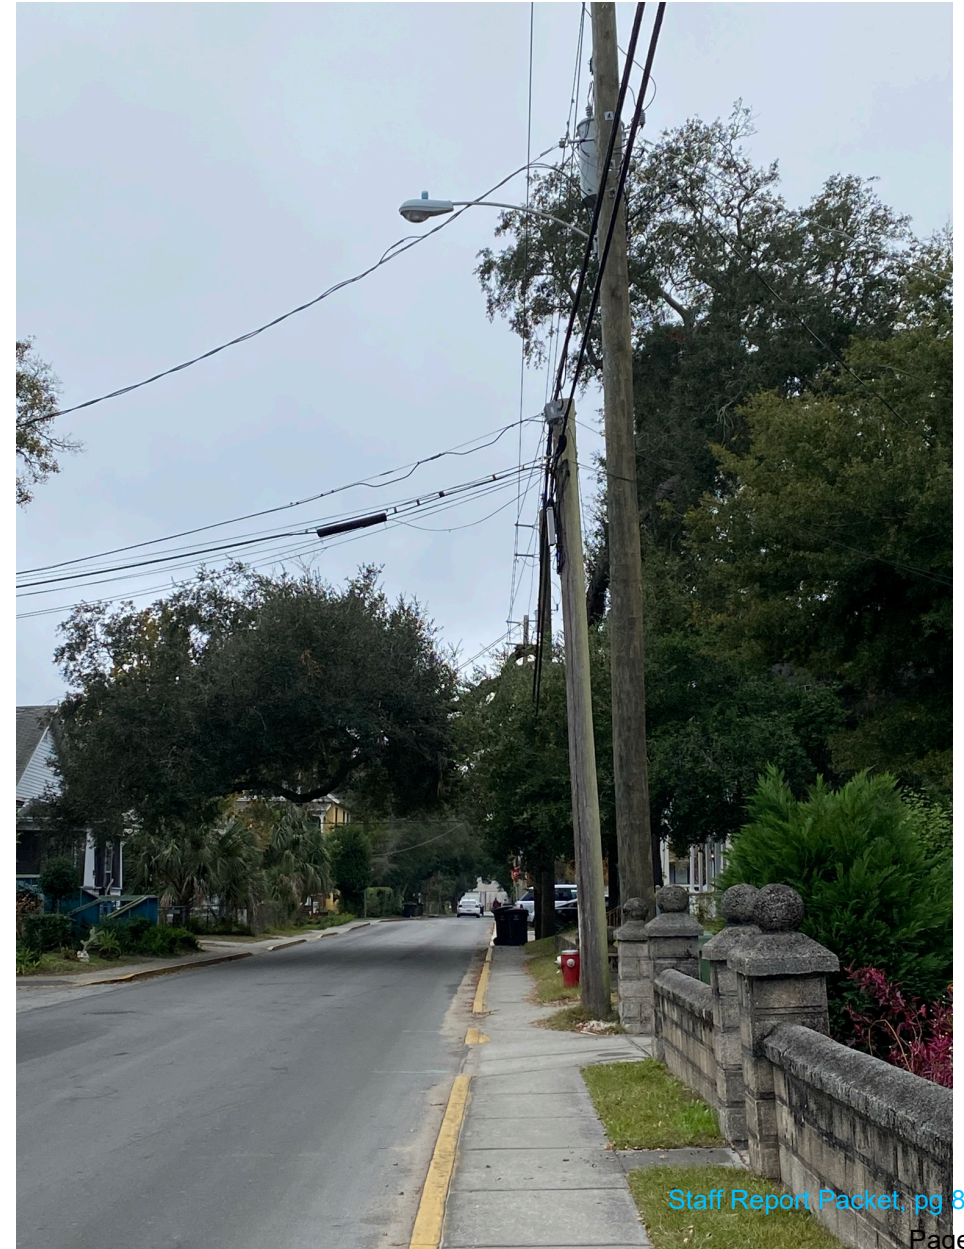
## STAFF PHOTOGRAPHS

### St. Augustine/FPL Lighting Fixture Replacement: Existing cobra head light fixtures on wood poles
