## CITY OF ST. AUGUSTINE HISTORIC ARCHITECTURAL REVIEW BOARD

### A G E N D A

**WEDNESDAY, DECEMBER 14, 2022 - 1:00 PM**

**CITY OF ST. AUGUSTINE HISTORIC ARCHITECTURAL REVIEW BOARD  
STAFF REPORT AND RECOMMENDATION  
Prepared for December 14, 2022 Meeting**

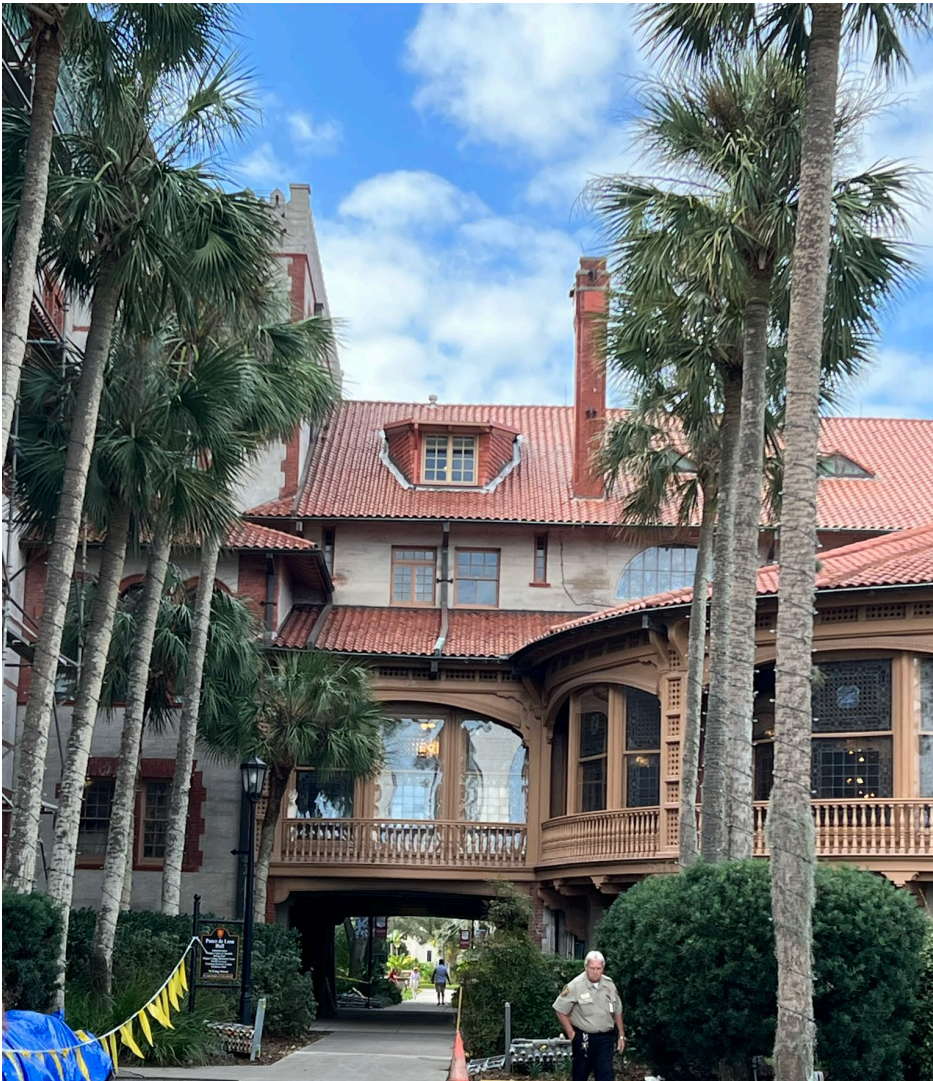
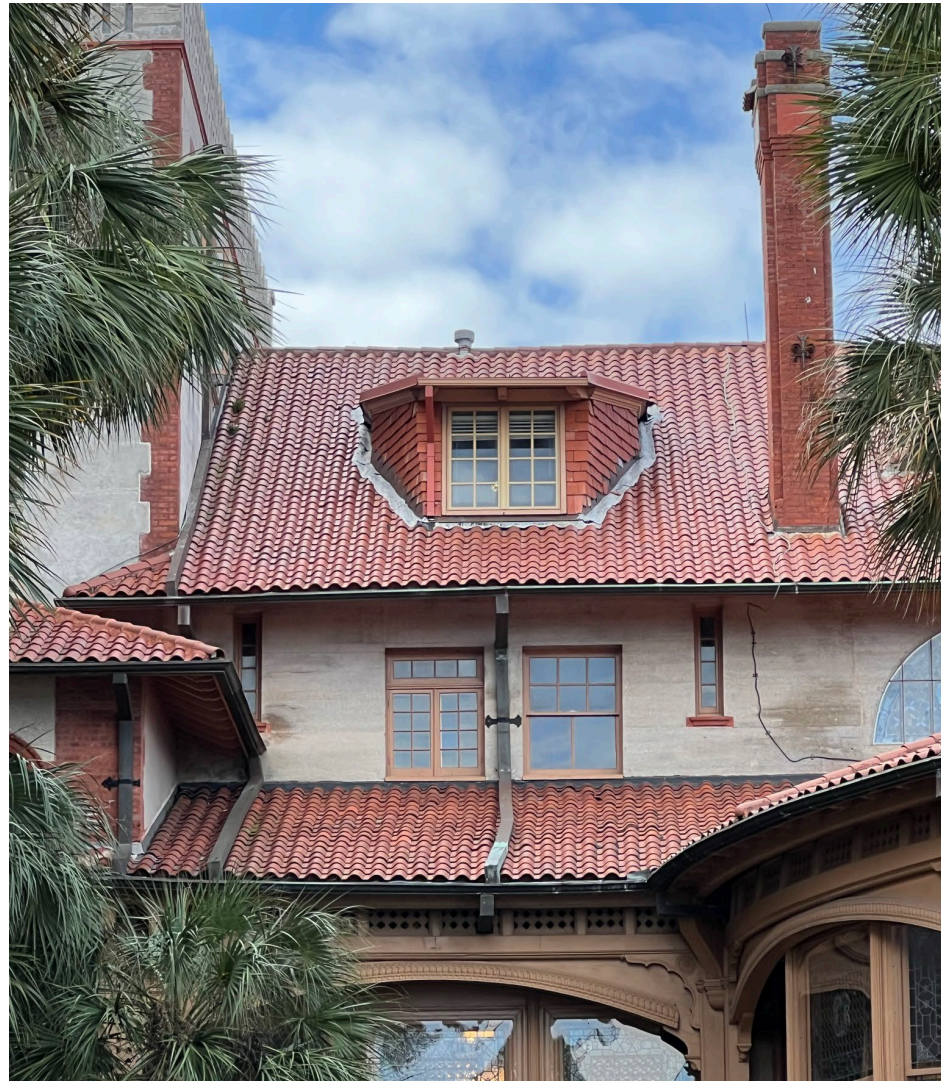
East Elevation  
Paired Window Sashes to be replaced with aluminum

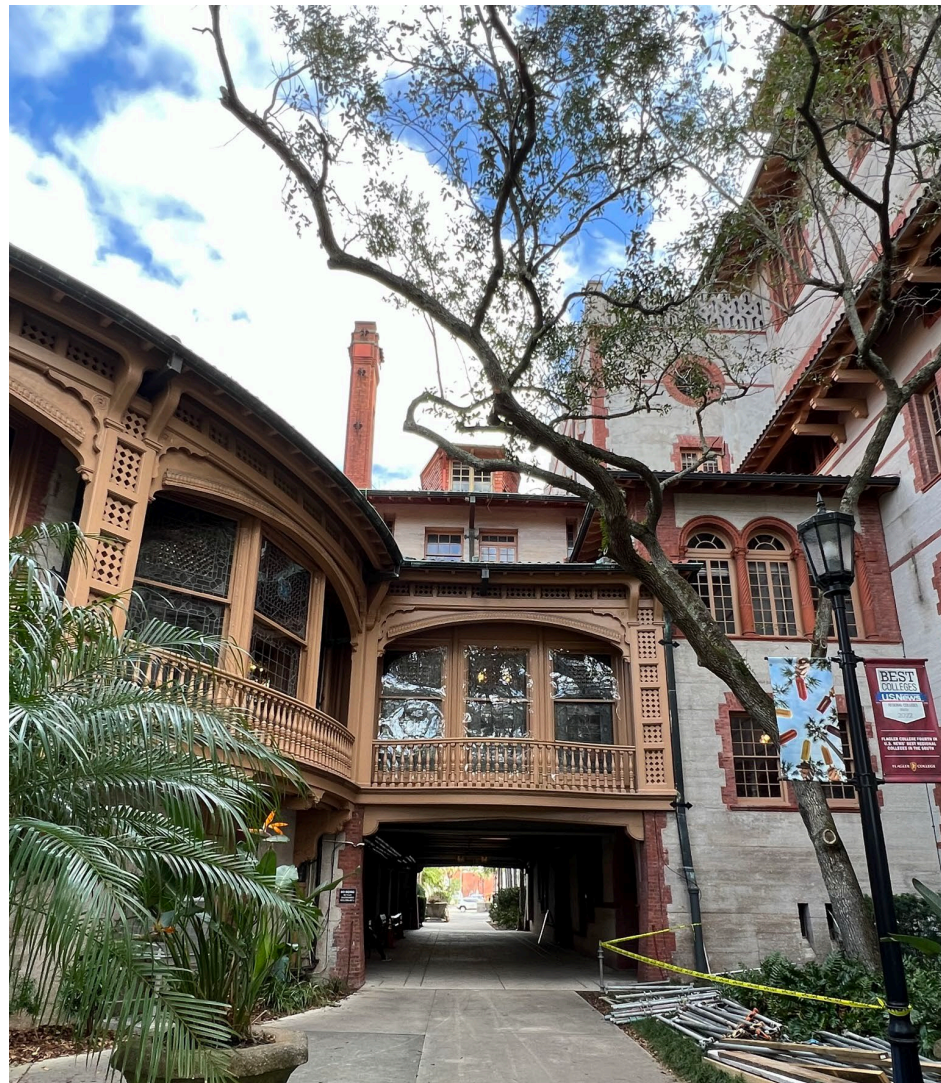
West Elevation  
Paired Window Sashes to be replaced with aluminum

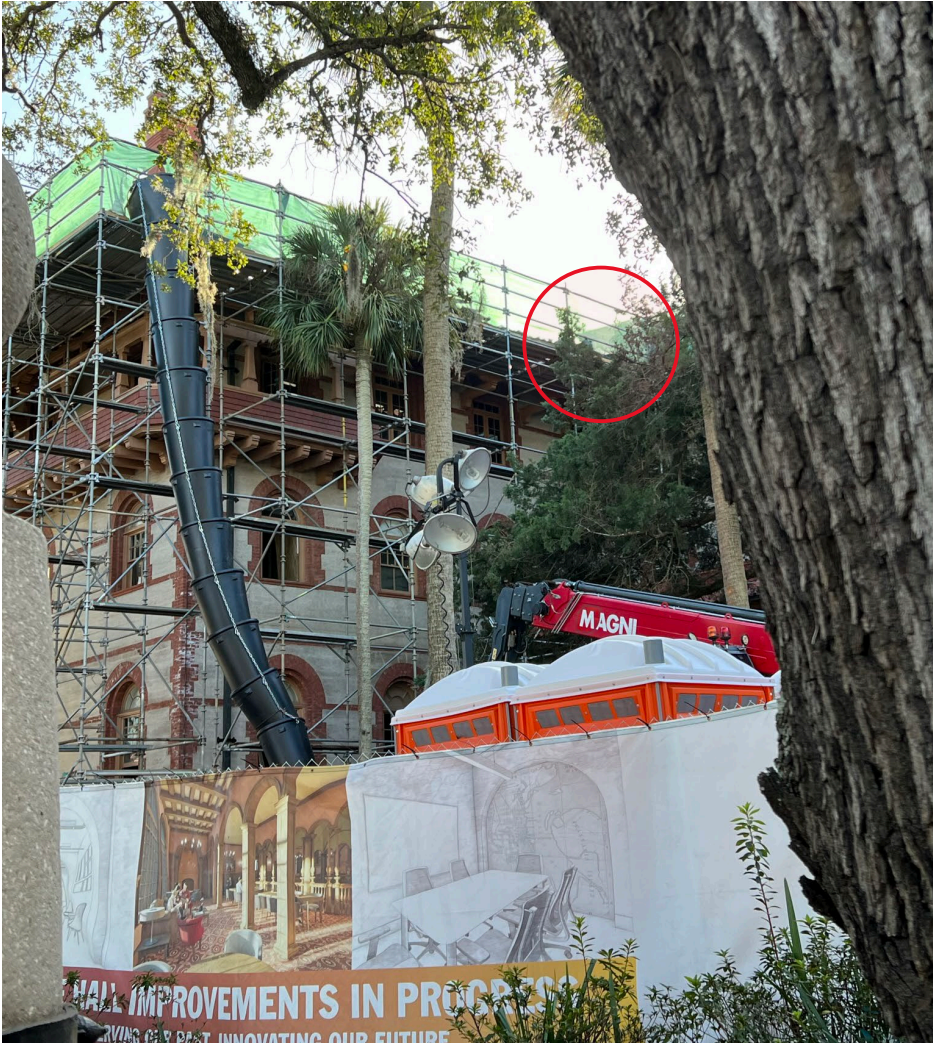
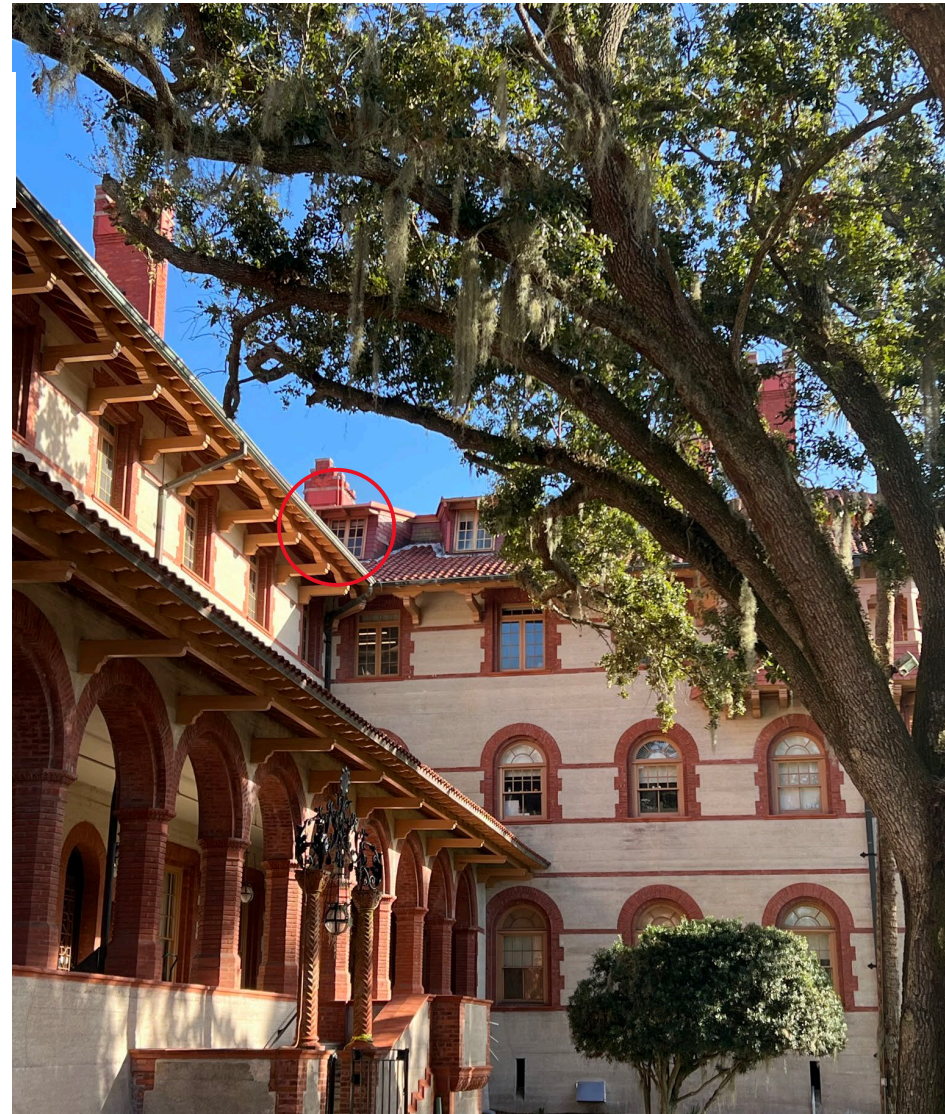
South Elevation West Wing  
Paired Window Sashes to be replaced with aluminum

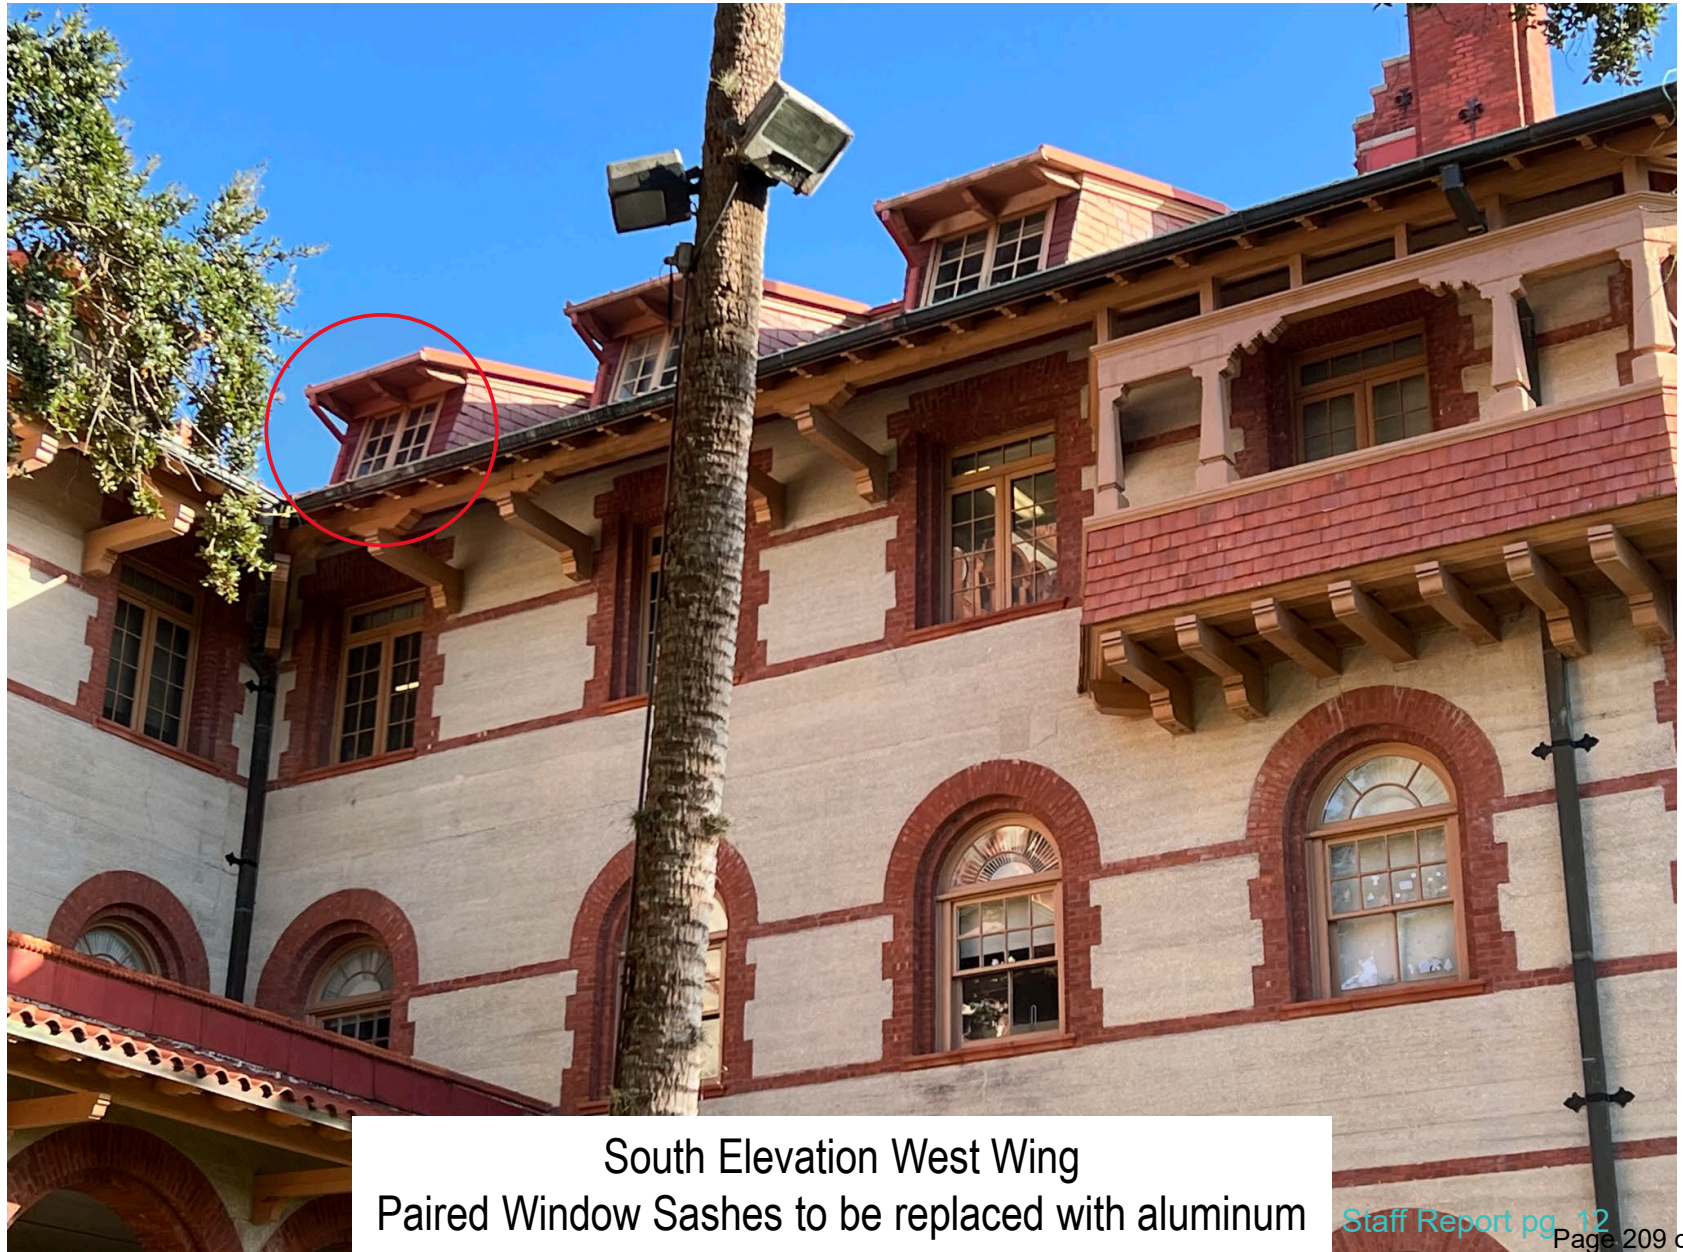
South Elevation West Wing  
Paired Window Sashes to be replaced with aluminum

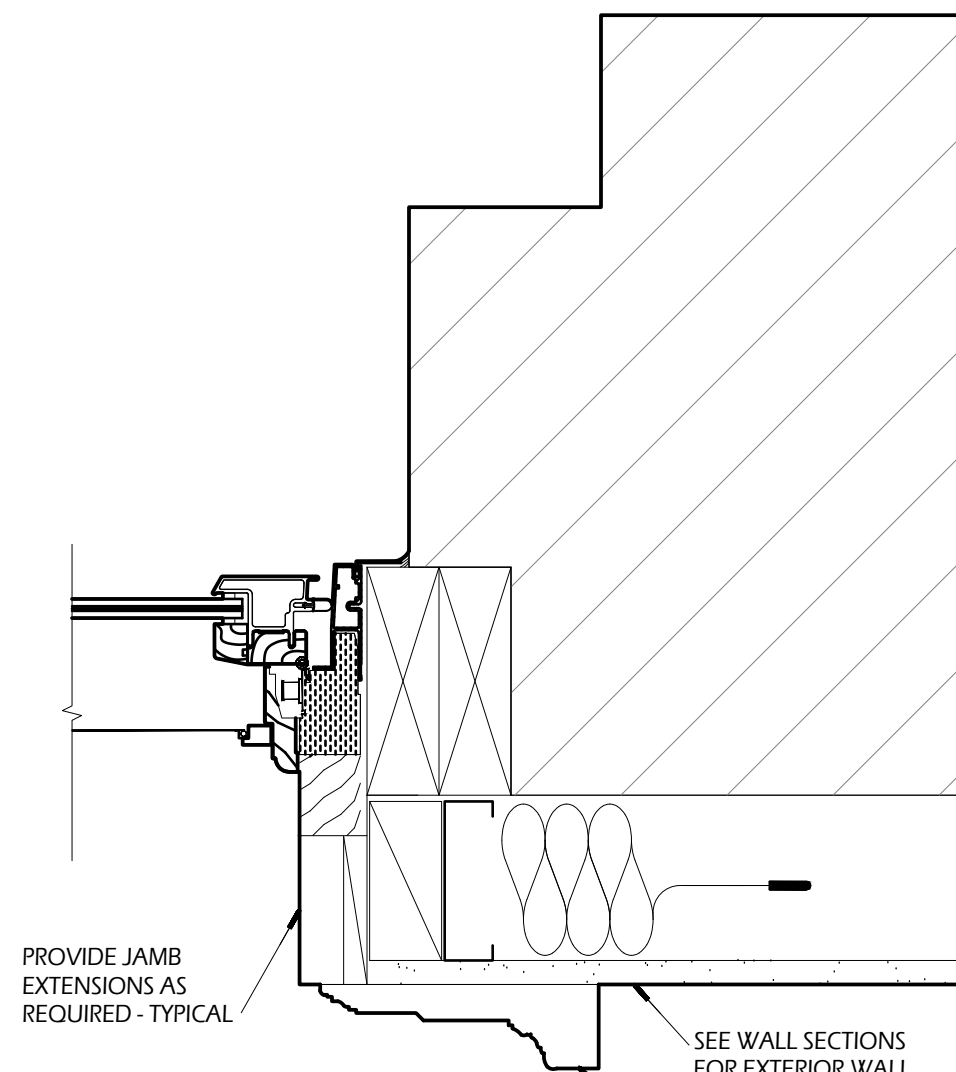
A5.22 DOUBLE HUNG WINDOW JAMB  
3" = 1'-0"

- WINDOW REPAIR NOTES:
1. COORDINATE CONSERVATOR WORK TO BE COMPLETED BY INTERNATIONAL FINE ARTS CONSERVATION STUDIO (IFACS) PER SEPARATE AGREEMENT WITH THE COLLEGE.
  2. PROVIDE JAMB EXTENSIONS AT WINDOWS AS NECESSARY FOR NEW EXTERIOR WALL FURRING.
  3. EPOXY WOOD FILLER REPAIR ANY DAMAGED WINDOW SASH AS NECESSARY.
  4. REPLACE ANY BROKEN GLASS TO MATCH EXISTING.
  5. REMOVE AND REPLACE SEALANTS AT PERIMETER OF WINDOWS.
  6. PREPARE PREVIOUSLY PAINTED SURFACES AS NECESSARY AND APPLY NEW PAINT FINISH.

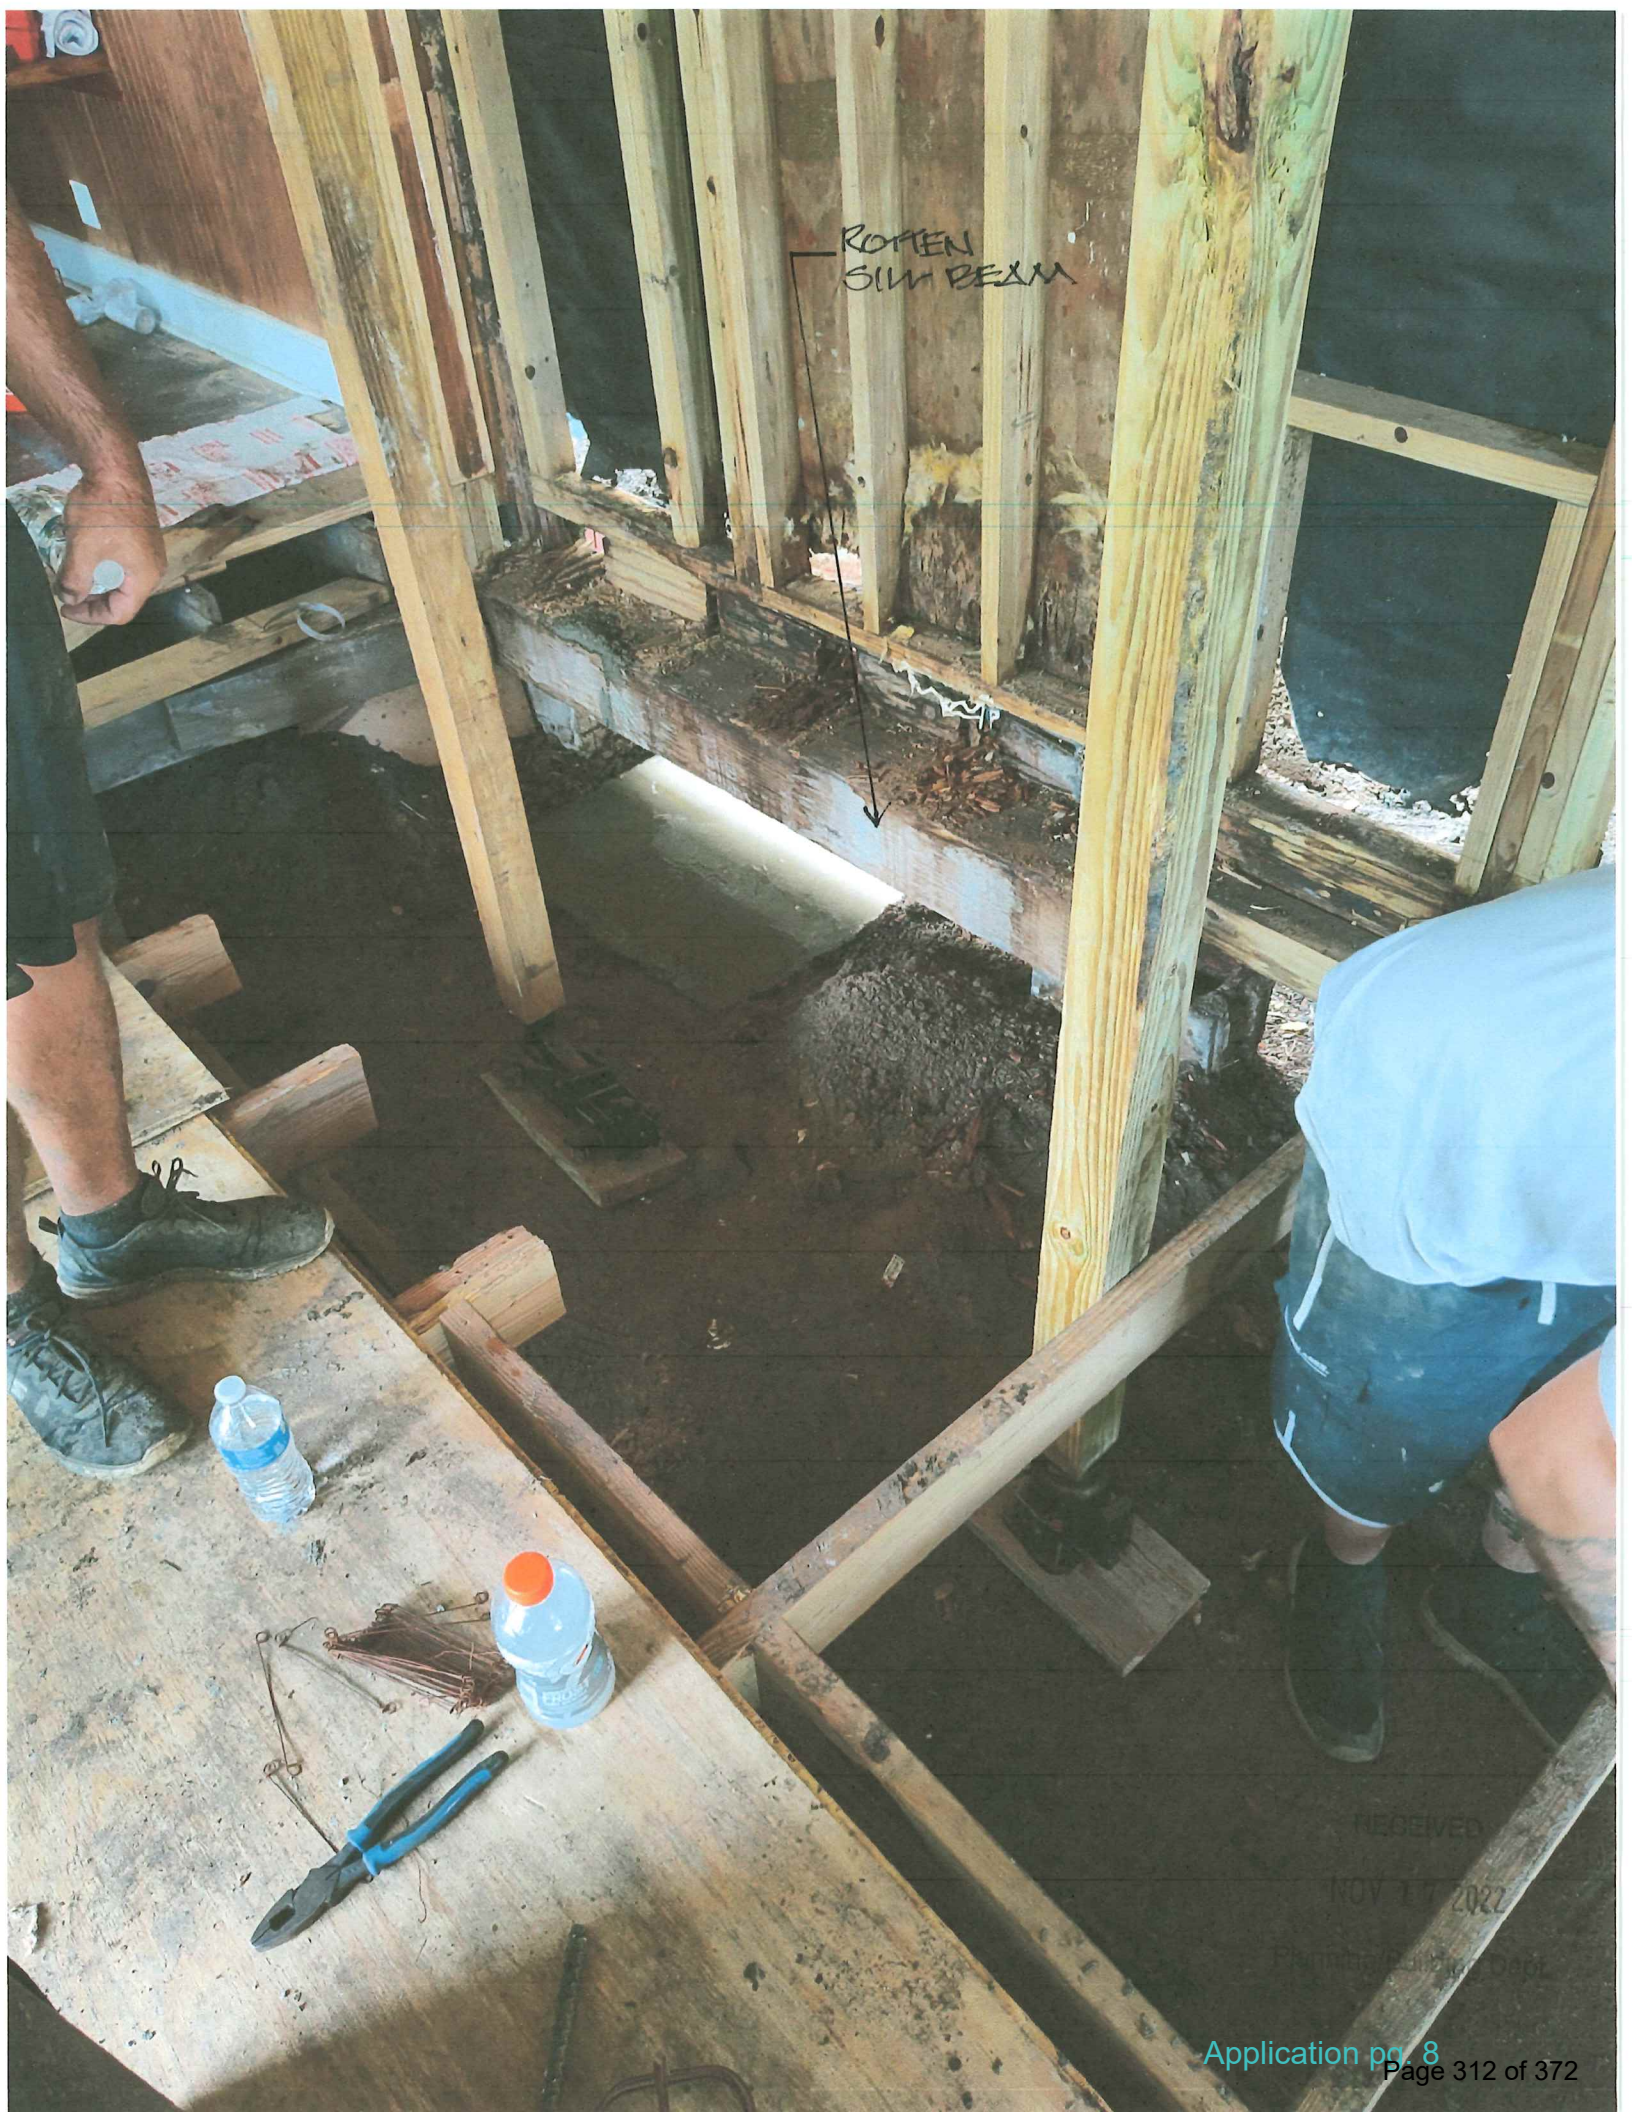
ROTTEN  
SILL BEAM

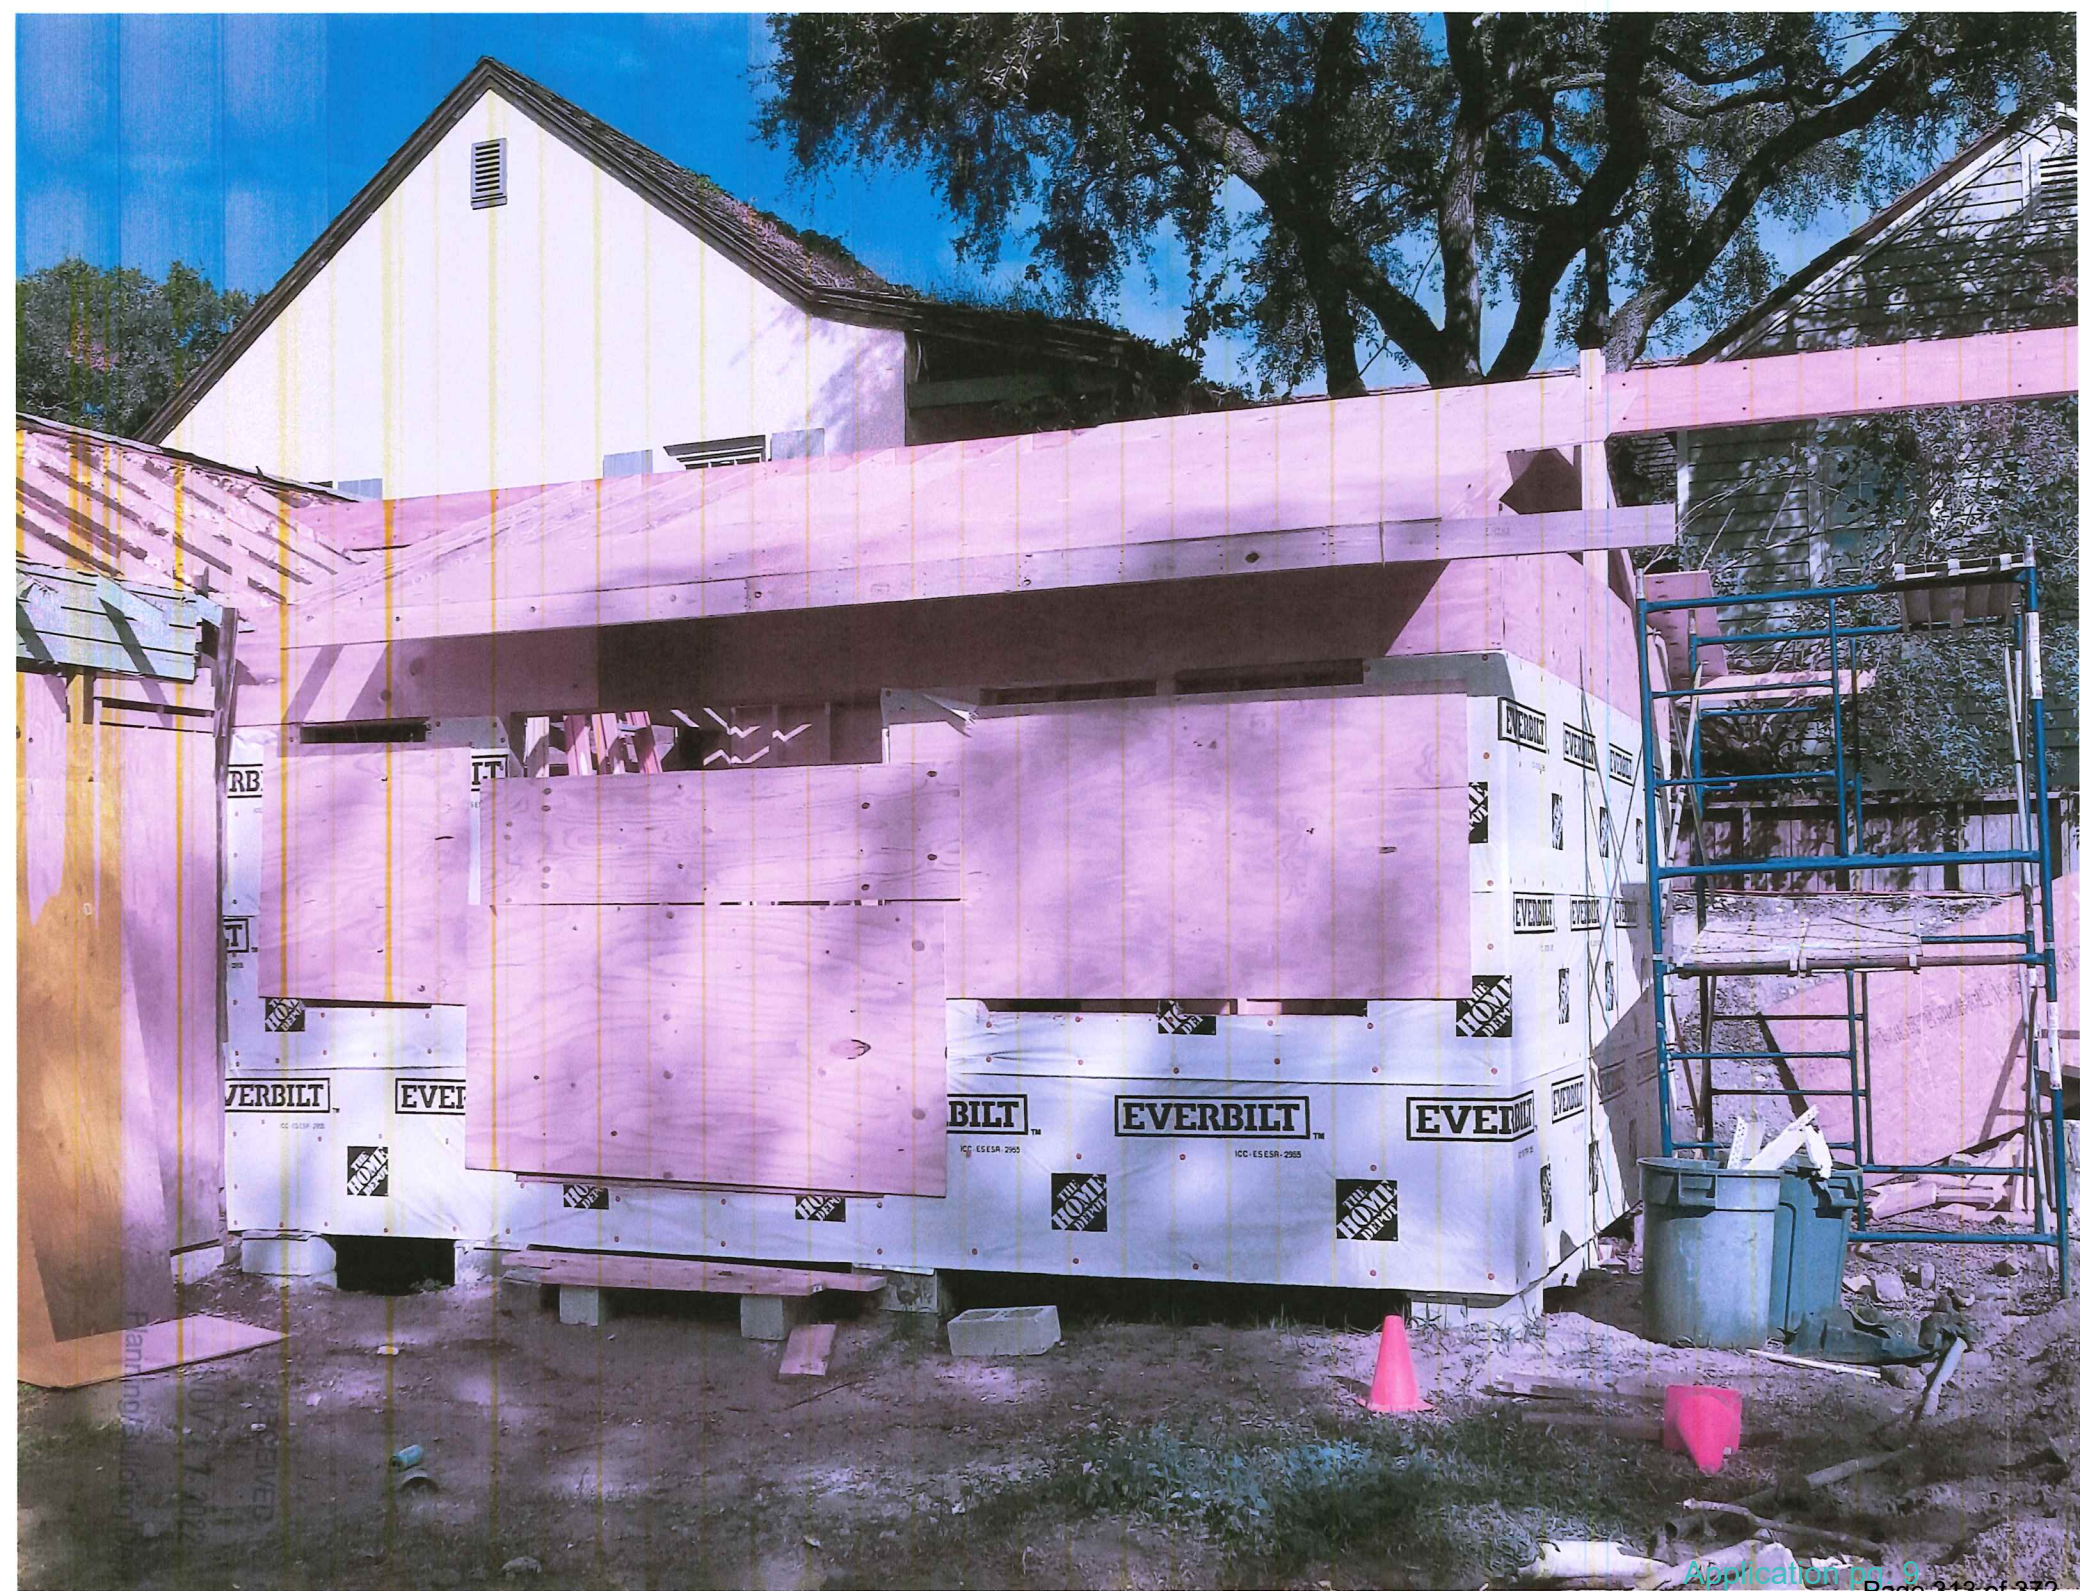
CURRENT STATUS OF ADDITION

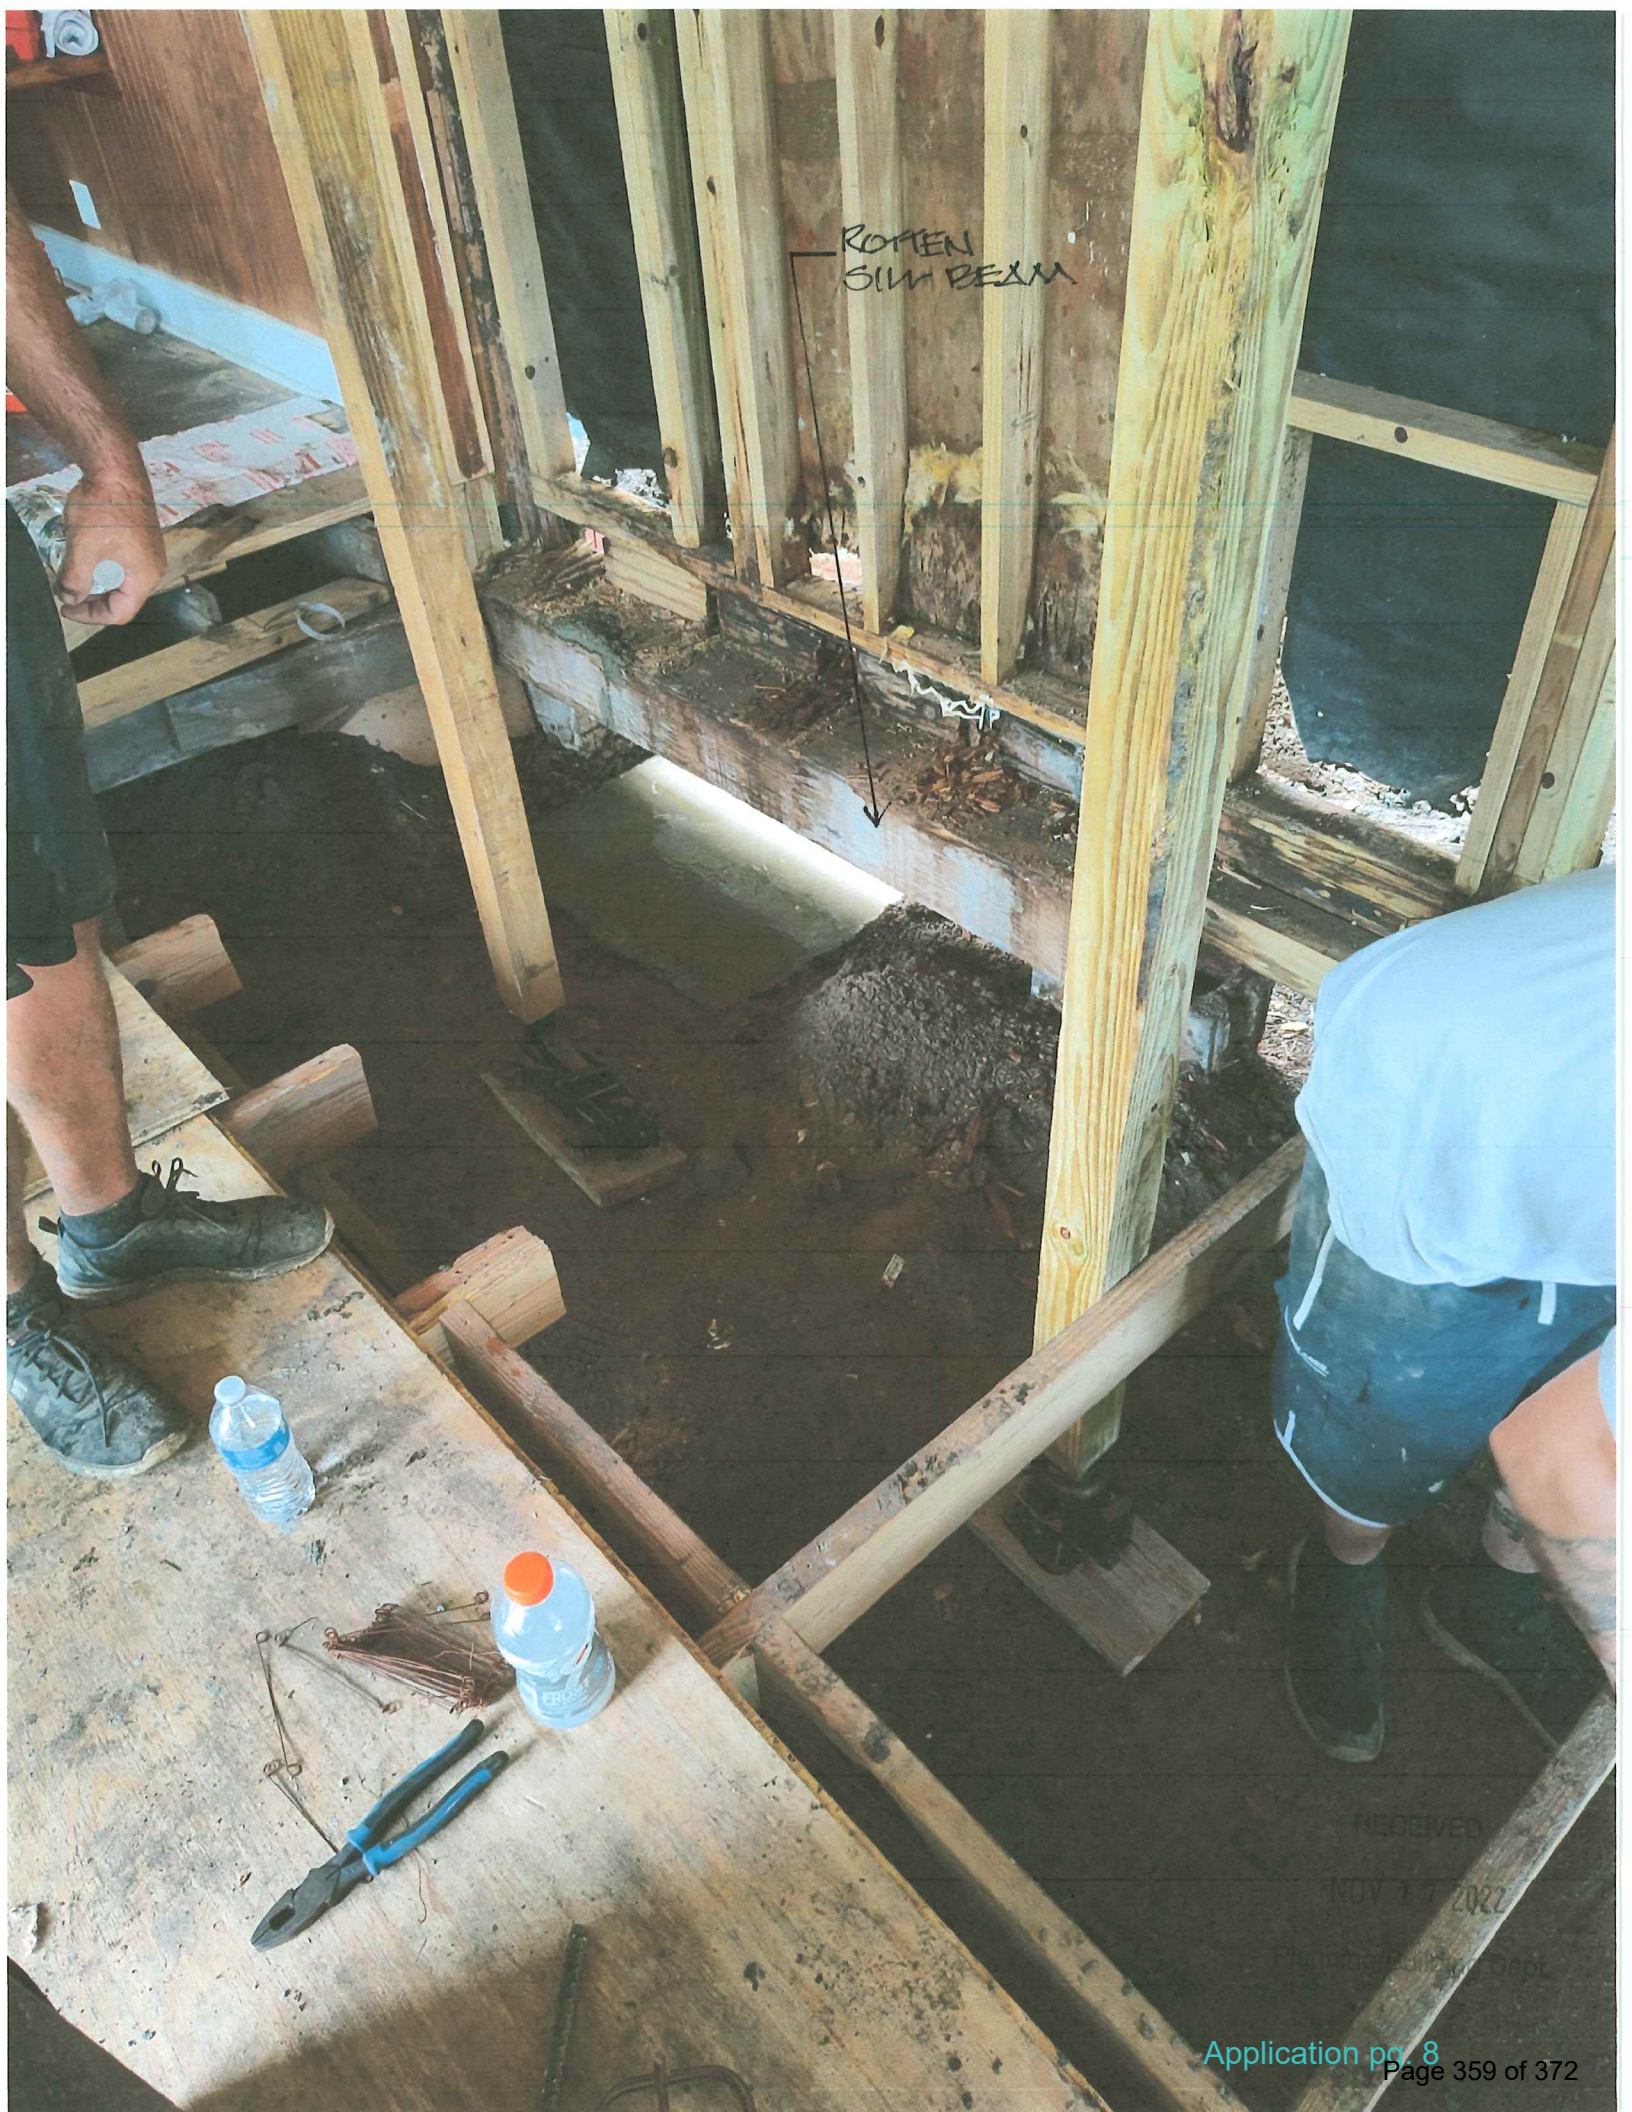
ROTTEN  
SILL BEAM

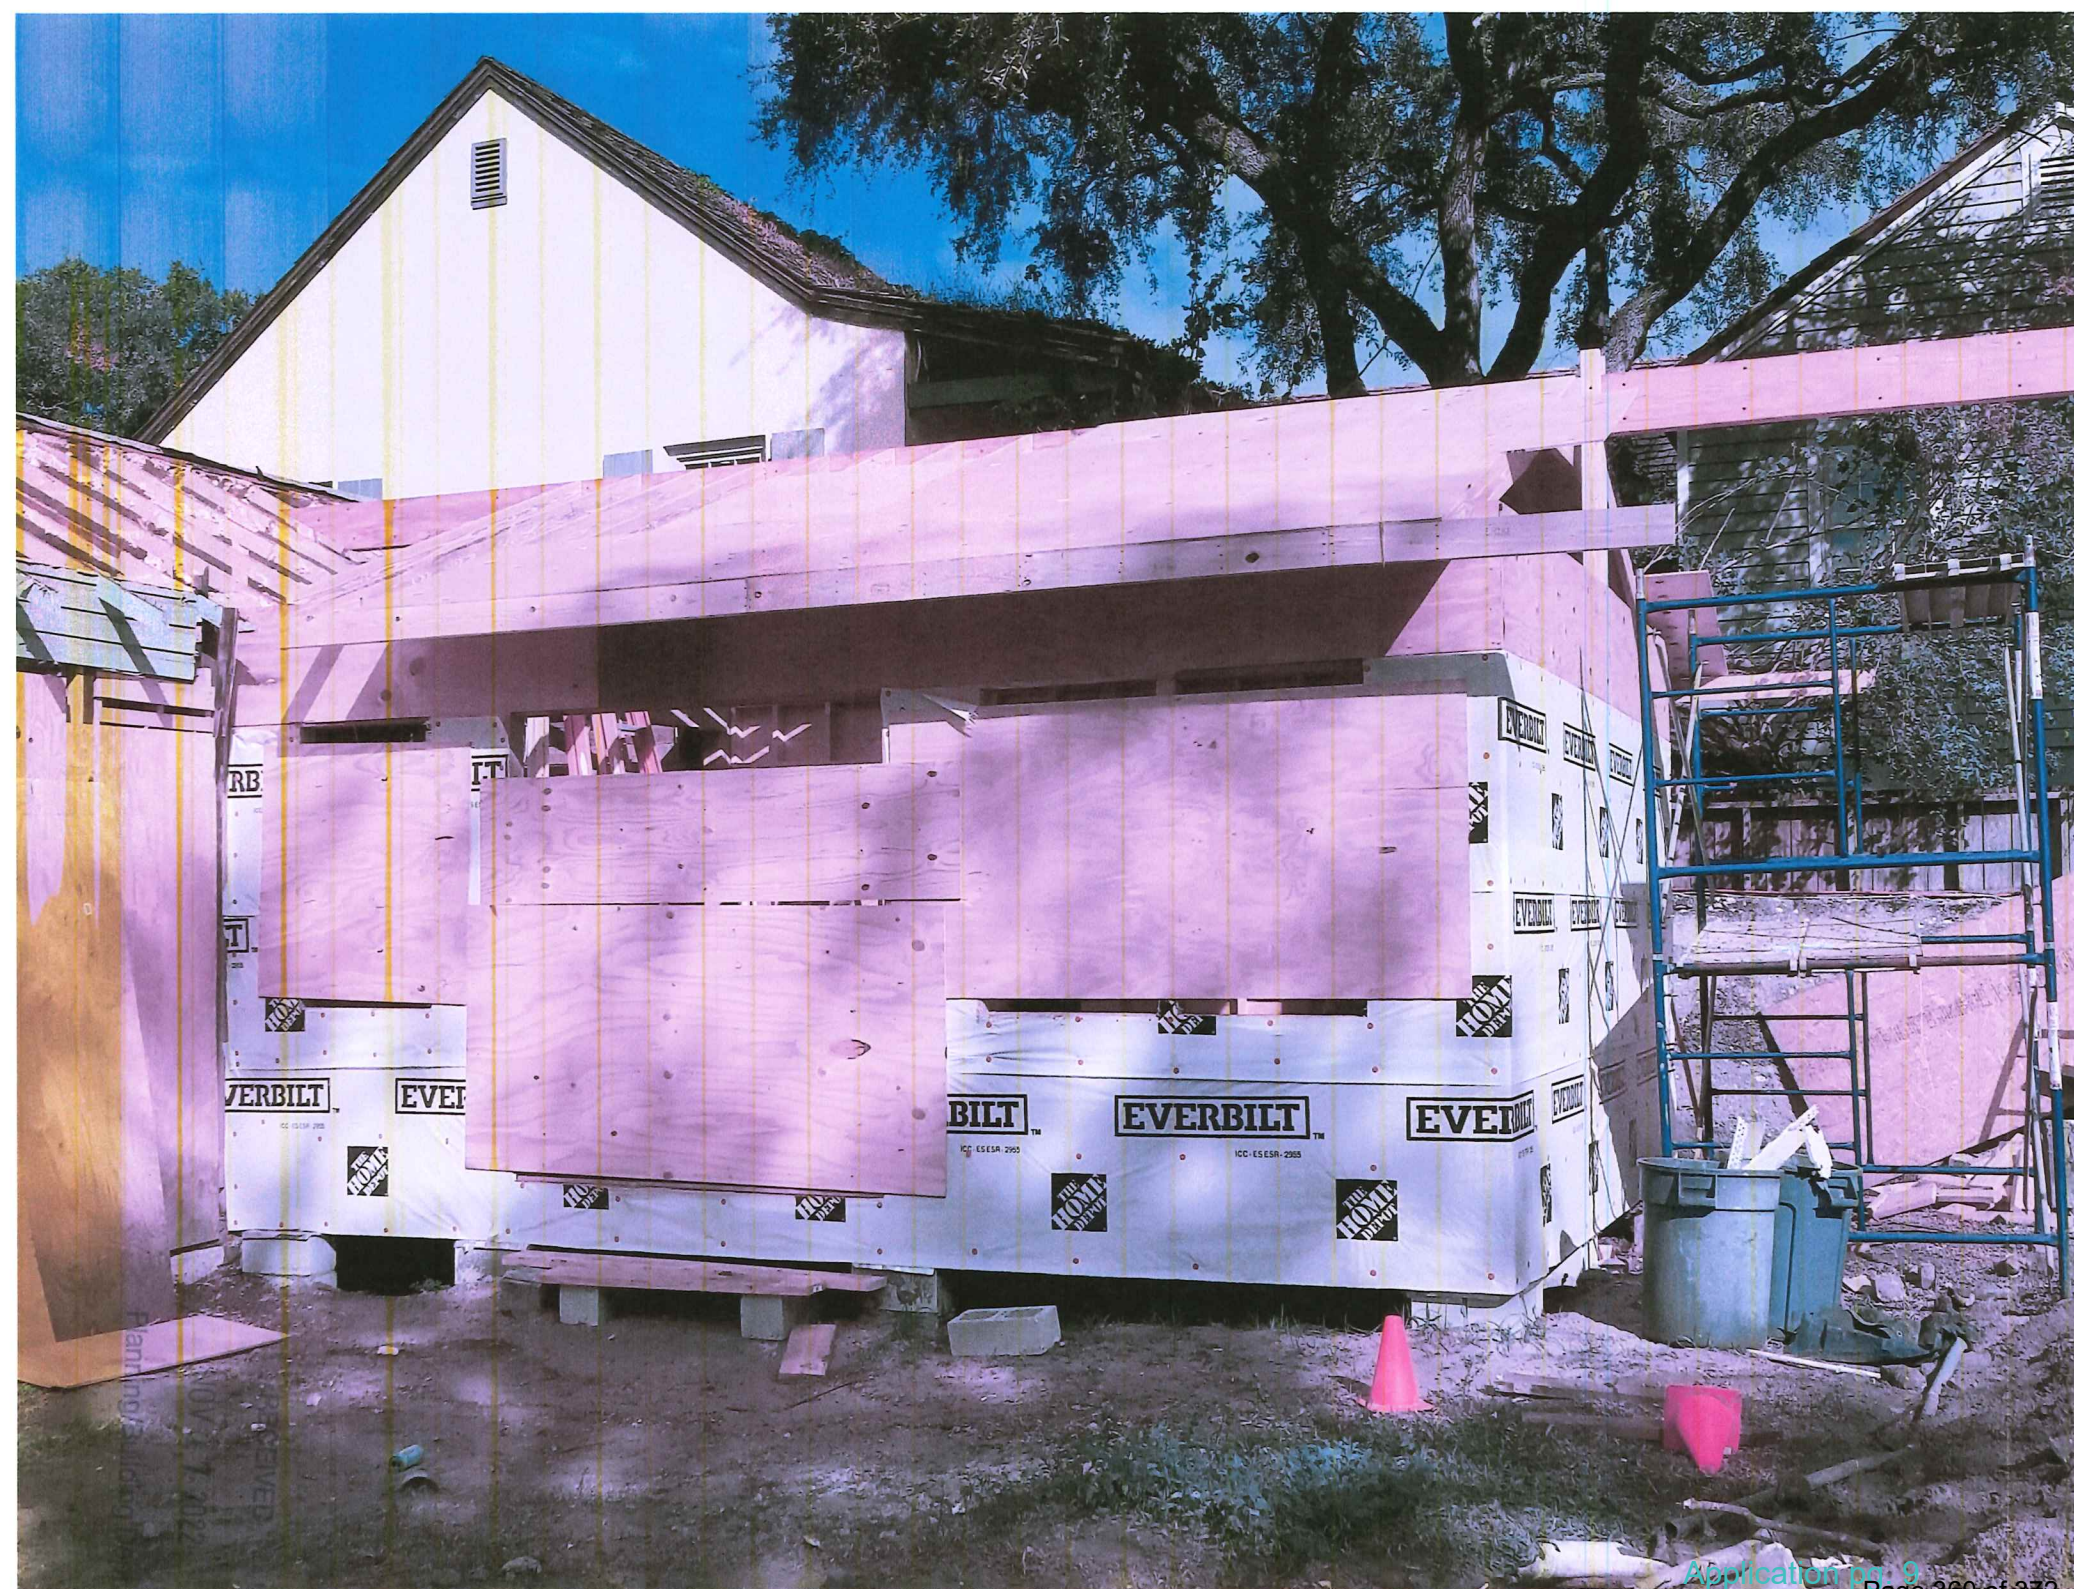
CURRENT STATUS OF ADDITION
