# City of St. Augustine

## Historic Architectural Review Board

### **A G E N D A \*amended**

**Thursday, October 17, 2019 1:00 p.m.**

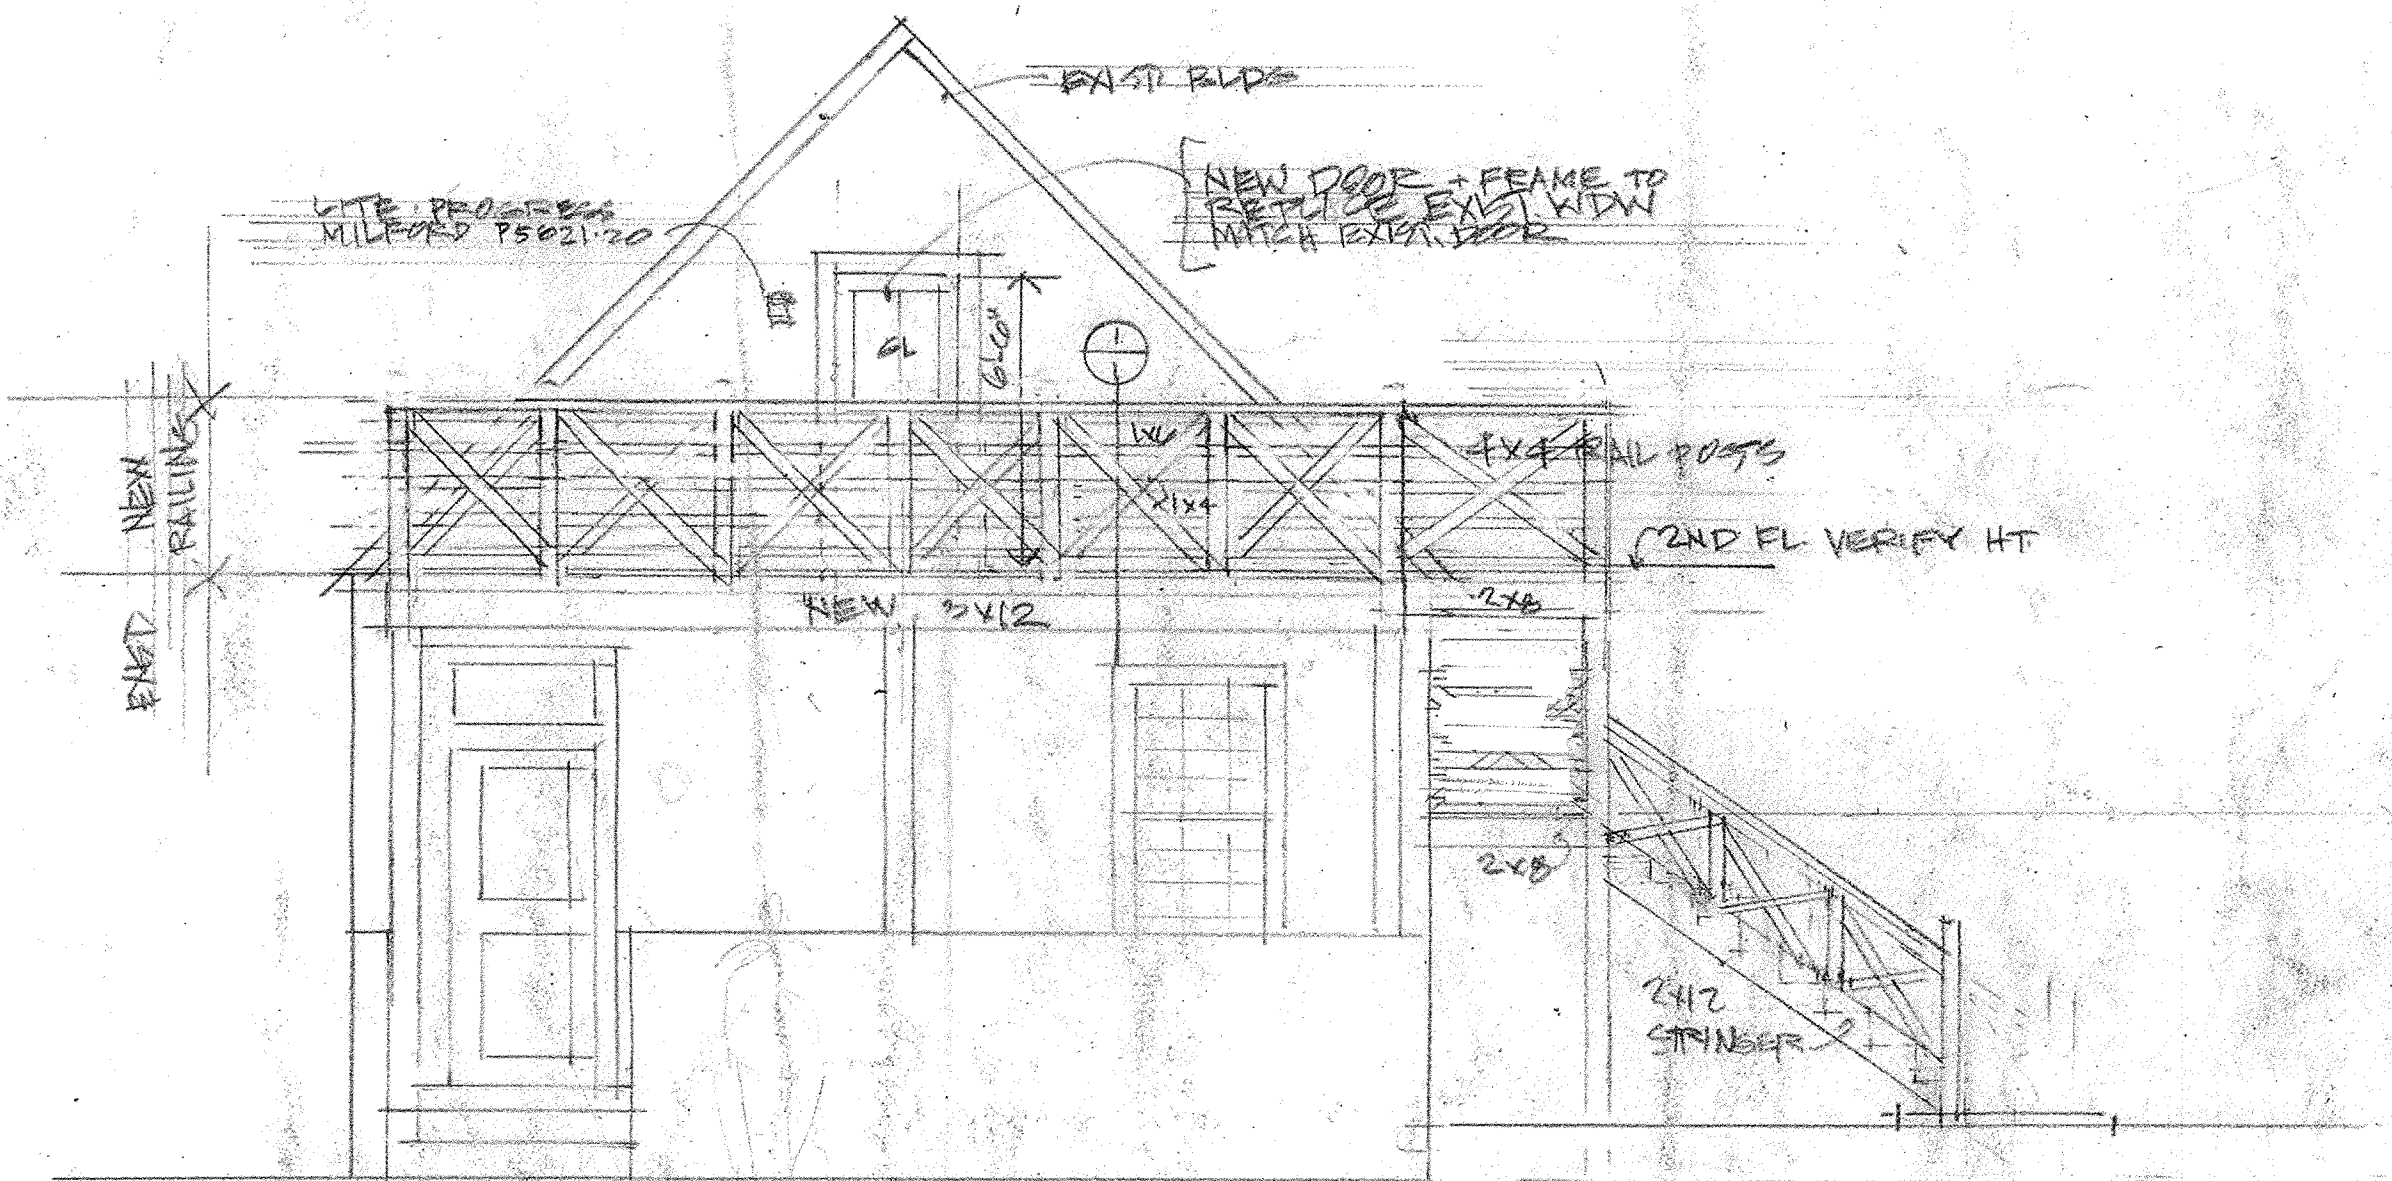
EAST ELEVATION  
SCALE 1/4"=1'-0"

1. DESCRIPTION OF WORK: WORK GENERALLY CONSISTS OF CONSTRUCTING AN UPPER DECK OVER AN EXISTING PORCH AS SHOWN.

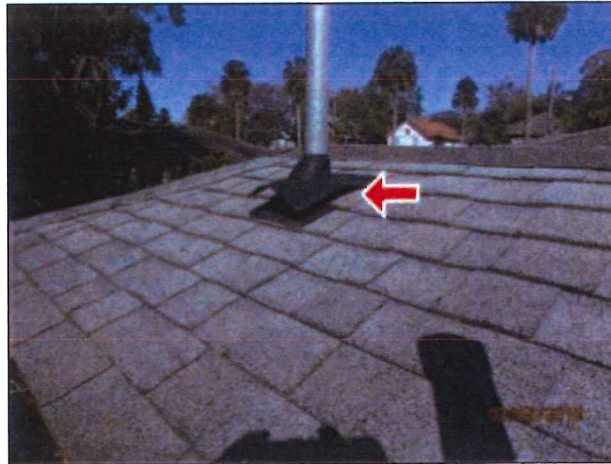
1.1 Picture 1

**1.1** The rubber flashing around the electrical service mast has lifted, repair needed.

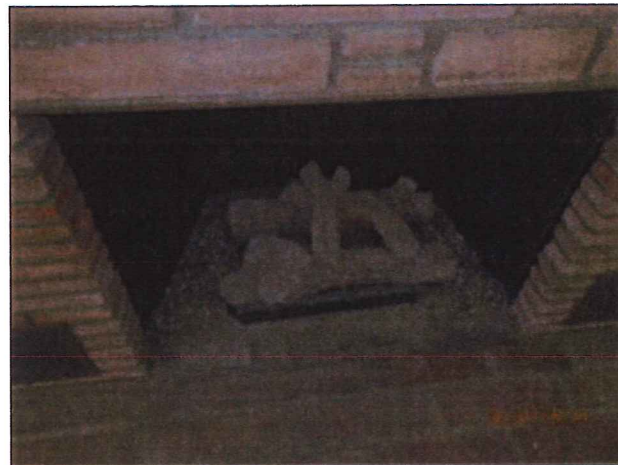
1.2 Picture 2

**1.2** FYI: The chimneys has been capped off, have the fireplace and chimneys inspected prior to use if you plan on using them in the future.

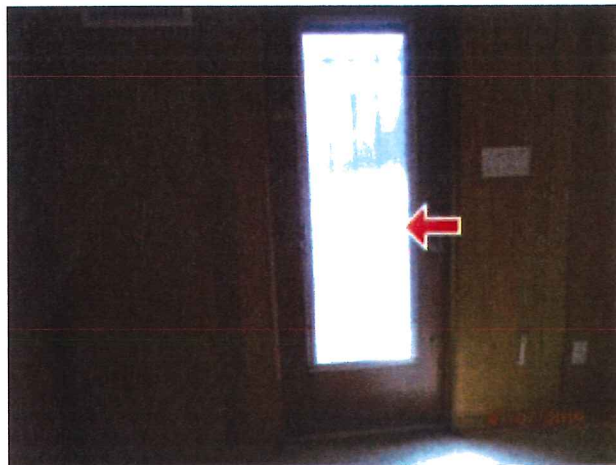
2.1 Picture 1

**2.1** The jalousie glass doors are not appropriate for central A/C. recommend replacing with insulated doors.

Exterior doors are missing weather stripping.

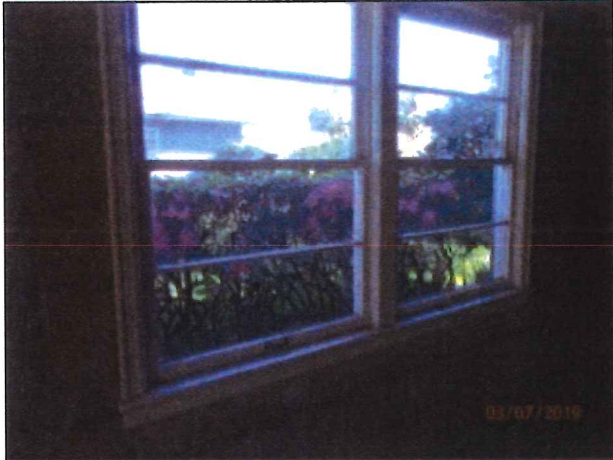
2.2 Picture 1

**2.2** Most of the old wood frame single pane windows did not open, recommend repairs or replacement to thermal glass windows.

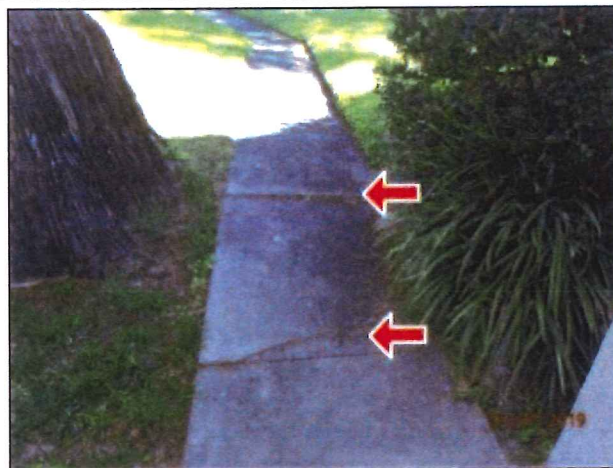
2.4 Picture 1

**2.4** The sidewalks have damage or is uneven causing trip hazards, repair for safety.

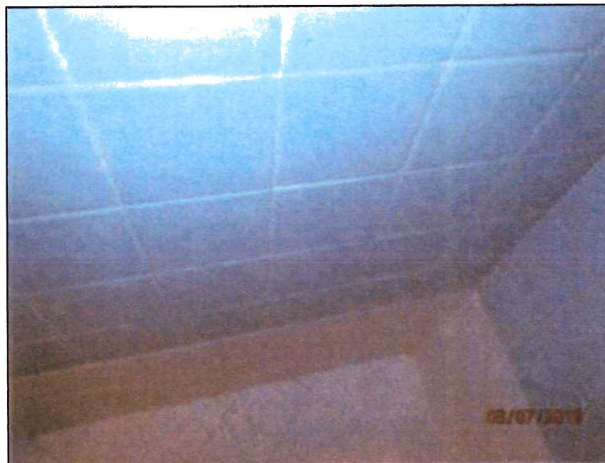
4.1 Picture 1

**4.1** Prior repairs were visible in the hallway shower, caulking/grouting needed in various areas.

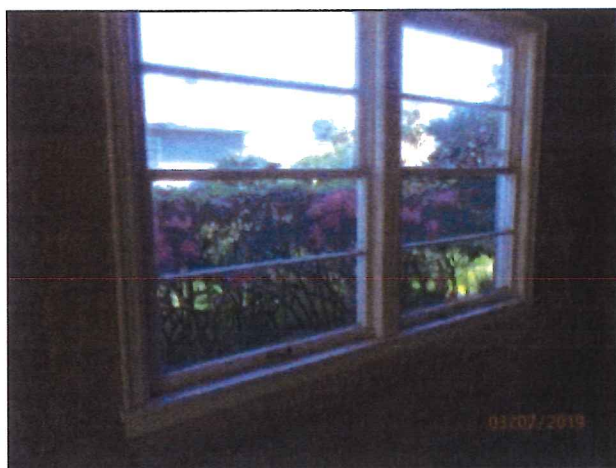
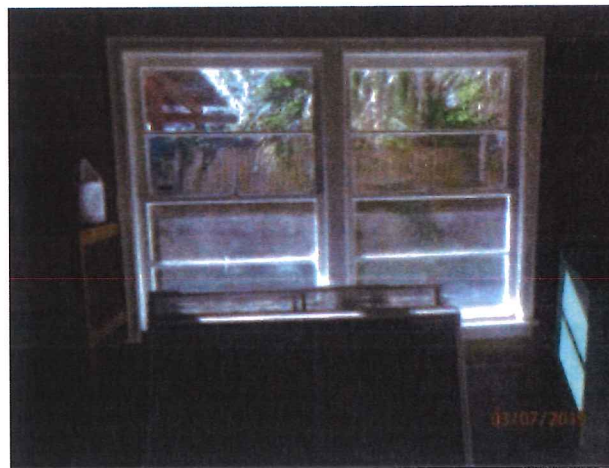
4.6 Picture 1

**4.6** Most of the old wood frame single pane windows did not open, recommend repairs or replacement to thermal glass windows.

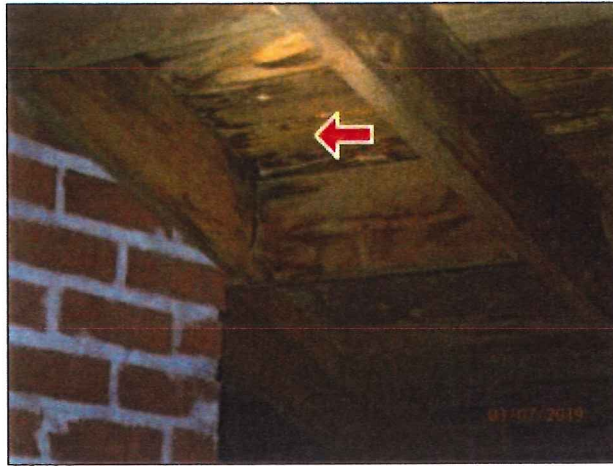
5.5 Picture 1

**5.5** Evidence of prior roof leaks around the chimneys, recommend removing the capped off chimneys when reroofing if they are not being used.

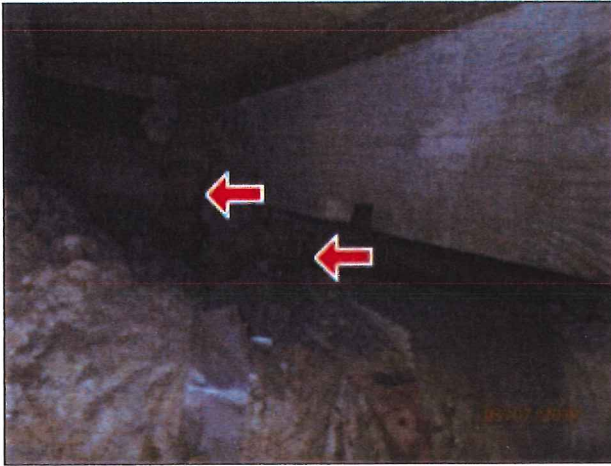
6.0 Picture 1

**6.0** The old cast iron waste lines are at the end of their useful life, recommend updating all old piping, supply and waste.

One of the bathroom sink drains is leaking water, repair needed.

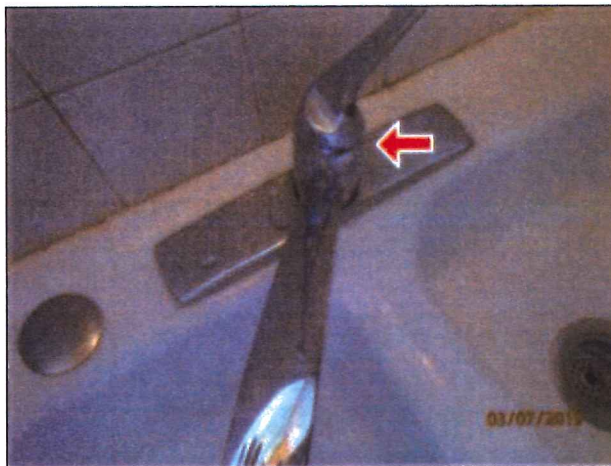
6.1 Picture 1

**6.1** The kitchen faucet leaks water when operated, repair or replace faucet as needed.

The water coming out of the master bathroom tub/shower faucet was discolored and has excessive debris, unable to determine if all of the supply piping was updated, replace all old piping in the house.

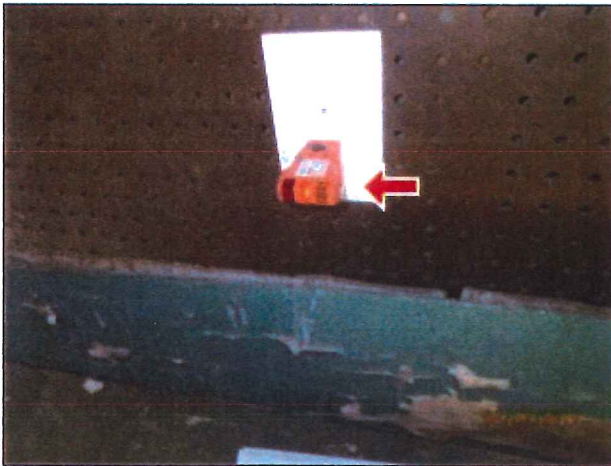
7.1 Picture 1

**7.1** Several electrical outlets were not grounded and some old cloth insulated wires were visible in the panel(s). Recommend having an electrical evaluate and update electrical system to modern standards. Two electrical panels were not readily accessible for inspection, metal panel covers were covered over, corrections needed.

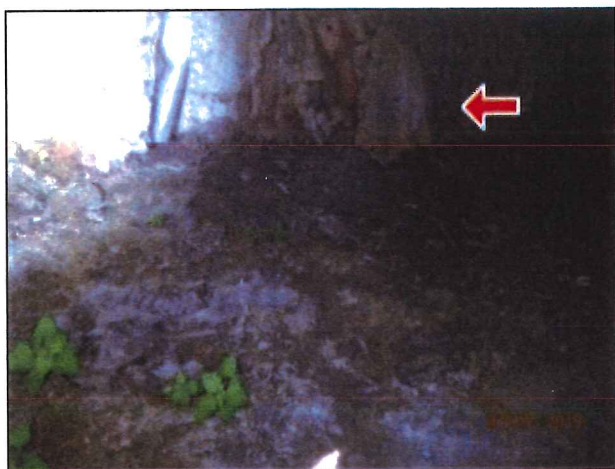
8.3 Picture 1

**8.3** The A/C ductwork under the house is damaged in several areas. The ducts are in contact with the ground. The ducts may have been under water during the last two flooding storms, recommend further evaluation. Recommend replacing ducts into the attic.

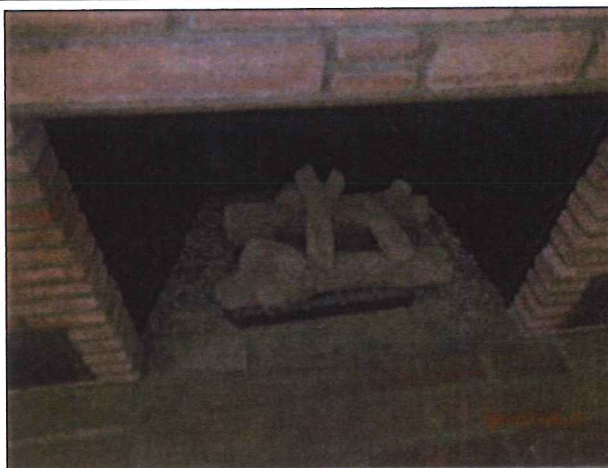
8.7 Picture 1

**8.7** Propane tank was not present, unable to test gas burner in the fireplace.

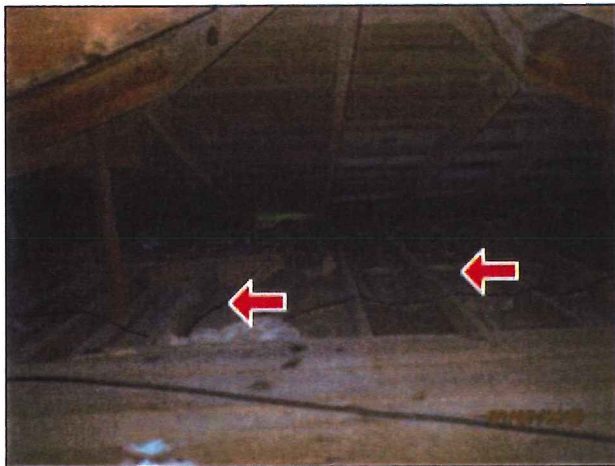
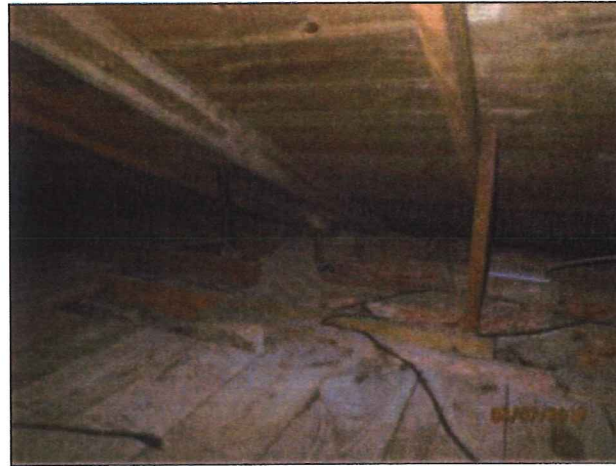
9.0 Picture 1

**9.0** The attic insulation is not adequate, missing or damaged, add additional insulation.

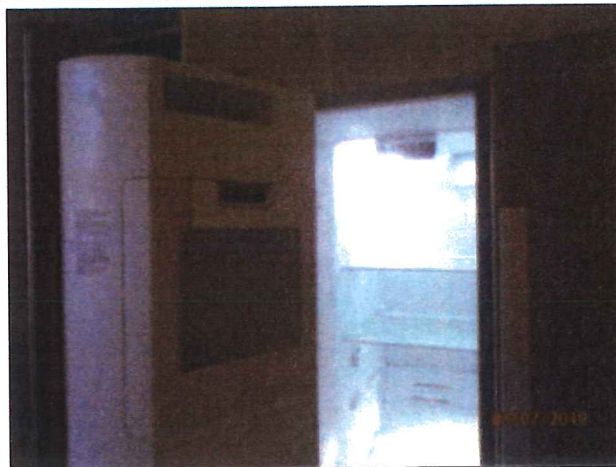
10.6 Picture 1

**10.6** The ice maker in the freezer was off. Recommend turning on to see if ice is harvested, test prior to the close of escrow.

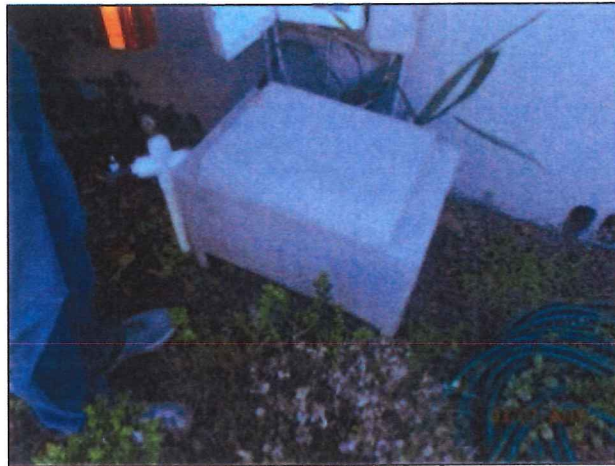
12.0 Picture 1

**12.0** The sprinkler well pump Did not operate, repair or replace pump as needed.
