## CITY OF ST. AUGUSTINE HISTORIC ARCHITECTURAL REVIEW BOARD

### A G E N D A

**THURSDAY, JANUARY 16, 2025 - 1:00 PM**

**CITY OF ST. AUGUSTINE HISTORIC ARCHITECTURAL REVIEW BOARD  
STAFF REPORT AND RECOMMENDATION  
Prepared for January 16, 2024 Meeting**

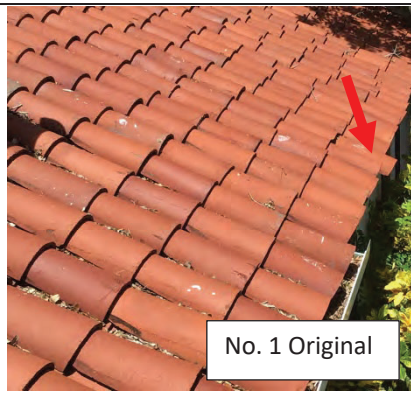
No. 1 Original

*N wing is original clay tiles (Pic 1), S wing is concrete tiles (Pic 2). There are approximately 15 broken tiles on both N and S side that need to be replaced. Tiles will be replaced with replica of existing.*

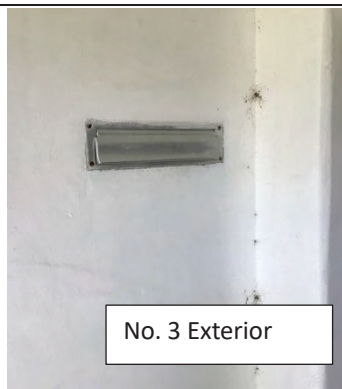
No. 3 Exterior

*Mail slot (Pic 3/4) does not appear to be of homes original character and is allowing pests to enter home. Replace with black iron mail slot that is completely enclosed on the interior wall.*

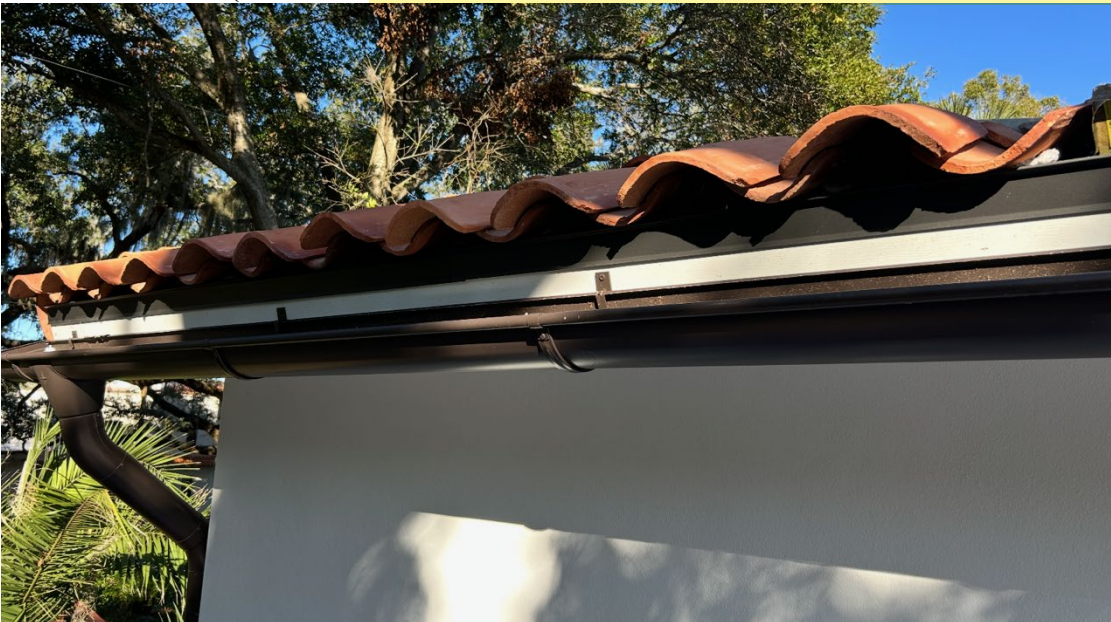
**Profile of new tiles (VIEW OF NEWLY BUILT DETACHED GARAGE WITH PROPOSED TILES):**

5. When comparing the size and shape of the proposed with the existing tile, staff also noted that the height of the arch for the new clay tiles was shorter (3" to top of barrel of proposed compared to 4 1/4" to top of barrel of the original tile) than the existing clay tile, but match in length, and are the same approximate width. Dimensions and specifications of the proposed tiles are included with the application packet. Photos of the existing tile on the historic house and the proposed tile that is being installed on the detached garage that was recently built were also provided by the applicant.

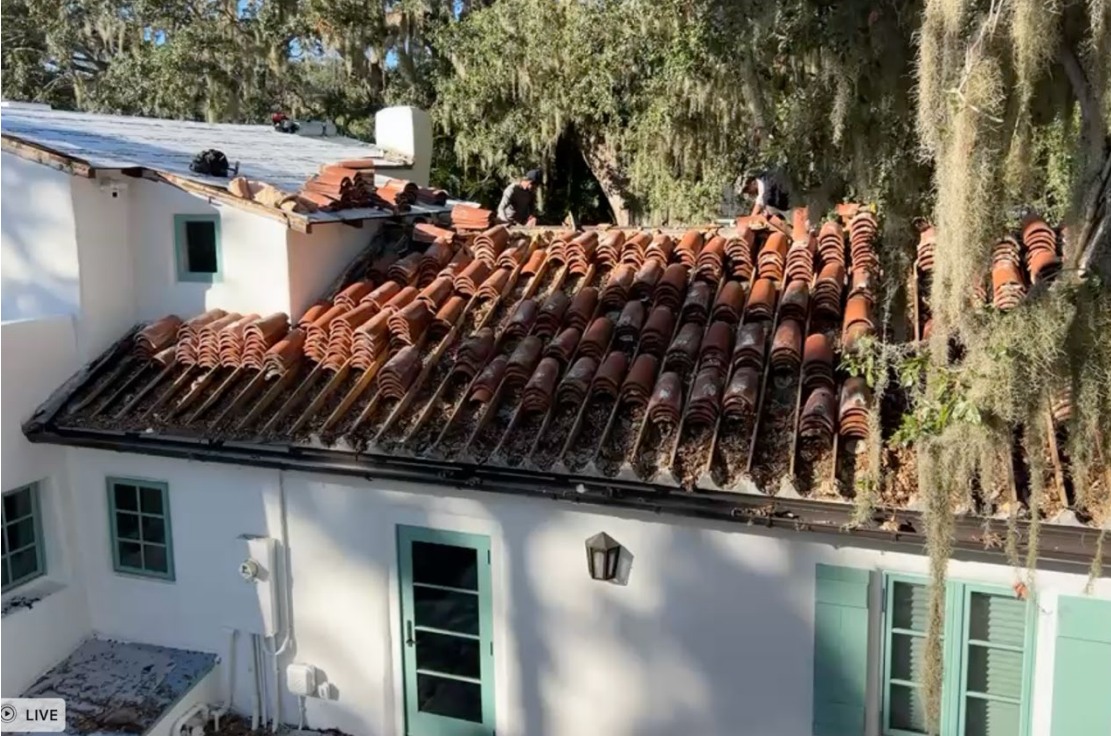
**Image of what roof looked like as they are removing the tile (VIEW OF HISTORIC HOUSE):**

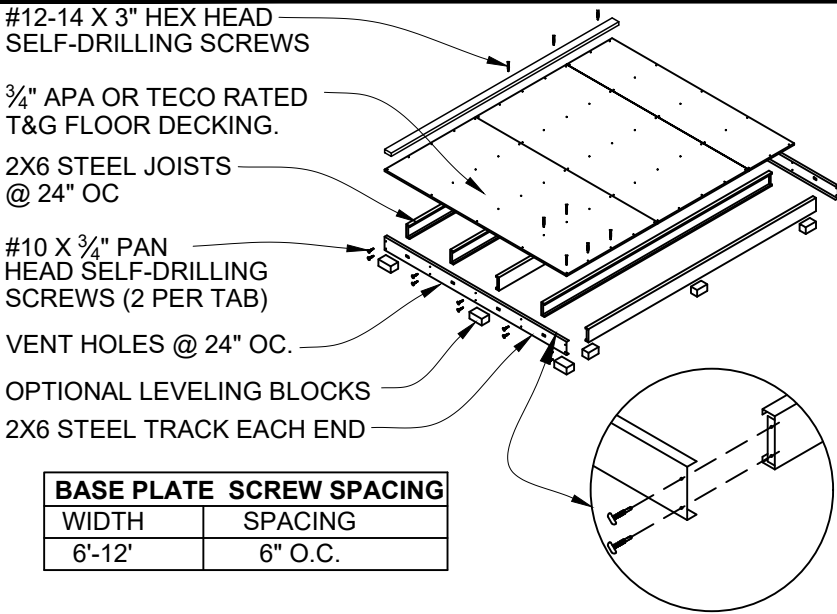
### 1 OPTIONAL STEEL SHED BASE DETAIL

- STEEL SHED FOUNDATION:  
600T125-054 - 16 GAUGE STEEL TRACKS G140 ZINC COATED  
600S137-054 - 16 GAUGE STEEL JOISTS G140 ZINC COATED @ 24" O.C.  
(SUPPLIER: ALLIED STUDCO (JOIST: 600S137-054 / TRACK: 600T125-054) ICC ER-4943P.

- 3/4" APA OR TECO RATED TONGUE AND GROOVE FLOOR DECKING. 24" MAX PANEL SPAN. STAGGER PANEL LAYOUT.
- FASTEN FLOOR DECKING TO JOIST & TRACKS USING #8 x 1 5/8" ZINC PLATED SCREWS @ 12" O.C. NO BLOCKING REQUIRED. ALL EDGES SHALL LIE ON FLOOR JOISTS. STAGGER PANEL LAYOUT PER APA CONDITION 1.

- FASTEN SOLE PLATE THROUGH FLOOR DECKING INTO JOISTS OR TRACKS WITH #12-14 X 3" GALVANIZED SELF-DRILLING SCREWS. REFERENCE SPACING CHART.
- ALLOWABLE FLOOR LIVE LOAD: 75 PSF FOR STEEL JOISTS CONTINUOUSLY SUPPORTED. 50 PSF FOR JOISTS ON BLOCKS AS SHOWN.

- USE OPTIONAL CONCRETE BLOCKS AS REQUIRED TO LEVEL BUILDING:  
SUGGESTED SIZES: 2" x 8" x 16", 4" x 8" x 16", OR 8" x 8" x 16".  
BLOCKS UNDER JOISTS SPACED @ 8'-0" O.C. MAXIMUM.  
BLOCKS UNDER TRACK SPACED @ 4'-0" O.C. MAXIMUM.

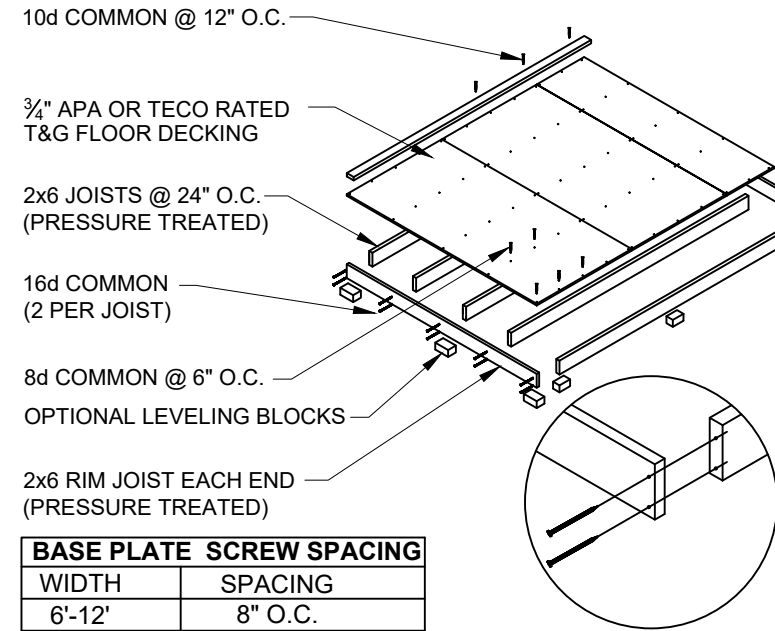
- WOOD SHED FOUNDATION:  
2x6 #2 PRESSURE TREATED SPRUCE-PINE-FIR RIM JOISTS  
2x6 #2 PRESSURE TREATED SPF JOISTS @ 24" O.C.
- 3/4" APA OR TECO RATED TONGUE AND GROOVE FLOOR DECKING. 24" MAX PANEL SPAN. NO BLOCKING REQUIRED. ALL EDGES SHALL LIE ON FLOOR JOISTS. STAGGER PANEL LAYOUT PER APA CONDITION 1. NAIL PLYWOOD TO JOISTS AND RIM JOISTS:  
BORDER: 8d COMMON SPACED @ 6" O.C.  
EDGE: 8d COMMON SPACED @ 6" O.C.  
FIELD: 8d COMMON SPACED @ 12" O.C.
- FASTEN SOLE PLATE THROUGH FLOOR DECKING INTO JOISTS OR RIM JOISTS WITH 10d COMMON SPACED @ 12" O.C.
- ALLOWABLE FLOOR LIVE LOAD: 40 PSF
- USE OPTIONAL CONCRETE BLOCKS AS REQUIRED TO LEVEL BUILDING:  
SUGGESTED SIZES: 2" x 8" x 16", 4" x 8" x 16", OR 8" x 8" x 16".  
BLOCKS UNDER JOISTS SPACED @ 8'-0" O.C. MAXIMUM.  
BLOCKS UNDER RIM JOISTS SPACED @ 4'-0" O.C. MAXIMUM.

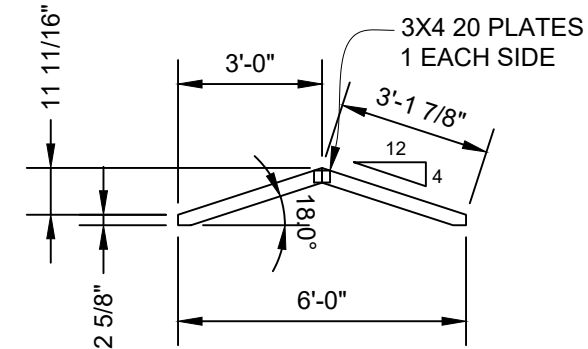
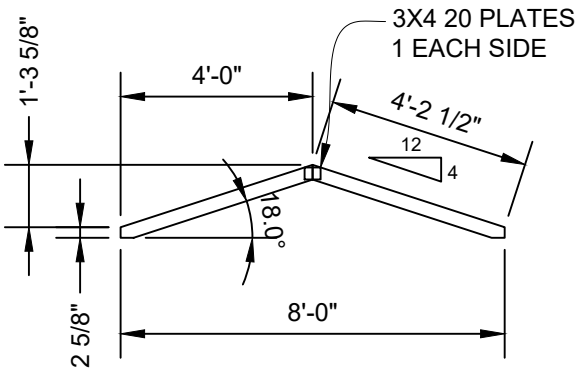
DESIGN LOADS:  
TOP CHORD LIVE LOAD = 20 PSF  
TOP CHORD DEAD LOAD = 10 PSF  
COLLAR TIE DEAD LOAD = 5 PSF

MAXIMUM DEFLECTION (12 FT. SPAN)  
VERT LL: 0.06 in.  
VERT TL: 0.08 in.

NOTE:  
TRUSS MAY BE USED ON BUILDING LENGTHS UP TO 24FT UNLESS CEILING JOIST OR OTHER TENSION TIE IS PROVIDED.

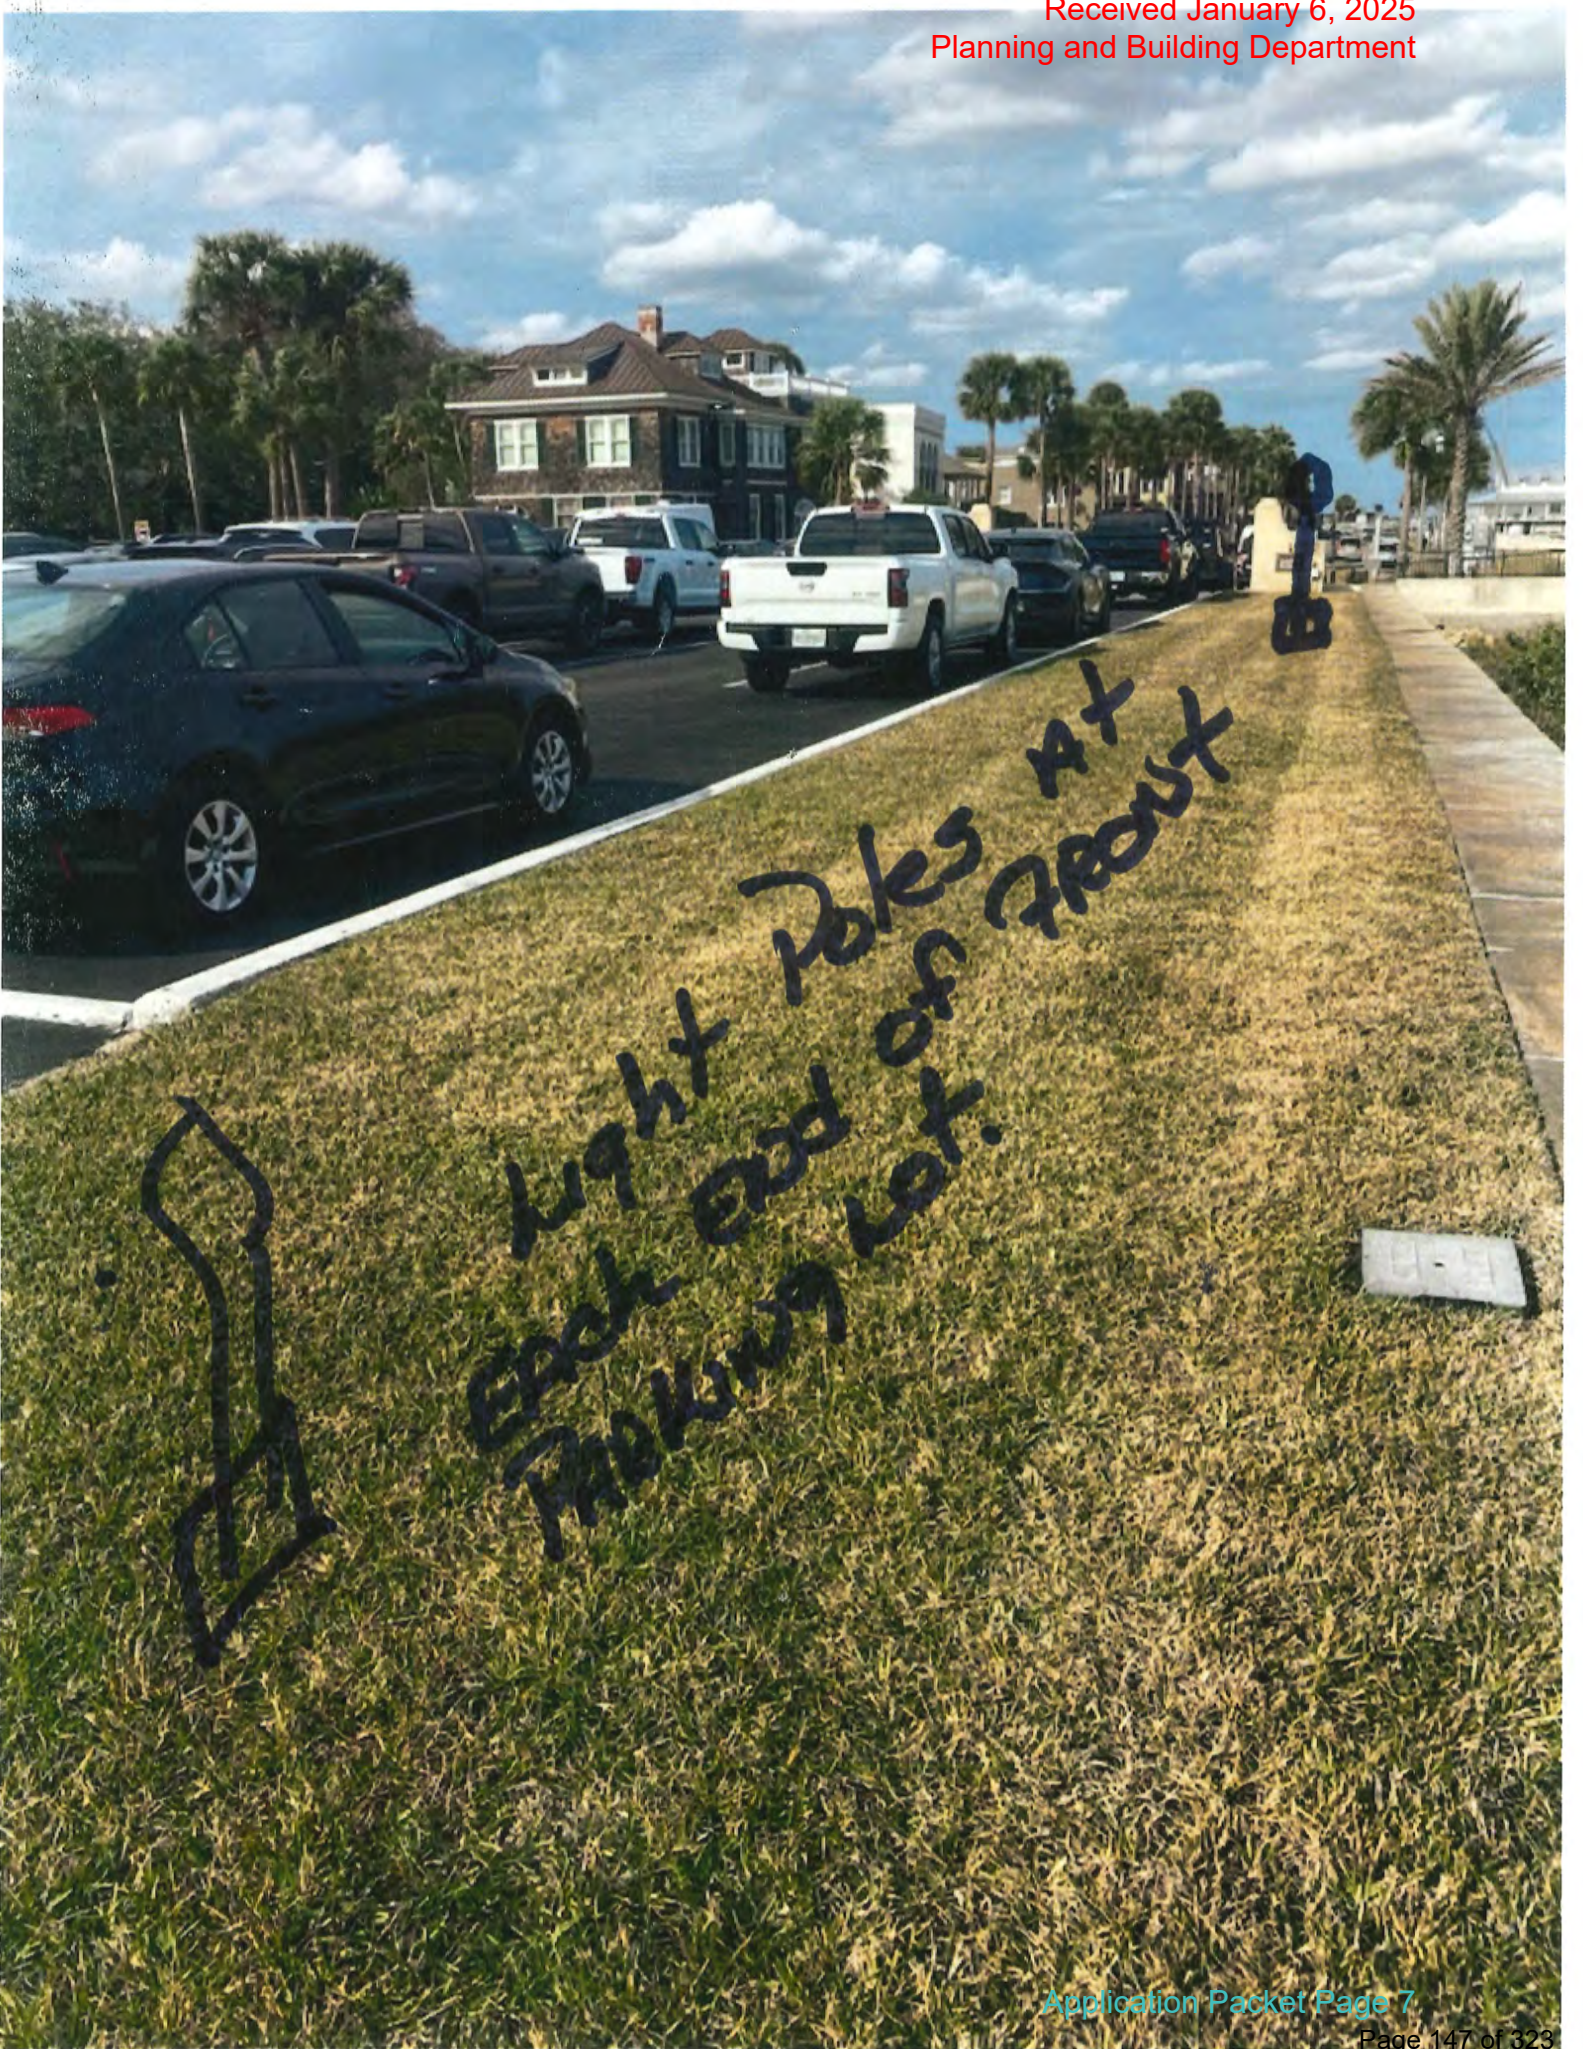
This Same Light Pole design  
For the Front Parking lot  
MARINE ST Front Parking lot  
2 lights

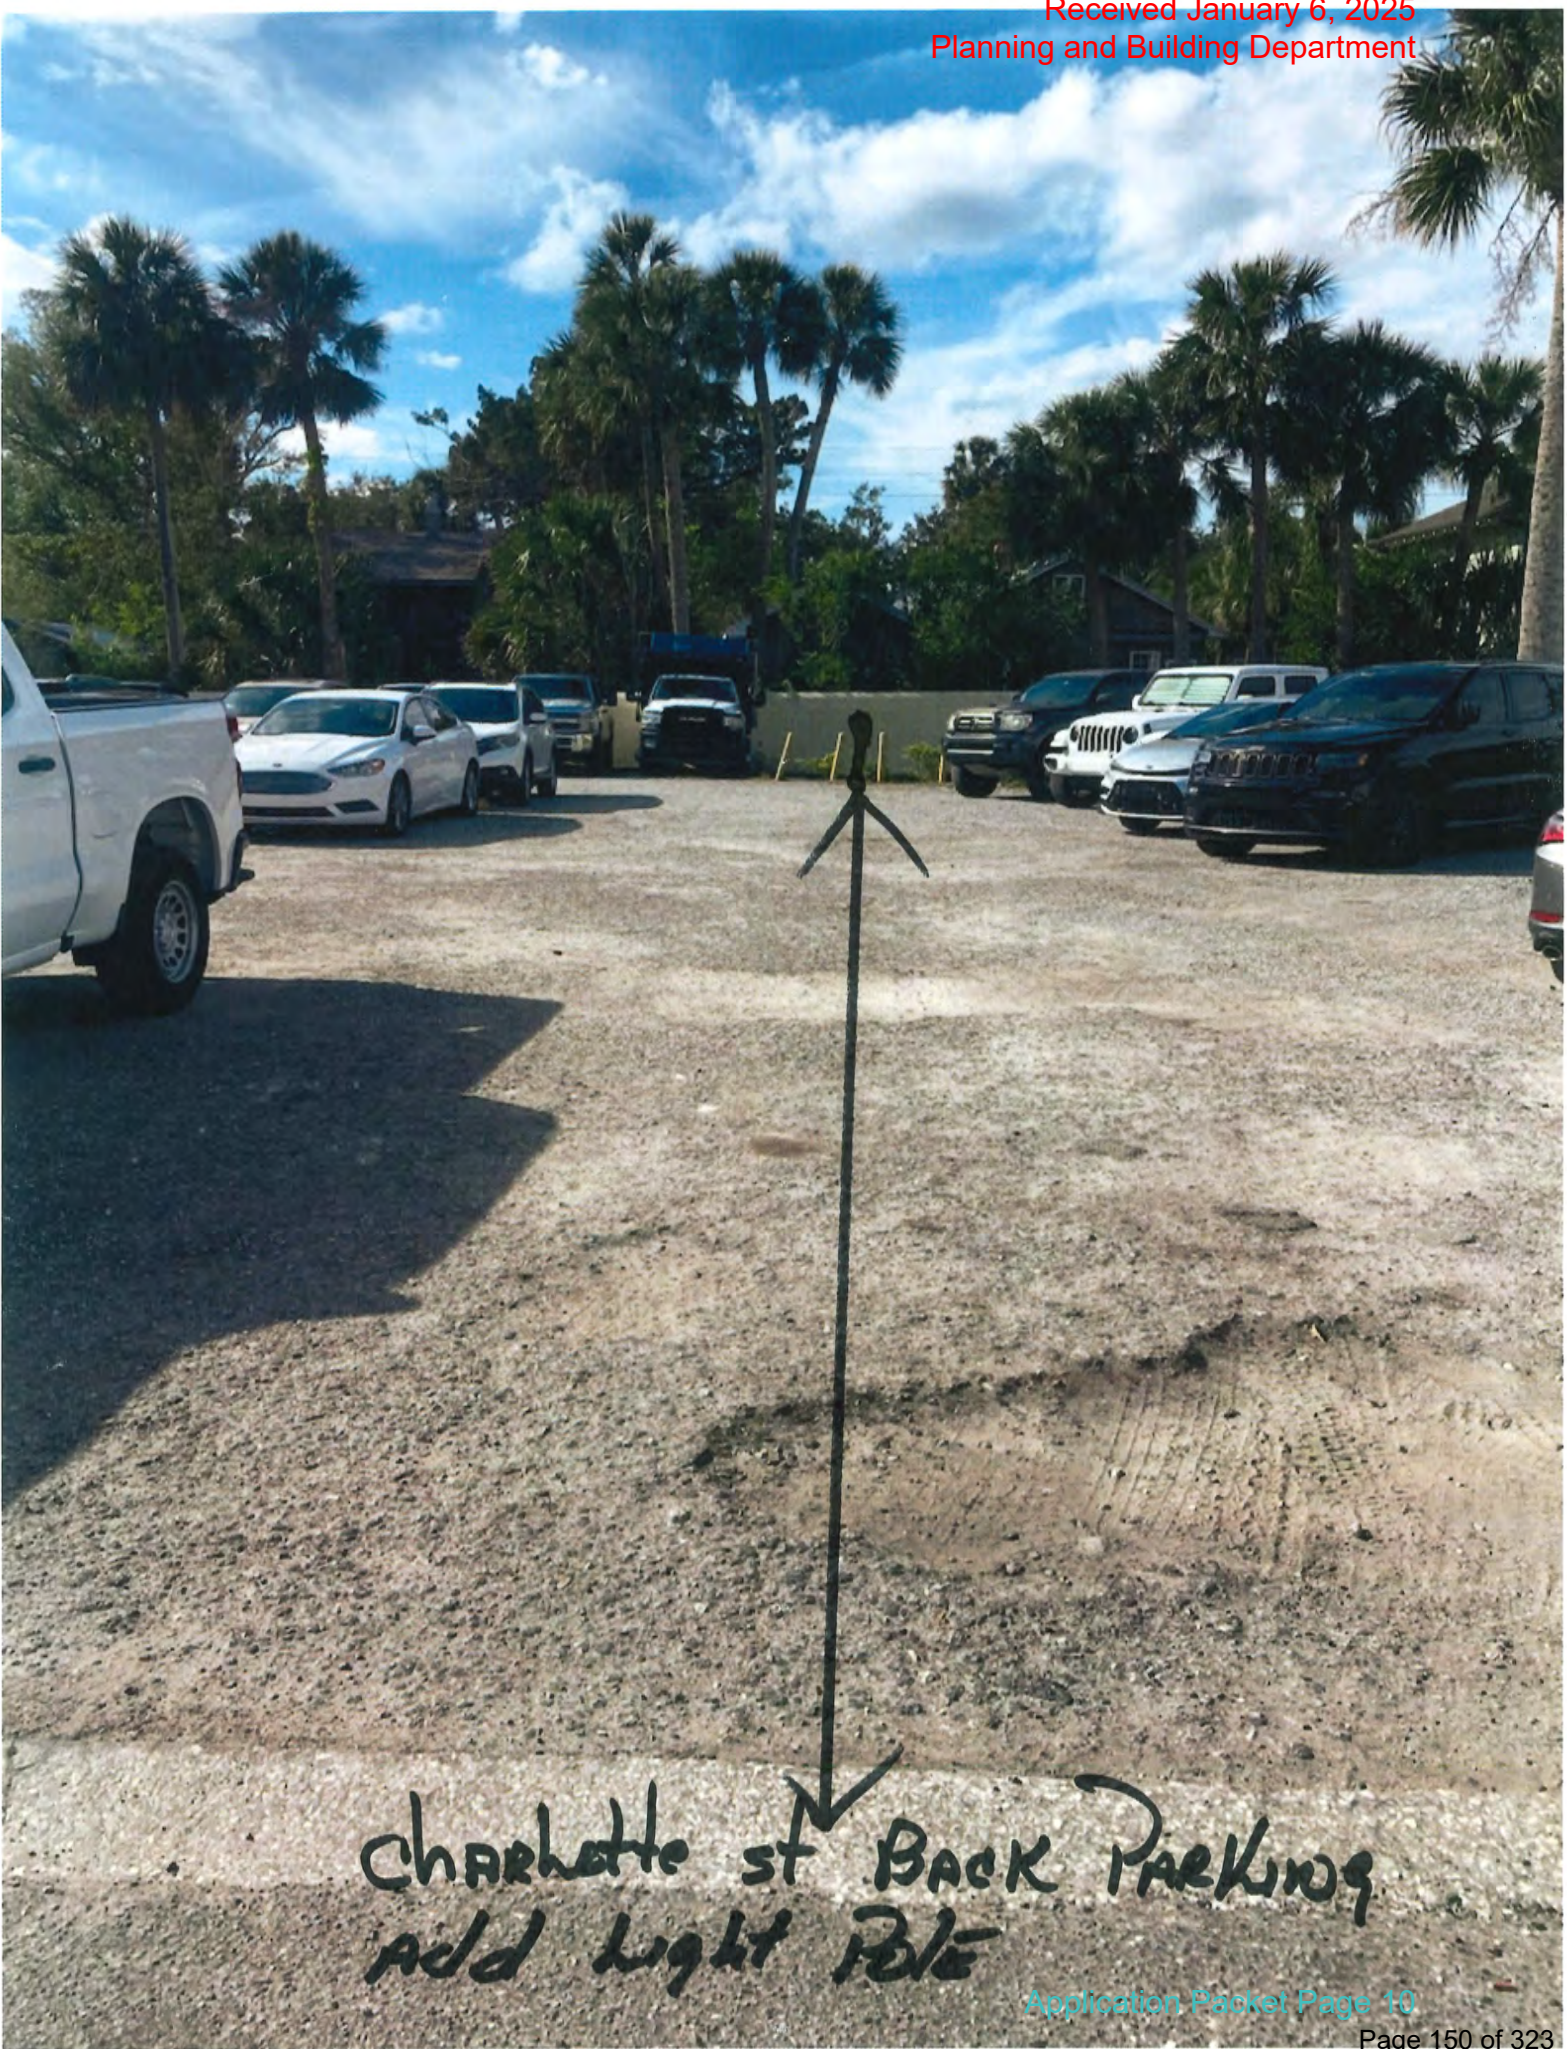
Charlotte st BACK Parking  
Add Light Pole

Charlotte St.  
Parking Lot  
install Light Pole

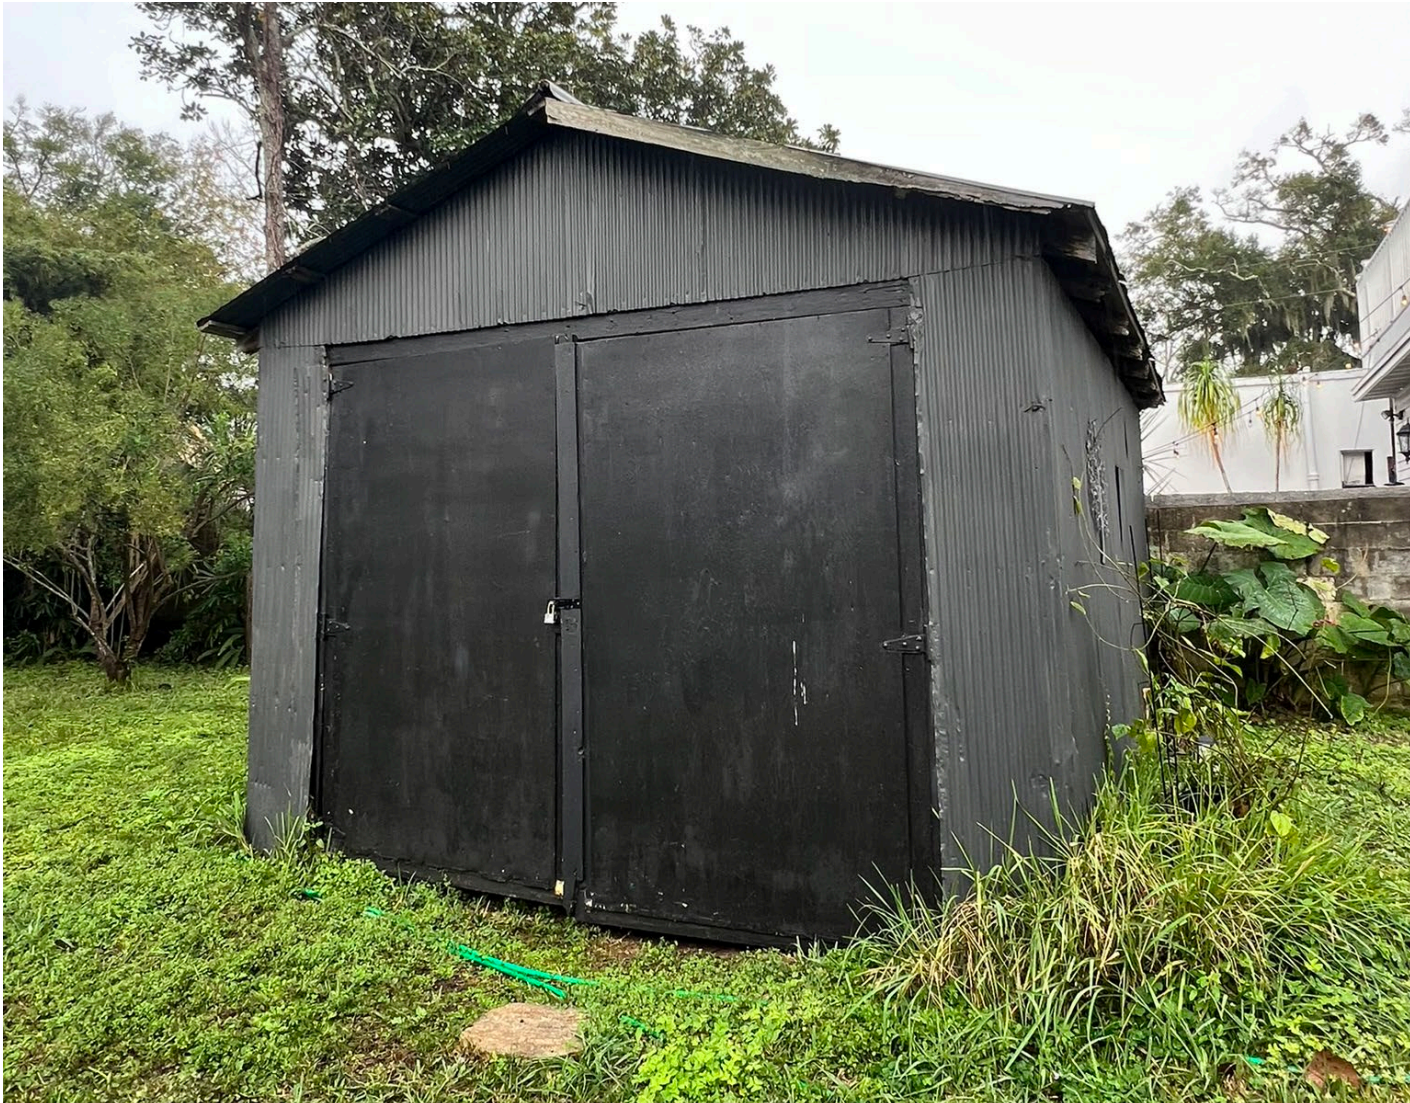
Shed proposed for demolition (noted on Sanborn Maps as 47-1/3 Abbott Street)

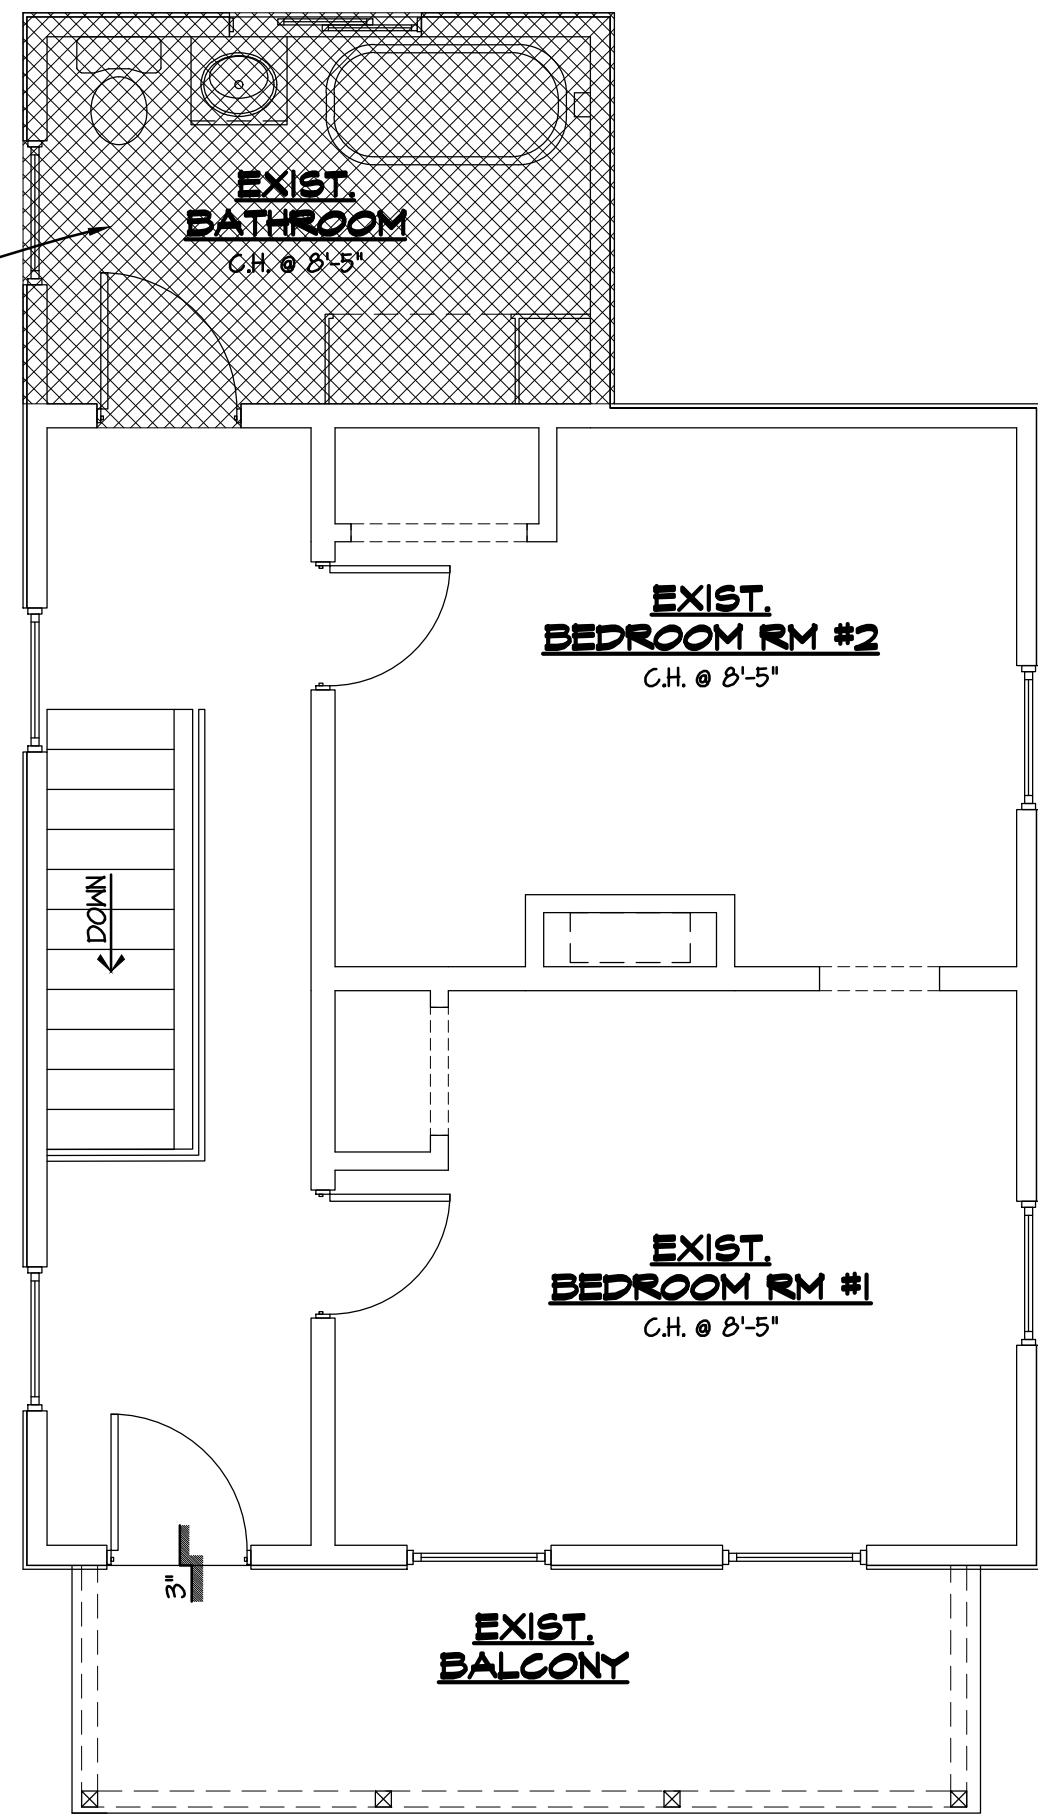
SECOND FLOOR DEMOLITION PLAN

1. REMOVE EXISTING CONSTRUCTION AS INDICATED IN THE DRAWINGS UNLESS NOTED OTHERWISE.
2. DEMOLITION WORK SHALL BE EXECUTED IN CONFORMANCE WITH ALL CODES AND ORDINANCES AS SET FORTH BY ALL GOVERNING AUTHORITIES.
3. BRACE ALL EXISTING STRUCTURE OR STRUCTURAL ELEMENTS AS NECESSARY DURING DEMOLITION.
