## HISTORIC ARCHITECTURAL REVIEW BOARD

**THURSDAY, MAY 21, 2026 - 1:00 PM**

**CITY OF ST. AUGUSTINE HISTORIC ARCHITECTURAL REVIEW BOARD  
STAFF REPORT AND RECOMMENDATION  
Prepared for May 21, 2026 Meeting**

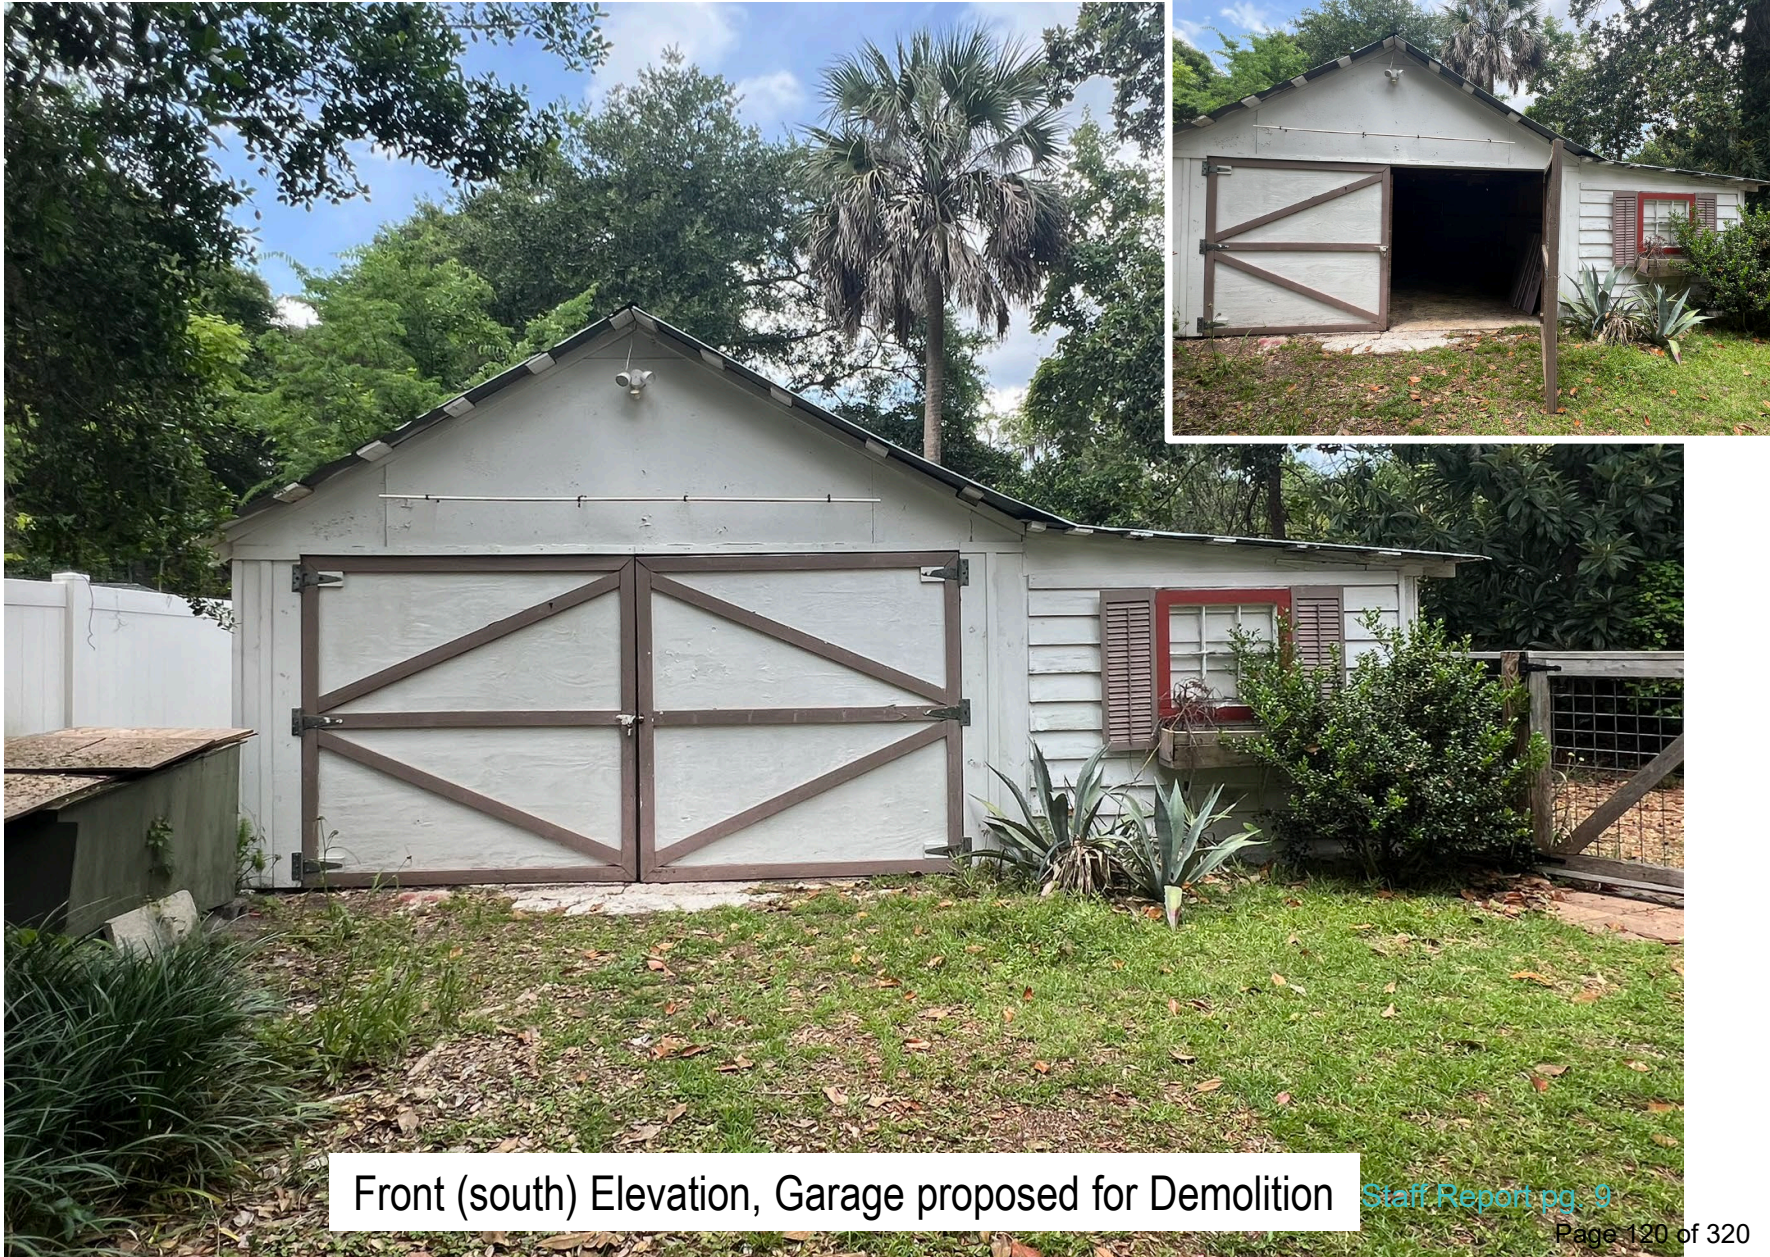
Front (south) Elevation, Garage proposed for Demolition

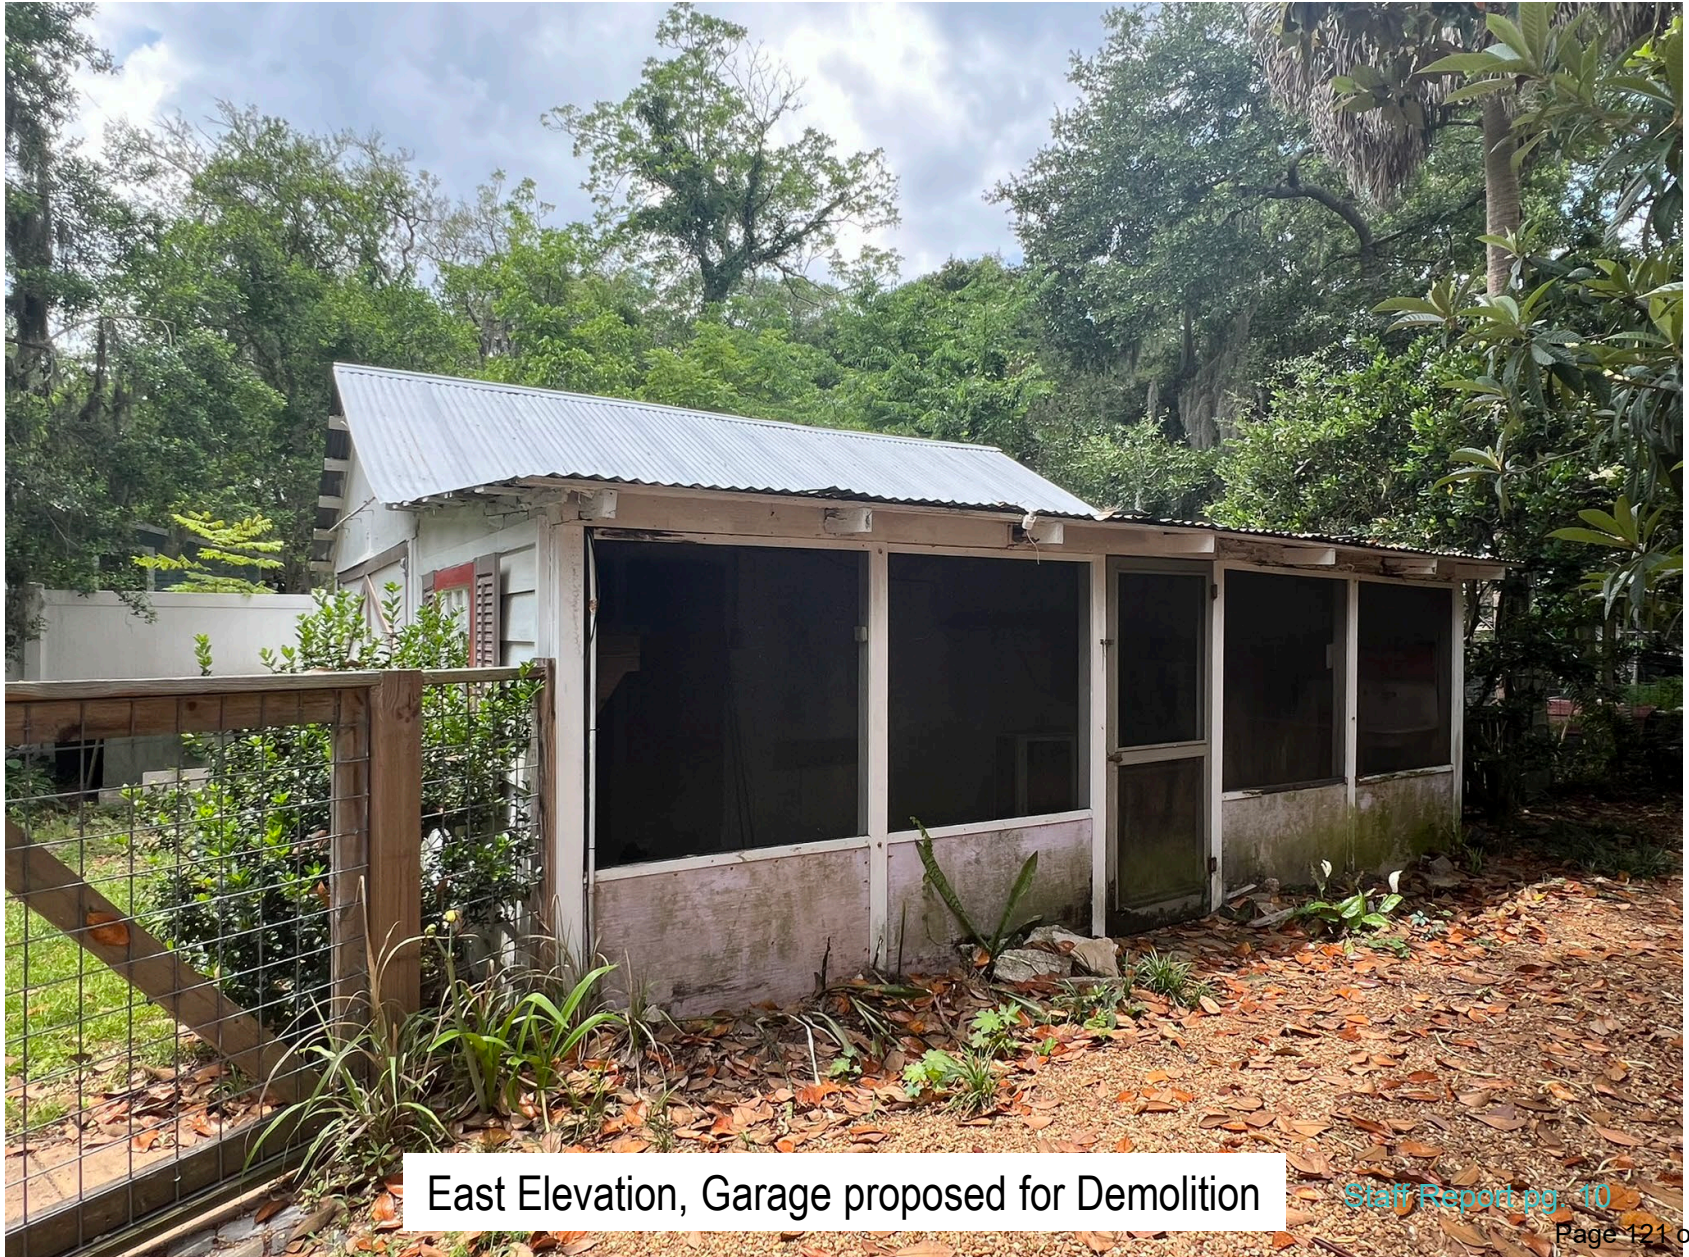
East Elevation, Garage proposed for Demolition

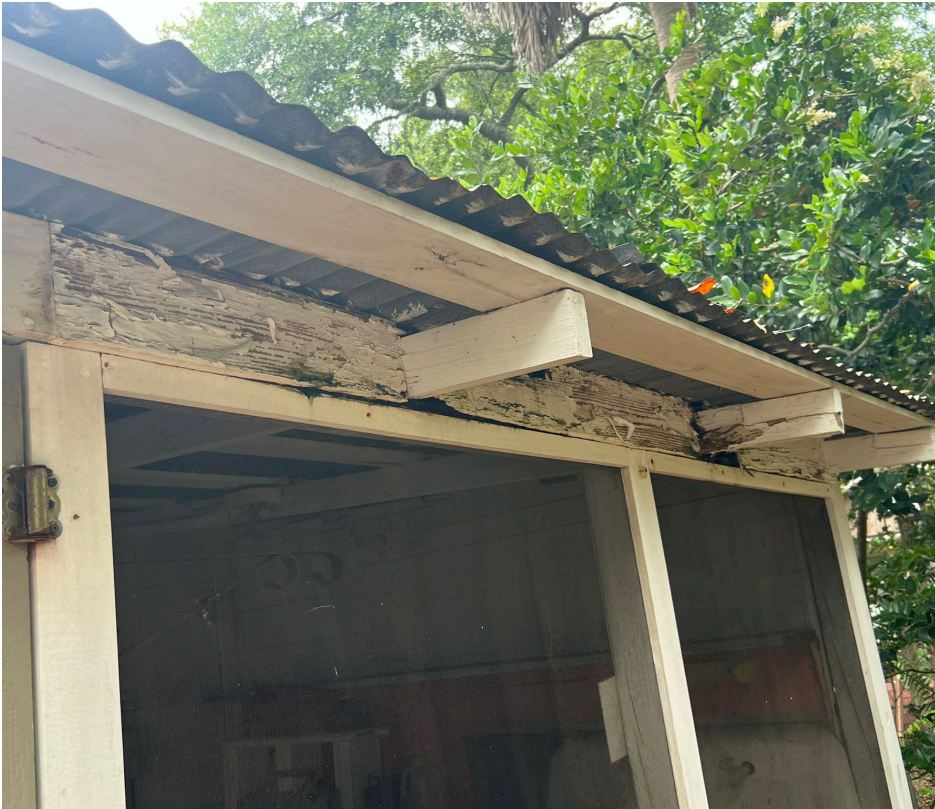
Garage Damage Details

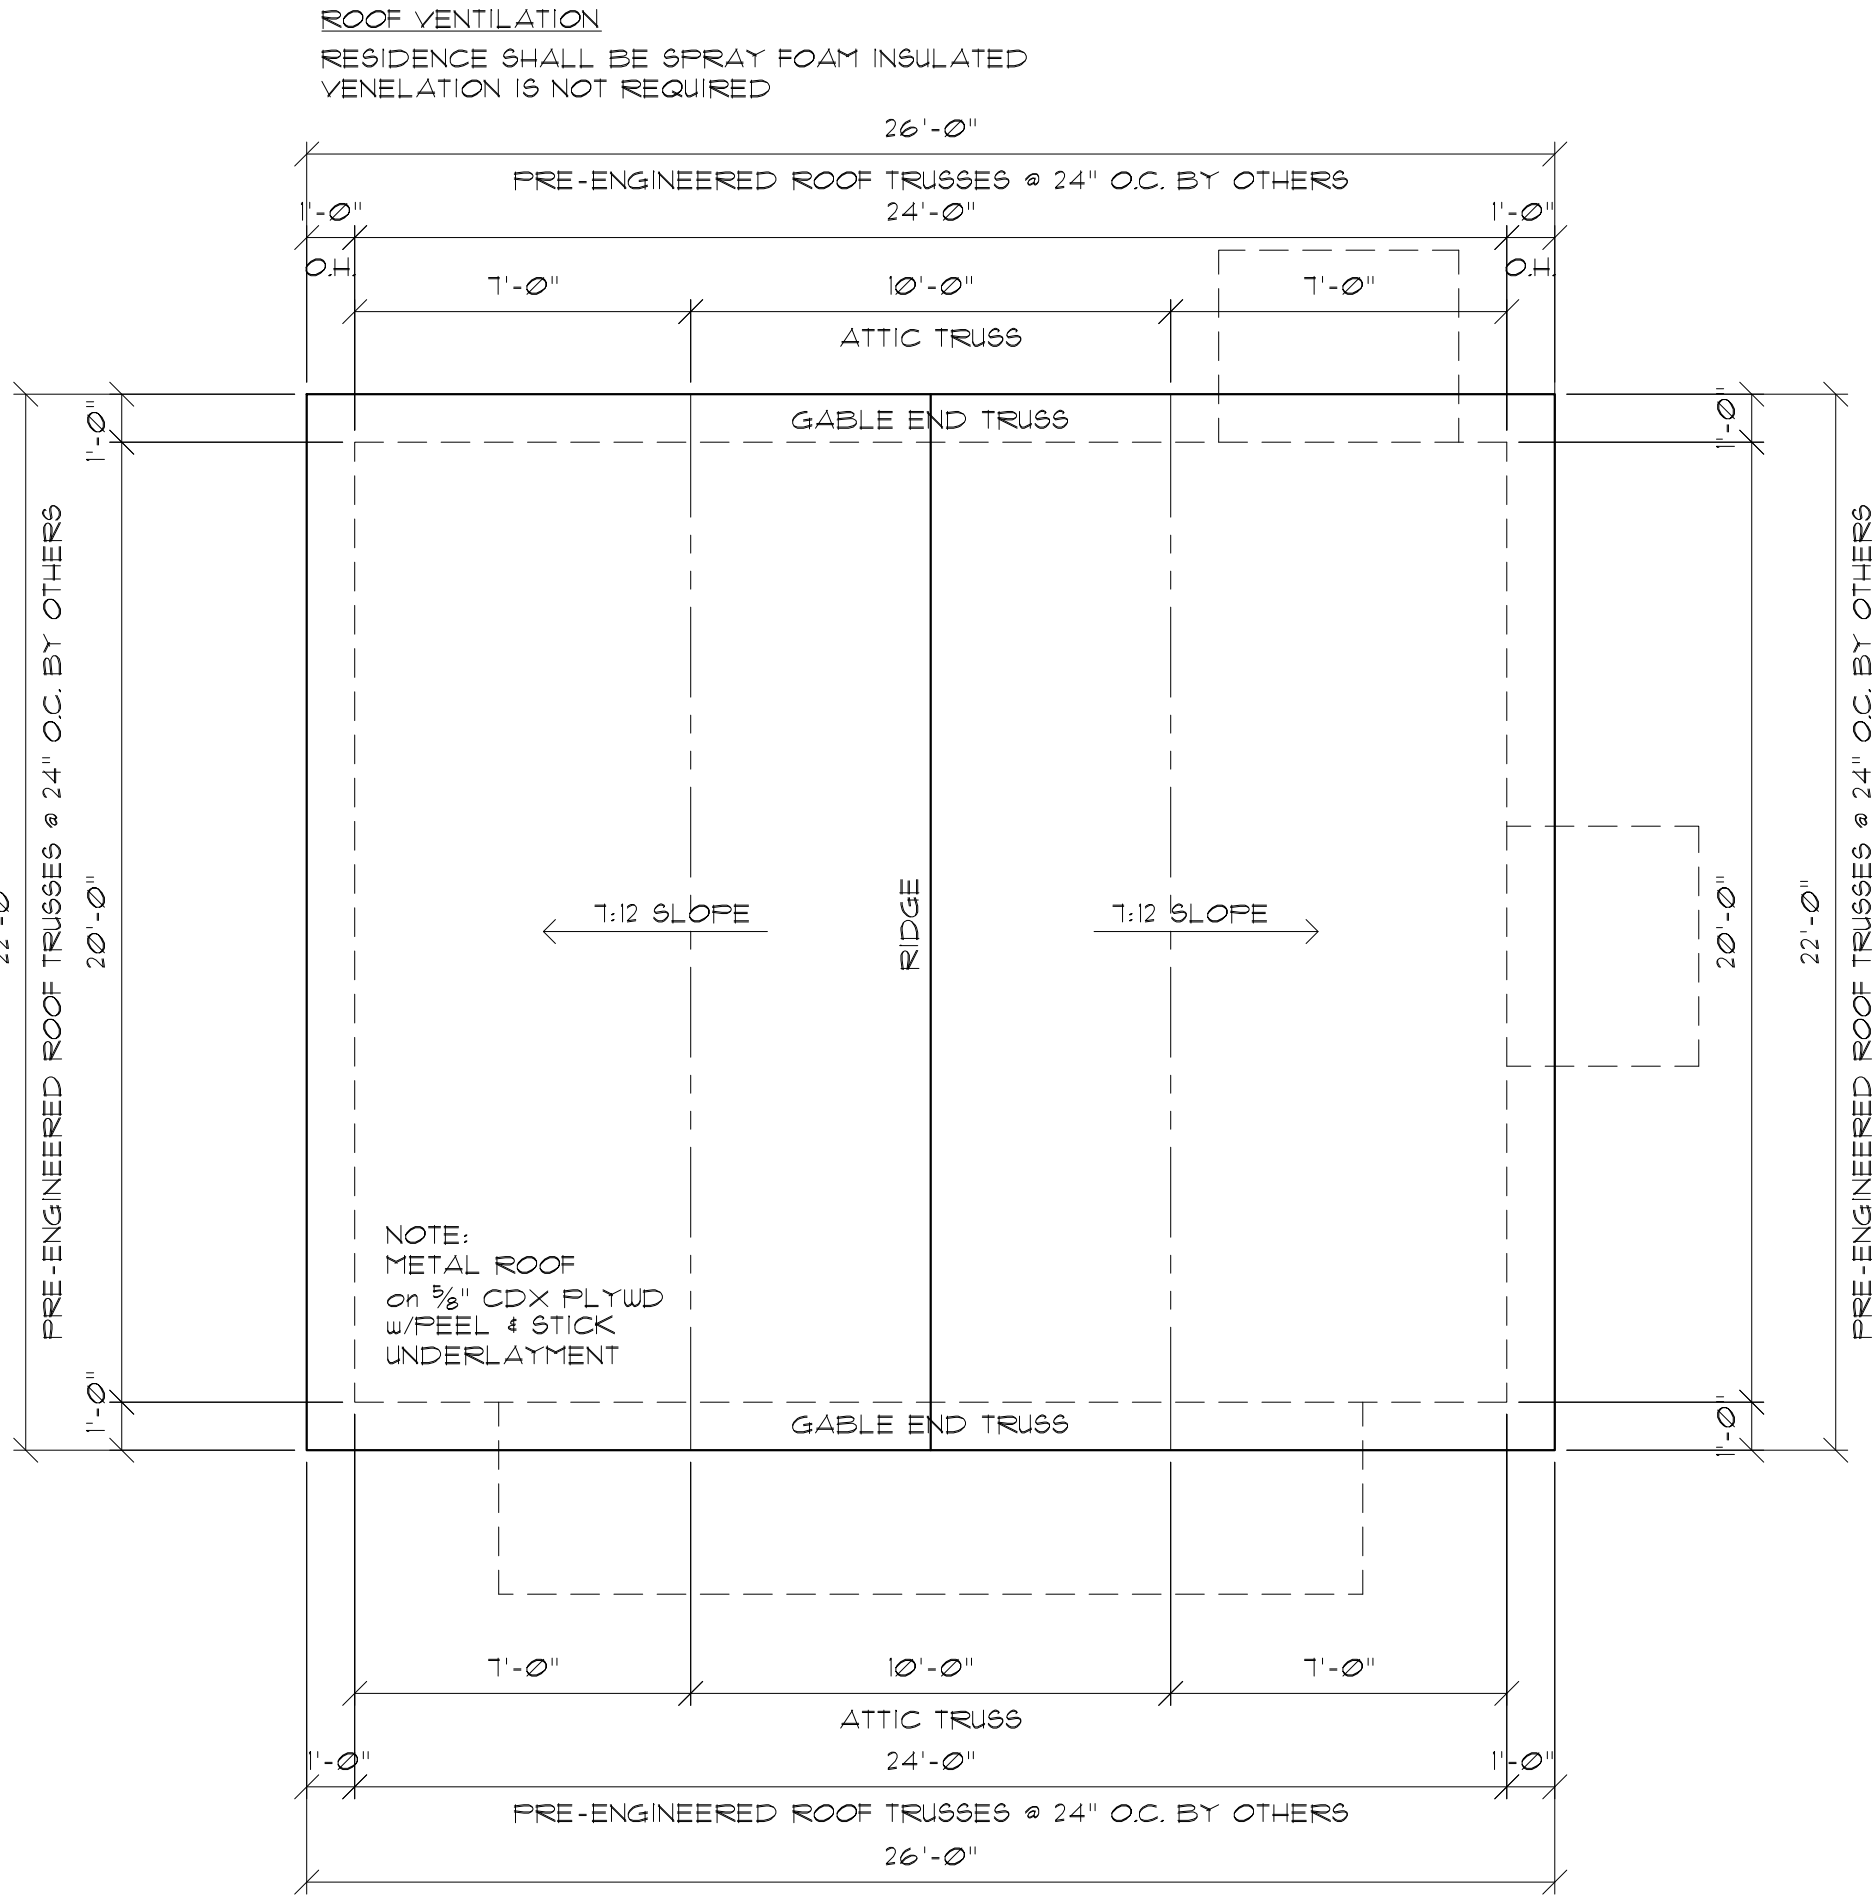
Roof Plan

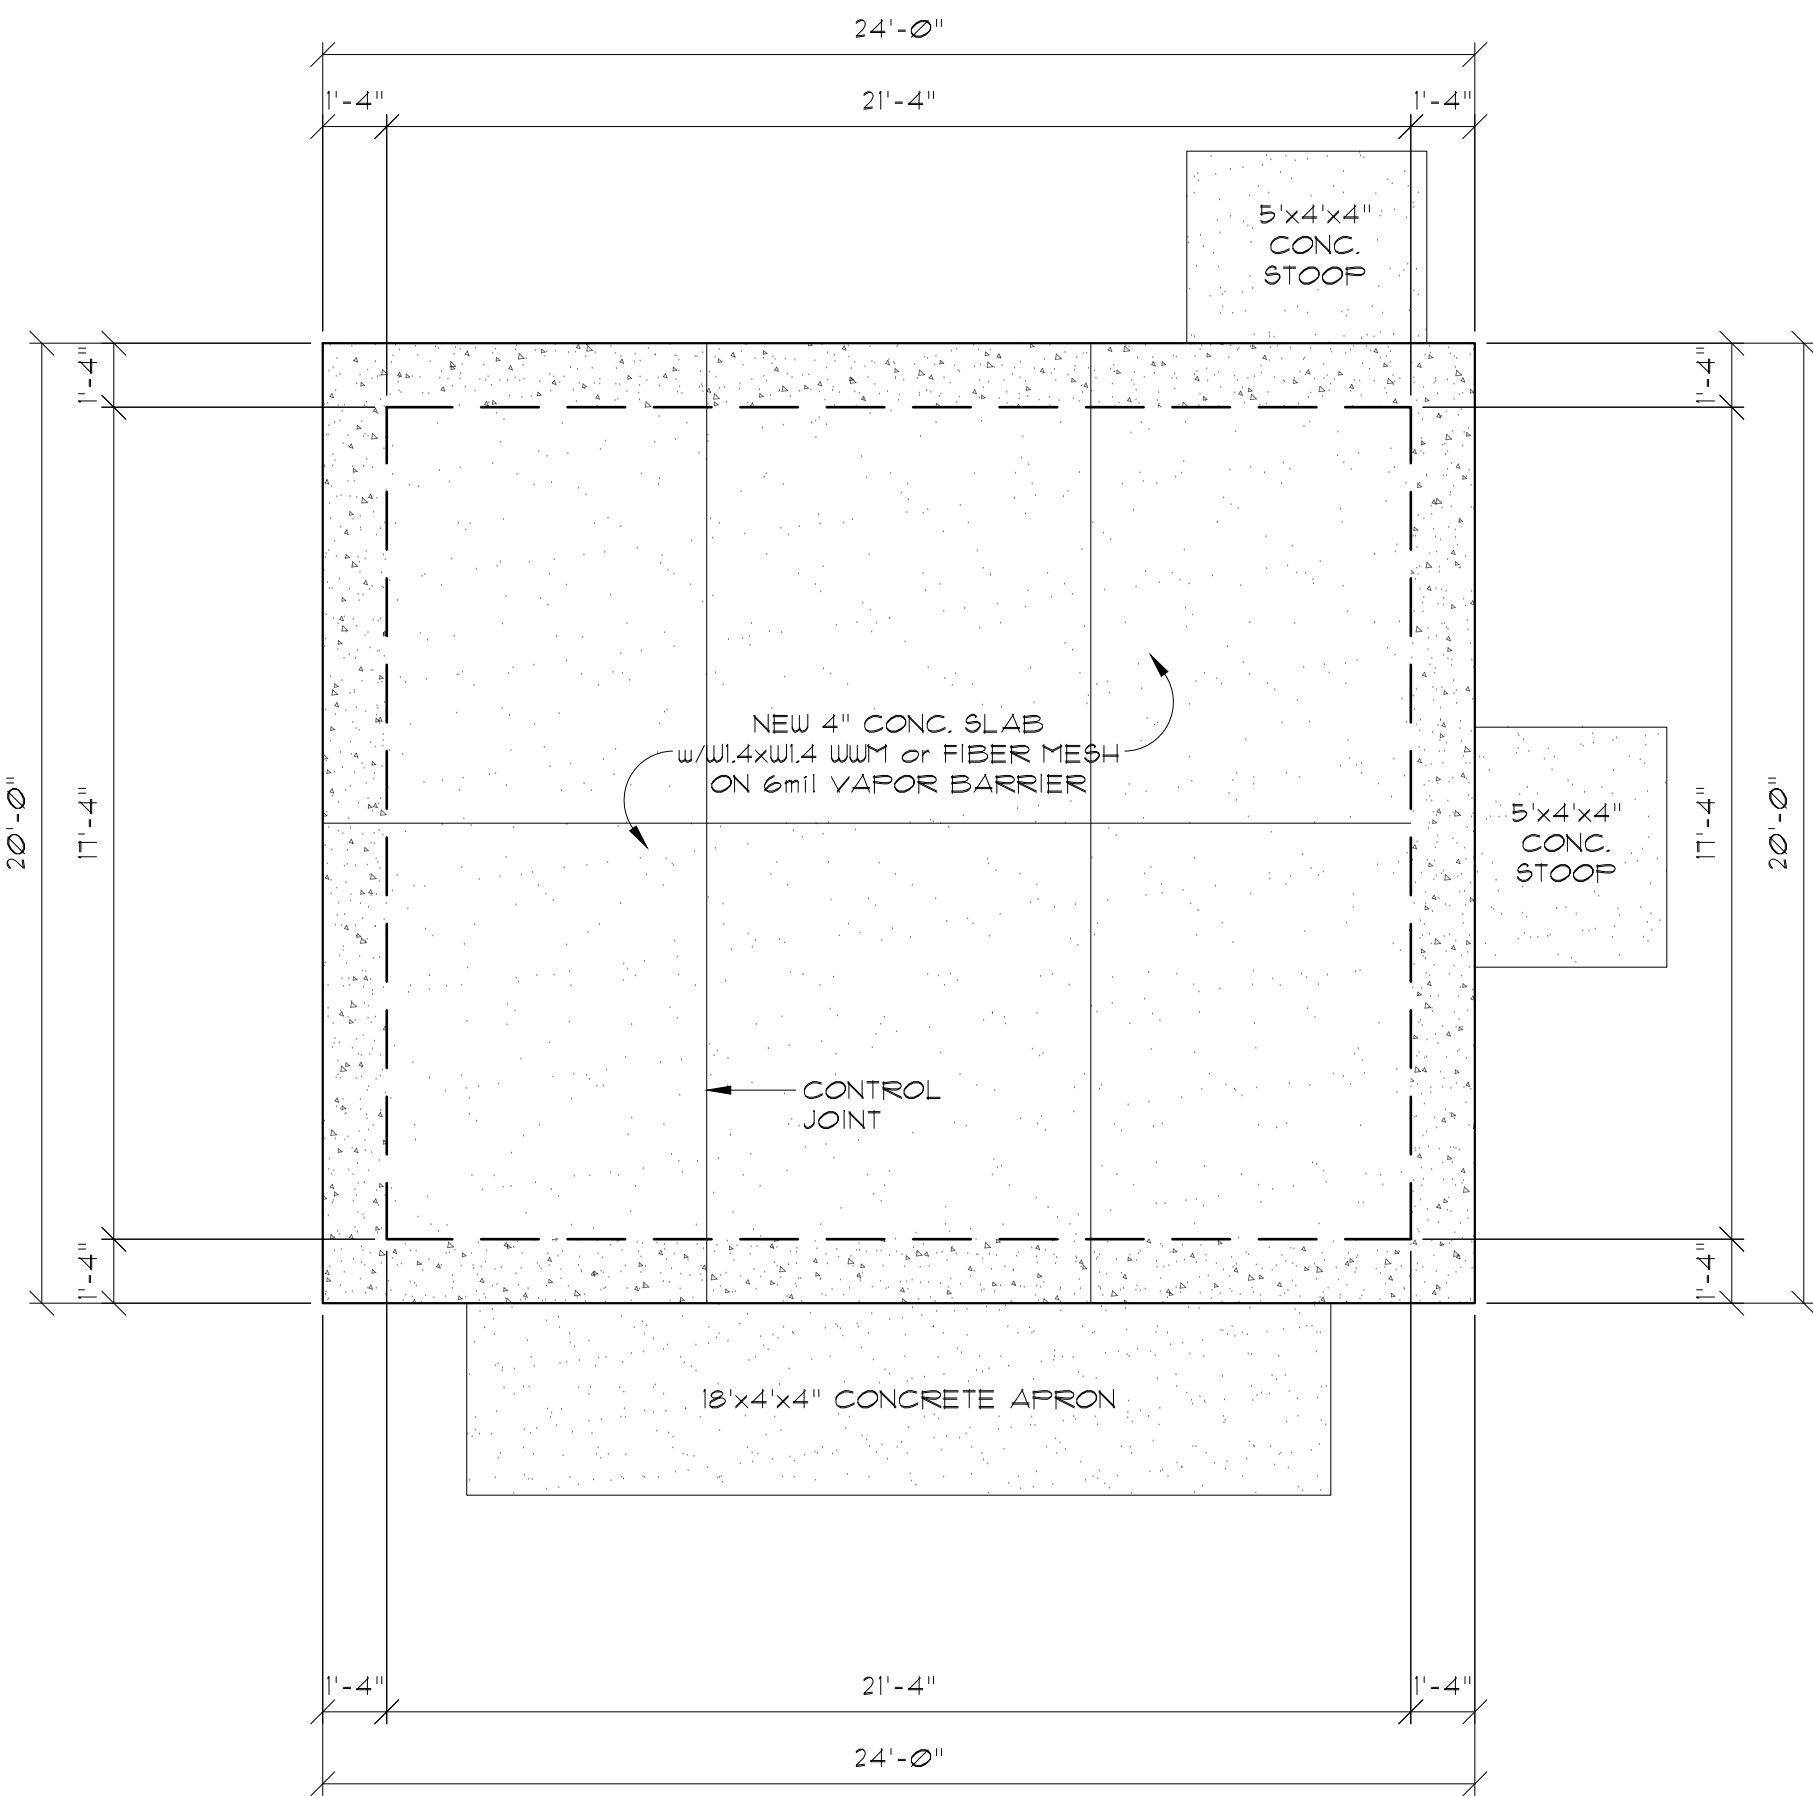
Foundation Plan

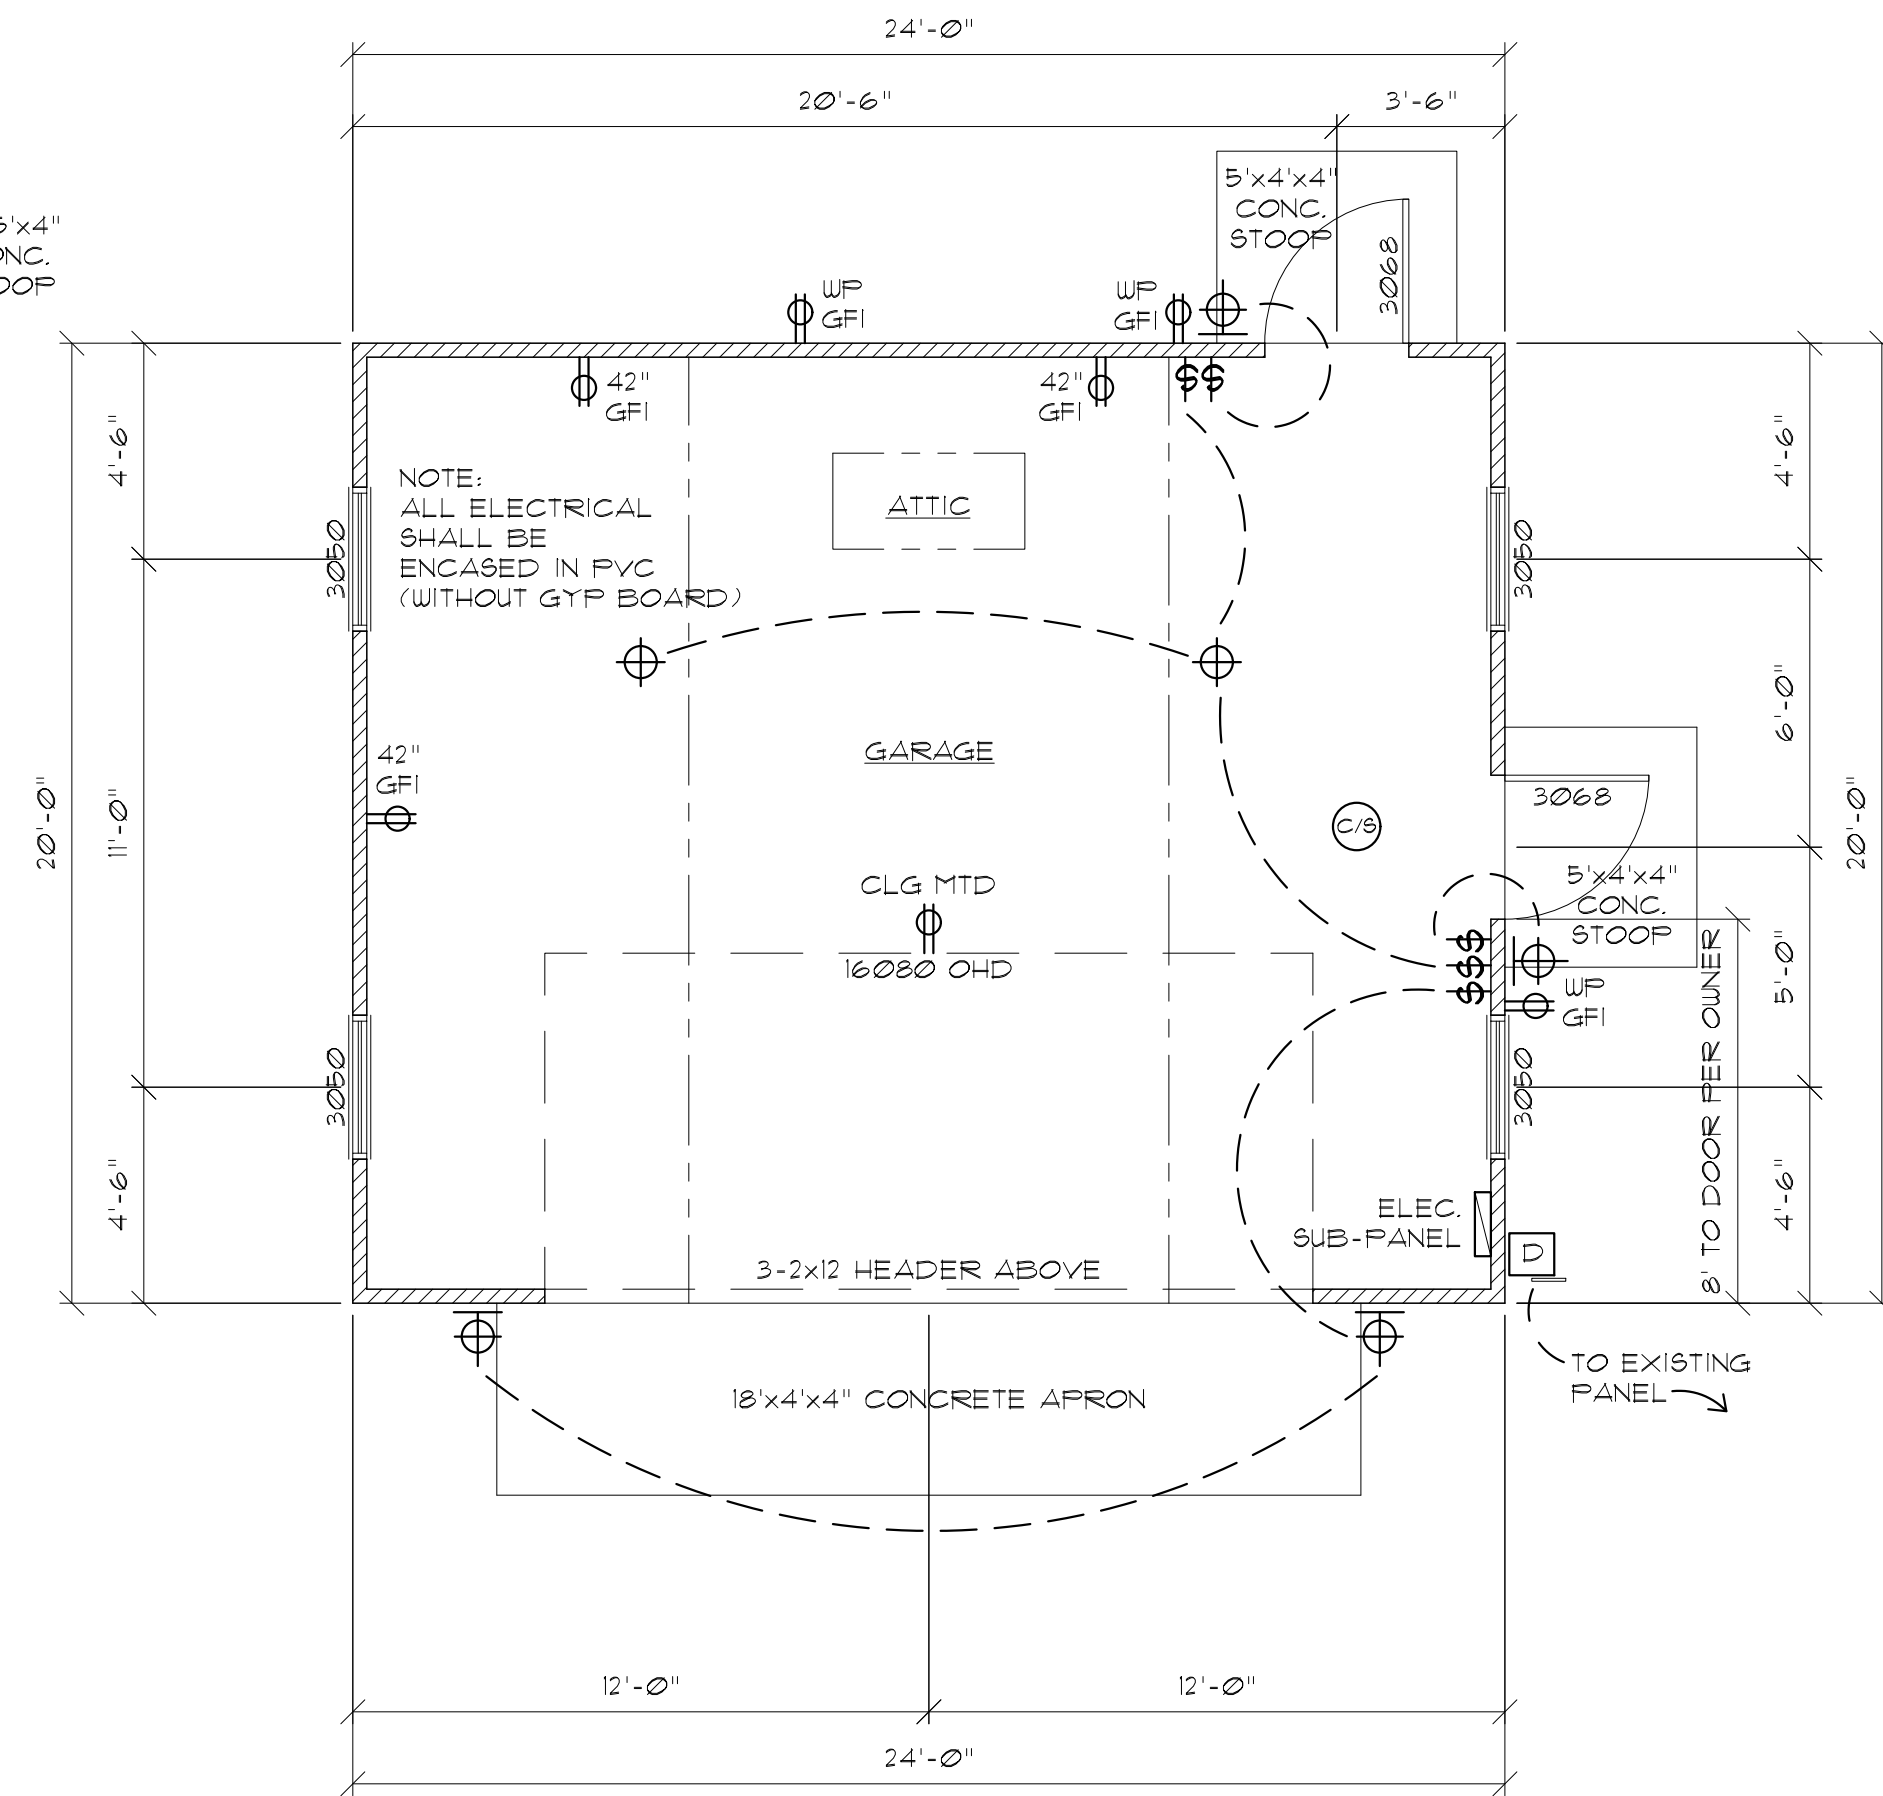
Floor Plan

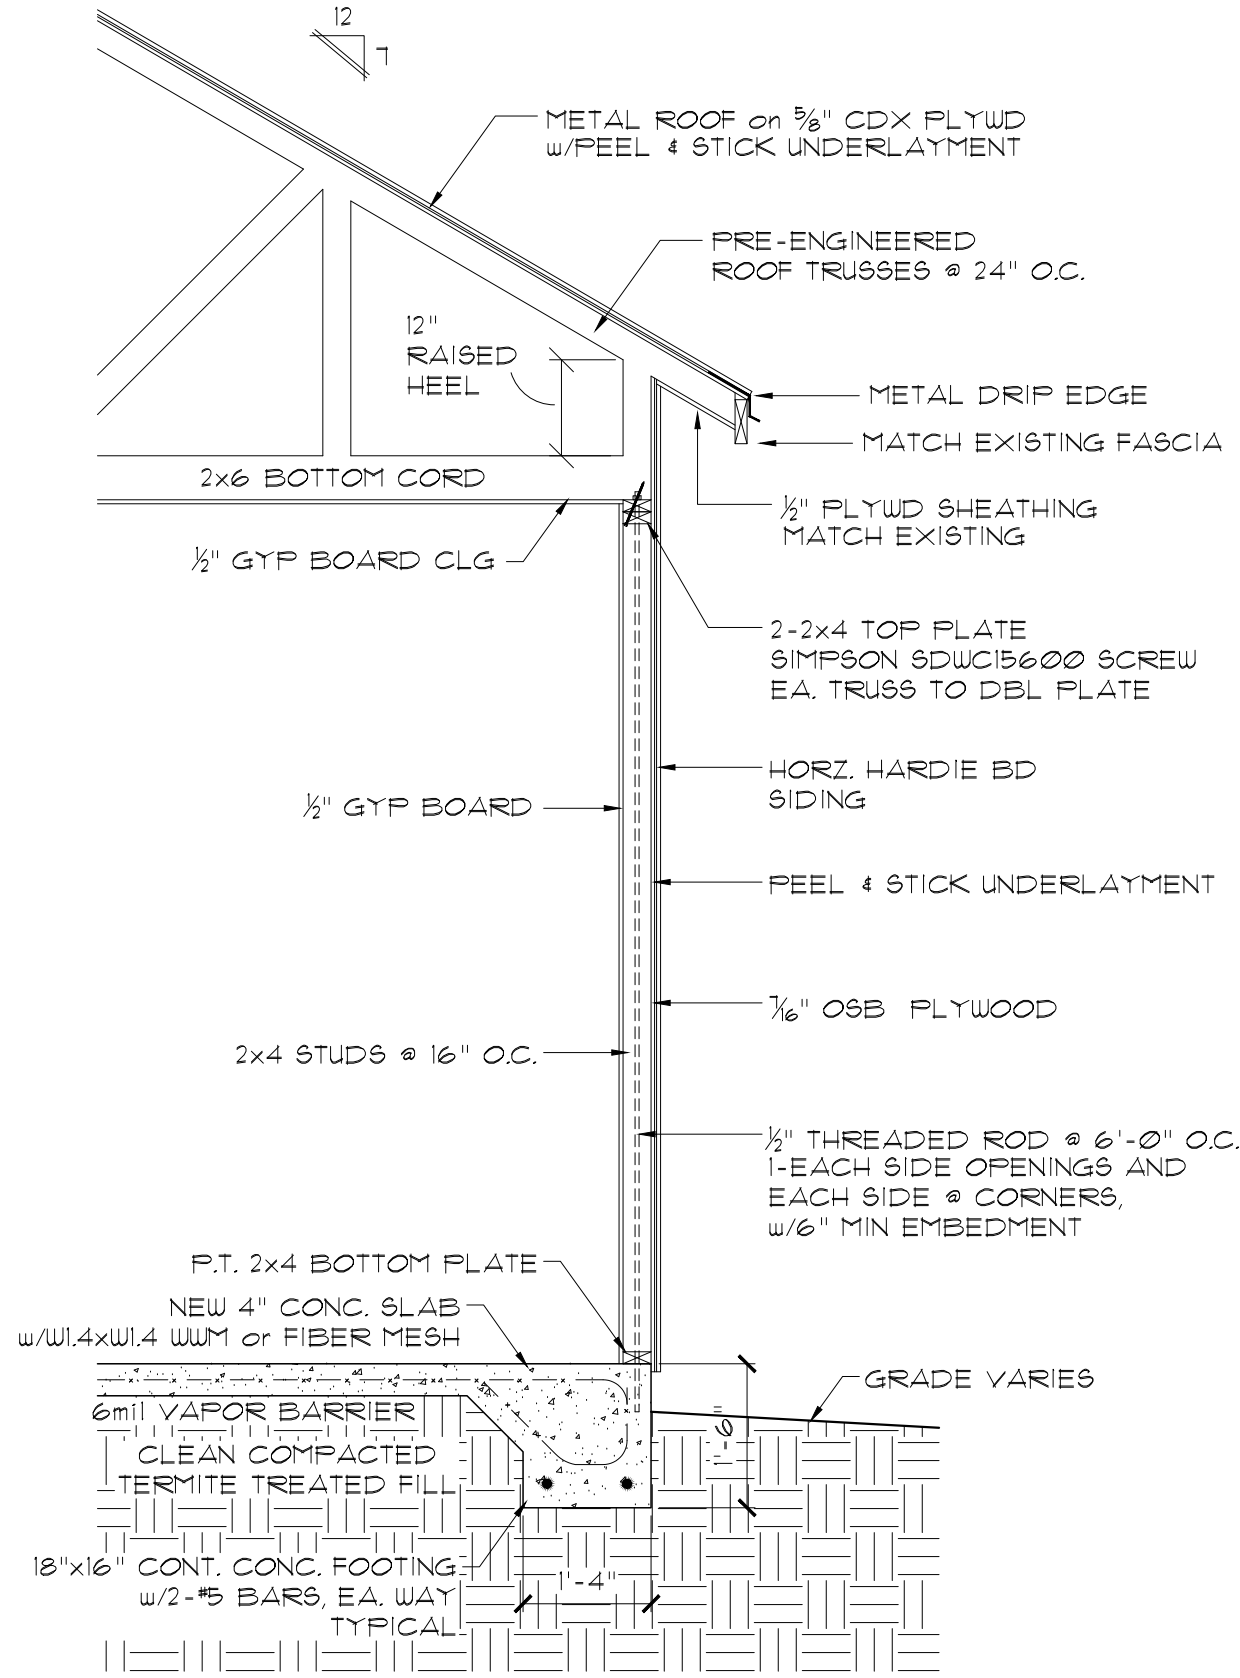
Wall Section  
1/2" = 1'-0"

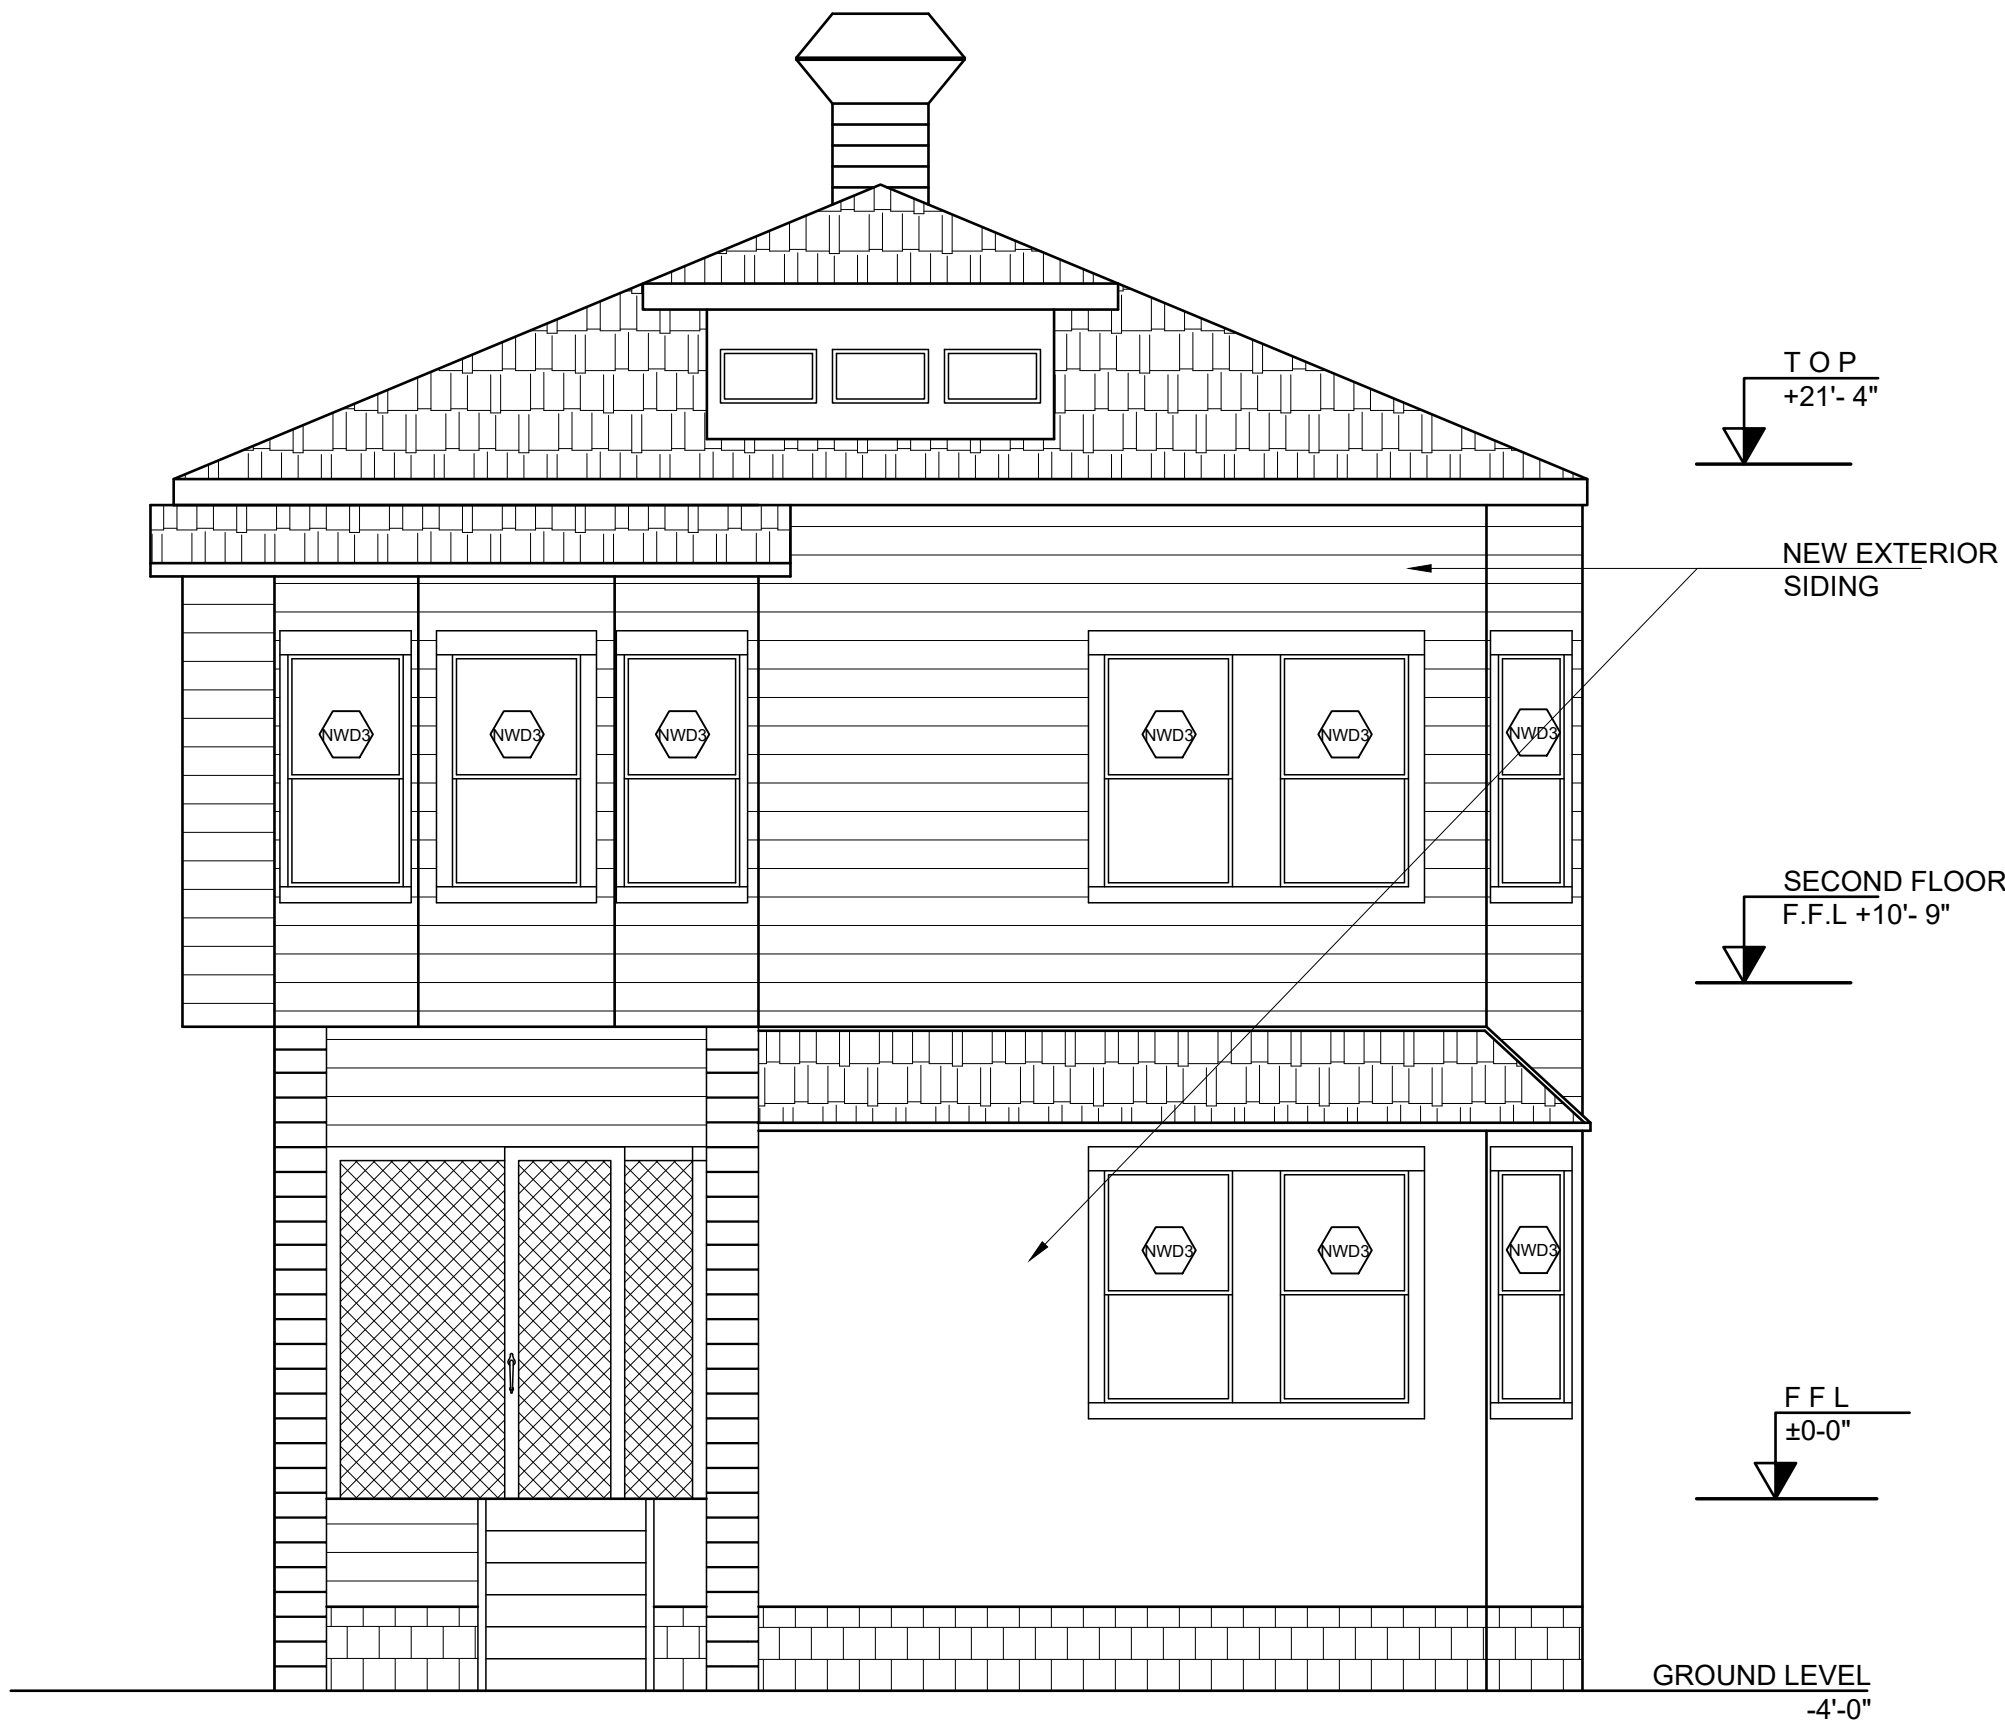
NEW REAR ELEVATION  
SCALE: 1/4"=1'
