## HISTORIC ARCHITECTURAL REVIEW BOARD

**THURSDAY, MAY 21, 2026 - 1:00 PM**

**CITY OF ST. AUGUSTINE HISTORIC ARCHITECTURAL REVIEW BOARD  
STAFF REPORT AND RECOMMENDATION  
Prepared for May 21, 2026 Meeting**

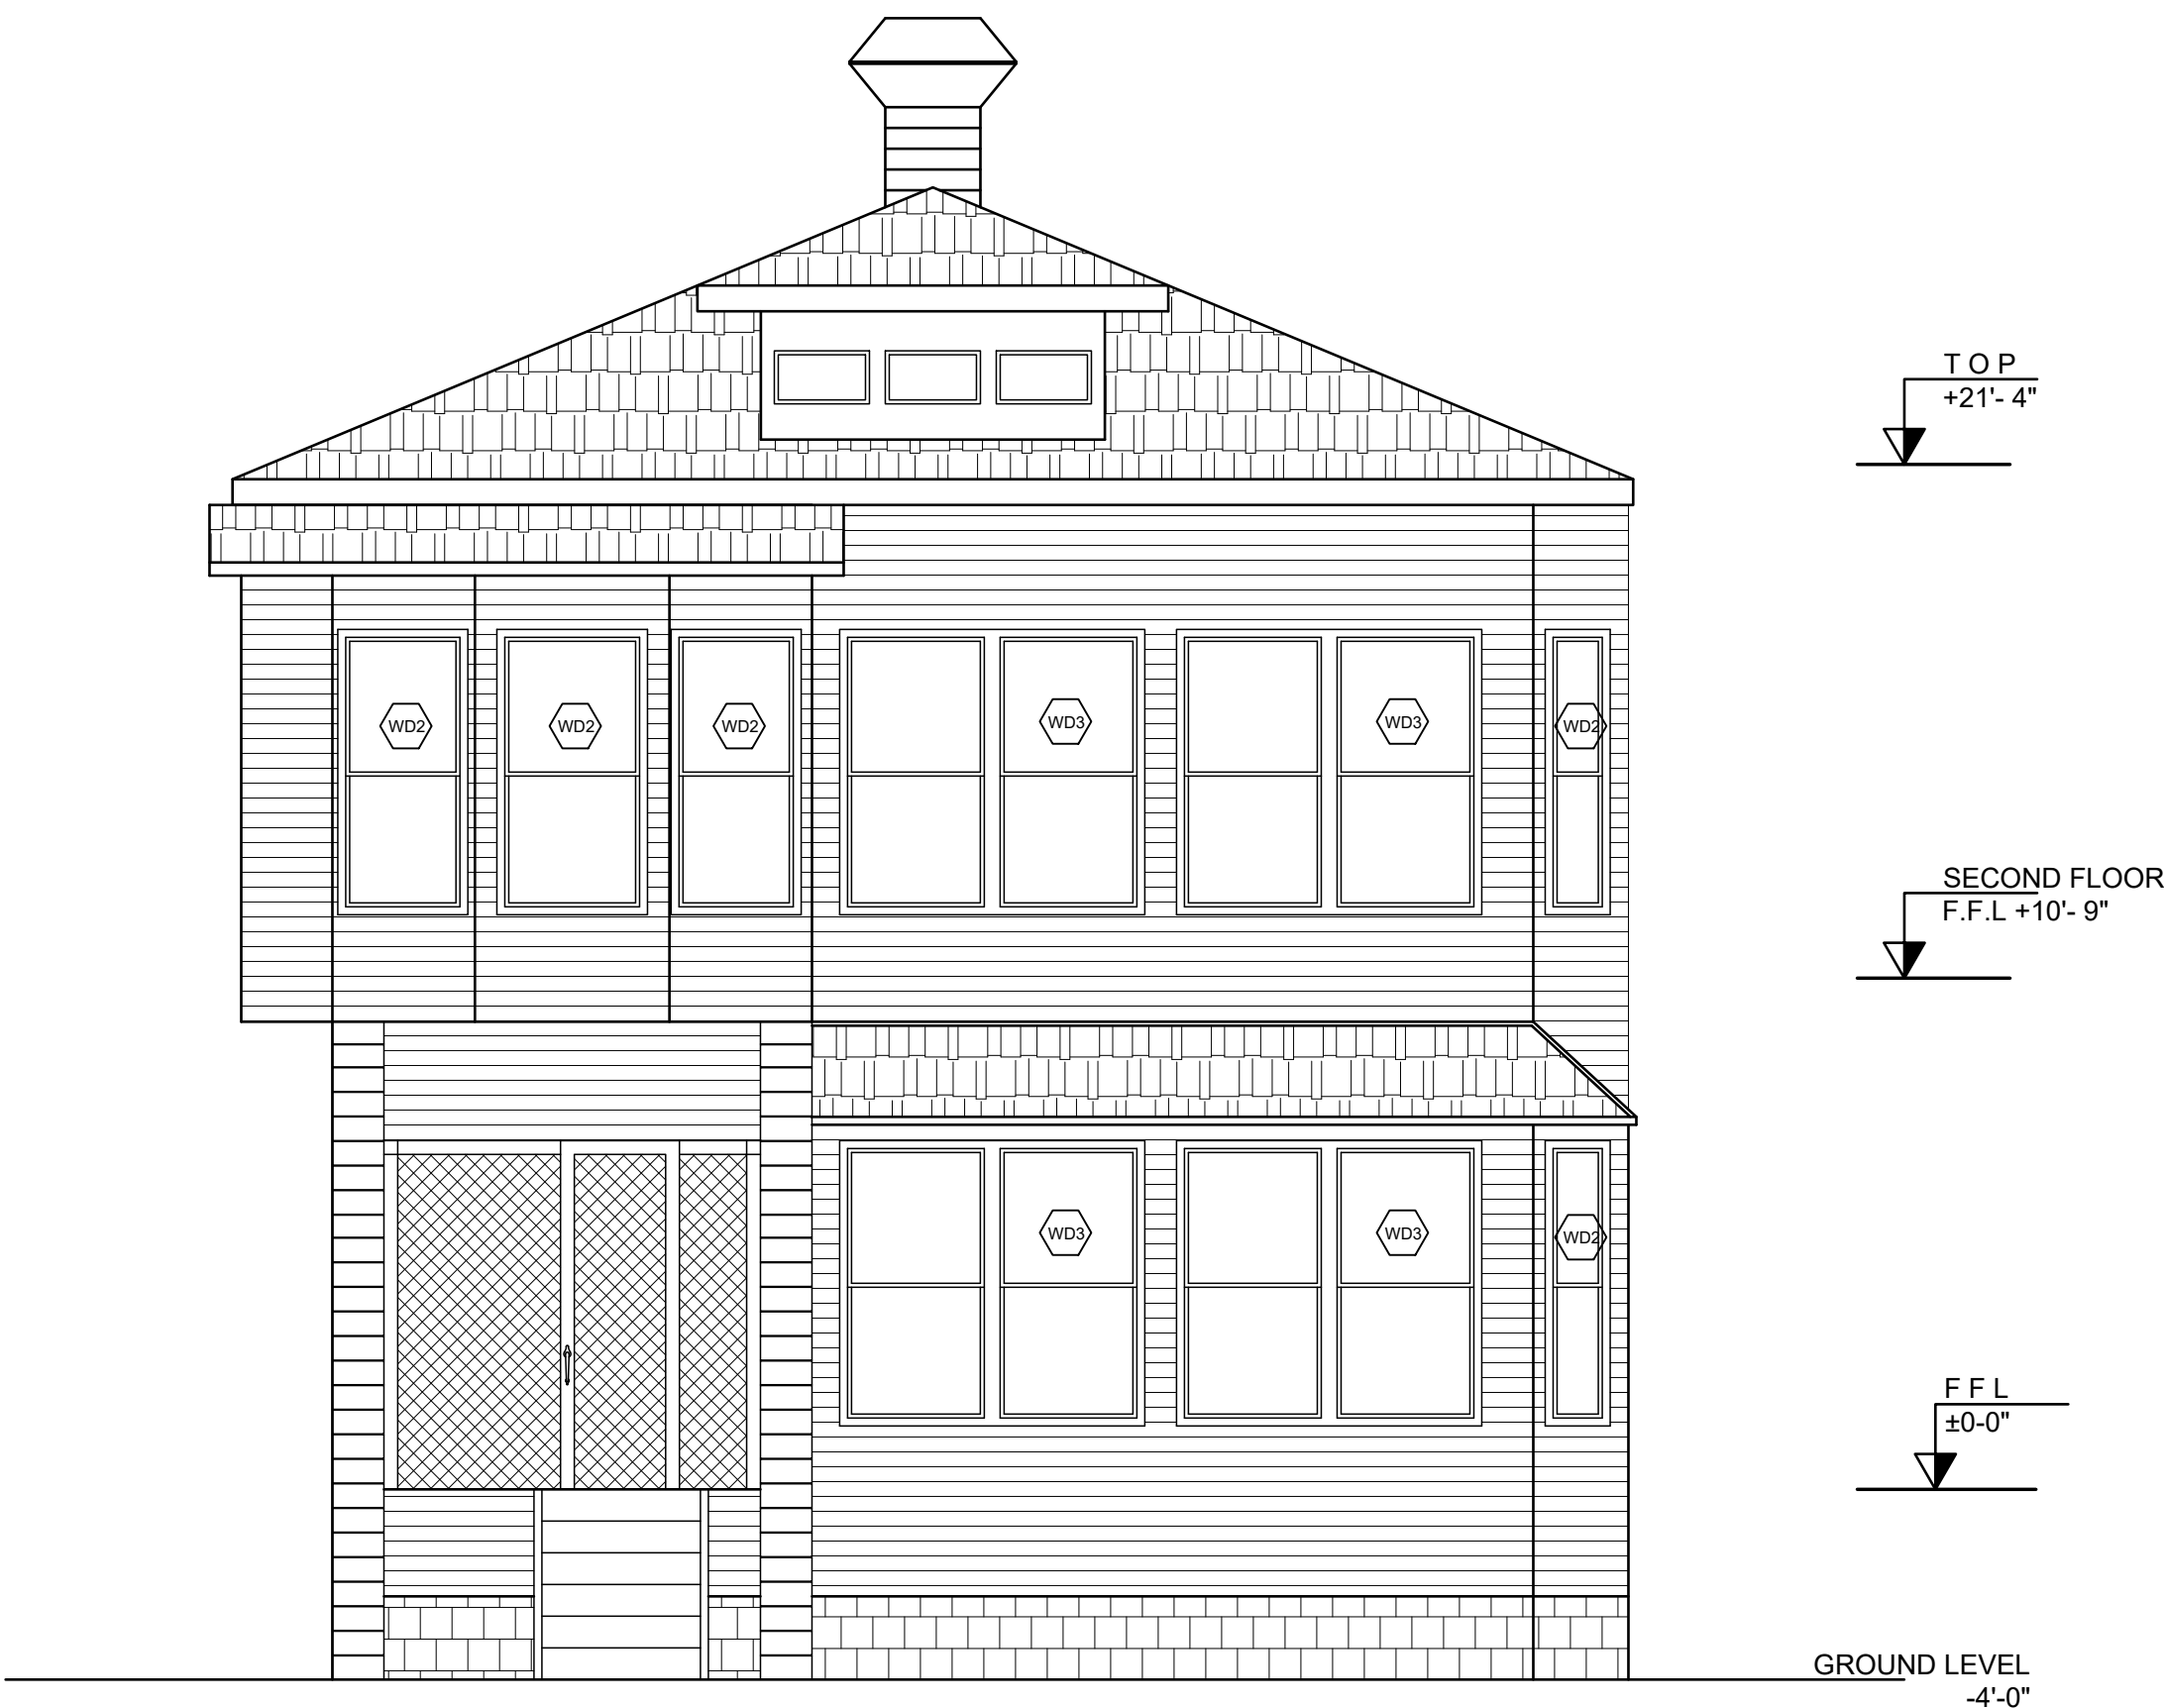
EXISTING REAR ELEVATION  
SCALE: 1/4"=1'

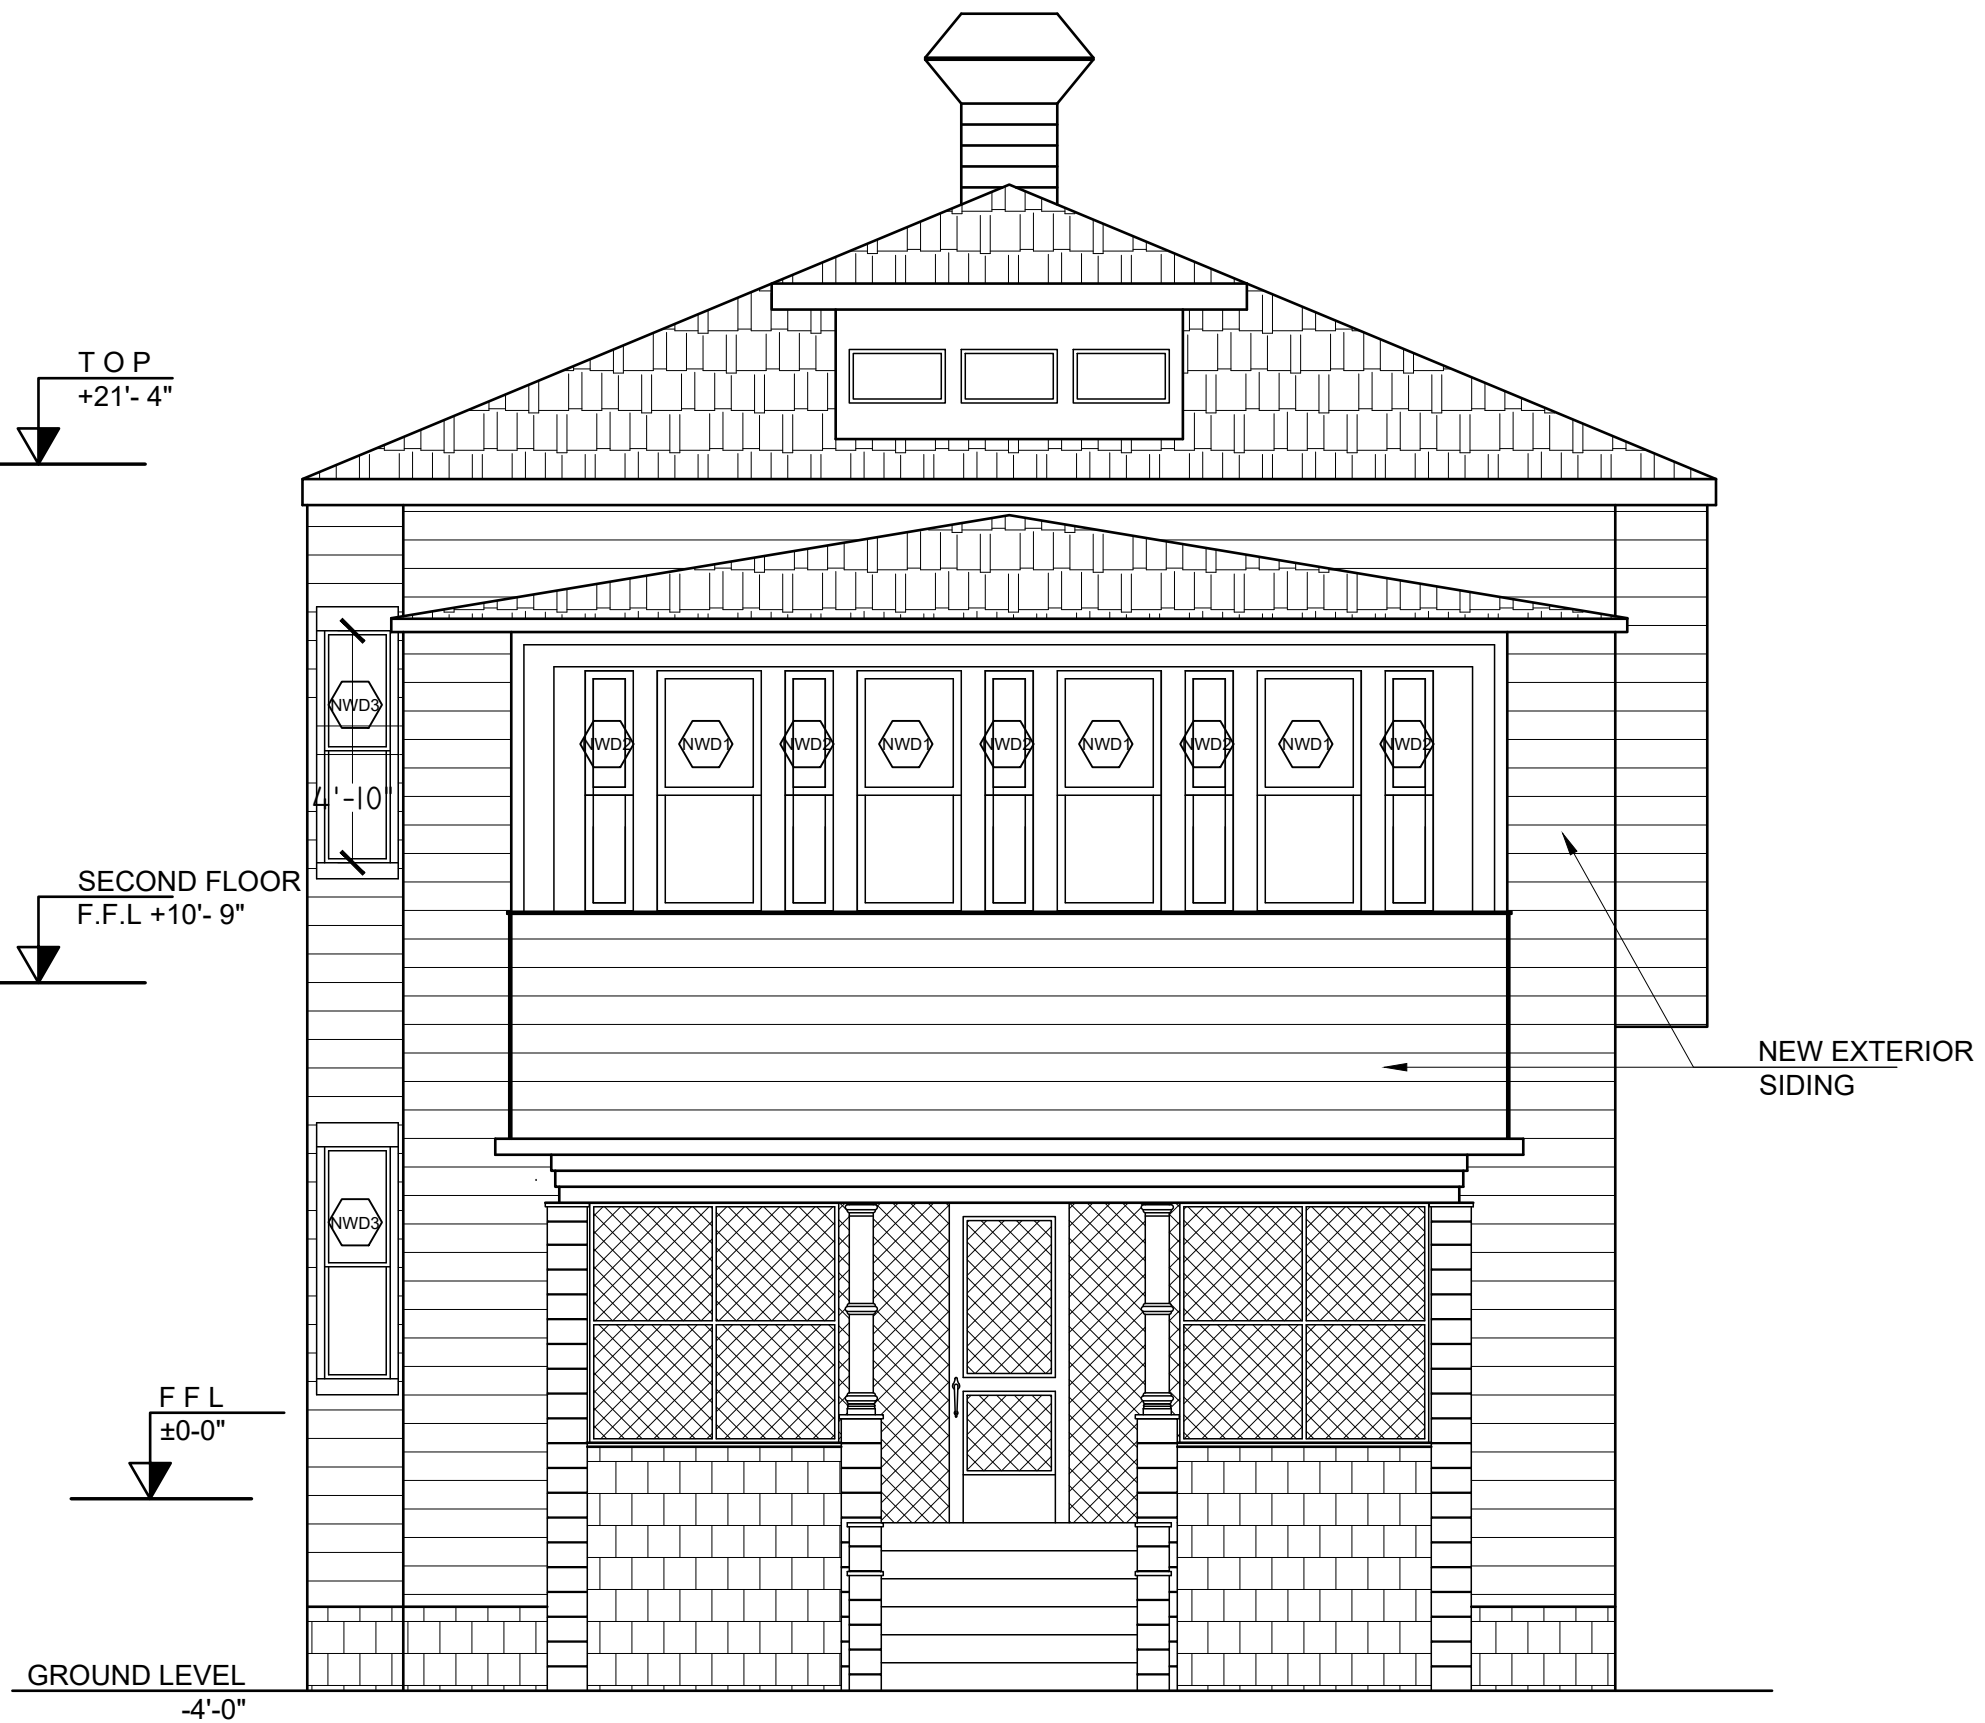
NEW FRONT ELEVATION  
SCALE: 1/4"=1'

- RESTORE THE FRONT ELEVATION WINDOWS TO MATCH THE ORIGINAL STYLE & DESIGN .
- FRAME OUT AROUND WINDOW OPENINGS TO ALIGN WITH THE DESIRED HISTORIC STYLE.
- ADD WINDOW SCHEDULE FOR EXISTING AND NEW WINDOWS TO MAKE SIZE COMPARISON.
- ADD OPENING FRAMING DETAILS.

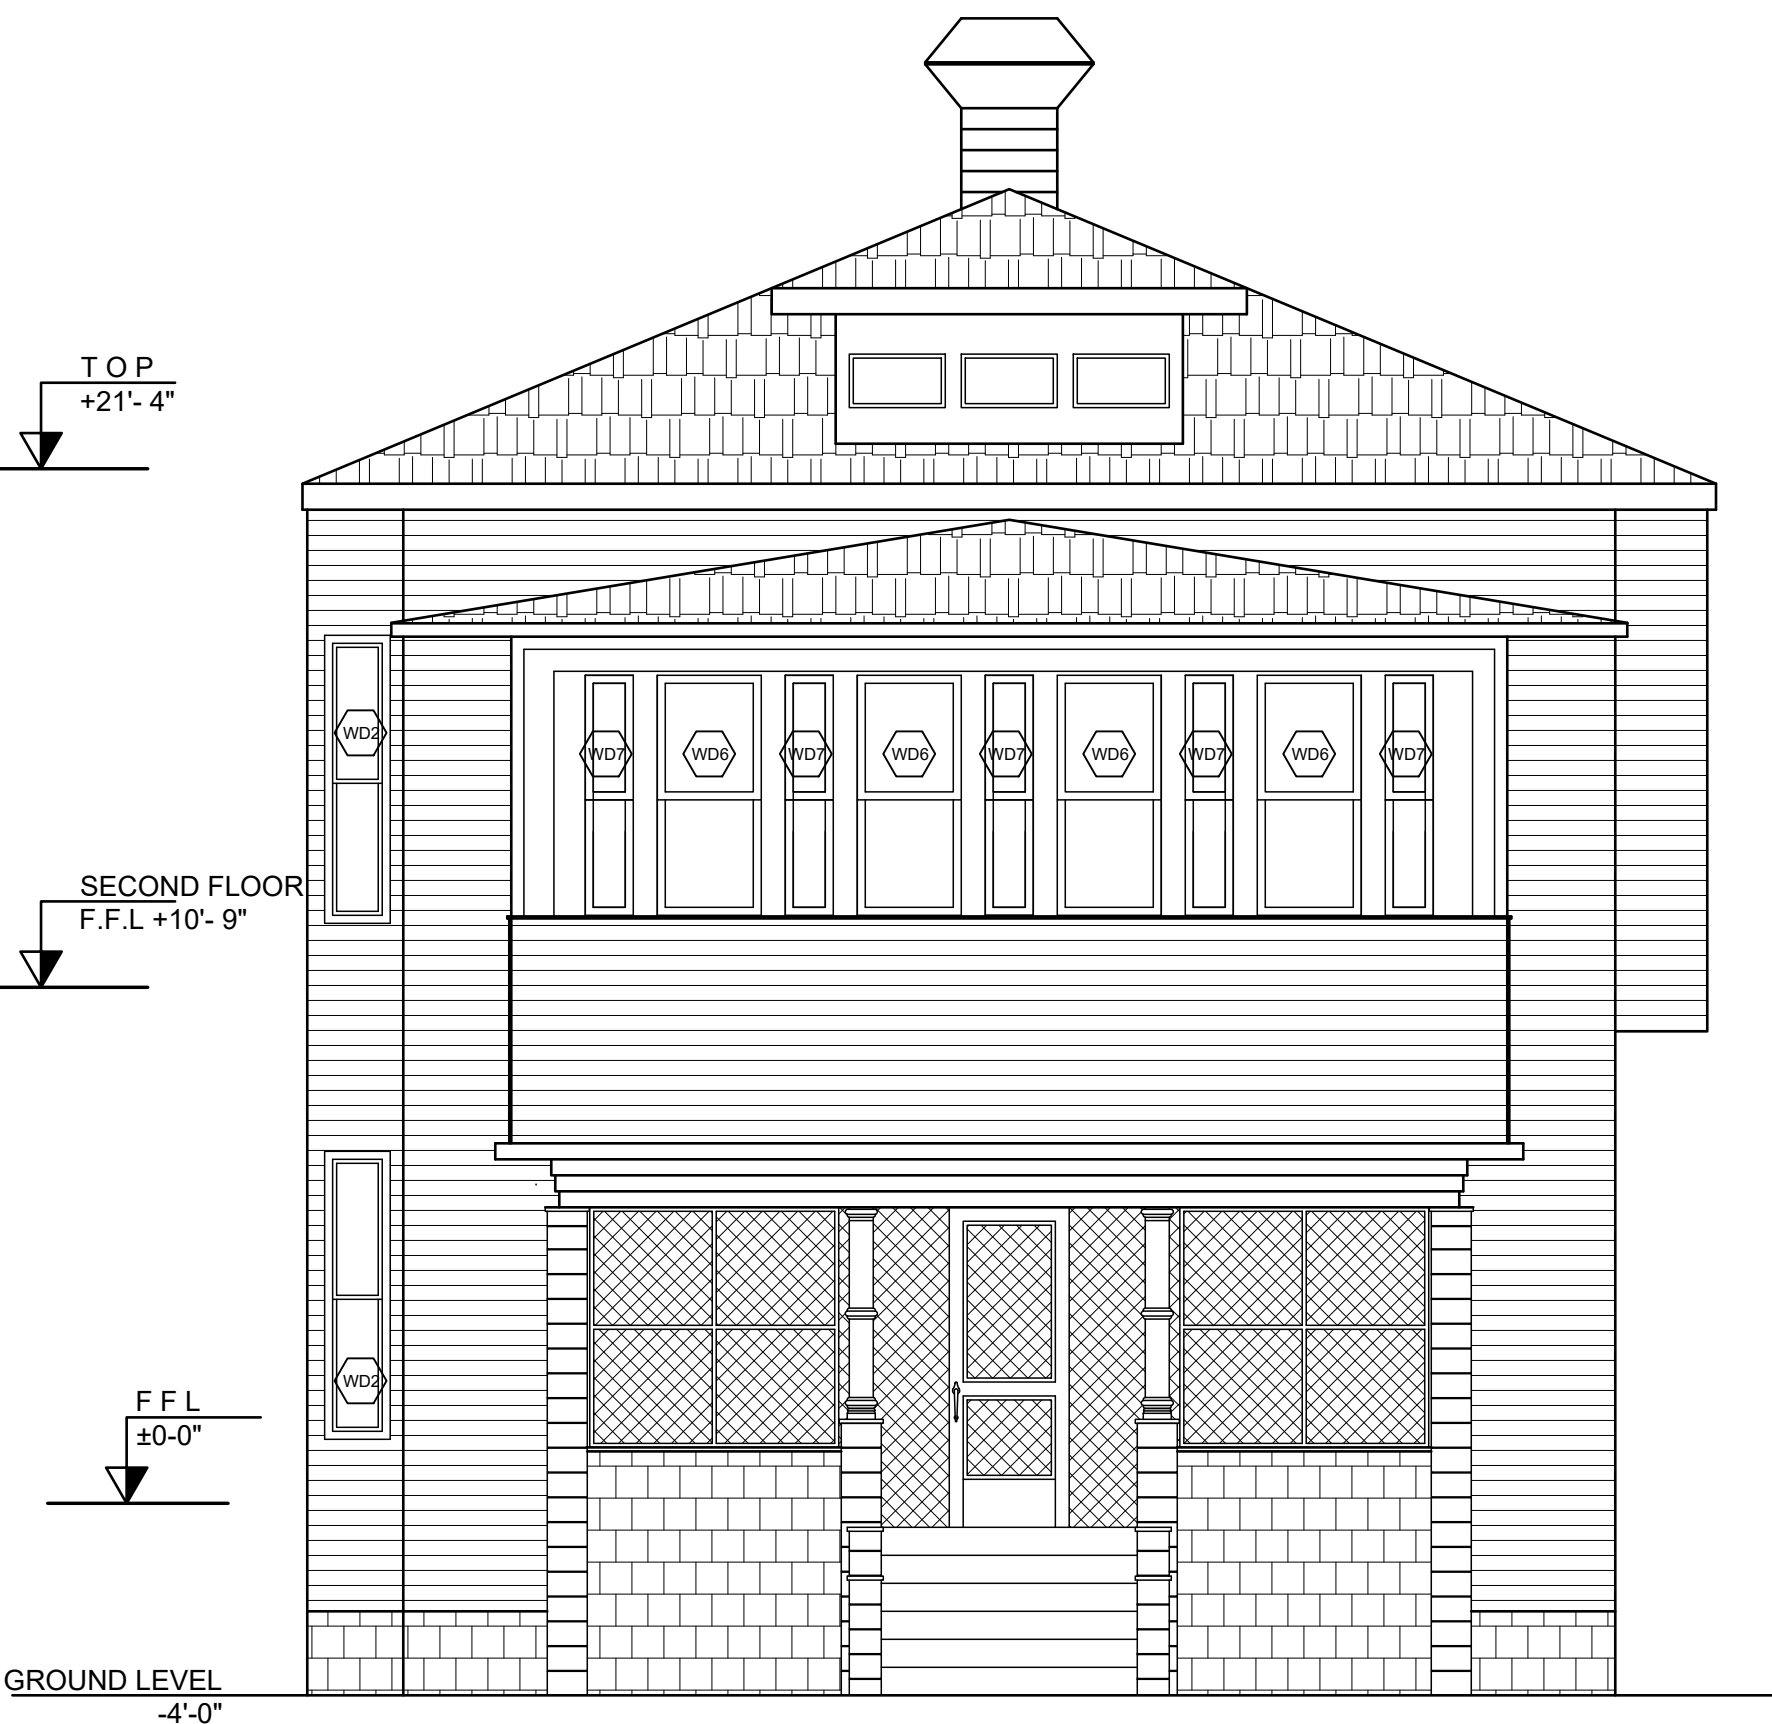
EXISTING FRONT ELEVATION  
SCALE: 1/4"=1'

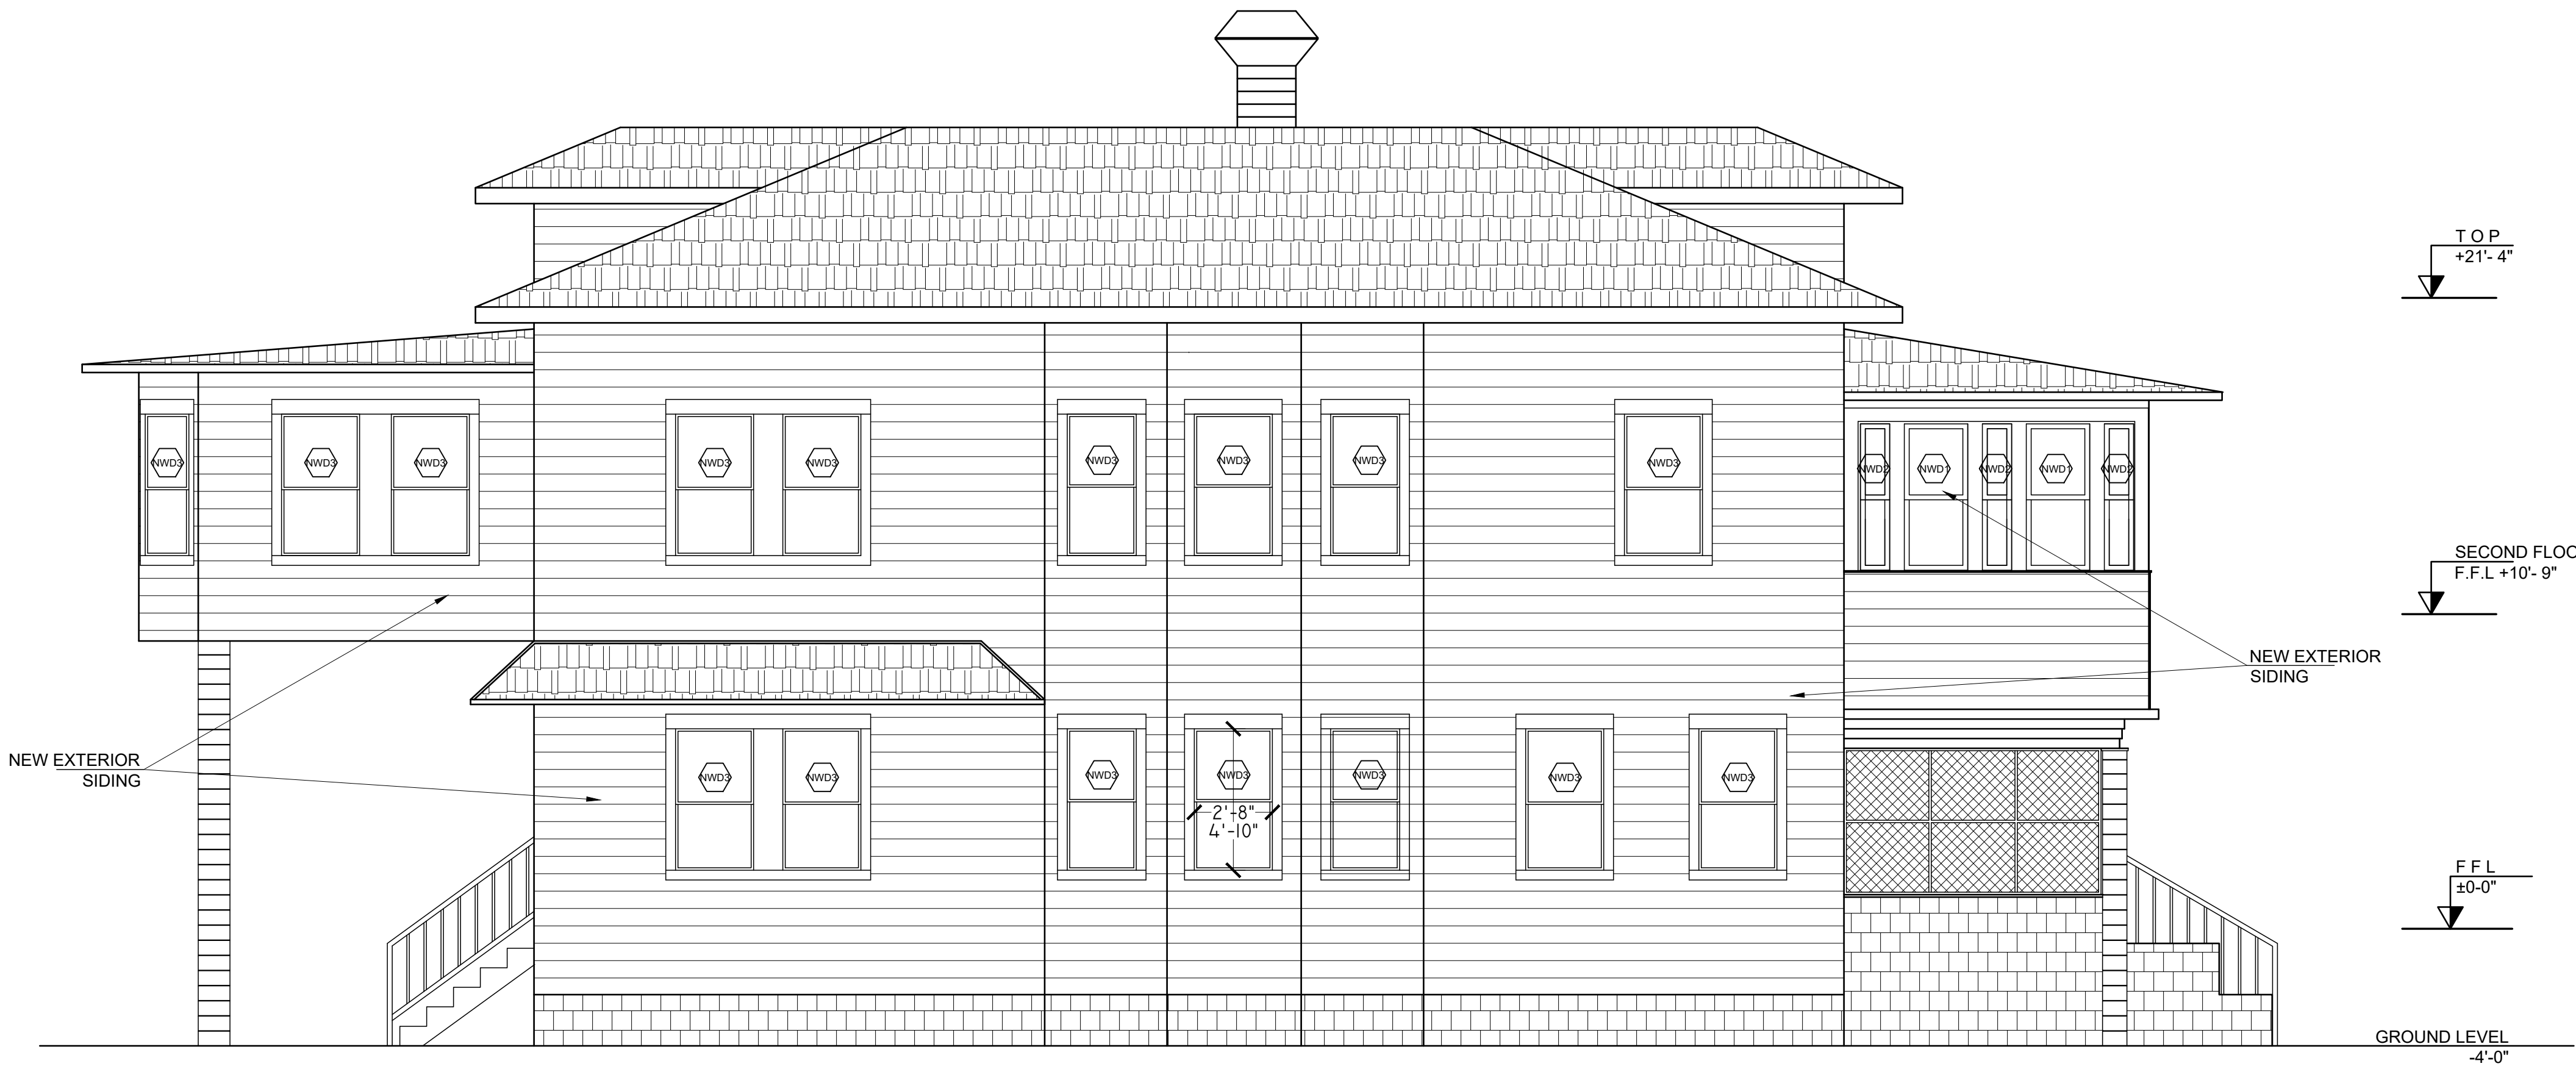
NEW LEFT ELEVATION  
SCALE: 1/4"=1'

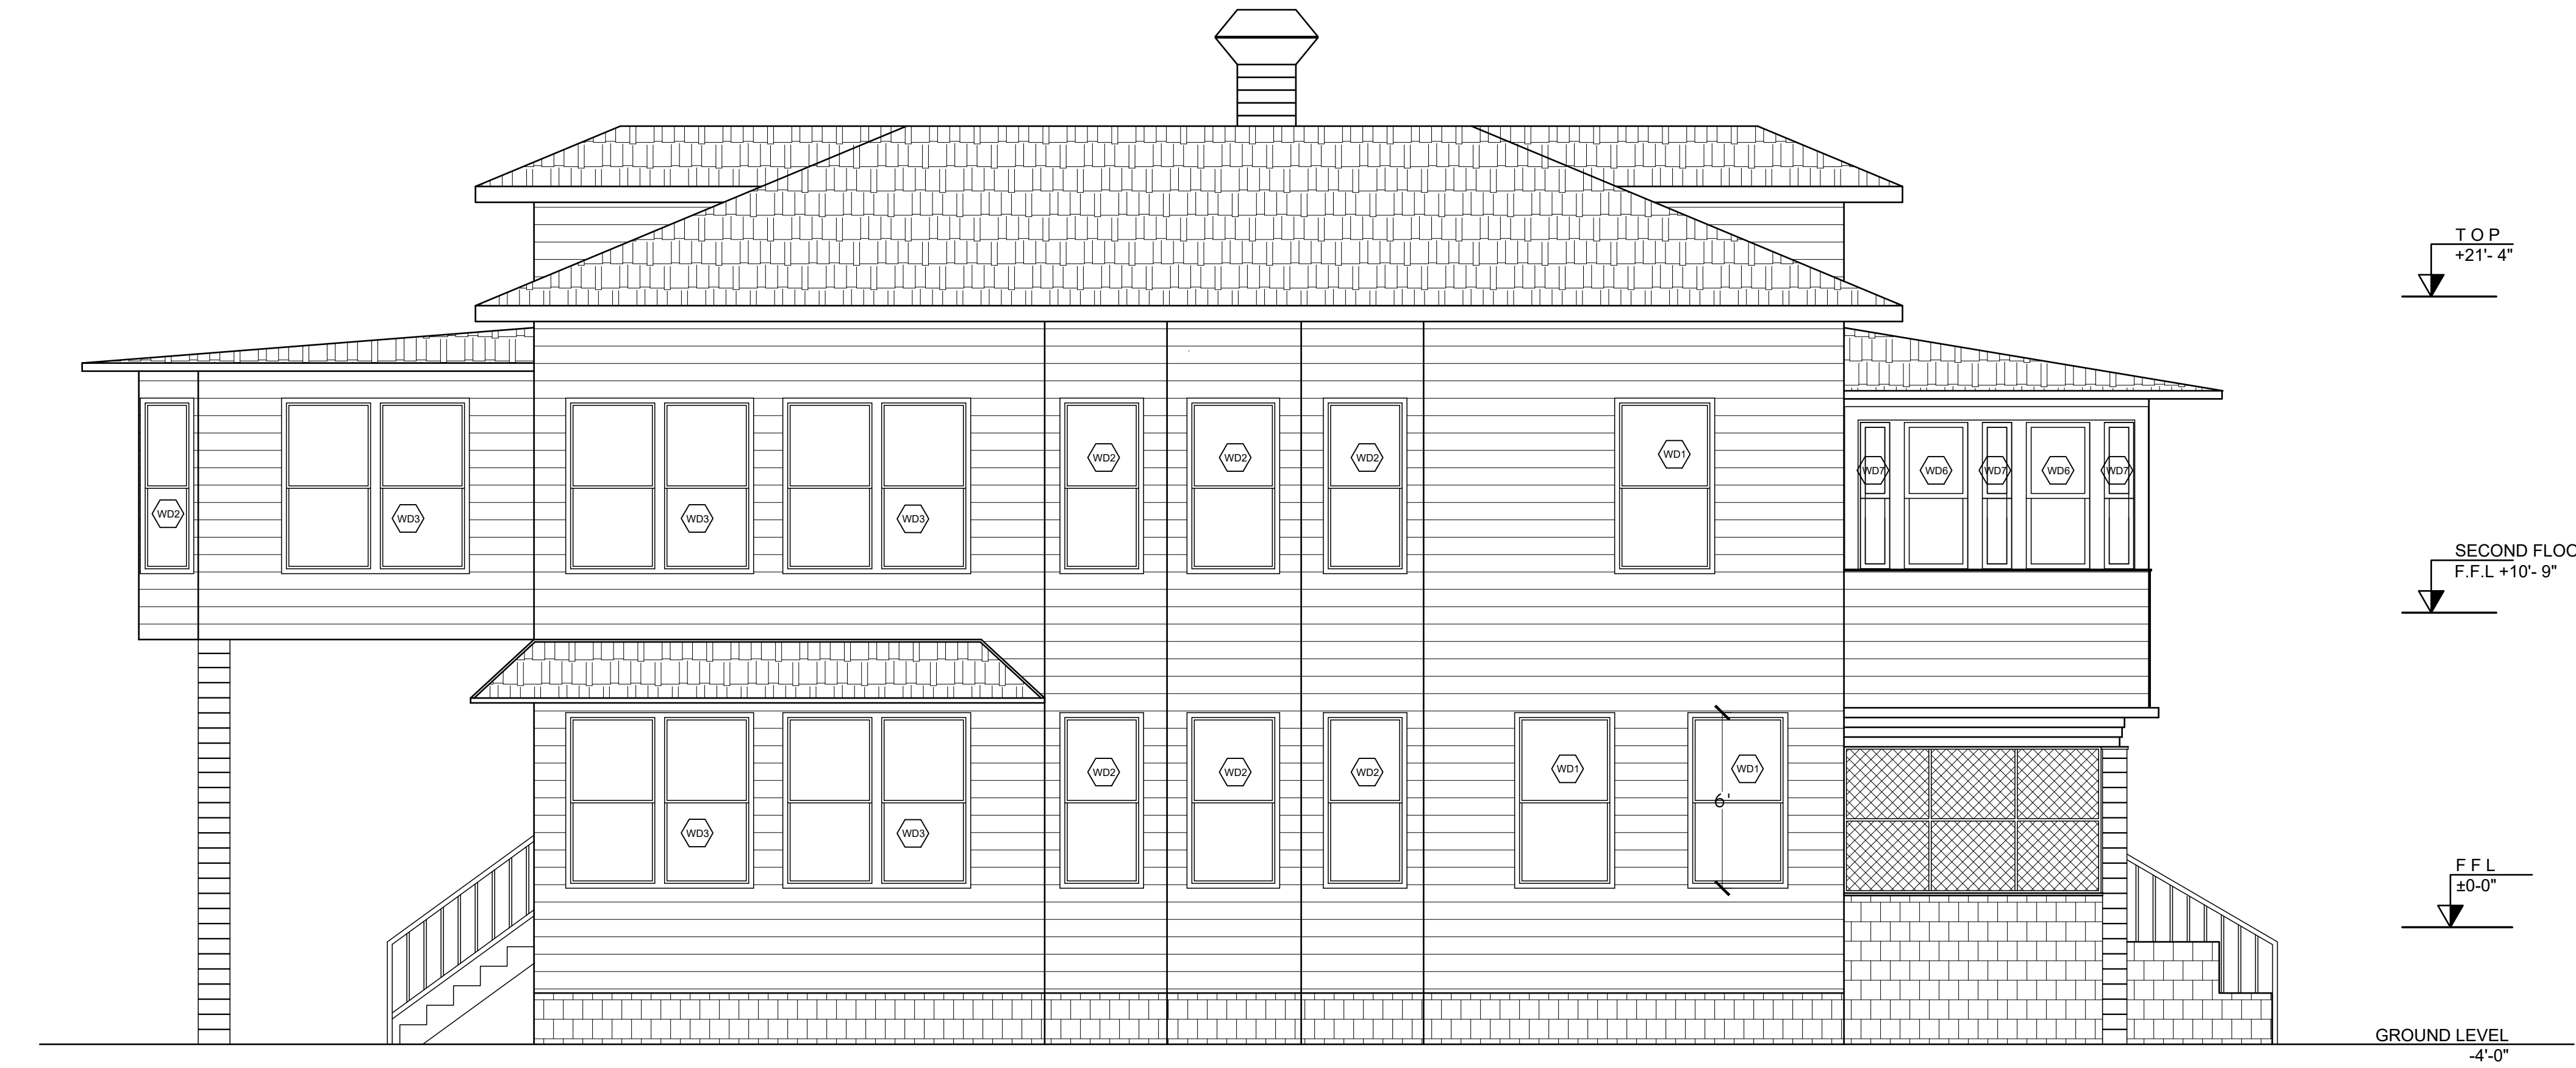
EXISTING LEFT ELEVATION  
SCALE: 1/4"=1'

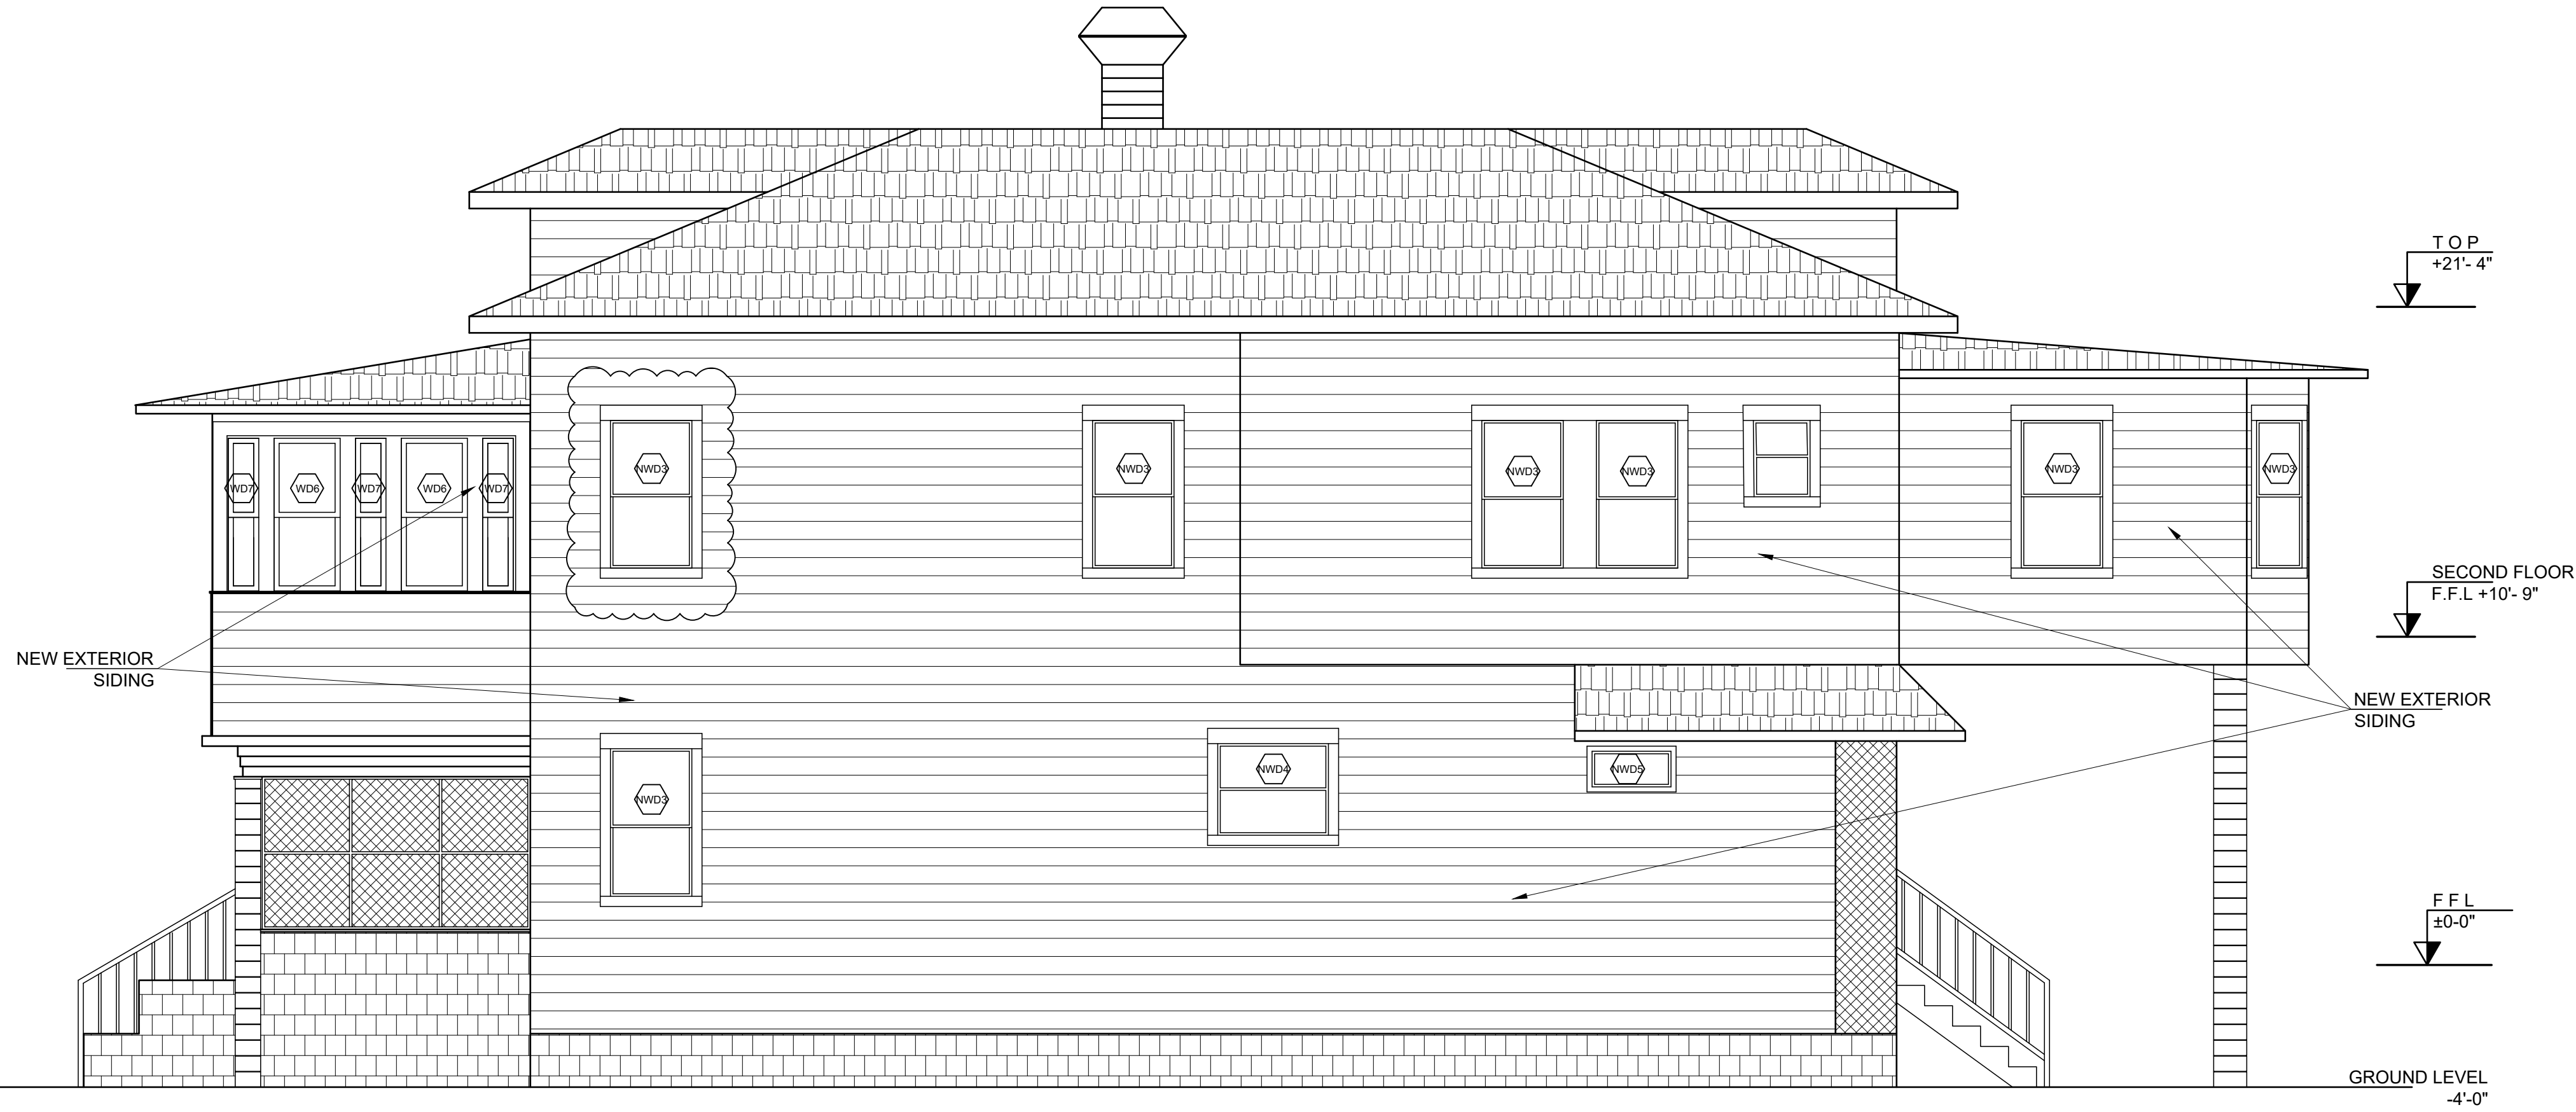
NEW RIGHT ELEVATION  
SCALE: 1/4"=1'

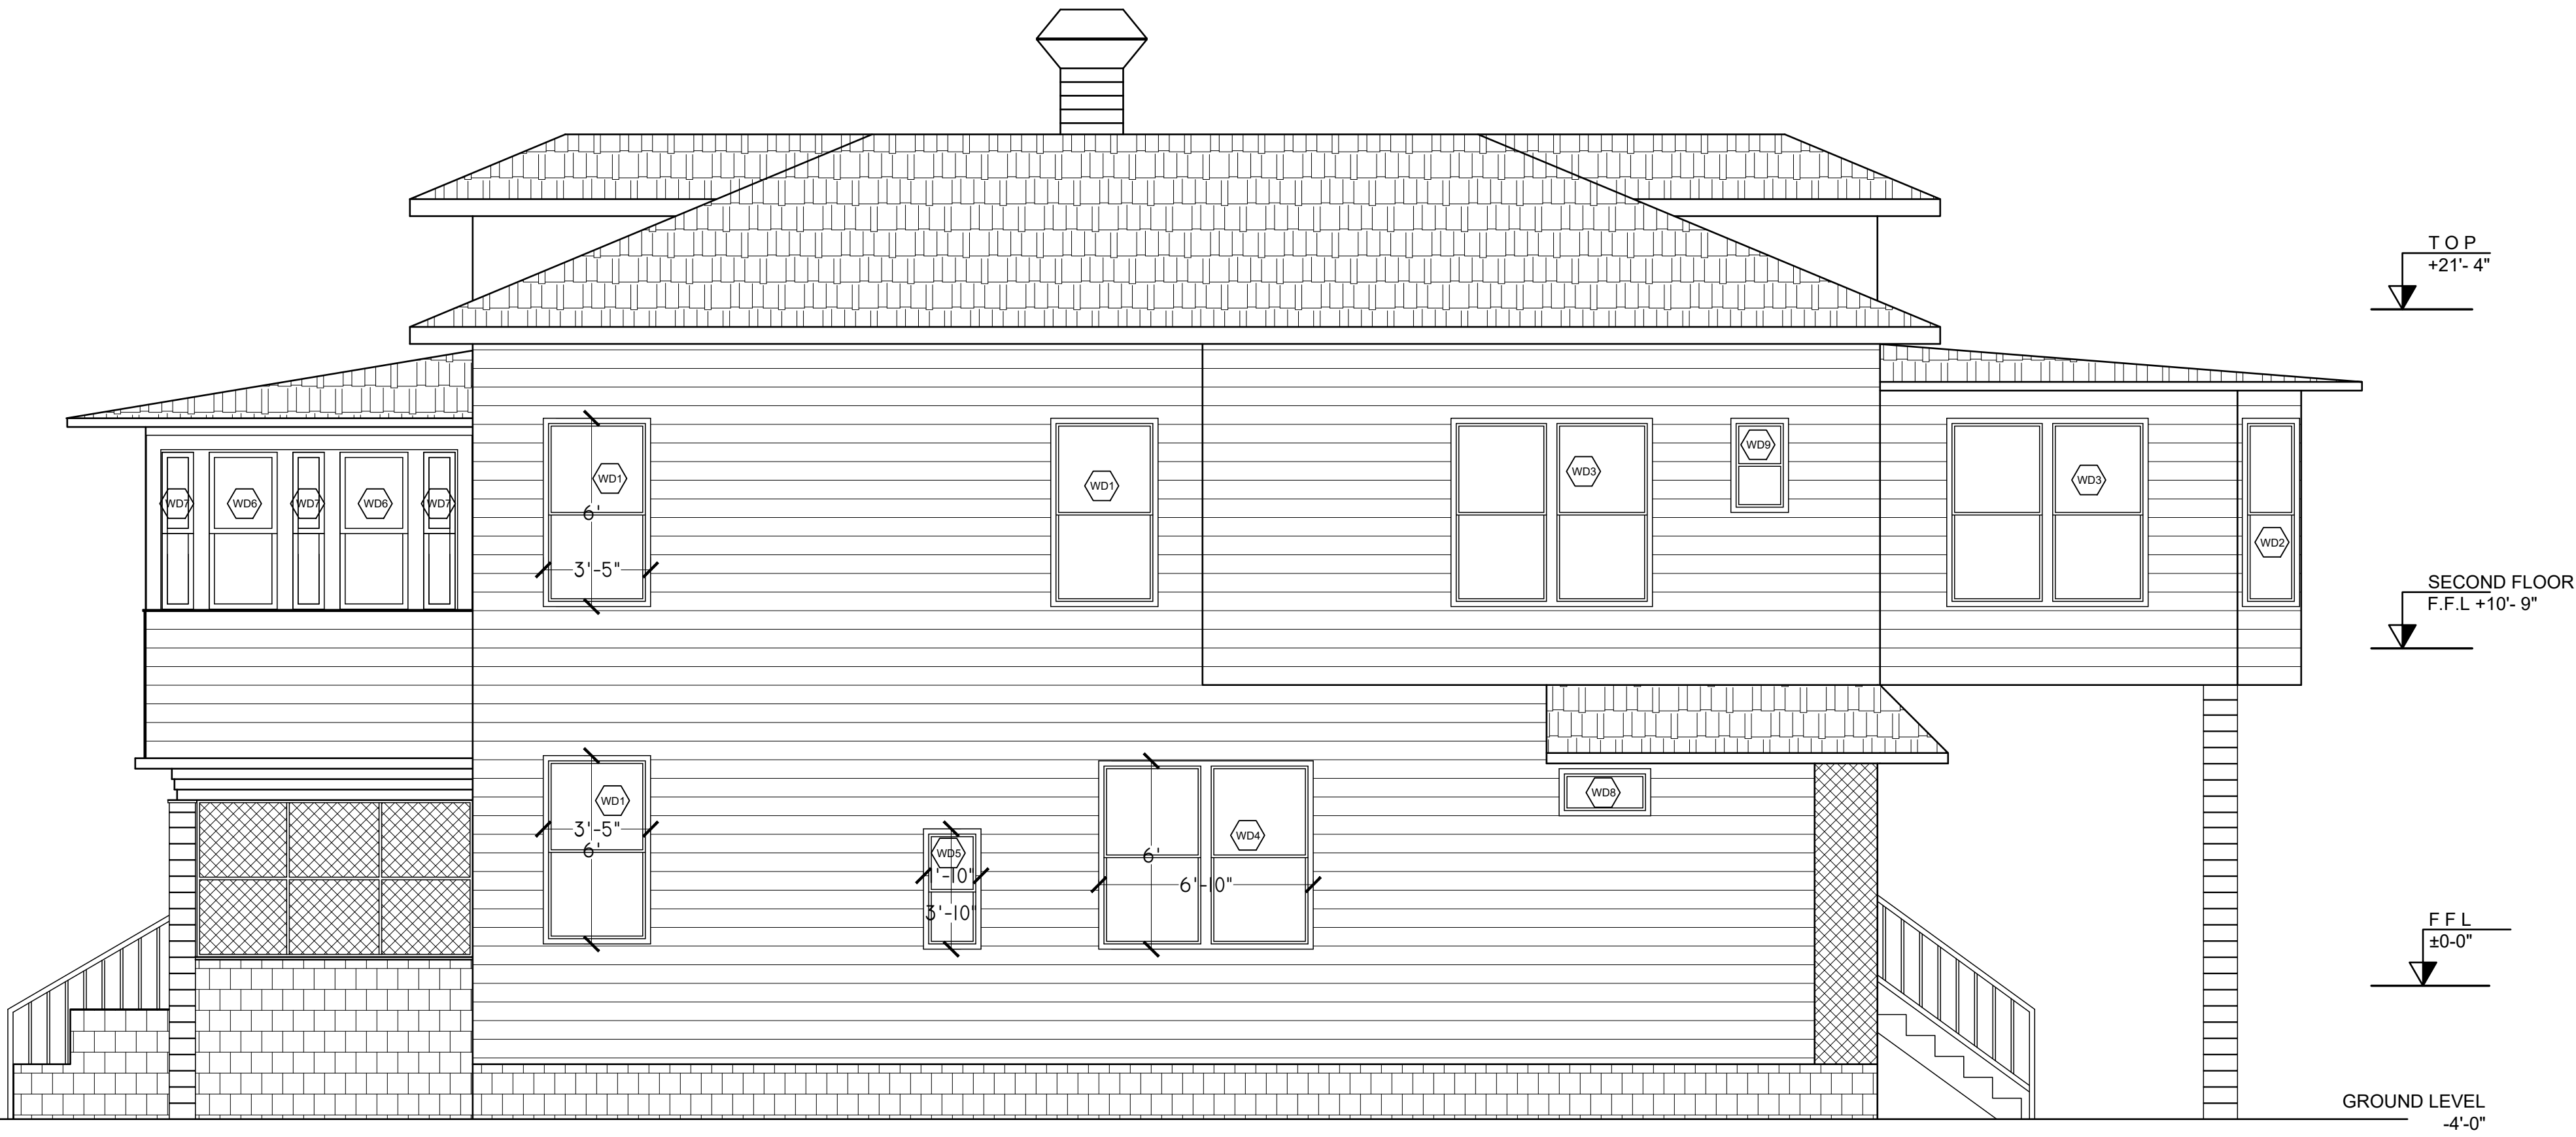
EXISTING RIGHT ELEVATION  
SCALE: 1/4"=1'
