## HISTORIC ARCHITECTURAL REVIEW BOARD

**THURSDAY, MAY 21, 2026 - 1:00 PM**

**CITY OF ST. AUGUSTINE HISTORIC ARCHITECTURAL REVIEW BOARD  
STAFF REPORT AND RECOMMENDATION  
Prepared for May 21, 2026 Meeting**

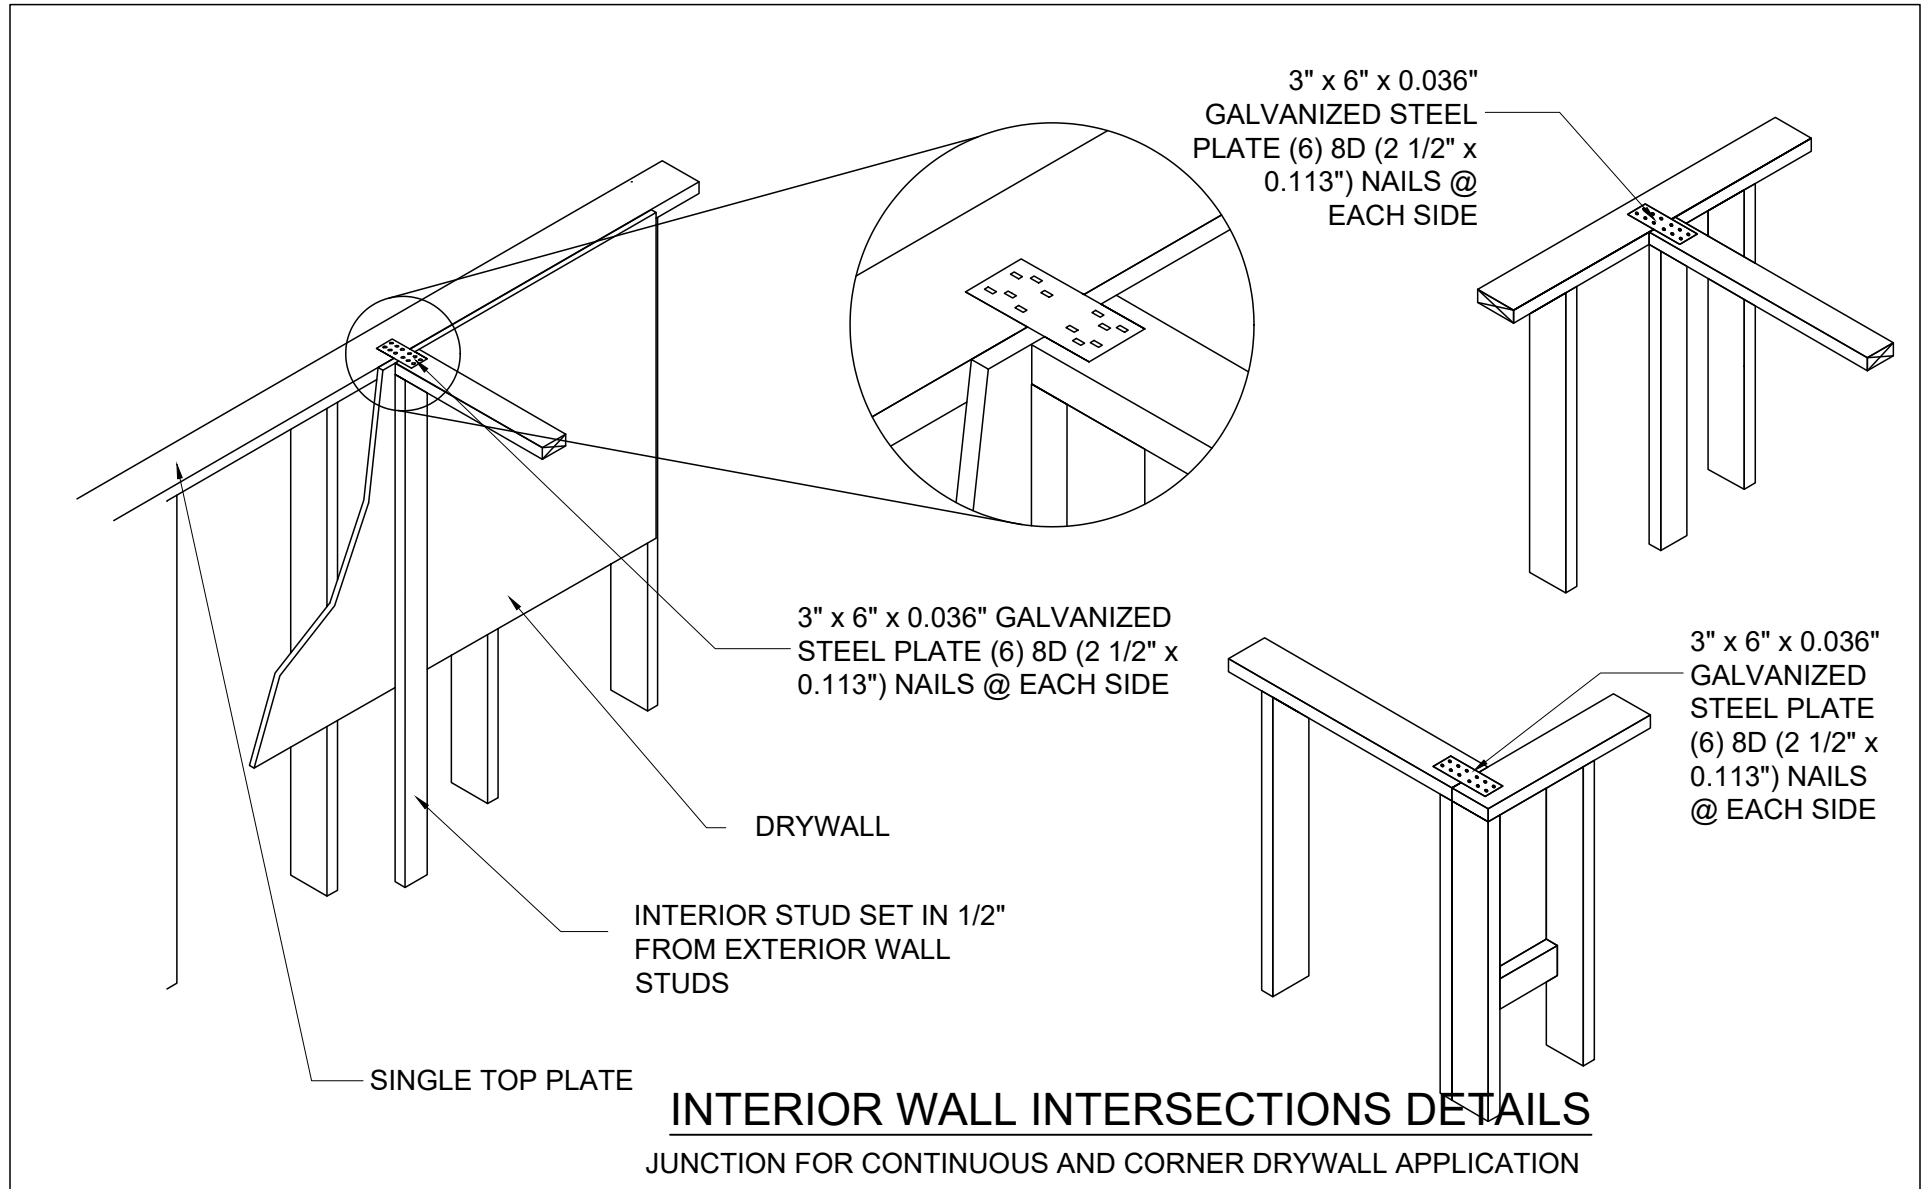
INTERIOR WALL INTERSECTIONS DETAILS  
JUNCTION FOR CONTINUOUS AND CORNER DRYWALL APPLICATION
