**CITY OF ST. AUGUSTINE HISTORIC ARCHITECTURAL REVIEW BOARD**

**A G E N D A - AMENDED\***

**THURSDAY, APRIL 15, 2021 - 1:00 PM**

**CITY OF ST. AUGUSTINE HISTORIC ARCHITECTURAL REVIEW BOARD  
STAFF REPORT AND RECOMMENDATION  
Prepared for April 15, 2021 Meeting**

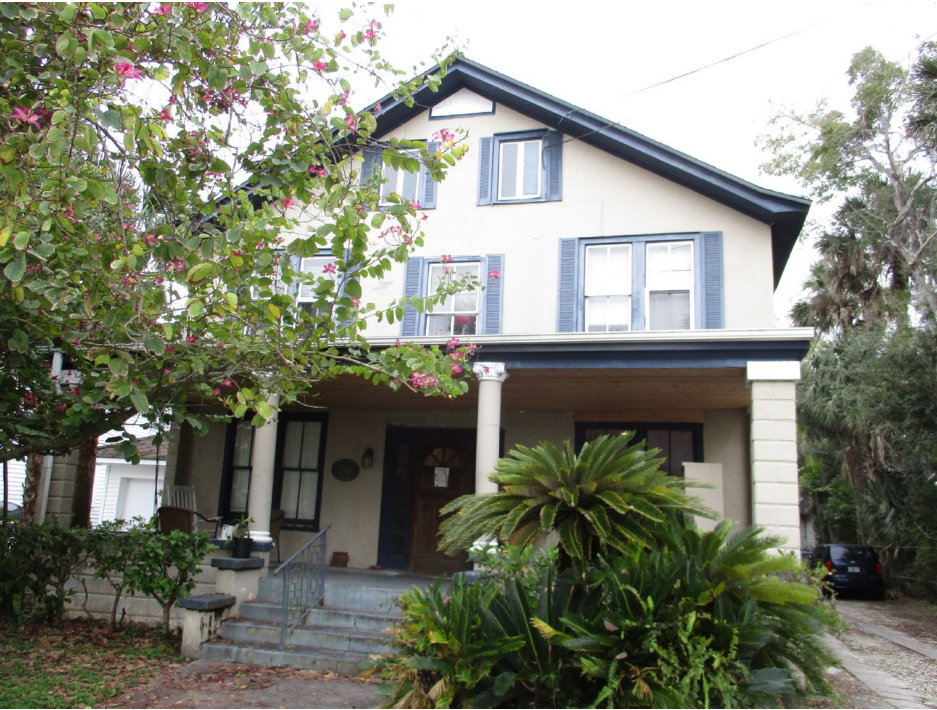
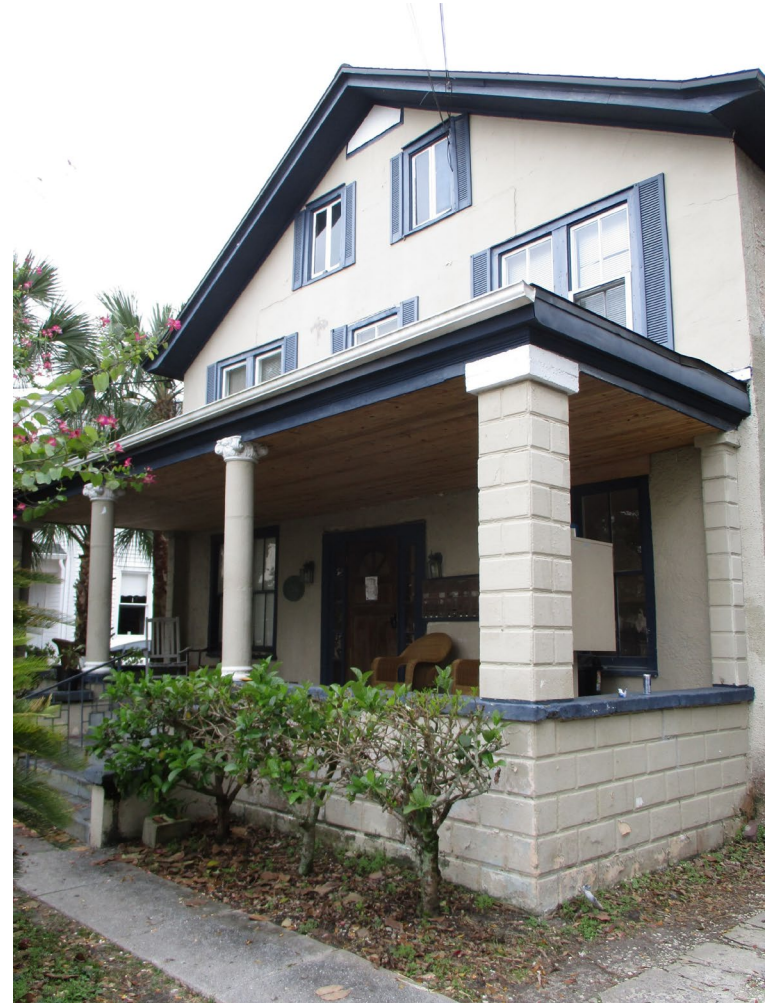
Front Façade / East Elevation:  
Smooth Plaster on front with different windows visible

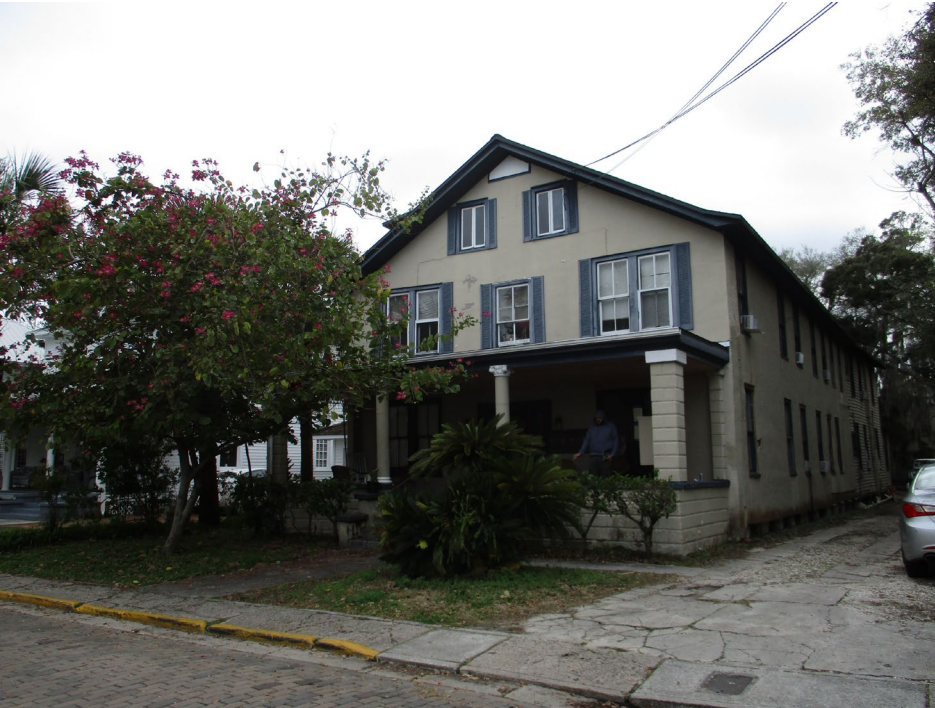
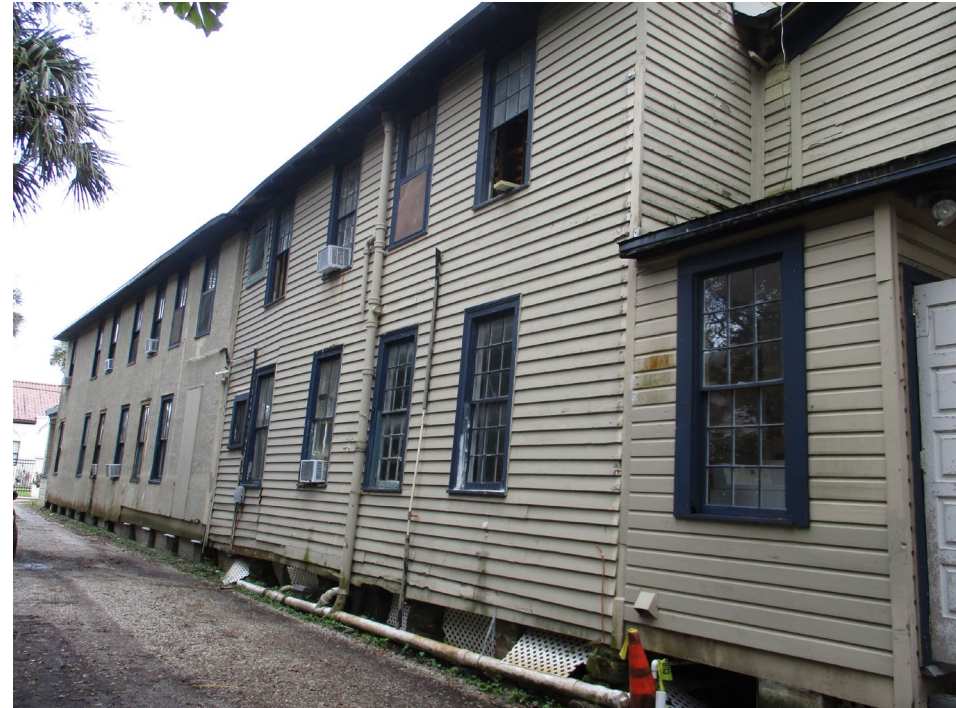
East and North Elevations:  
Smooth plaster on front façade /east elevation with different window types;  
Different plaster treatment on north elevation (east end),  
and various wood siding and different window configurations visible

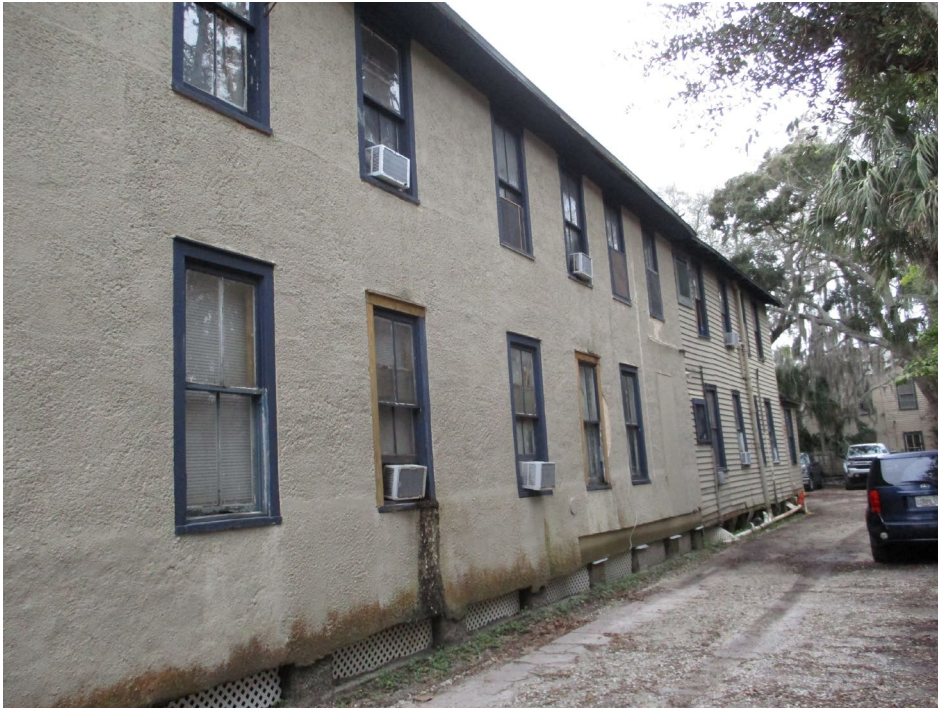
North Elevation:  
Plaster on front/east end with different wood  
siding and windows visible

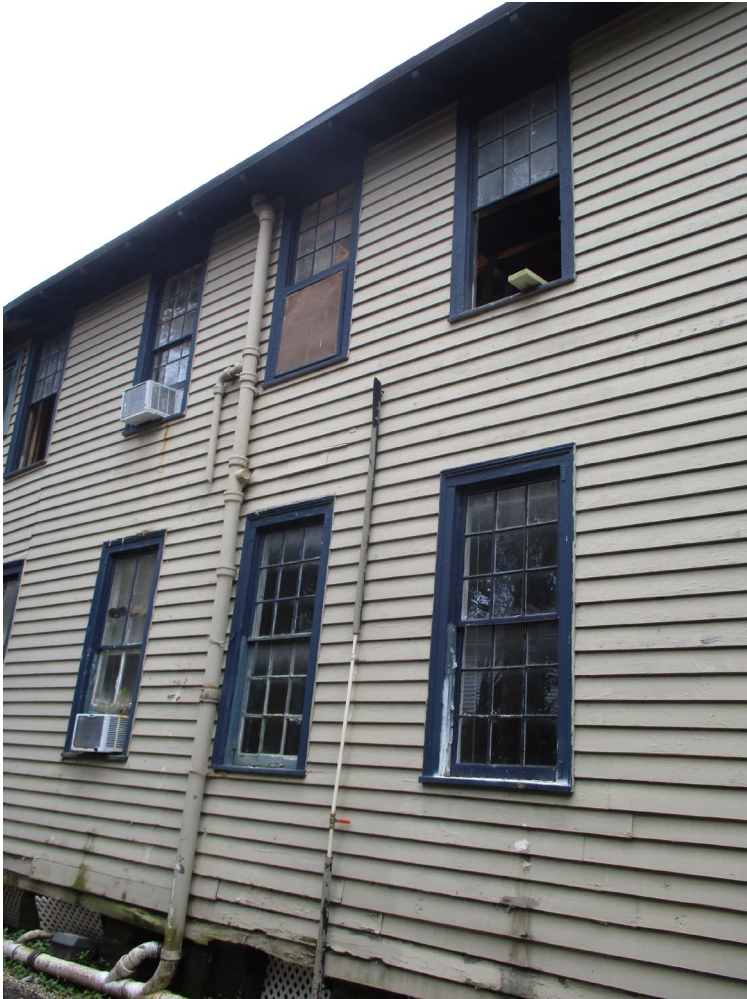
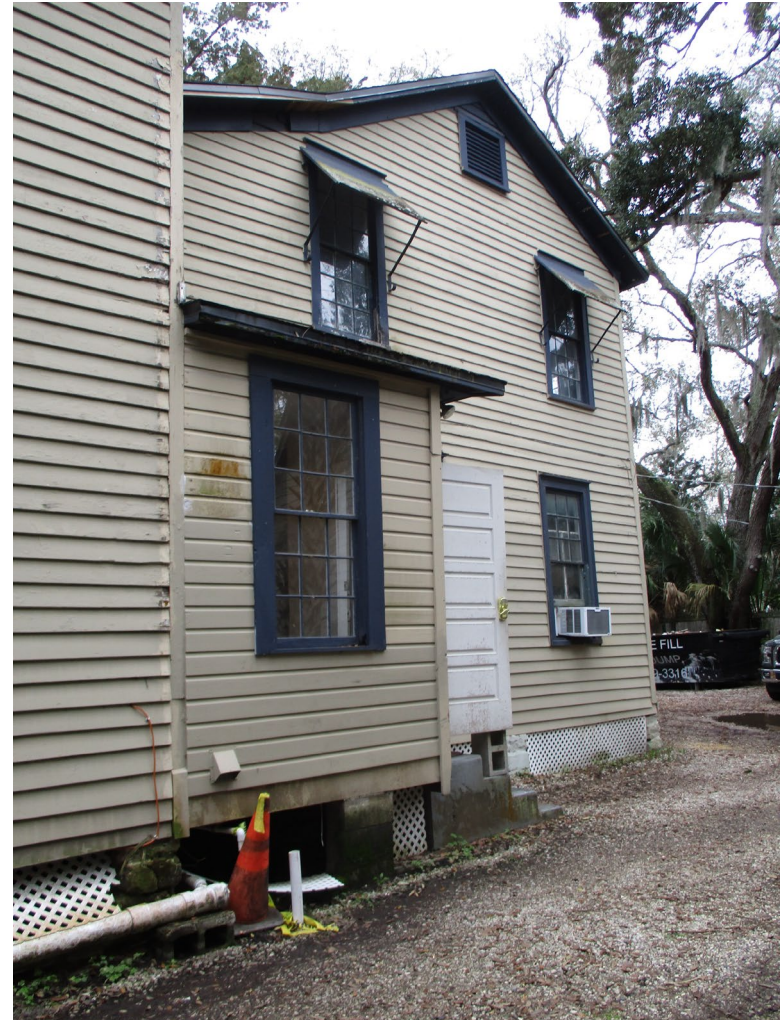
North Elevation, toward rear:  
different wood siding and windows visible

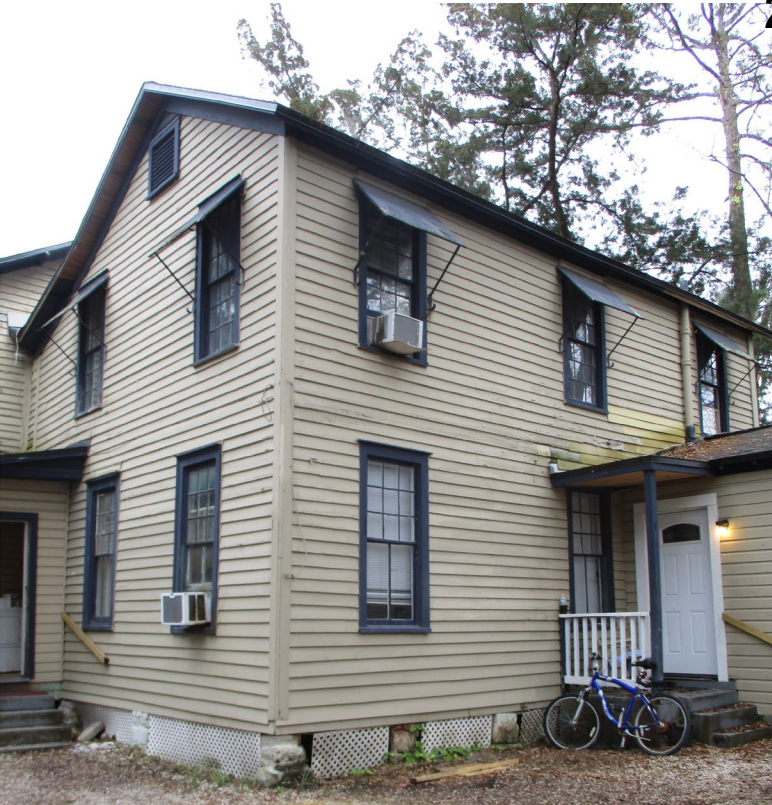
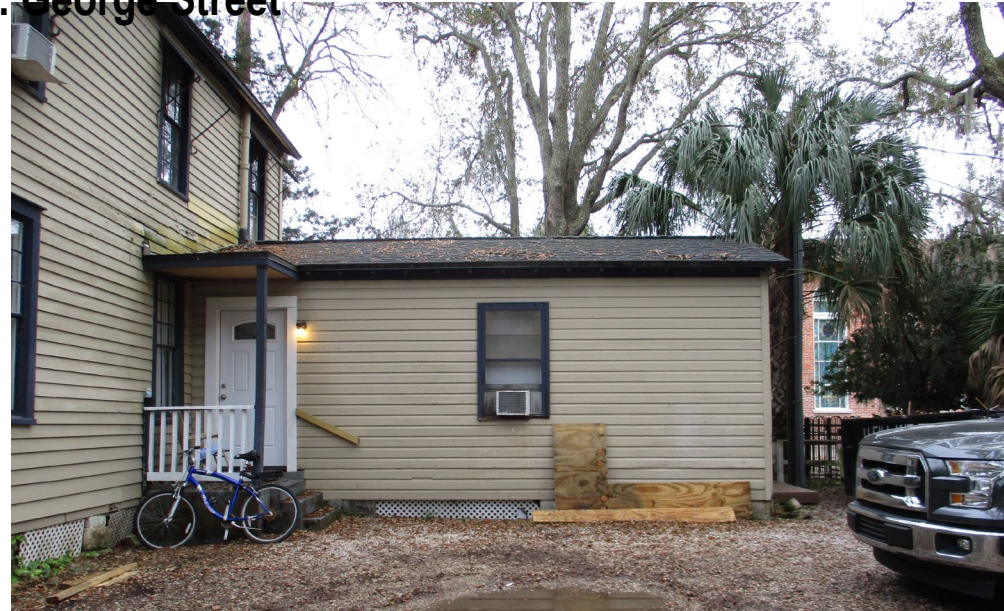
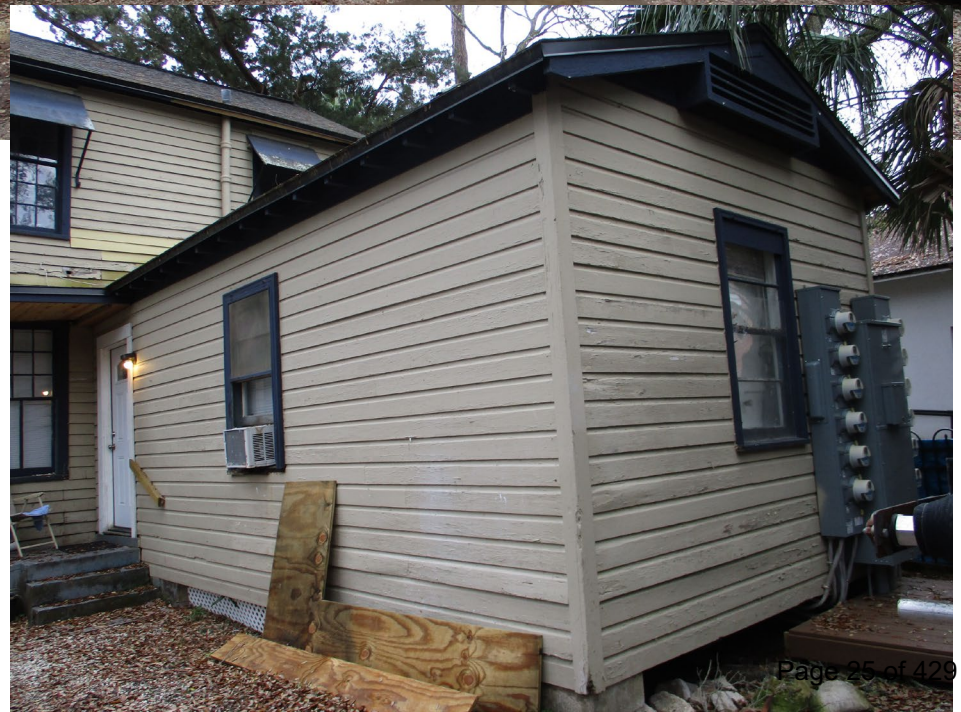
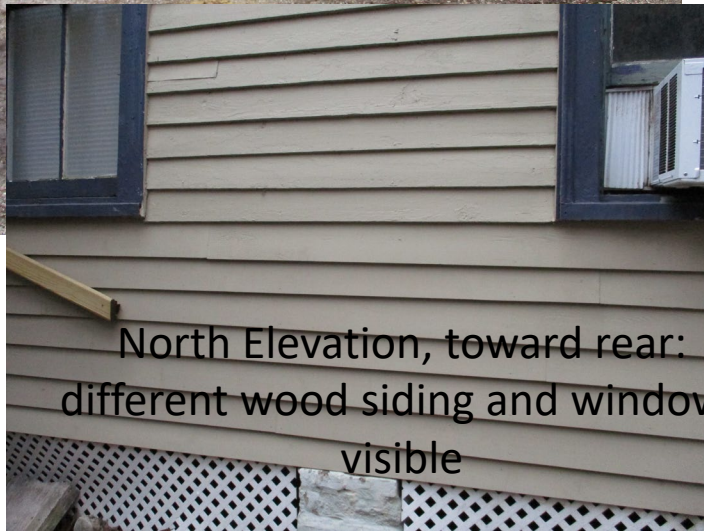
North Elevation, toward rear:  
different wood siding and windows  
visible

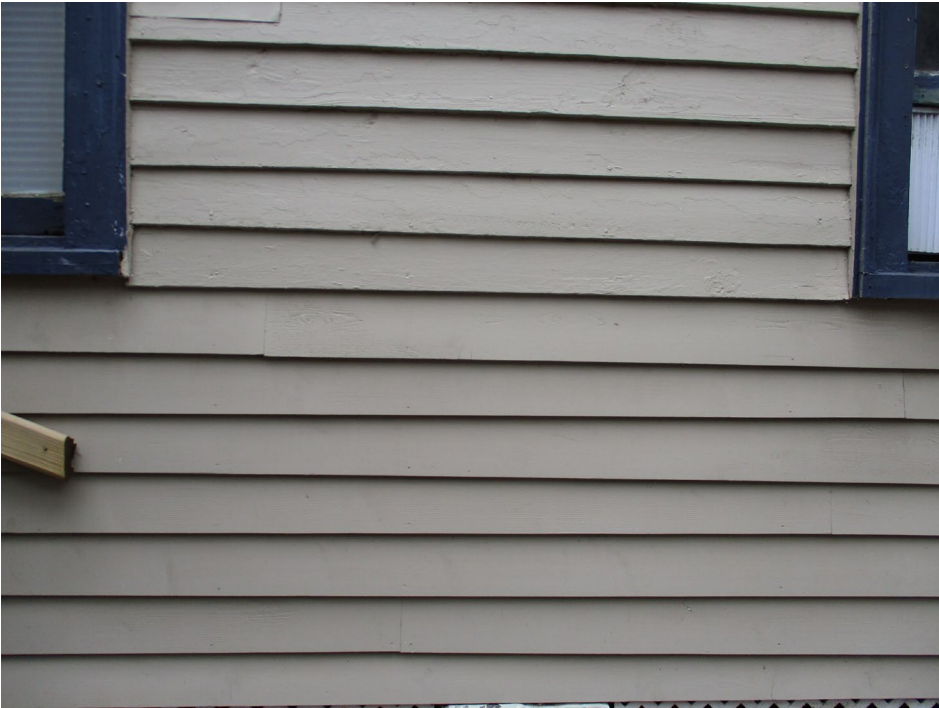
North Elevation:  
different wood siding visible

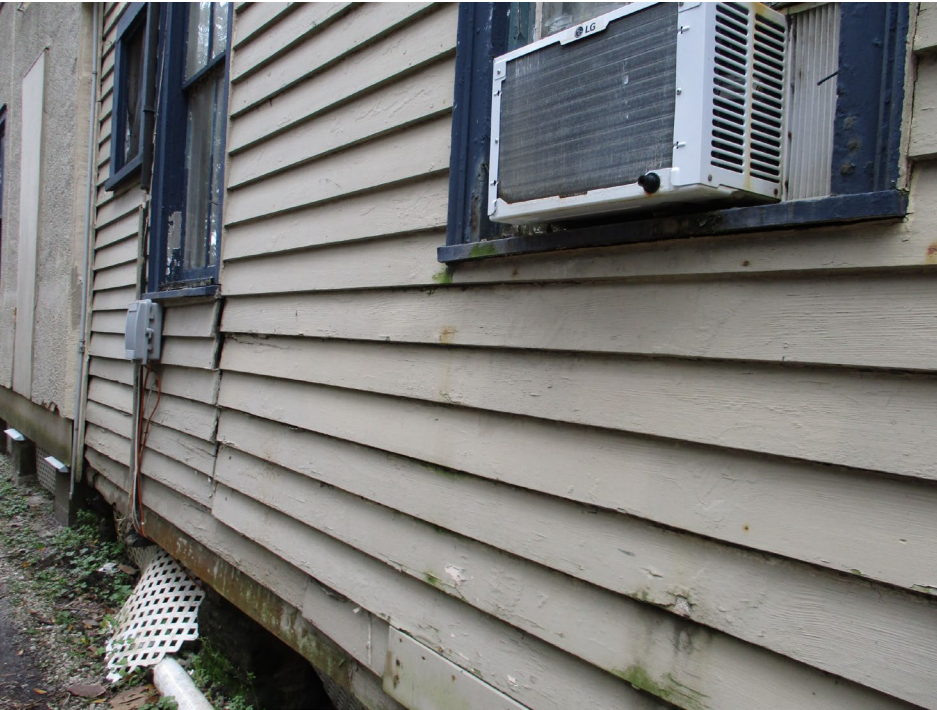
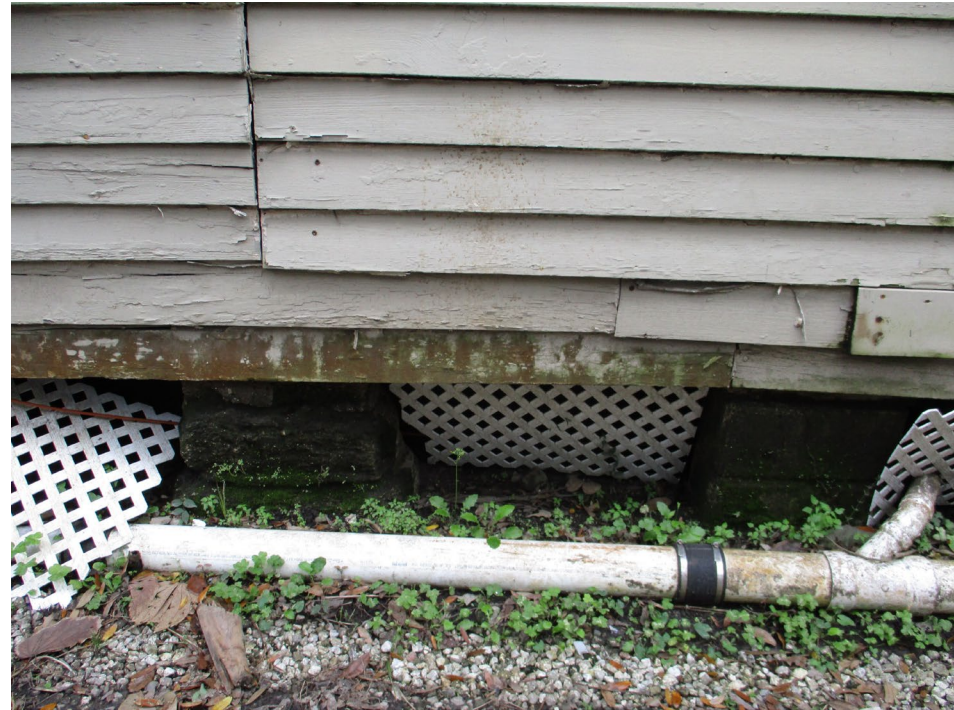
North Elevation: wood siding

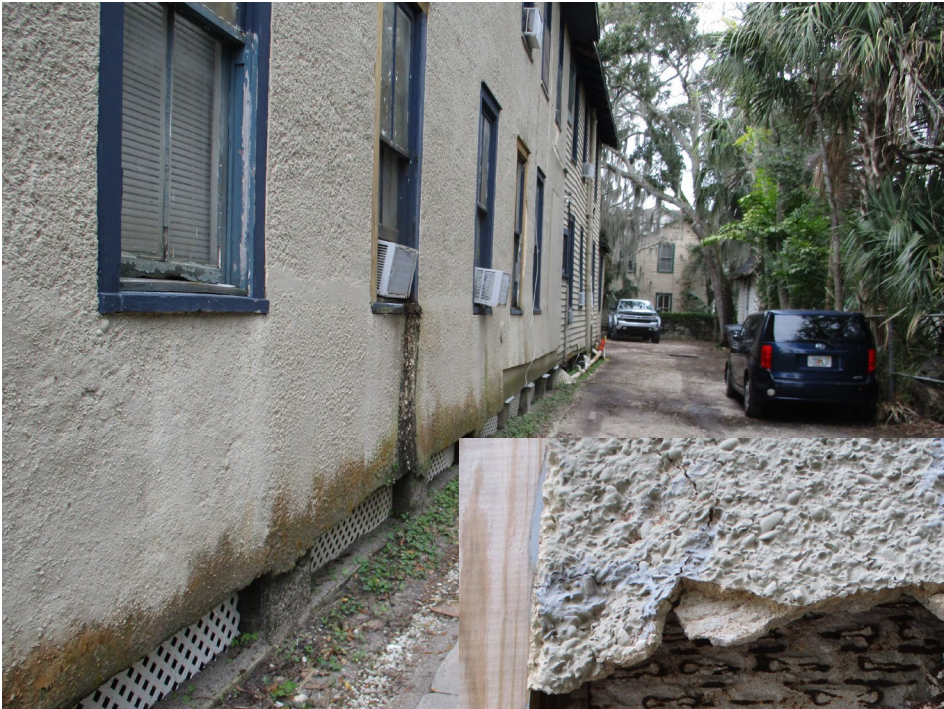
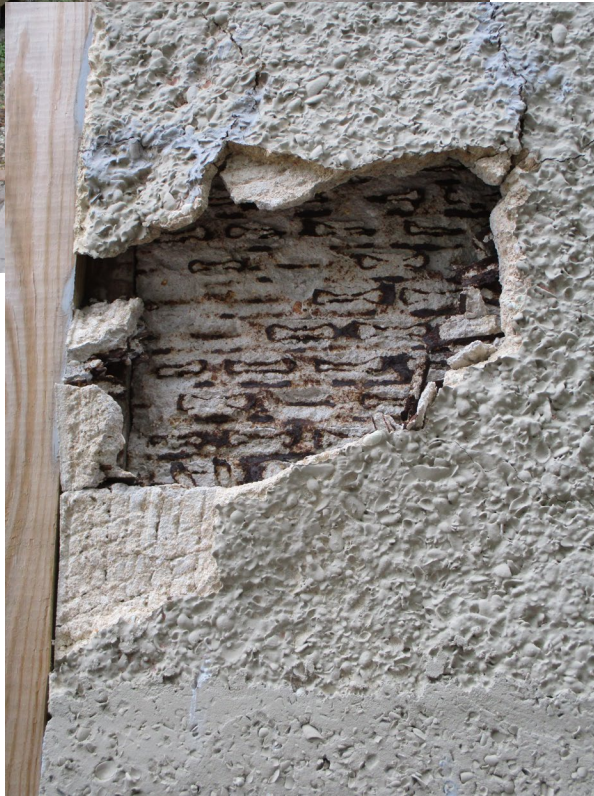
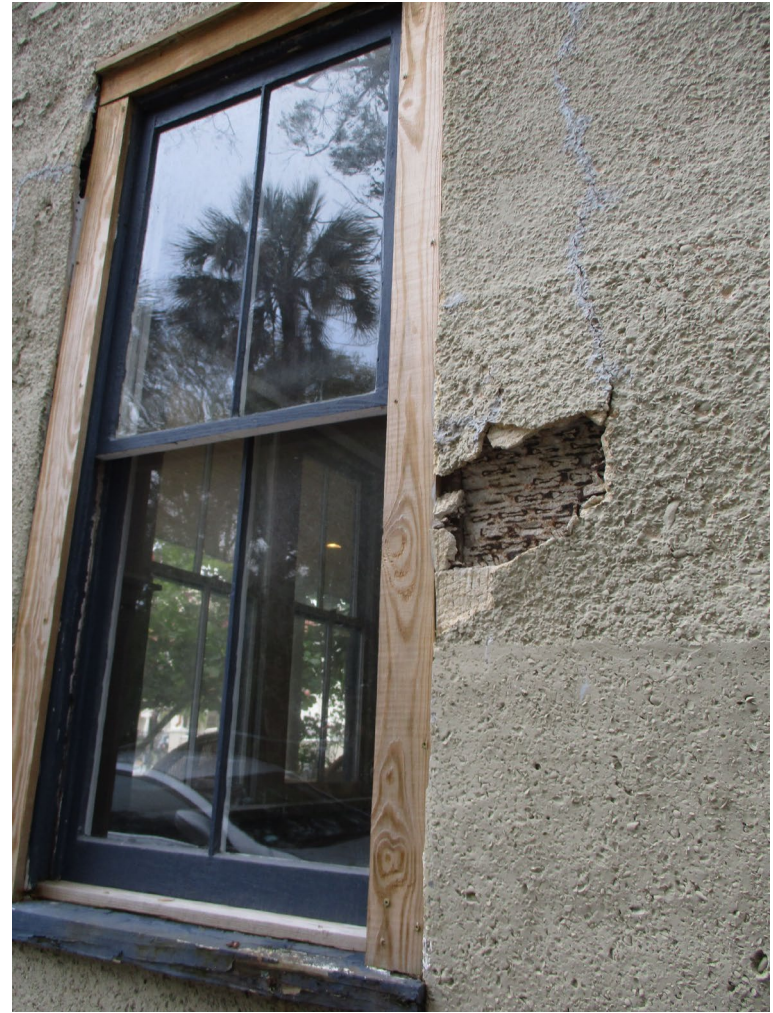
North Elevation: plaster

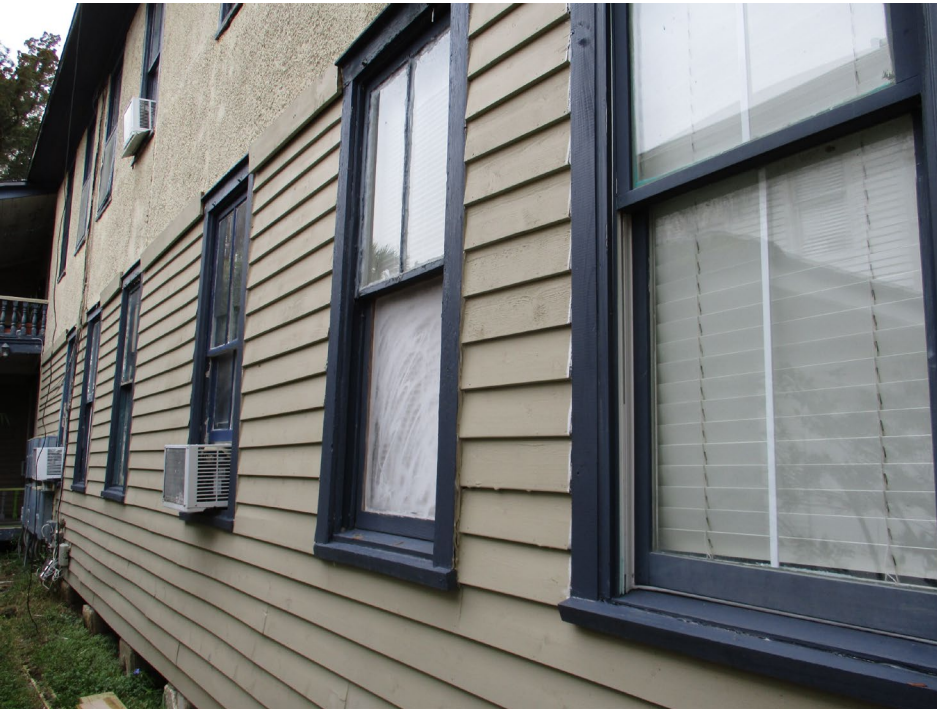
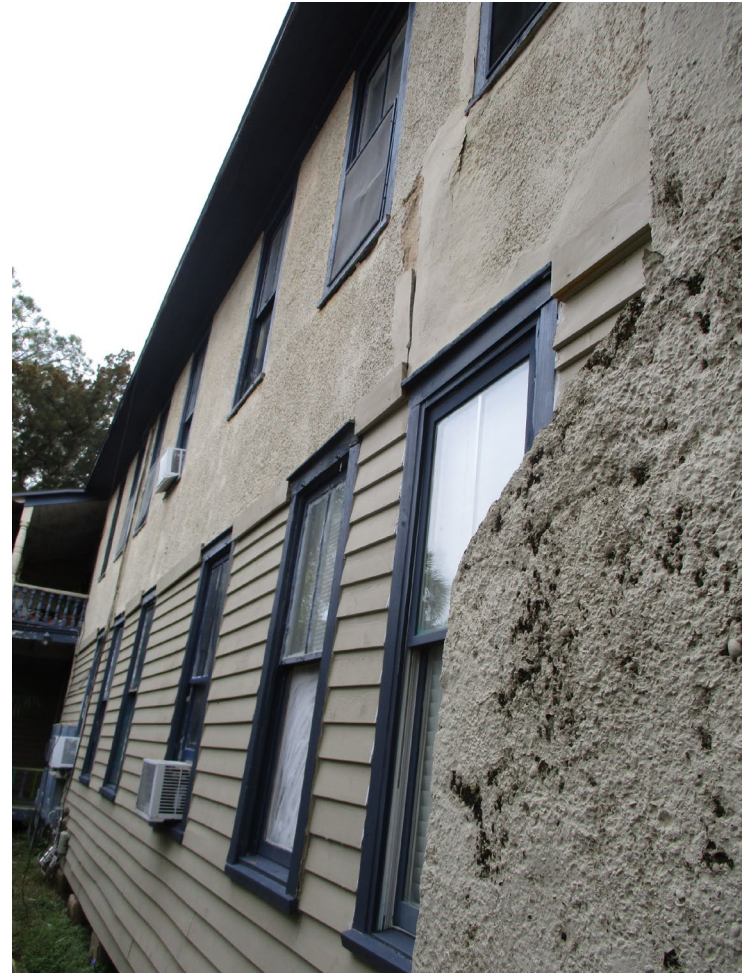
South Elevation: East of remaining original side porch

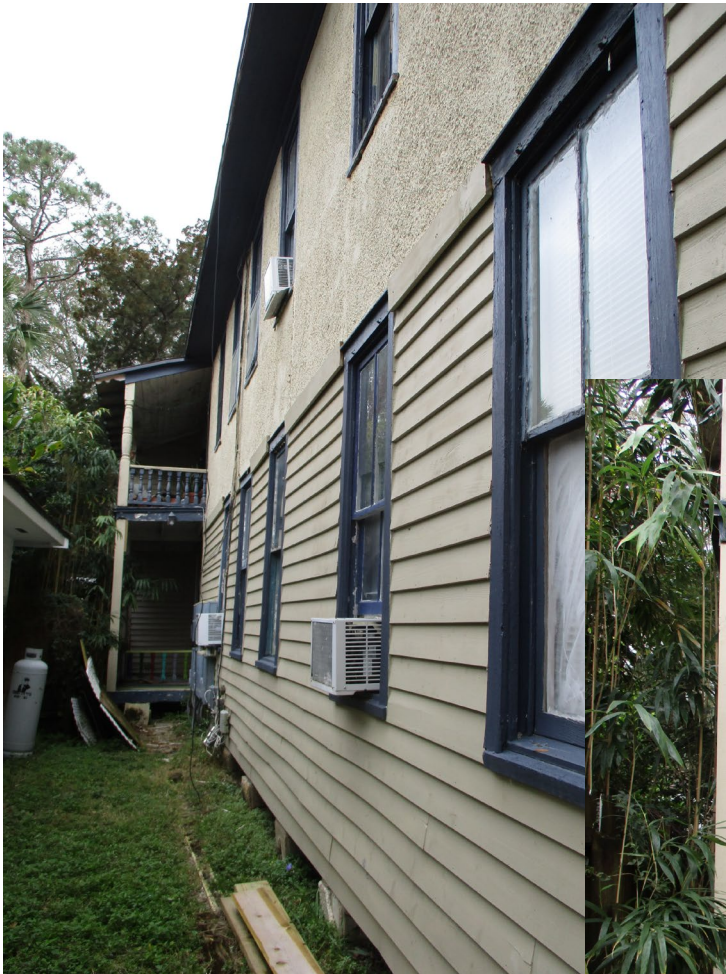
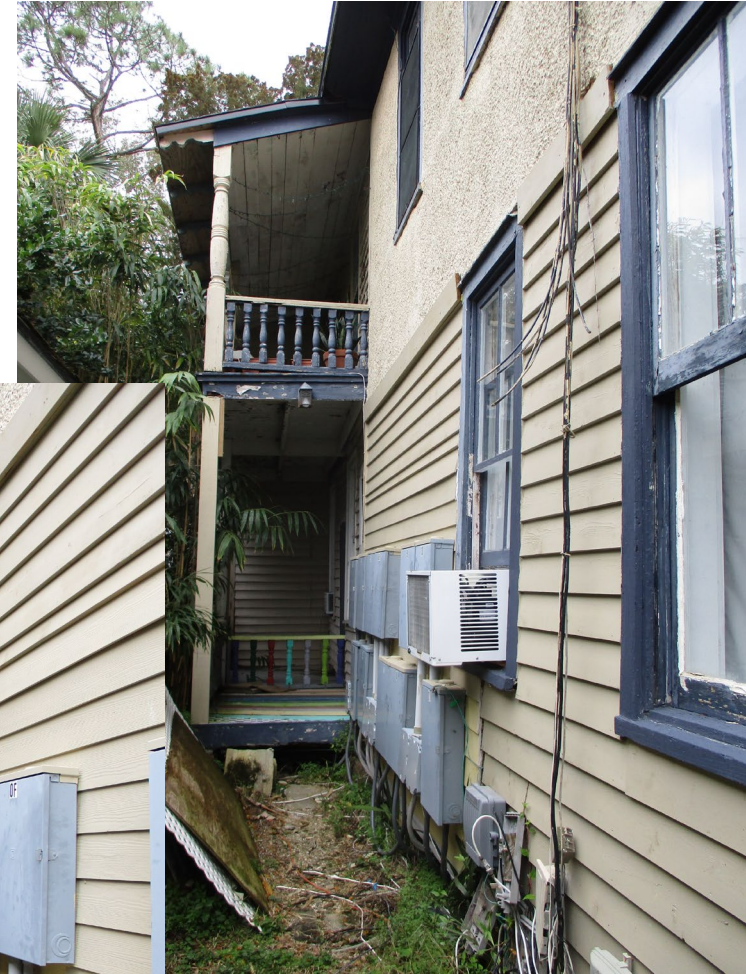
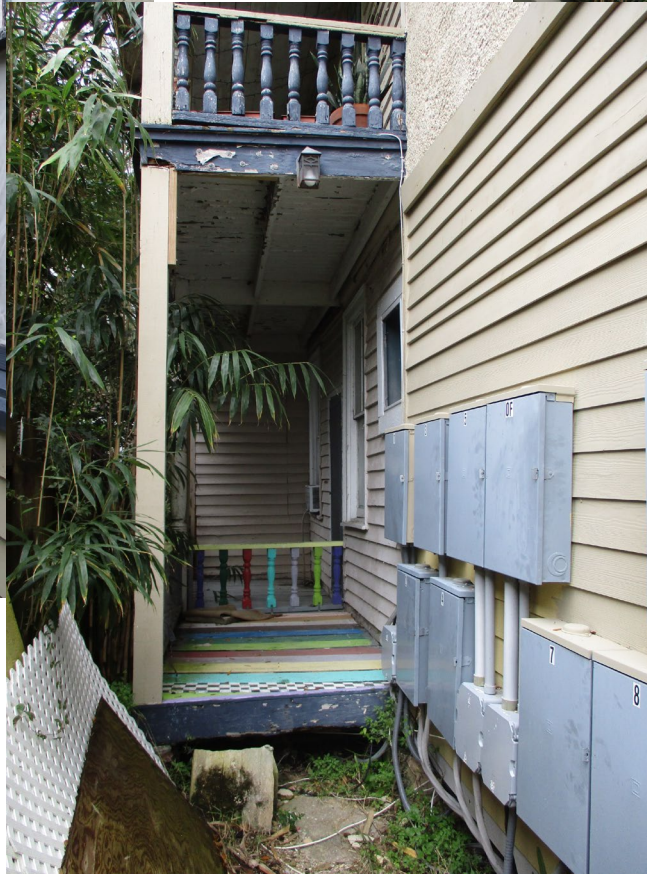
South Elevation: East of remaining original side porch

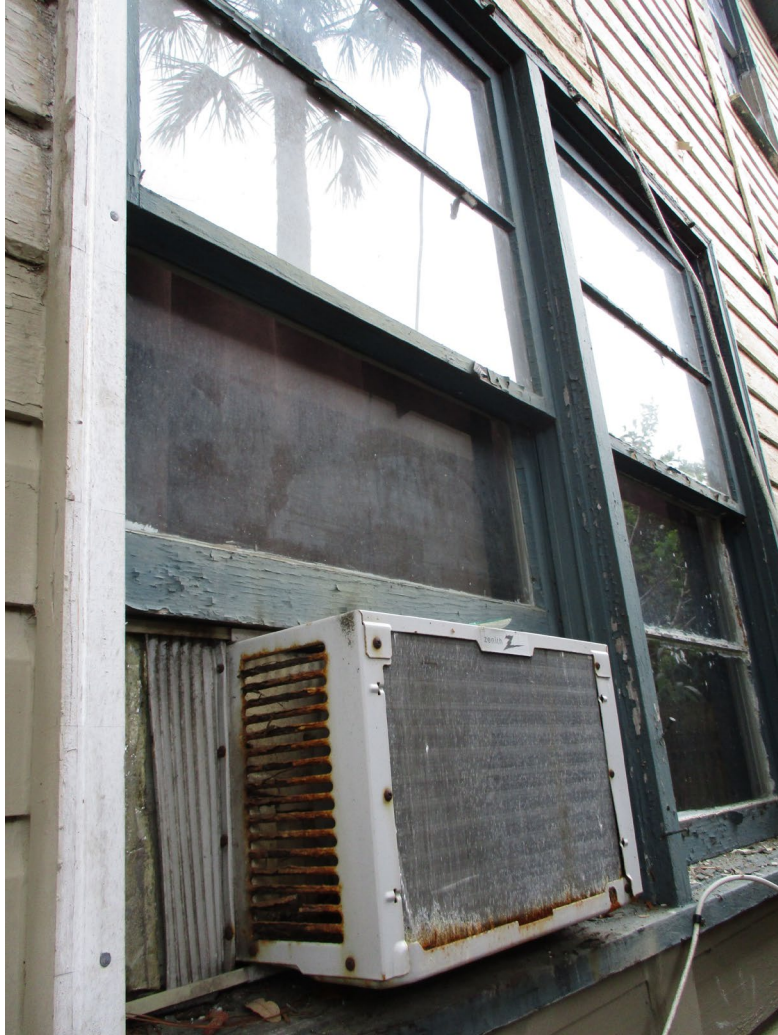
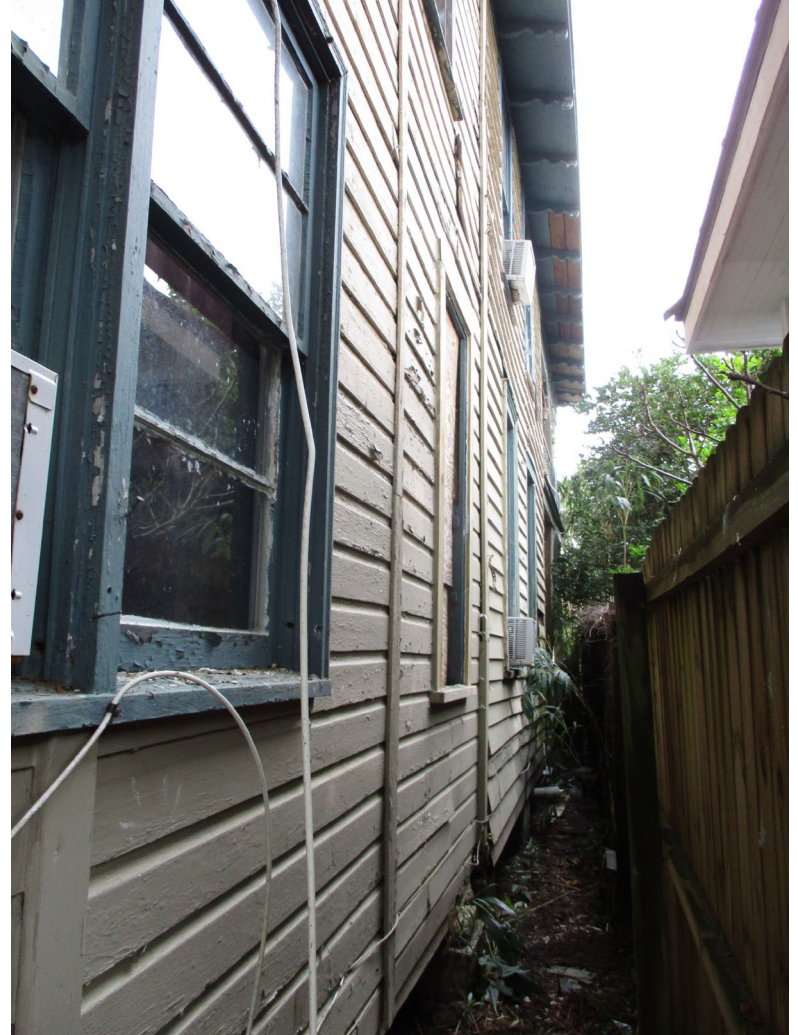
South Elevation: west of remaining original side porch

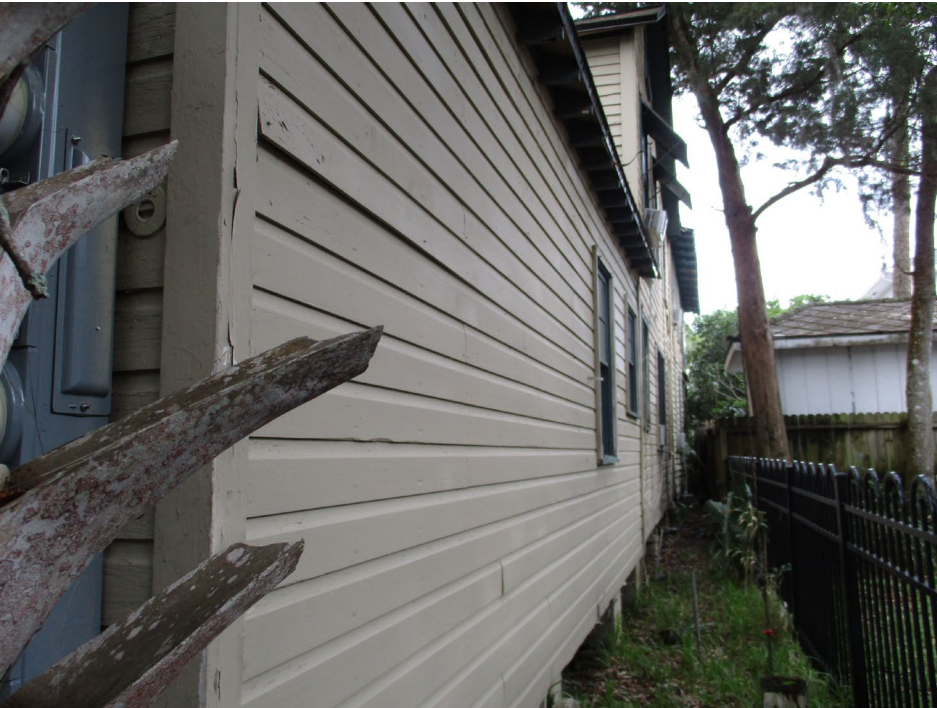
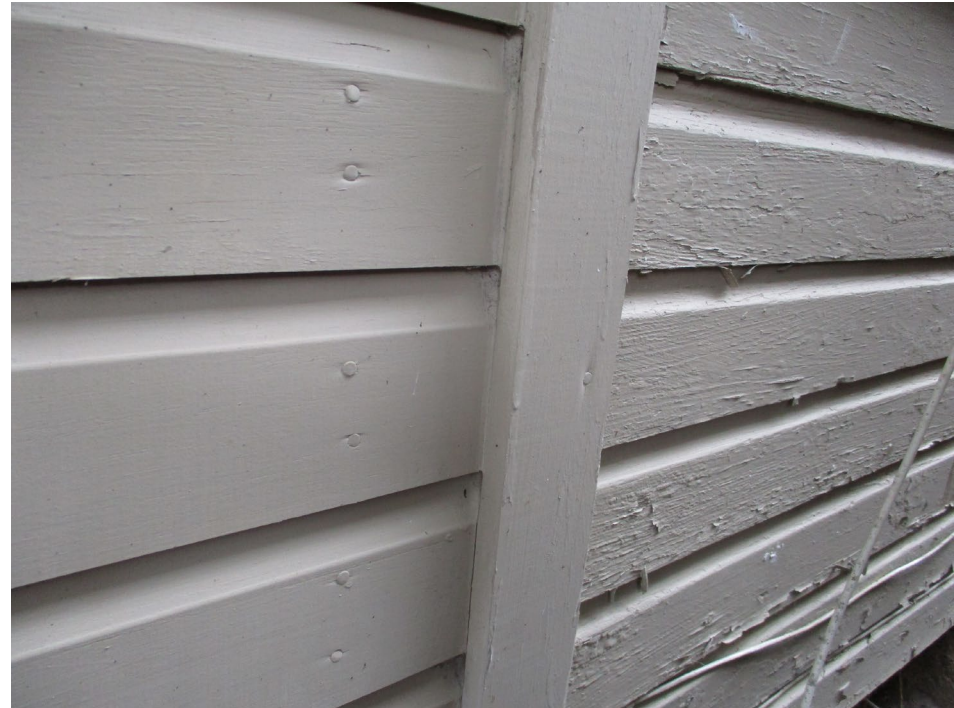
South Elevation: west of remaining original side porch with different wood siding visible

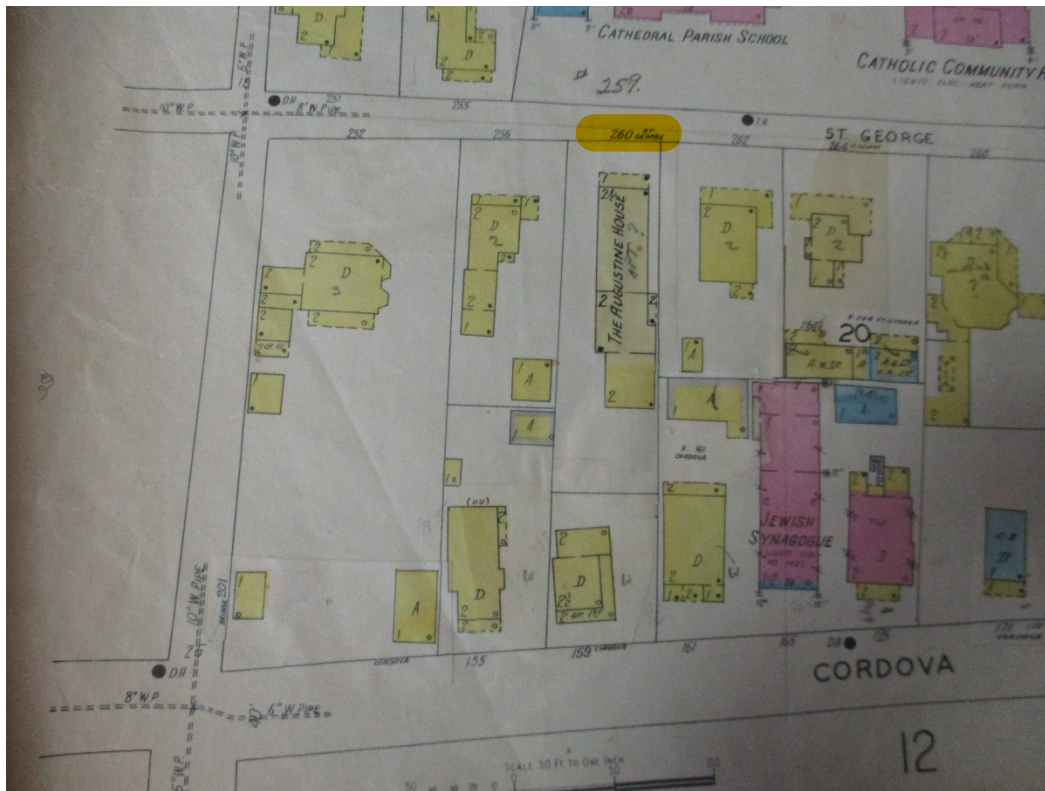
**1930 Sanborn Map, revised to 1957**

Sanborn Map research from the first available publication of 1884 shows how the front of the building was immediately adjacent to St. George Street. By 1899, the rear portion of the structure slightly changed with its configuration of from the hyphen to the rear wing attachments and then stayed much the same through 1917. On the 1924 Sanborn and through the 1930 revised to 1947 map, the building's rear attachments are altered, possibly combined or replaced, into what is now a visibly elongated structure, which also incorporates the original front block of the building after it was moved back, with a portion of the original wrapped front porch visible on the south side. A one-story porch extends across the front façade, which is set back from the street. By the 1957 revised map, the rearmost wing, rear porch, and detached garage have been removed

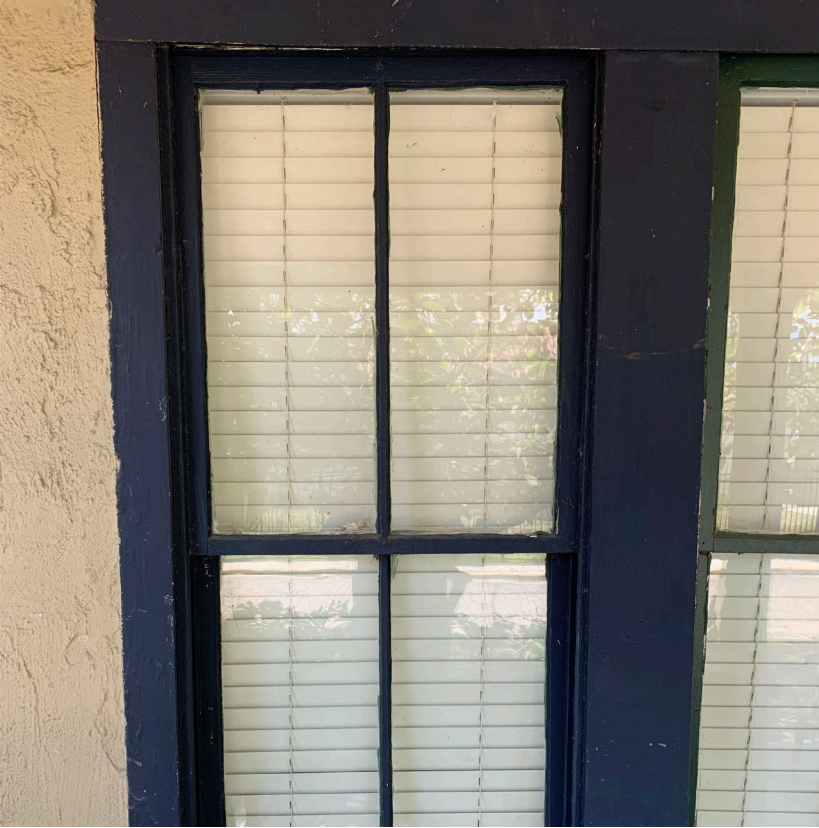
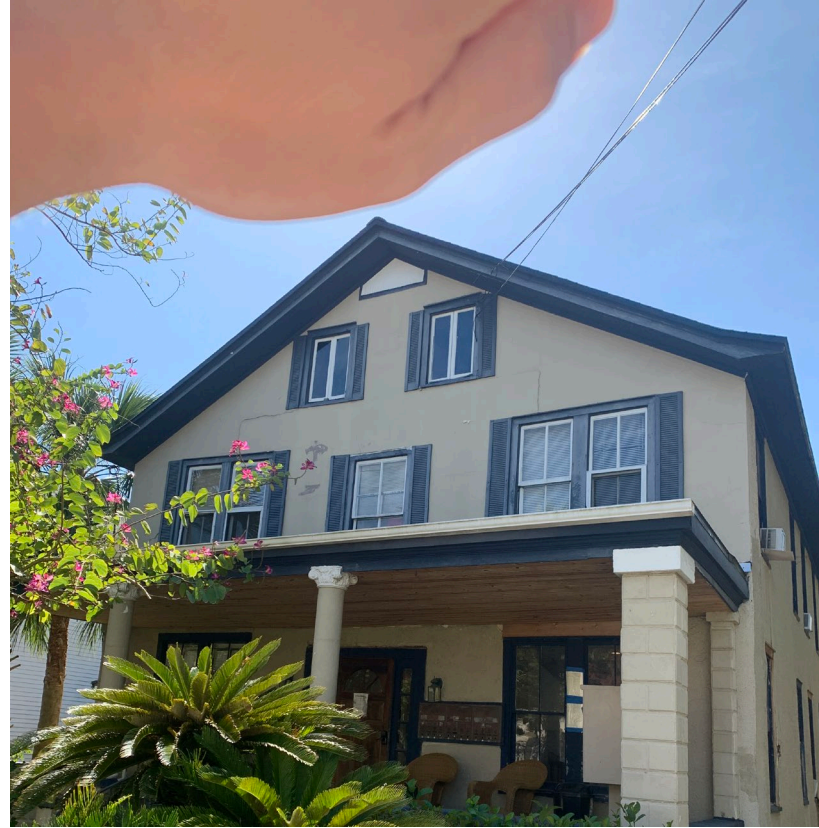
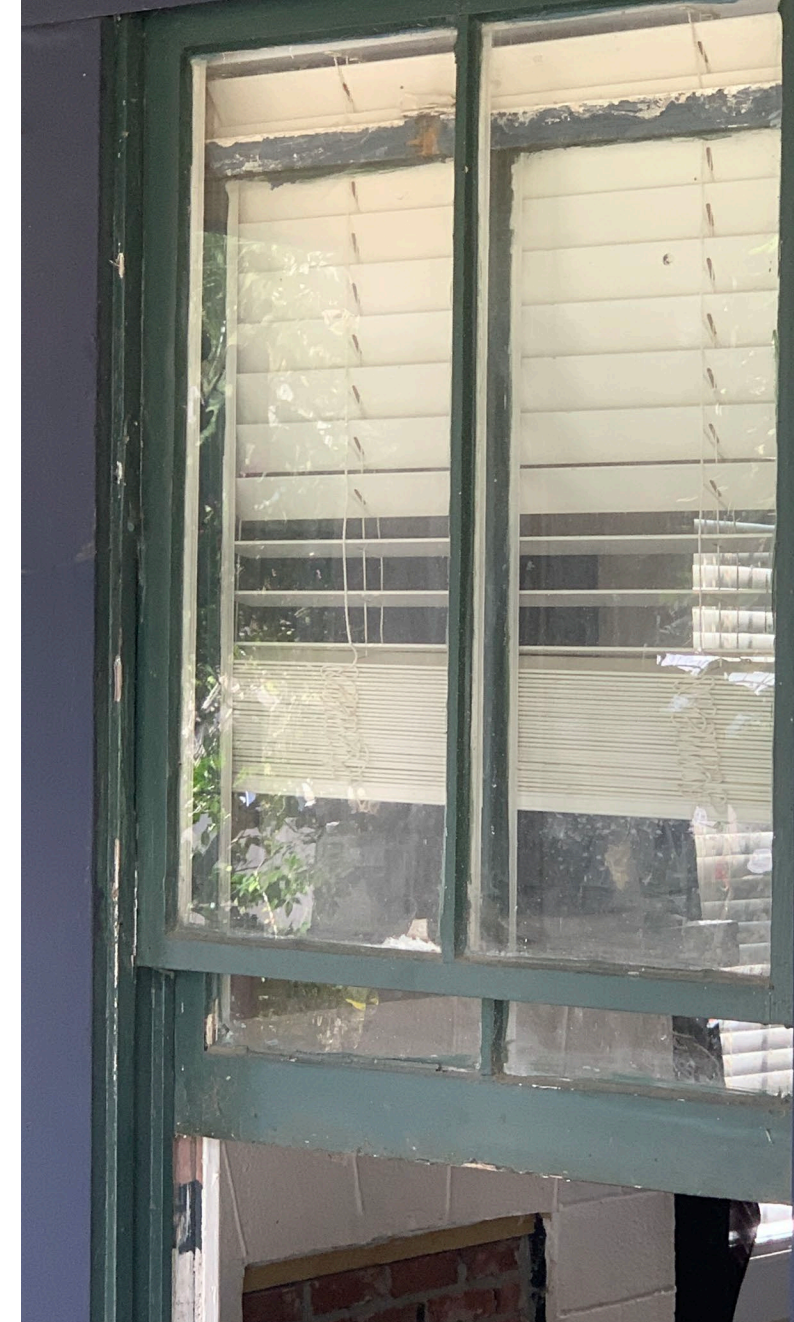
## Windows Being Restored

- All 9 of the windows on the first two levels of the front elevation of the property and 55 feet back on either side are wood sash, 2 over 2 double hung windows that do have a counter balance system. They appear to be in salvageable condition and will be retained and preserved under my proposed renovations along with the attic windows

- I am proposing to retain and restore all of the windows on the side of the property fronting onto St. George St. and all of the windows 60 feet back on each side (north & south) of the building. This includes all of the windows within the 1920s addition located at the front of the property and 3 fixed 9 light windows that are in the original structure. Additionally, I am proposing to preserve the attic dormer windows. Due to the building sitting so close to the property line and taking up the majority of the property; these are the only windows that you can really see when passing along St. George St.
