**CITY OF ST. AUGUSTINE HISTORIC ARCHITECTURAL REVIEW BOARD**

**A G E N D A - AMENDED\***

**THURSDAY, APRIL 15, 2021 - 1:00 PM**

**CITY OF ST. AUGUSTINE HISTORIC ARCHITECTURAL REVIEW BOARD  
STAFF REPORT AND RECOMMENDATION  
Prepared for April 15, 2021 Meeting**

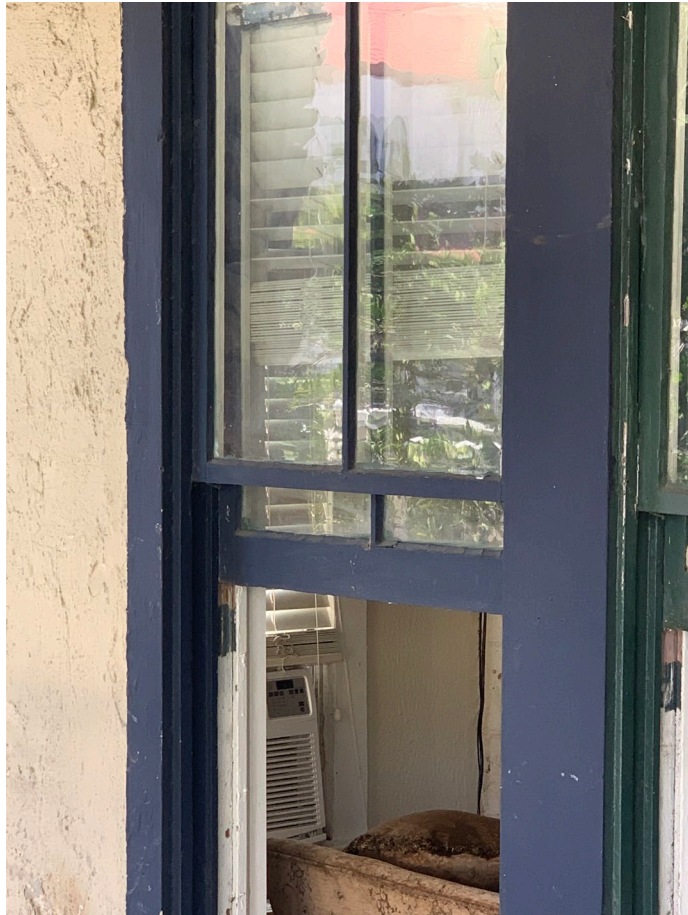
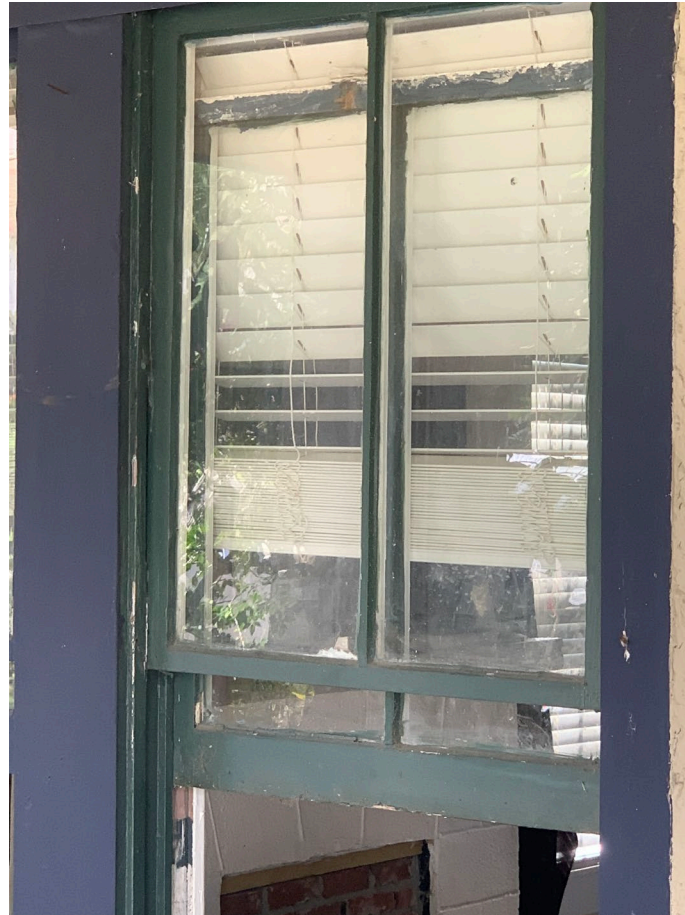
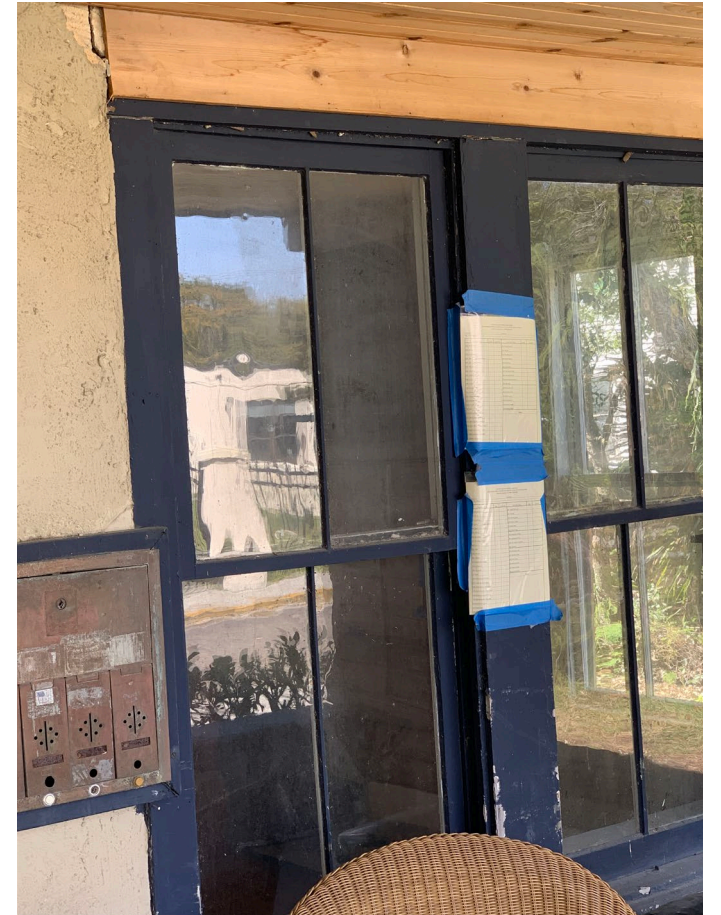
# Front Elevation Windows

- All 9 of the windows on the first two levels of the front elevation of the property and 55 feet back on either side are wood sash, 2 over 2 double hung windows that do have a counter balance system. They appear to be in salvageable condition and will be retained and preserved under my proposed renovations along with the attic windows

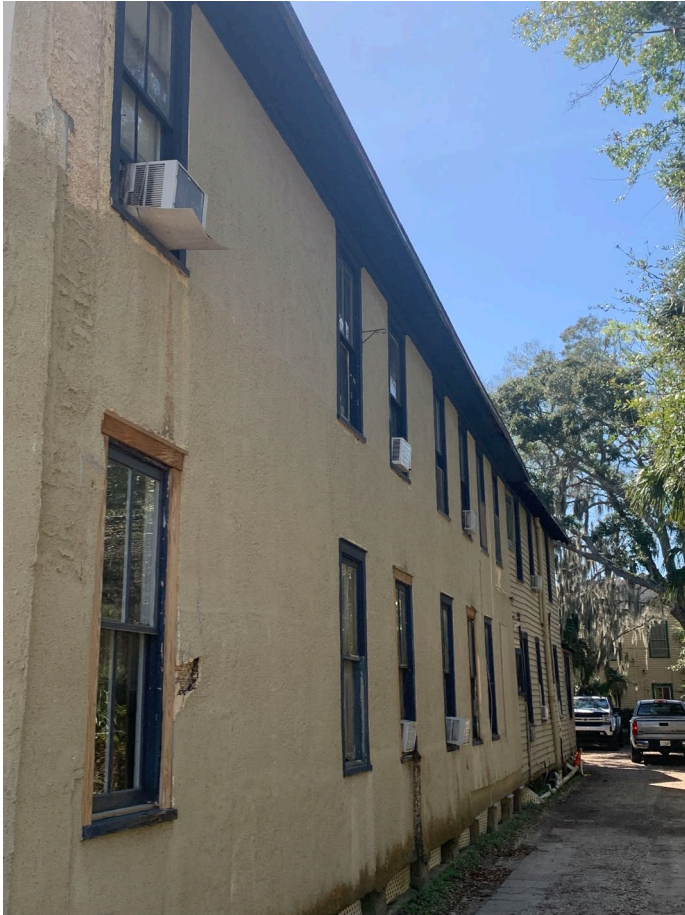
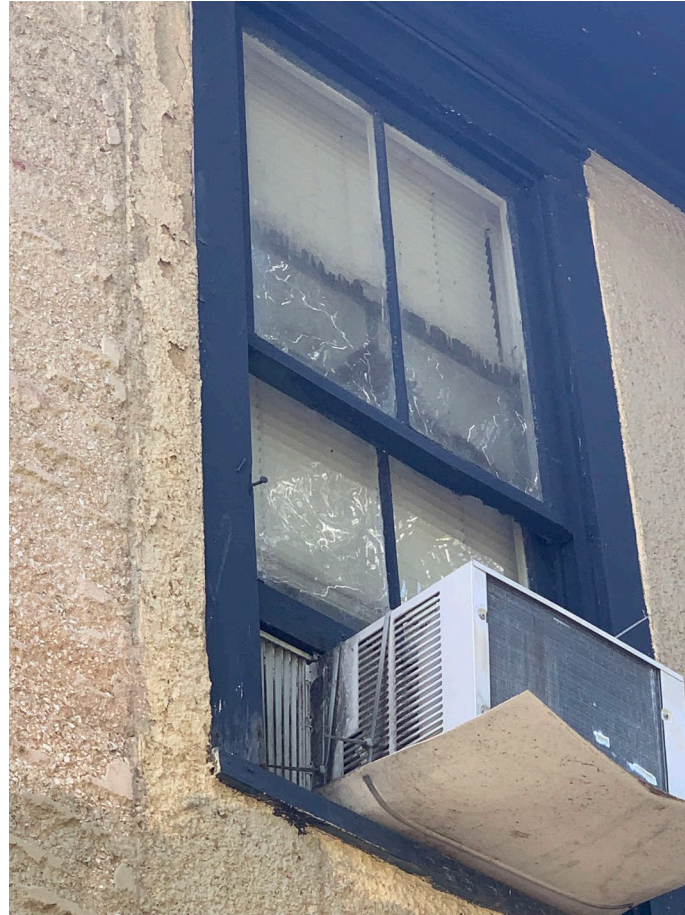
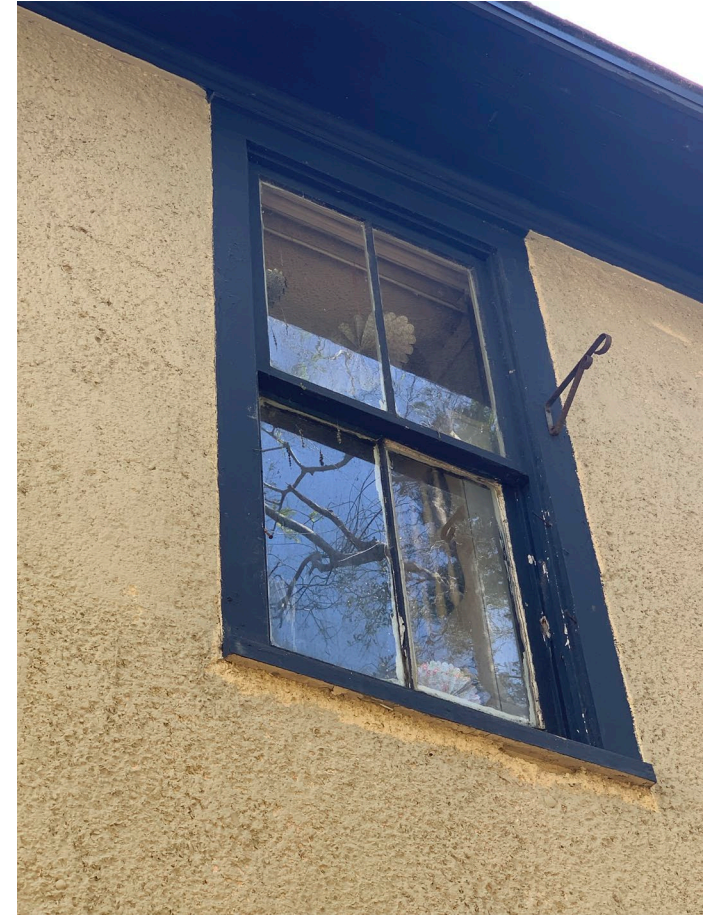
# Windows North Elevation Stucco Portion Upper Level

- I am proposing/requesting to replace the remaining windows with the exception of the 9 over 9 window on the small one story section where the side entry door is along the north/driveway side and one window that is located on the second floor on the far east side of the south facing gable section. These are the only two windows that are not in living spaces that are tenant occupied. None of the windows that are in any section of the building other than the 1920s addition that makes up the front 55 feet of the property were built with counter balances.

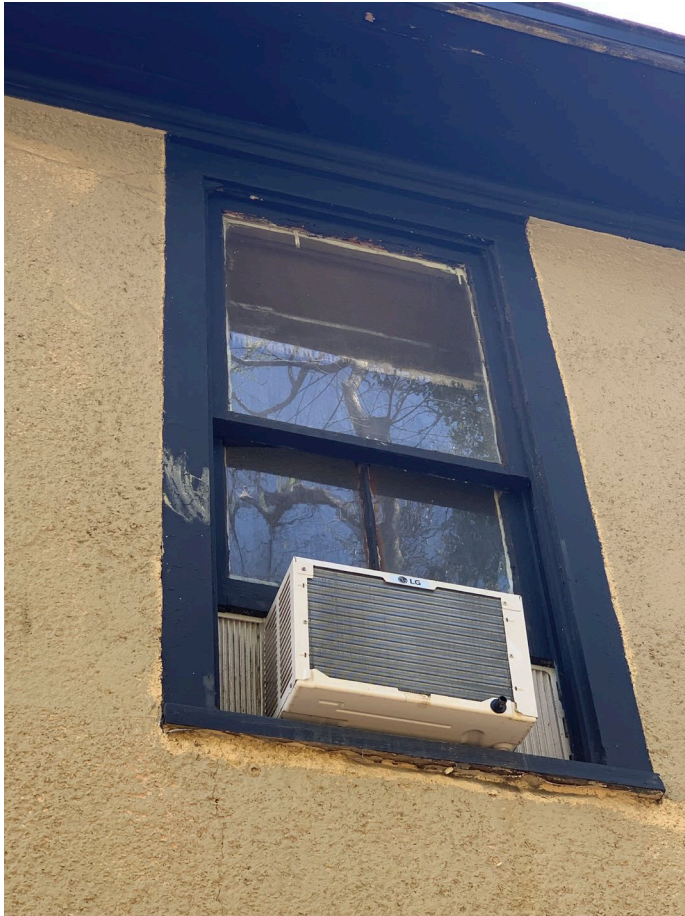
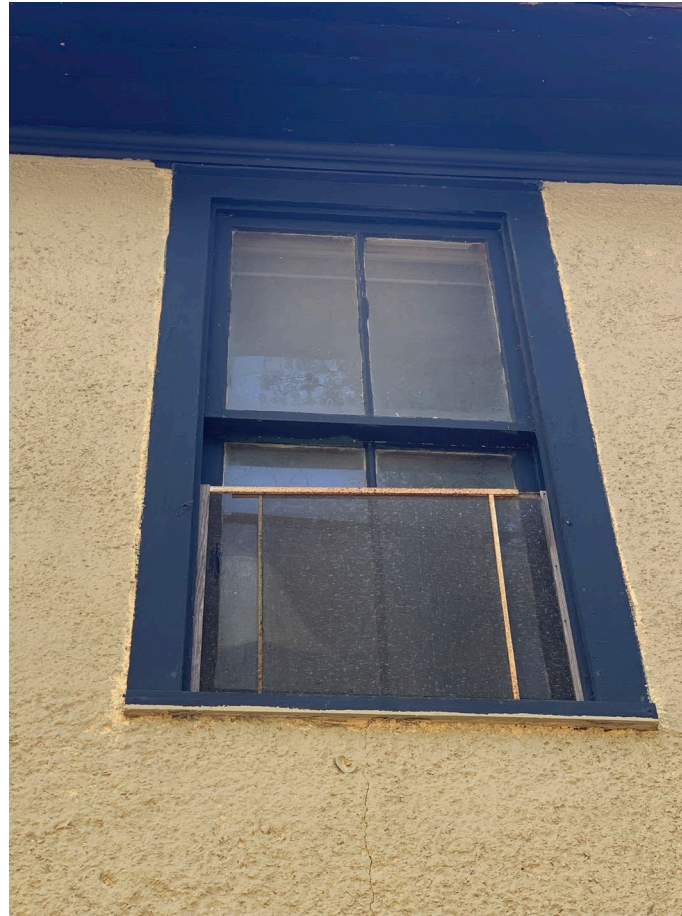
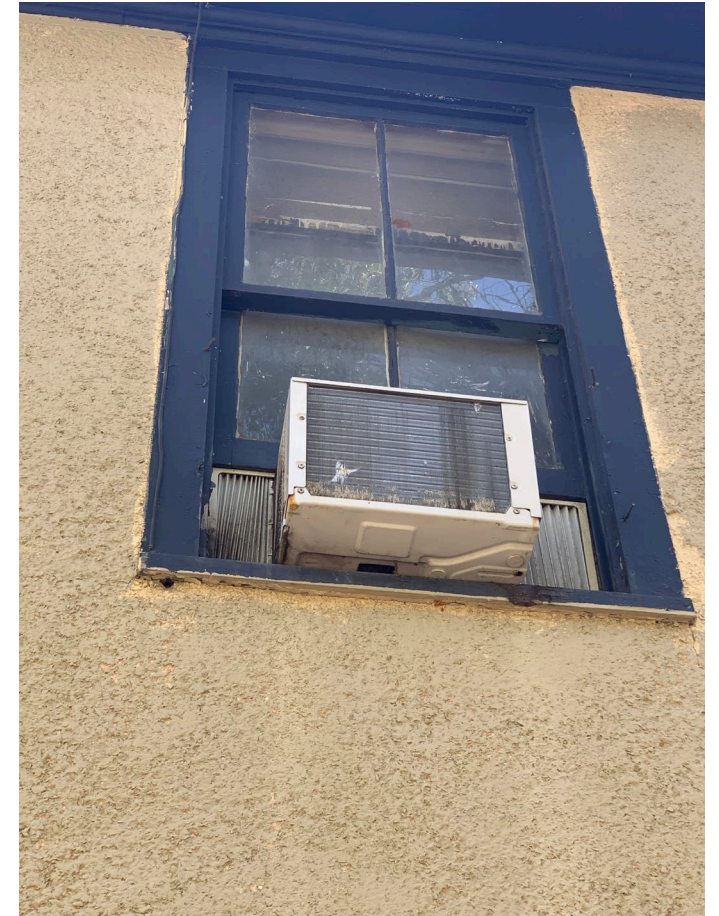
# Windows North Elevation Stucco Portion Cont. Upper Level

The 3<sup>rd</sup> window from the front is missing the center grille

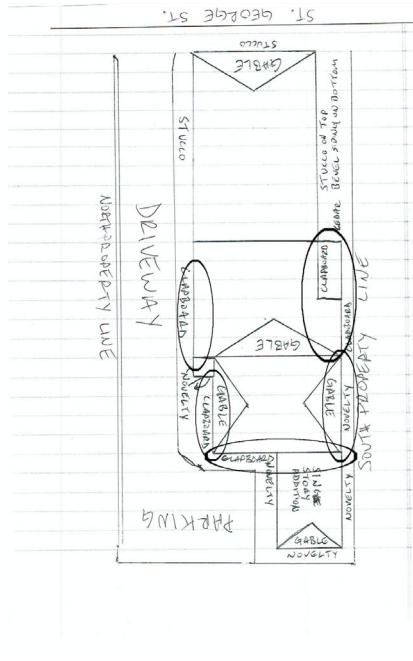
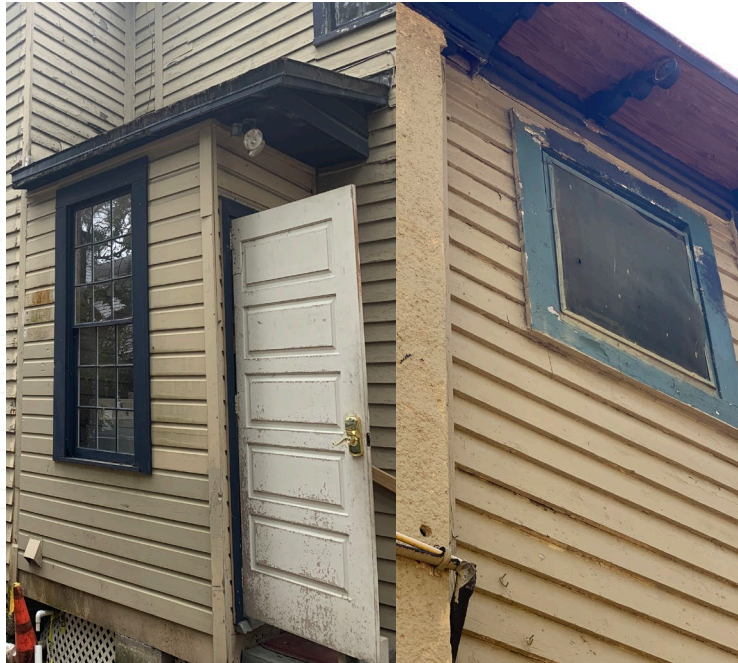
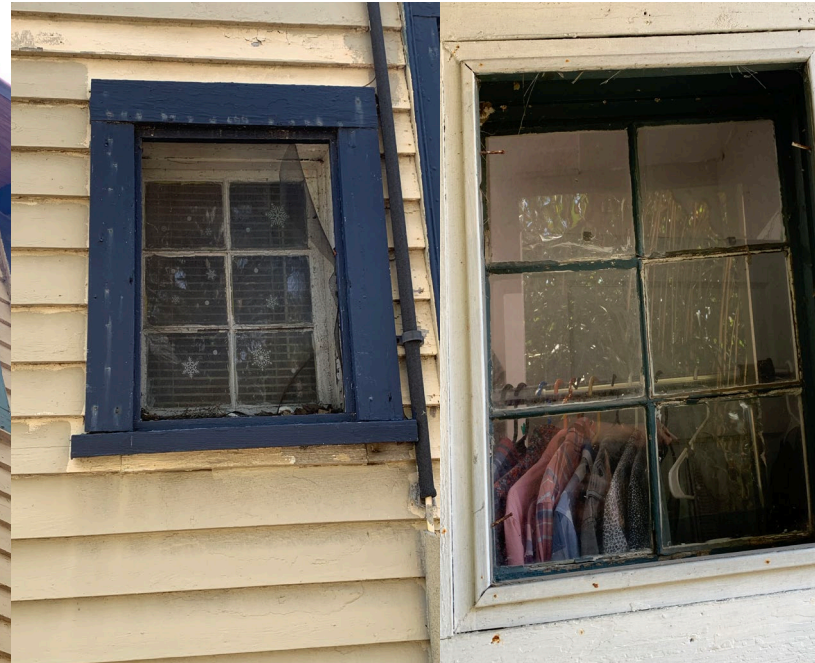
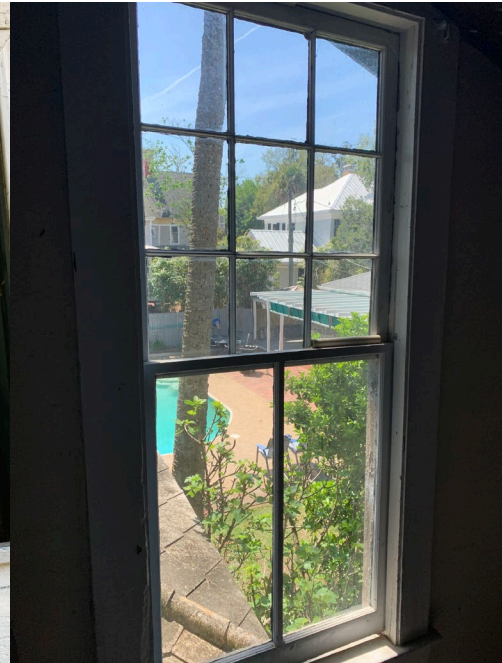
# Windows Continued Two Story Wood Sided Section

- I am proposing to replace the windows in the two story wood sided portions of the building with all wood, raised mutton, 9 over 9 windows to match what appears to have been original to the building and make up the majority of what still exist in this section of the building. I am proposing to keep and restore the two fixed 6 light windows at the front of the clapboard section just behind the 1920s stucco addition, the fixed 6 light window on the 1<sup>st</sup> floor porch on the southern side of the property, the 9 over 9 on the single story, novelty sided side entrance and the eastern most 9 over 9 window on the second floor of the novelty sided gable section of the south facing side of the building. These five windows are either fixed light or not located in living spaces within the property.

|---Proposing to Keep---|

Keep & replace  
Bottom sash with  
9 light from other  
Removed window

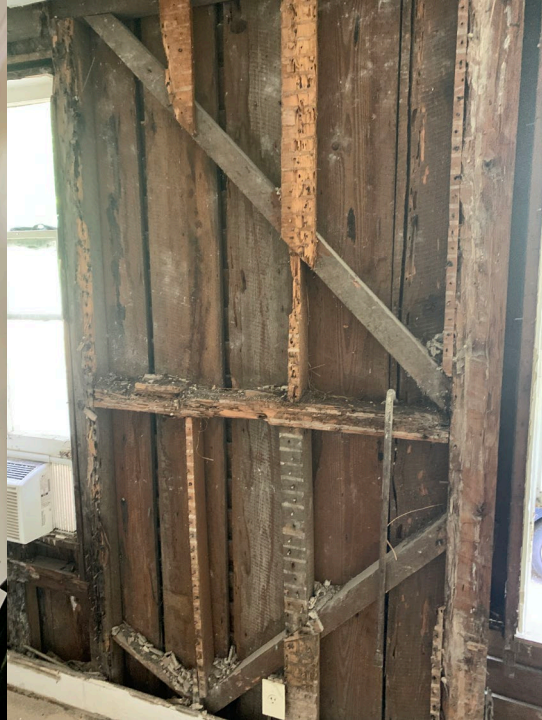
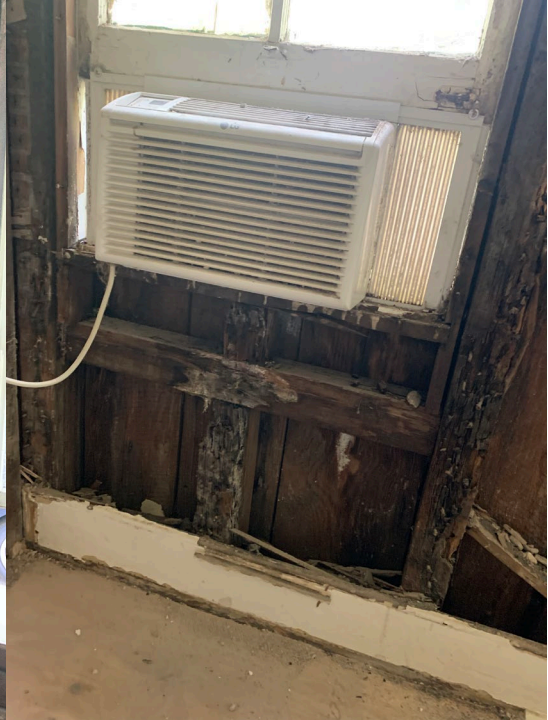
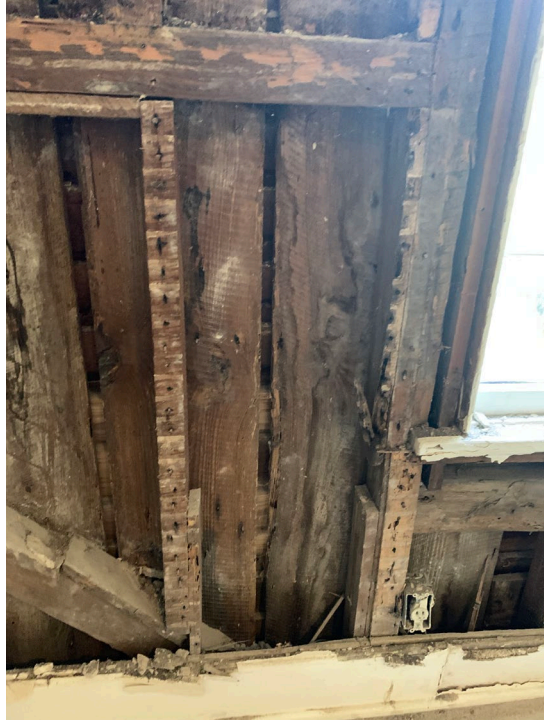
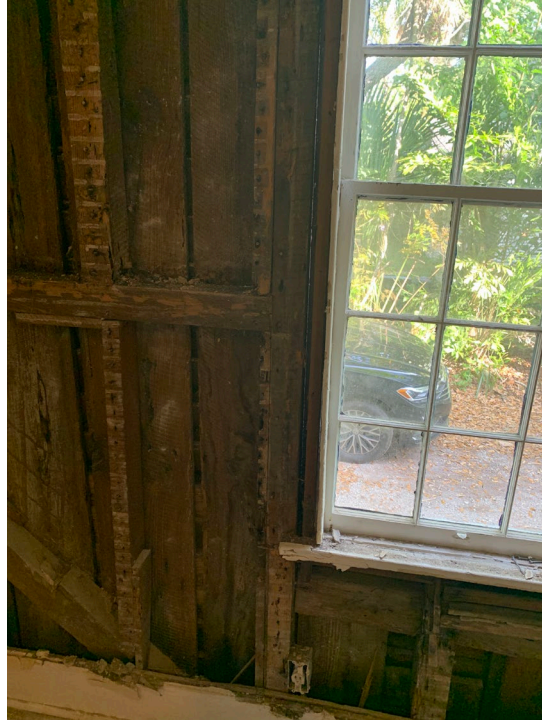
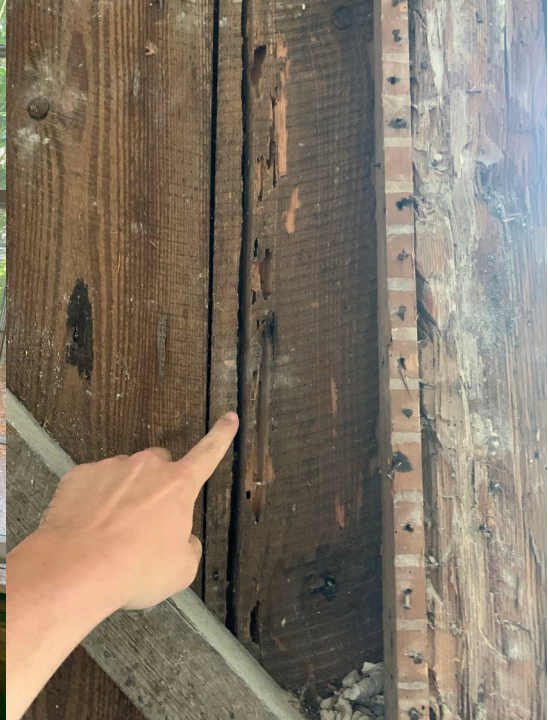
# Windows Cont. - Interior framing and sheathing

- The pictures attached are from the inside of the clapboard sided structure on the northern elevation just to the east of the side entry door along the driveway. These photos show both the condition of the framing members and wall sheathing behind the siding as well as the framing butted directly up to the window. When framing this building, they did not allow for a cavity between the window and framing to add weights and pulleys.
- Due to the building being tenant occupied and the framing being so close to the window that it doesn't allow for weights, ropes and pulleys; I feel as though the only reasonable option is to replace the windows on the rear two story clapboard sections, novelty sided sections and the rear one story novelty sided addition

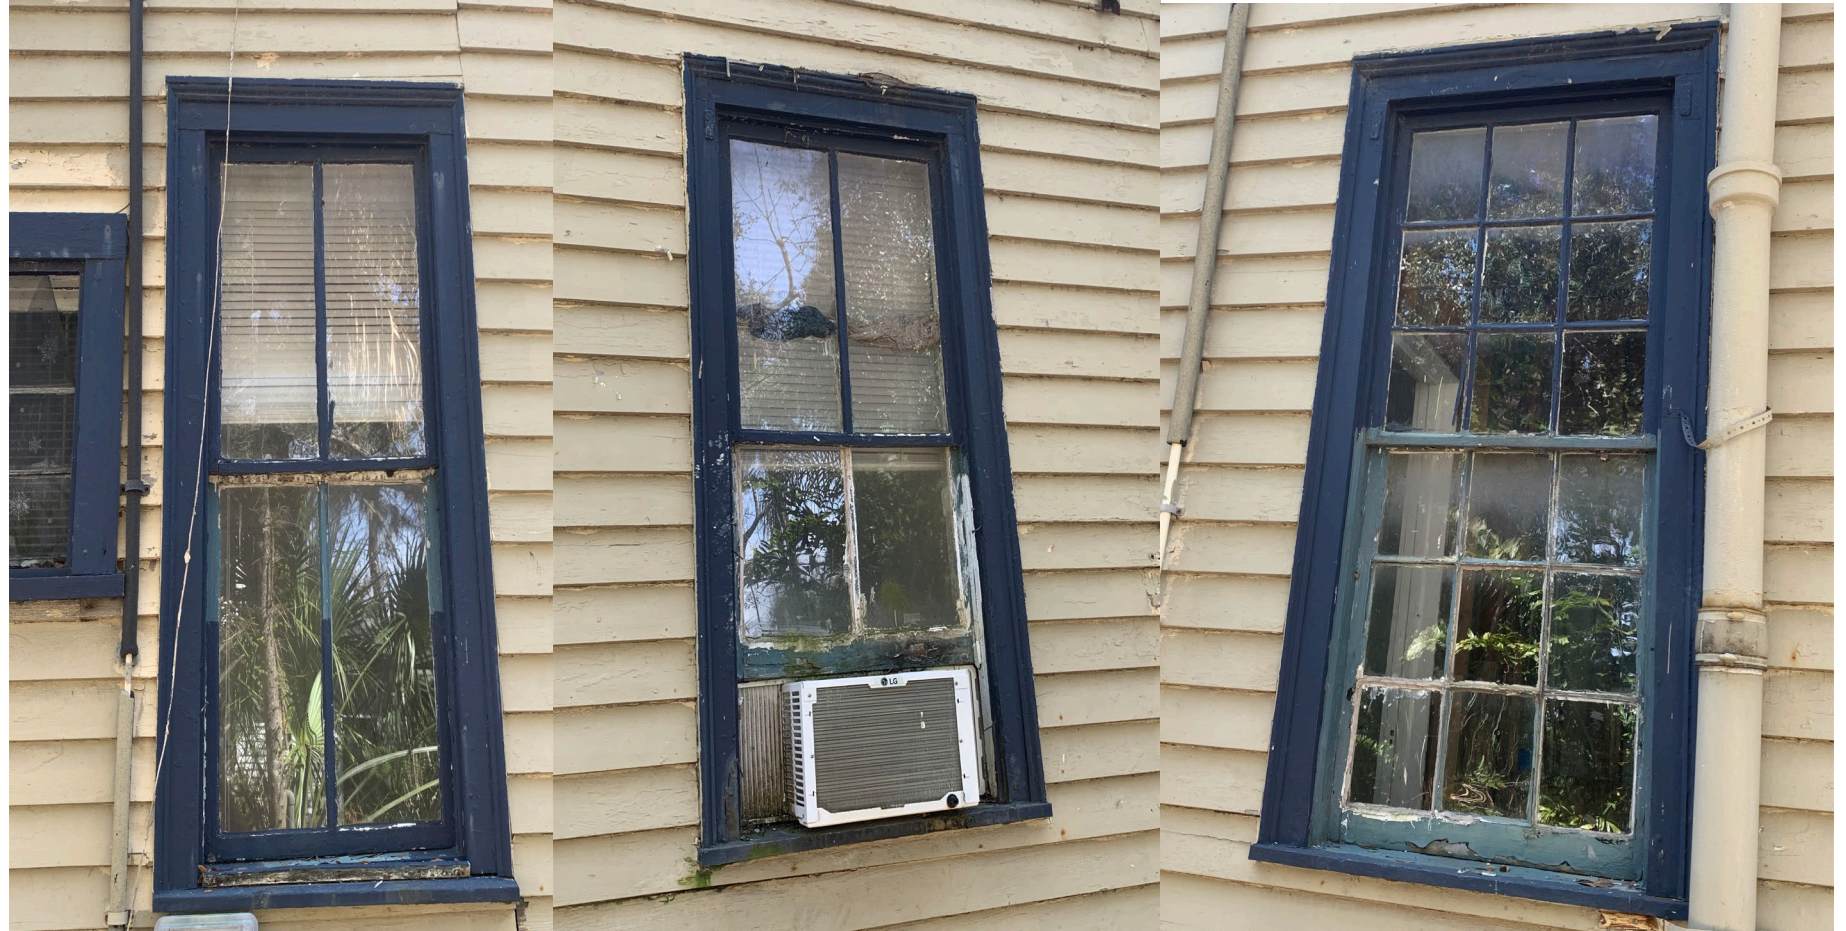
This is supposed to be 9/9

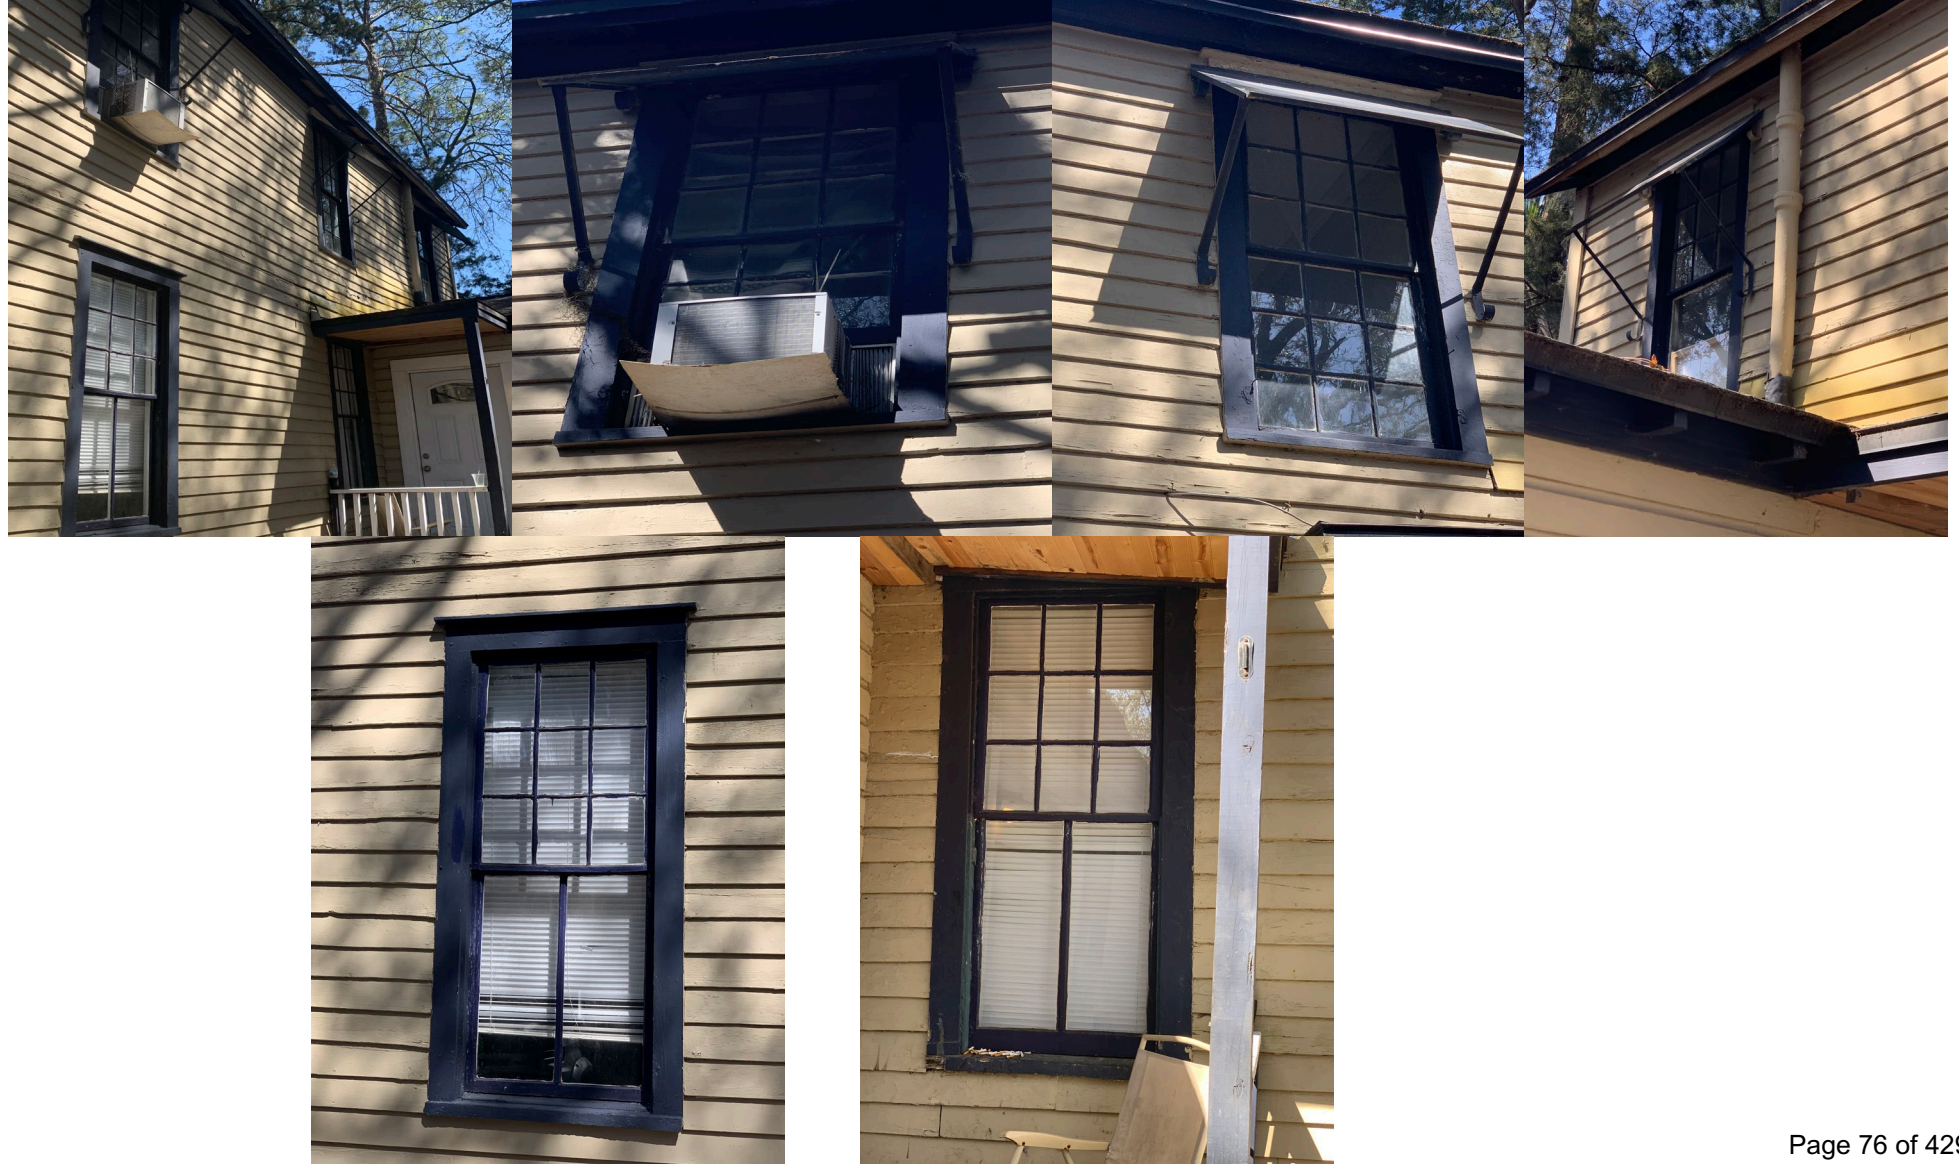
# Rear/West Facing Section

None of these windows have counter balances and these units are occupied

None of these windows have counter balances and this unit is occupied. I am proposing to replace each one of these wooden 2 over 2 horizontal grille windows with new, all wood, 2 over 2 windows with horizontal grille windows due to the lack of counter balances or the practical retrofitting of counter balances.

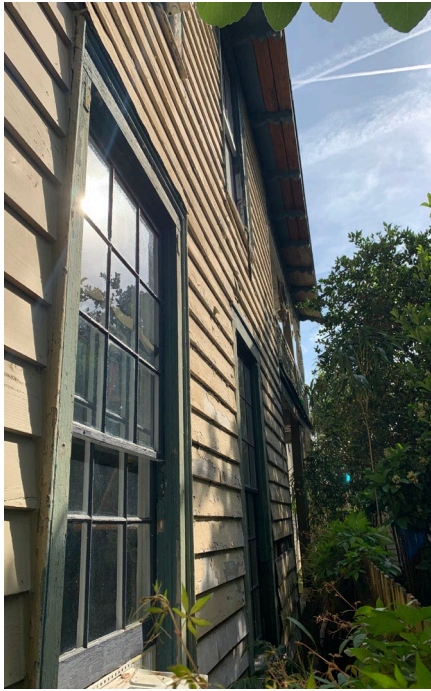
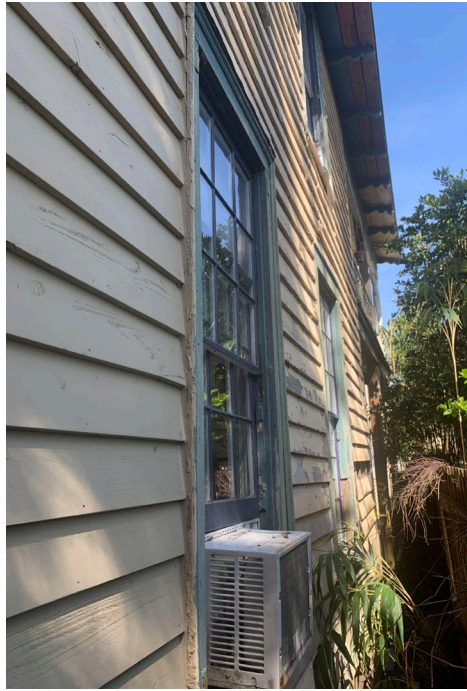
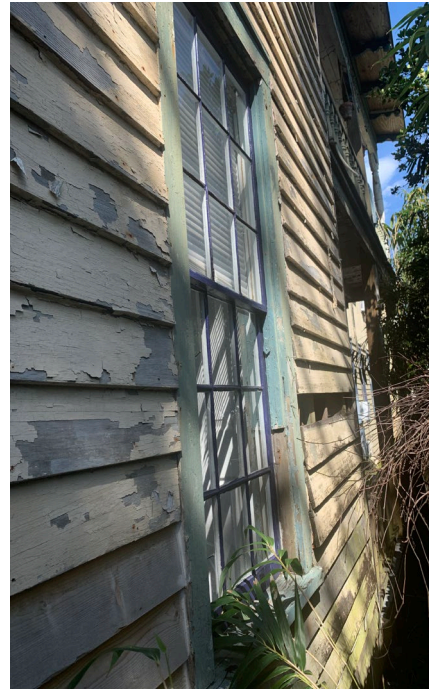
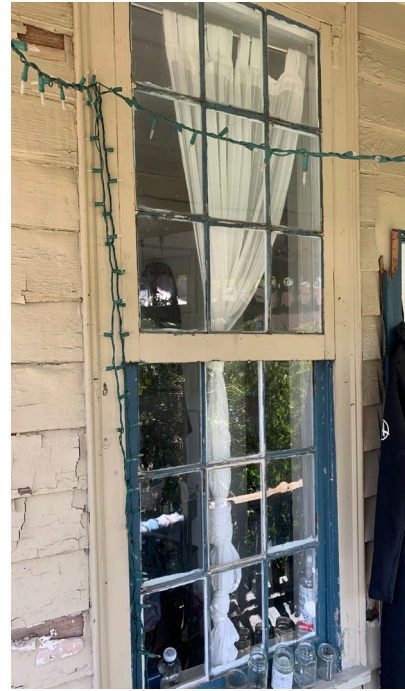
# Southern Elevation Porch & Clapboard Section Continued

Upstairs Porch

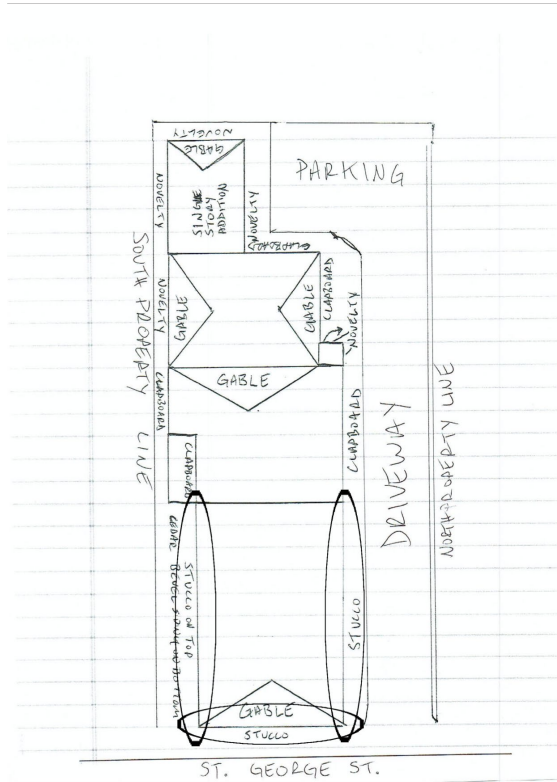
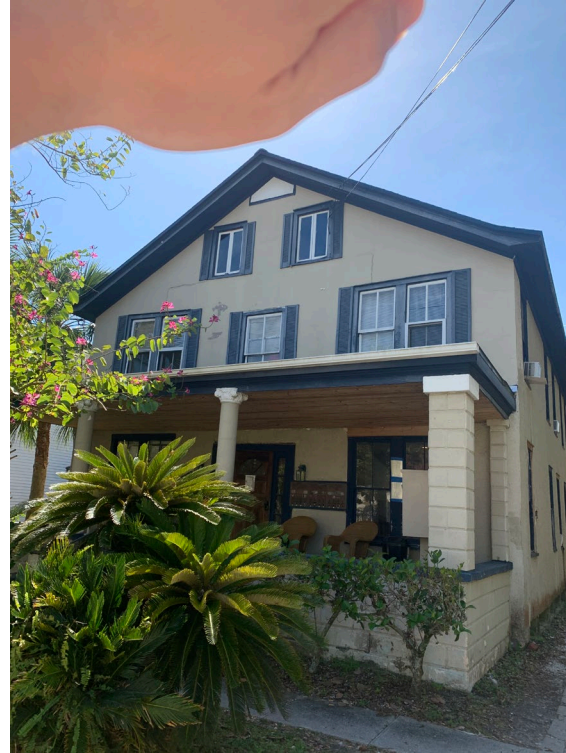
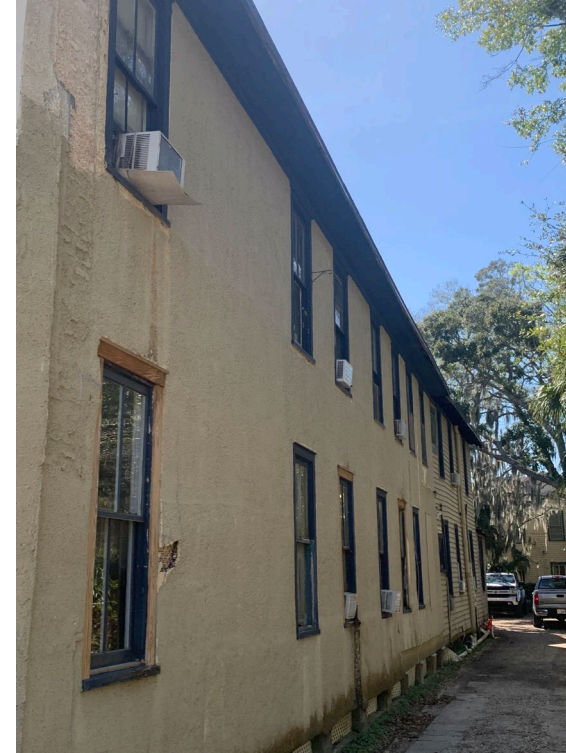
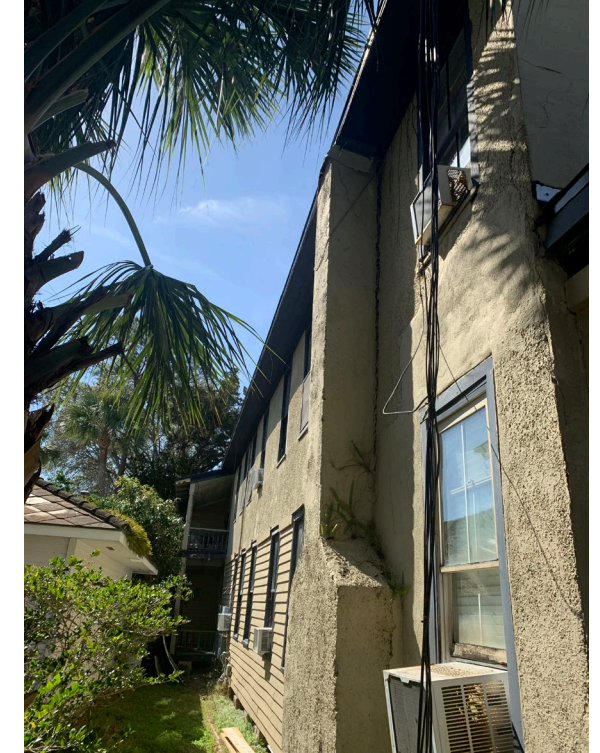
# Stucco Replacement

- As Mr. Benoit agreed to in the previous HARB meeting on March 18<sup>th</sup>, 2021; the stucco on the property is failing in several places and needs to be replaced to preserve the structural integrity of the property.

- I am requesting to replace all of the stucco where existing and the section of cedar bevel siding that appears to have been recently installed in place of stucco with a traditional 3 layer stucco with a smooth or fine sand finish similar to what currently exists on the front of the property.

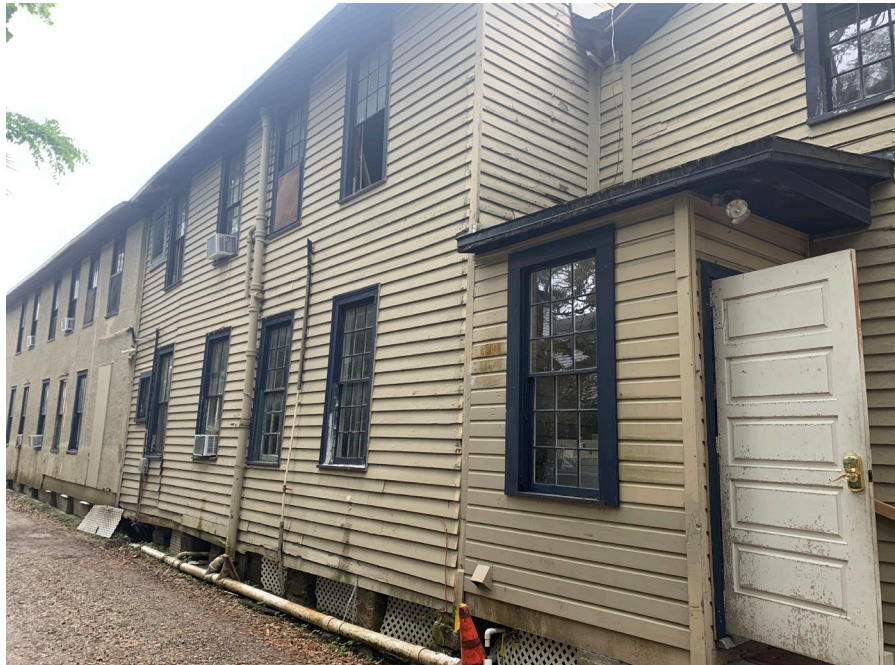
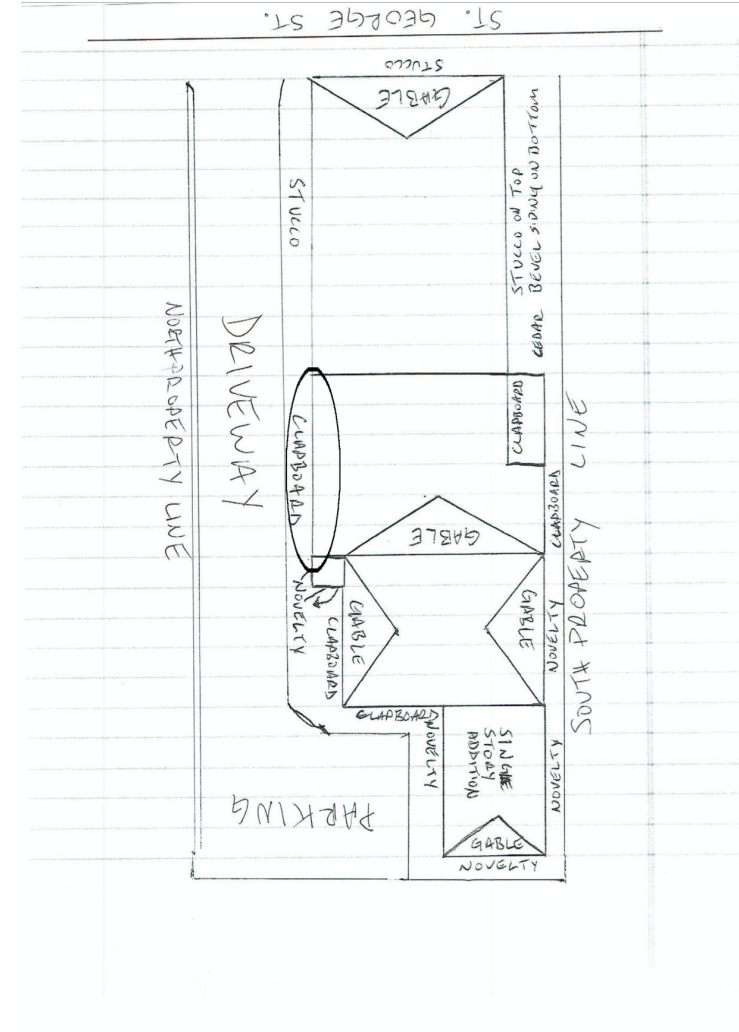
# Siding Replacement Continued

- I am proposing to replace roughly 25-40% of the clapboard siding on the north facing section between the stucco and the small novelty sided entrance with matching wood clapboard siding. Most of this siding appears to be in decent condition with the exception of the bottom 3-4 feet which is mostly rotted. The east 10-12 feet of this section appears to have been replaced and is separating from the framing. I would like to replace these two areas to correctly install the east 12 feet of this section closest to St. George St. and correct any damaged framing members behind it to prevent water and pest intrusion.

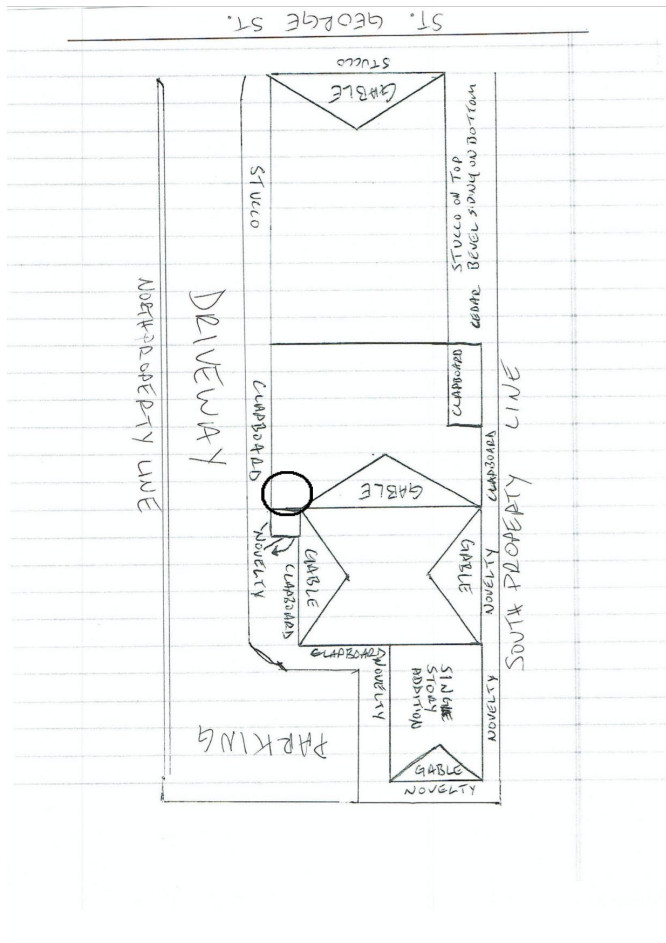
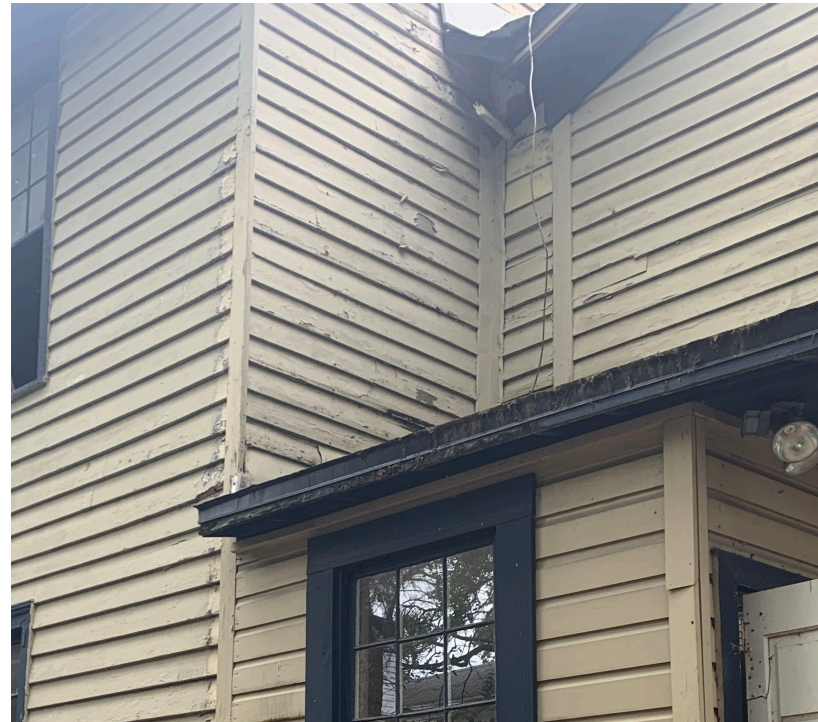
# Siding Replacement Continued

- I am proposing to replace the bottom 7-8 rotten boards of the rear/west facing portion of wall above the small single story entrance located along the driveway on the north facing side of the property with wood clapboard siding to match

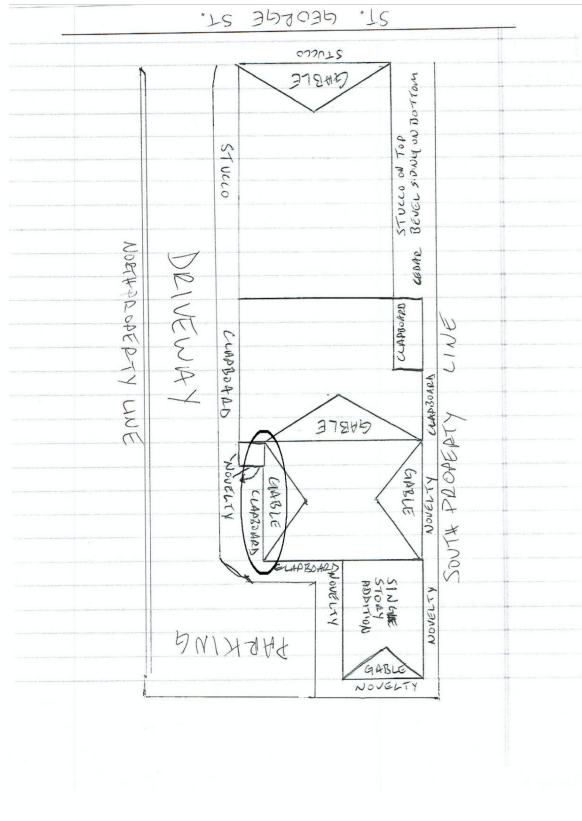
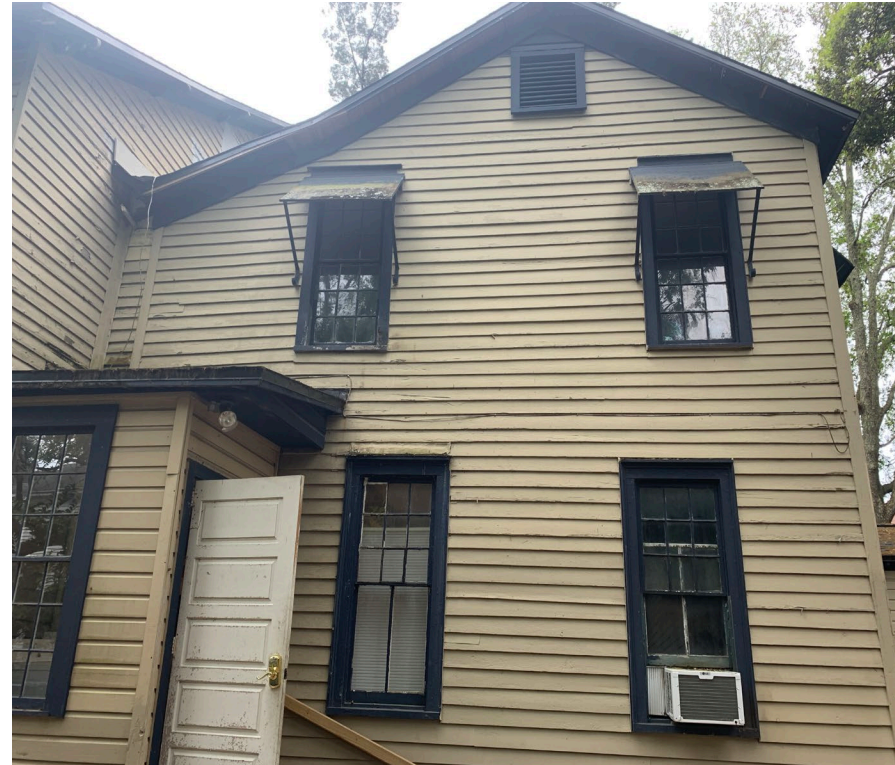
# Siding Replacement Continued

- Replace approximately 10% of the clapboard siding on the gable section along the north facing side to the rear of the side entry door with wood clapboard siding.

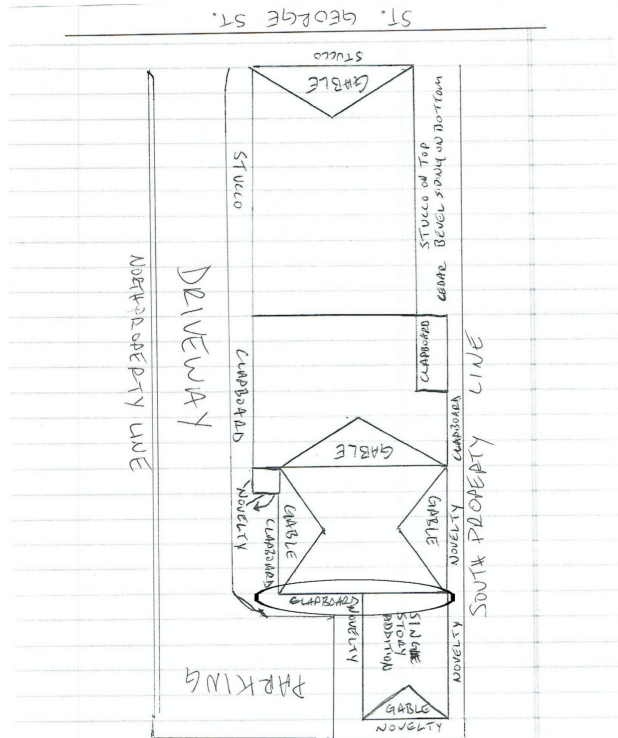
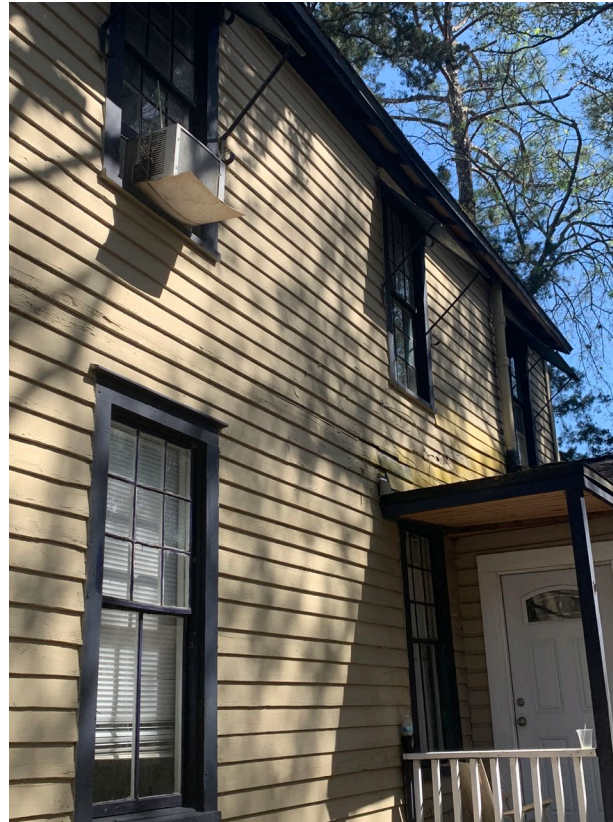
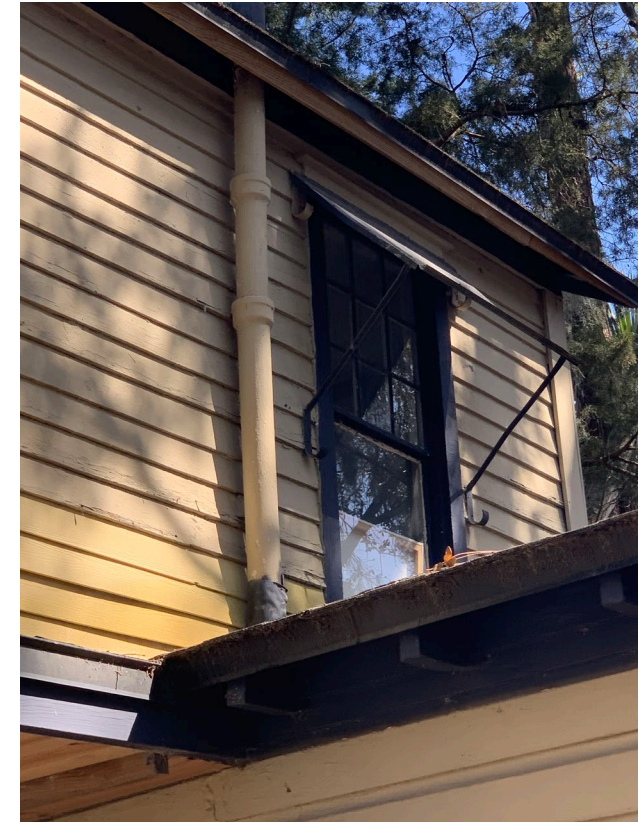
# Siding Continued

- Replace roughly 15-25% of the rear, west facing portion of the 2 story section of the building. Some of this section of the property has already been replaced with lap board hardie planks. I'm proposing to replace the hardie with wood clapboard siding to match the rest of this side and some other rotten boards.
