**CITY OF ST. AUGUSTINE HISTORIC ARCHITECTURAL REVIEW BOARD**

**A G E N D A - AMENDED\***

**THURSDAY, APRIL 15, 2021 - 1:00 PM**

**CITY OF ST. AUGUSTINE HISTORIC ARCHITECTURAL REVIEW BOARD  
STAFF REPORT AND RECOMMENDATION  
Prepared for April 15, 2021 Meeting**

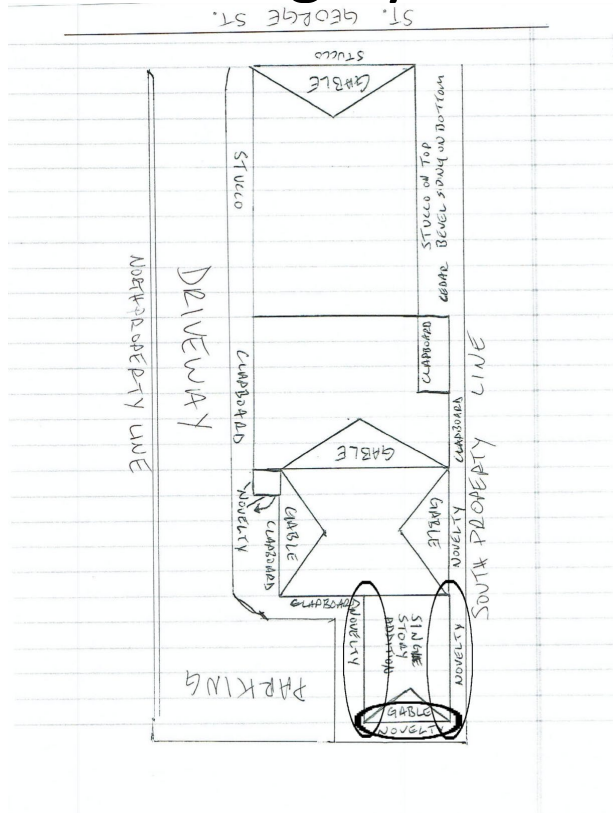
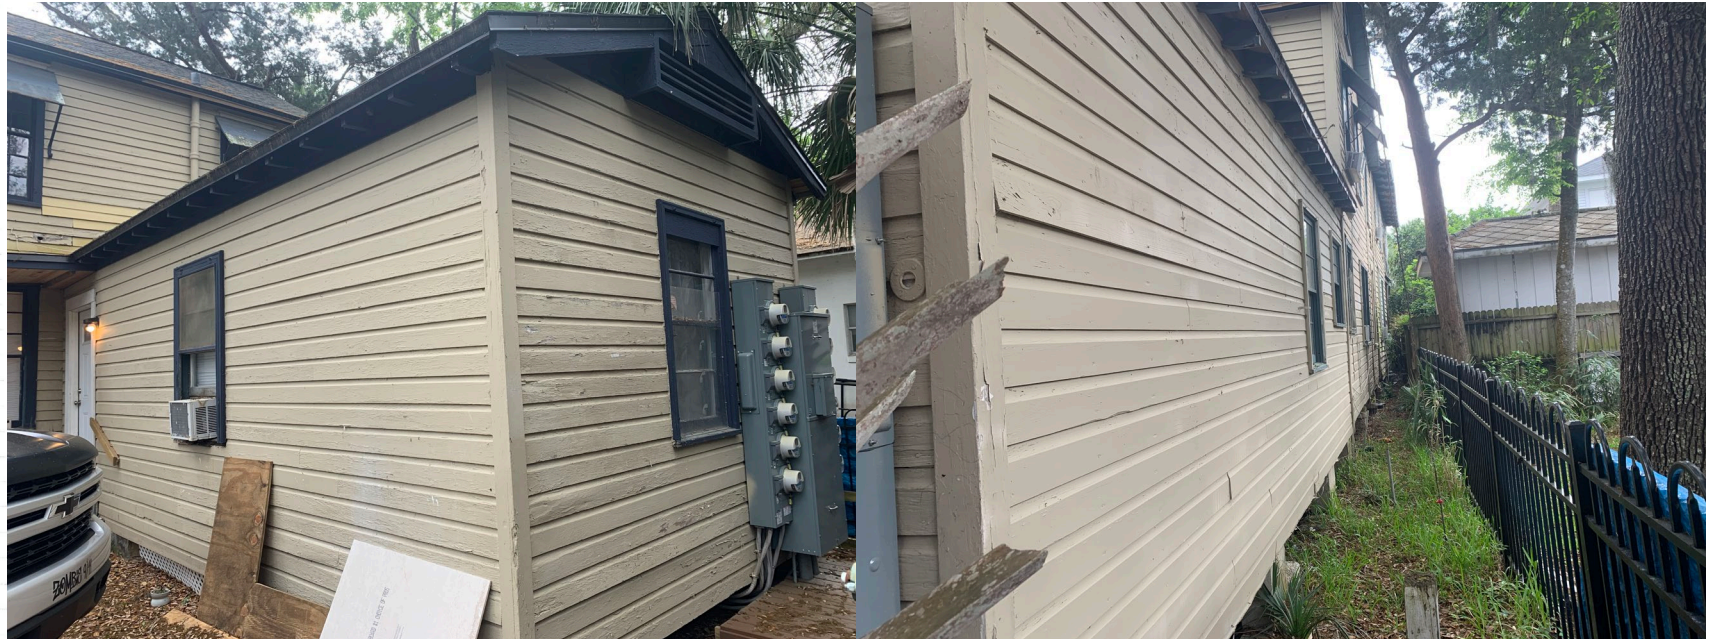
# Siding Continued

- Replace roughly 10-15% of the novelty siding on the one story rear addition with matching novelty siding. This siding is mostly in good shape with the exception of a few boards on the north facing side and roughly 25% of the rear, west facing side.

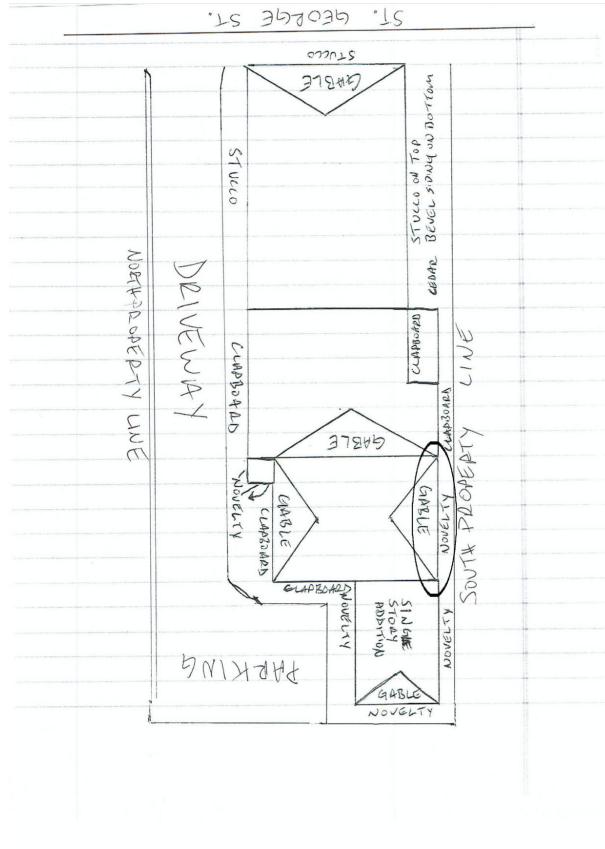
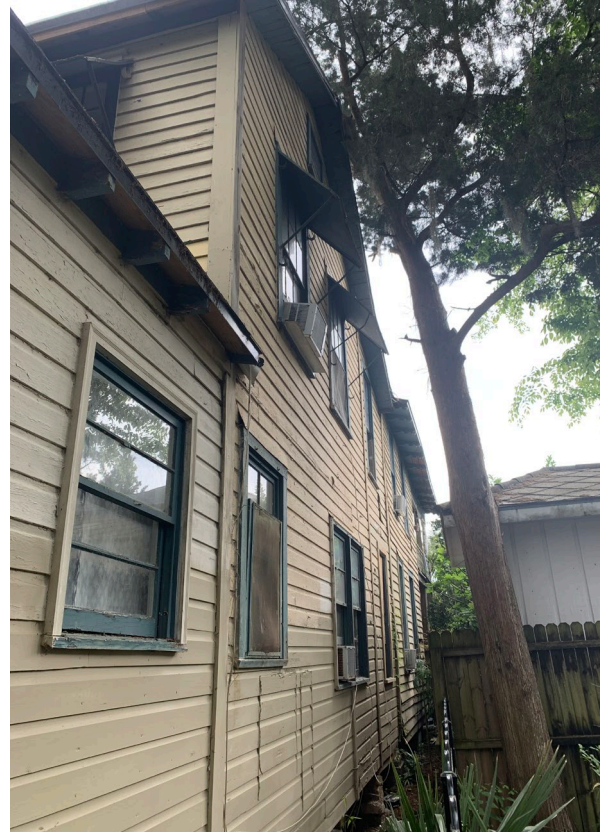
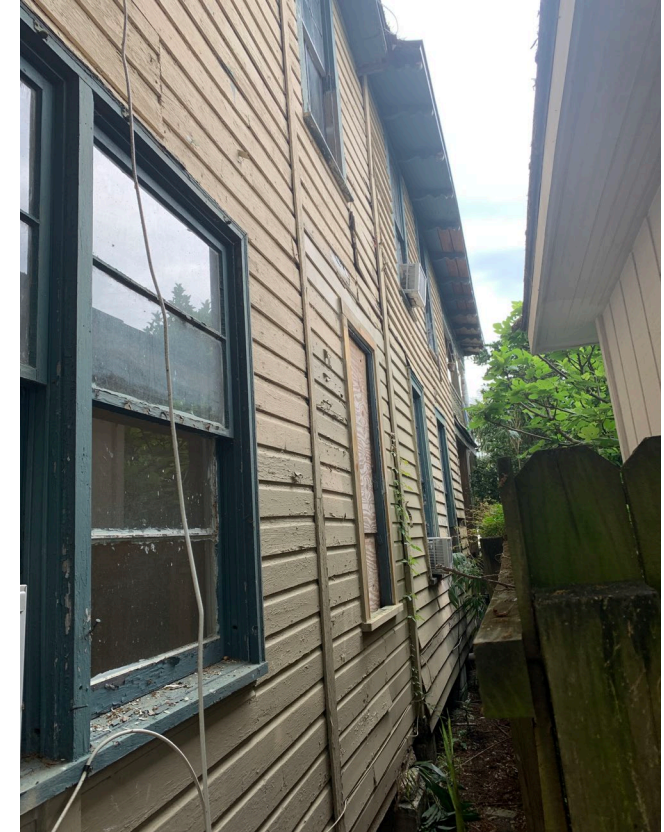
# Siding Continued

- Replace roughly 50-75% of the novelty siding on the south facing gable section of the property just east (in front of) the one story addition at the rear of the property with matching novelty siding. This section of the property is in very bad condition. It is separating from the framing members and is very brittle and rotted.

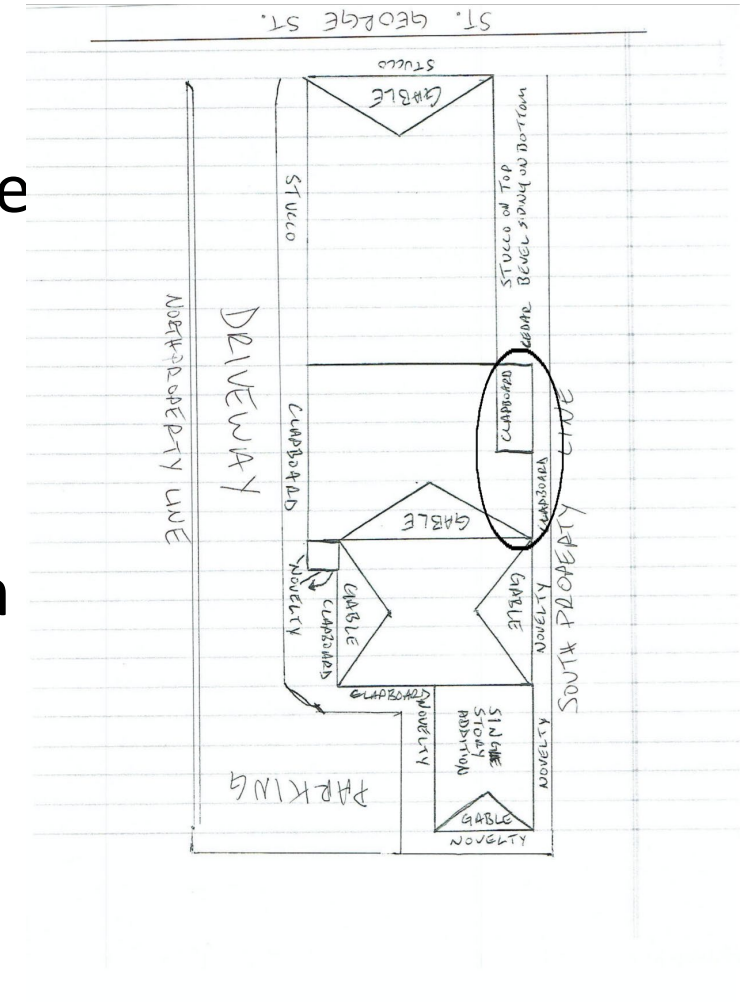
# Siding Continued

- Replace roughly 50-75% of the clapboard siding on the porch section that is immediately behind the stucco section on the south facing side of the property and the 16 foot section between the porch and the novelty sided gable section with new wood clapboard siding to match. This section is in very bad shape with several rotten boards, several boards that have separated from the framing members and some boards that appear to have separated completely and fallen off the side of the building.

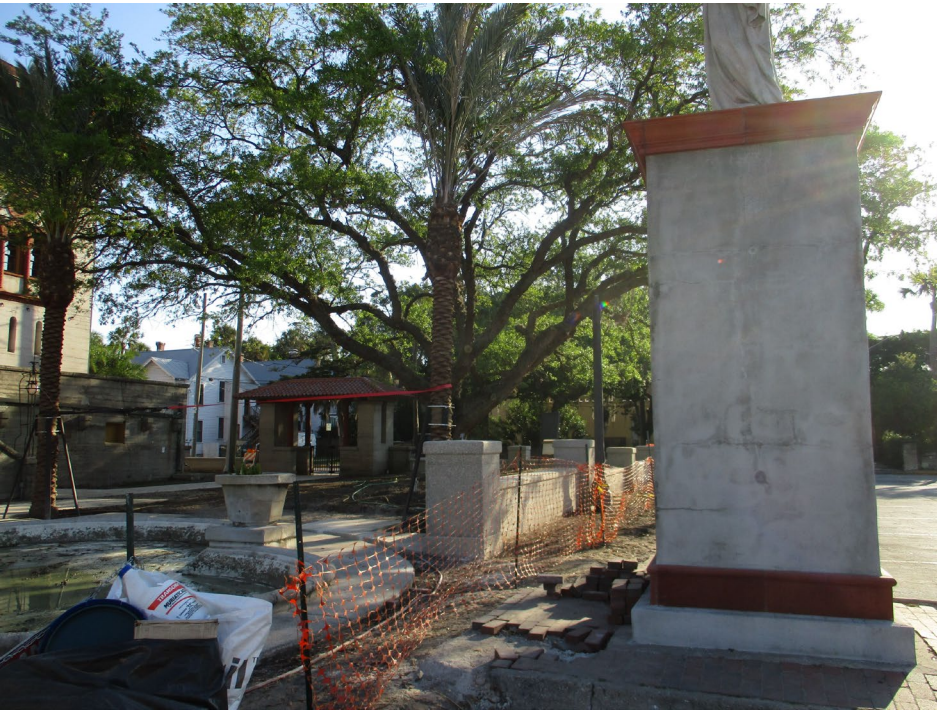
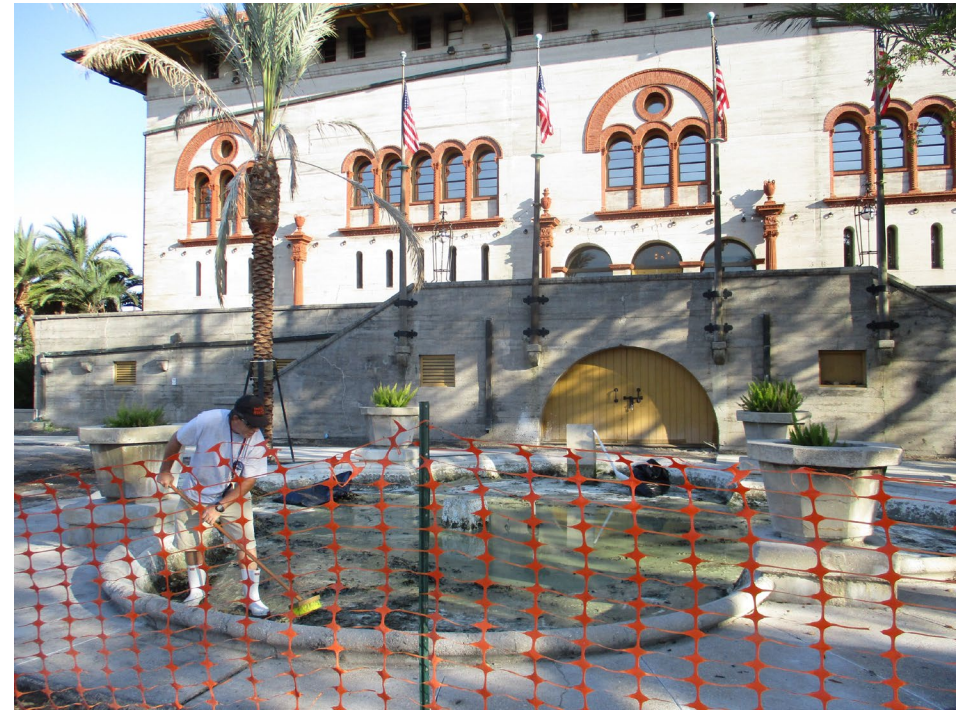
### 75 King Street

Facing north and east toward former Alcazar Hotel building and the South Garden with the fountain adjacent to the sculpture

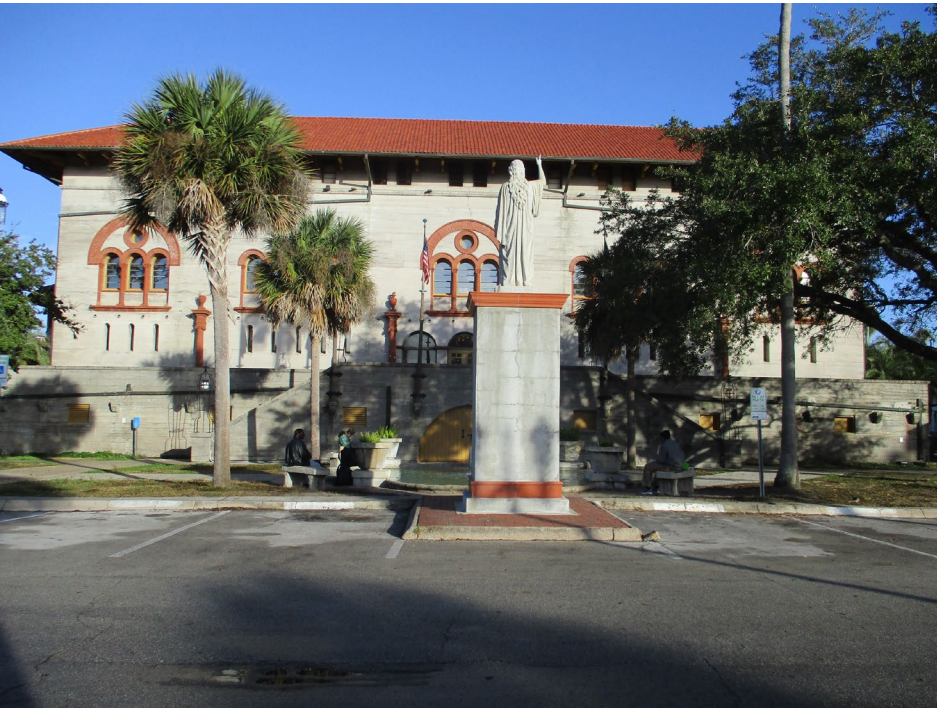
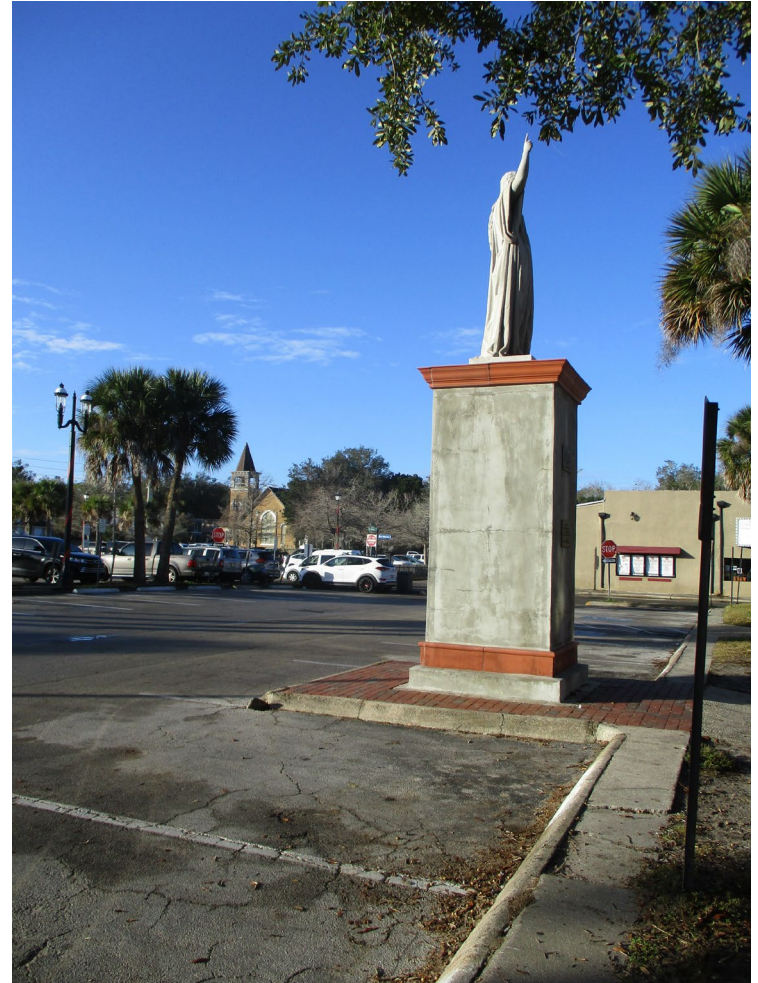
### 75 King Street

Facing north toward former Alcazar Hotel building and the South Garden;  
looking west toward Granada Street

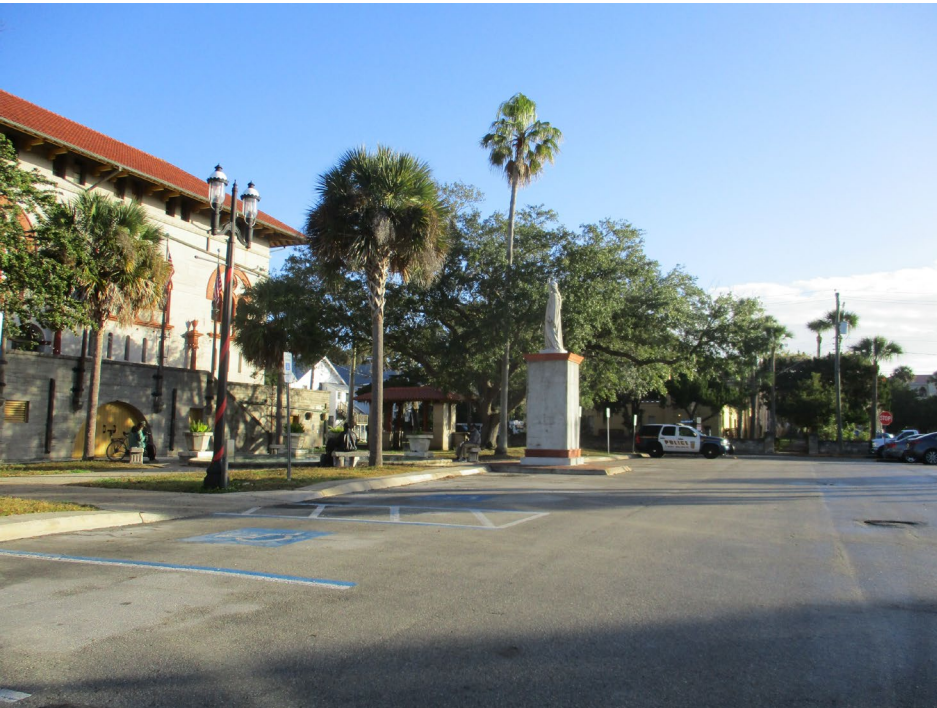
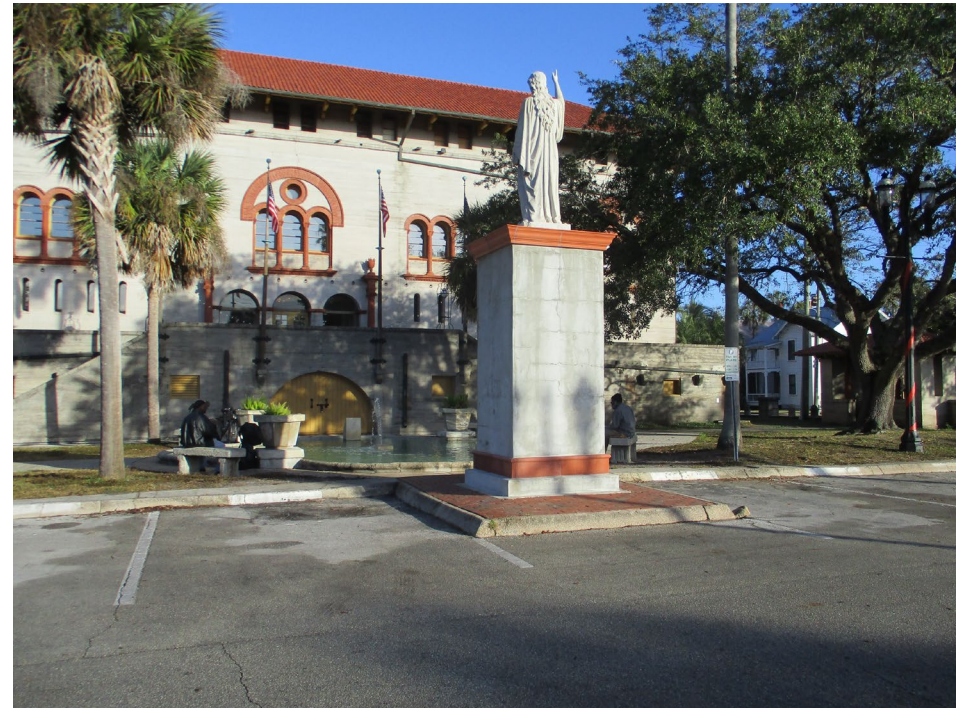
**STAFF PHOTOGRAPHS:**  
**Taken 2020, prior to modifications to South Garden**  
**75 King Street**

Facing northeast toward former Alcazar Hotel building and the South Garden;  
looking east toward Cordova Street

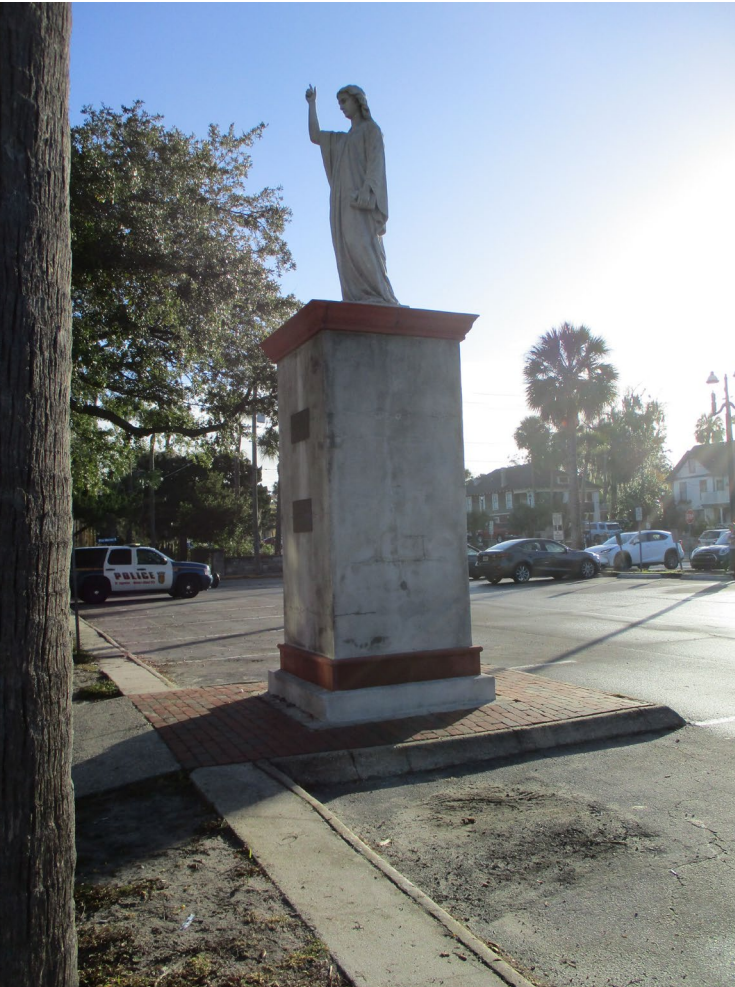
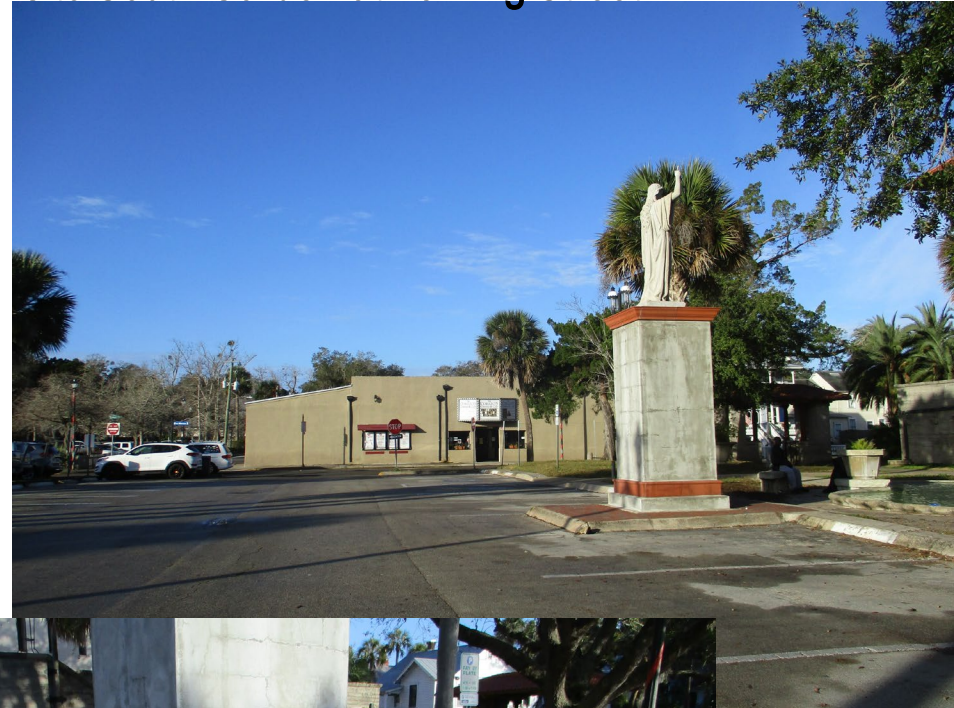
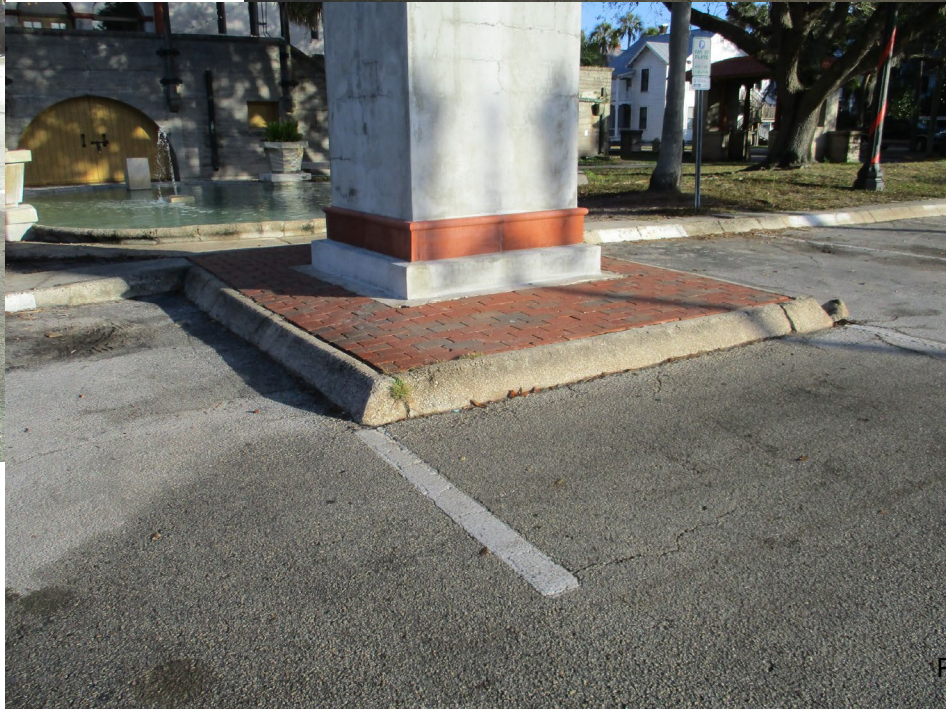
**STAFF PHOTOGRAPHS:**  
**Taken 2020, prior to modifications to South Garden at 75 King Street**

Project area: Sculpture peninsula and adjacent city parking spaces

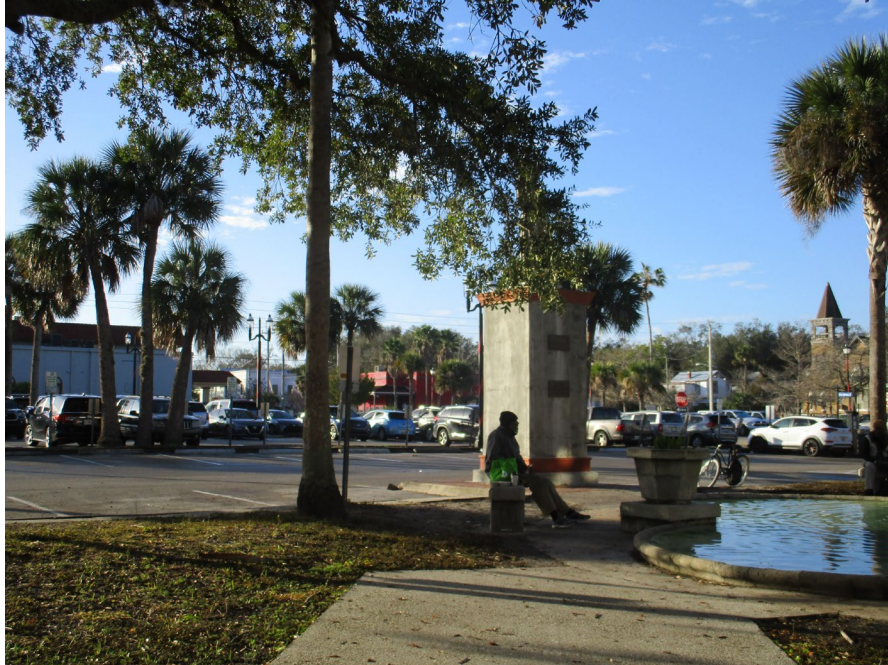
**STAFF PHOTOGRAPHS:**  
**Taken 2020, prior to modifications to South Garden**  
**75 King Street**

Looking toward proposed expanded project area:  
Sculpture peninsula and adjacent city parking spaces

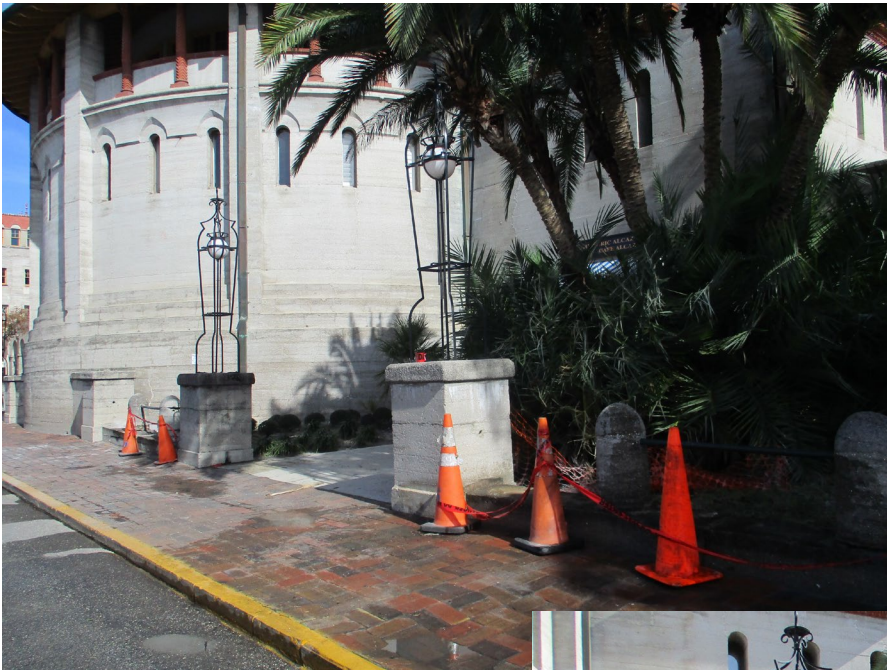
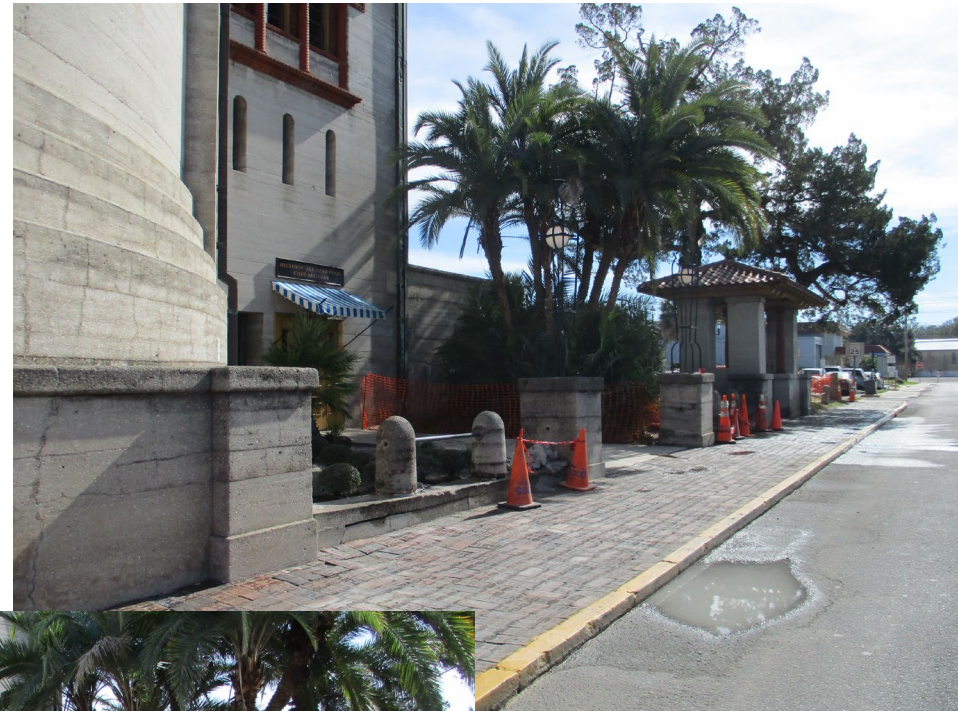
**STAFF PHOTOGRAPHS:**  
**Taken 2020, prior to modifications to South Garden at 75 King Street**

Proposed expanded project  
area for perimeter wall:  
south of the  
Lightner Museum's  
restaurant entrance

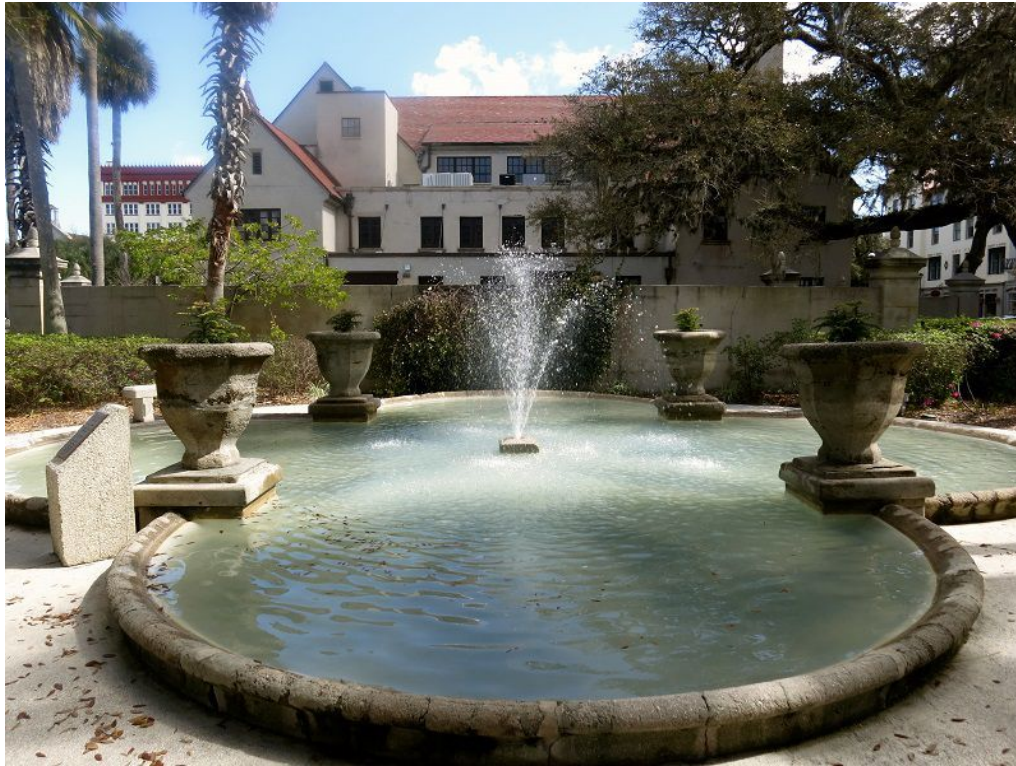
# FOUNTAIN IMPROVEMENTS

UPDATED FOUNTAIN SPRAY  
(SIMILAR TO FOUNTAIN AT GOVERNMENT HOUSE 48 KING STREET)

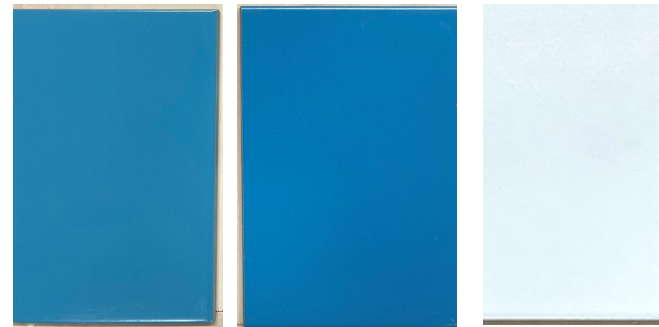
## MOSAIC TILES

- HANDMADE ITALIAN GLAZED PORCELAIN TILES
- $\frac{3}{4}$ " X  $\frac{3}{4}$ " MOSAIC PIECES
- THREE COLOR TONES

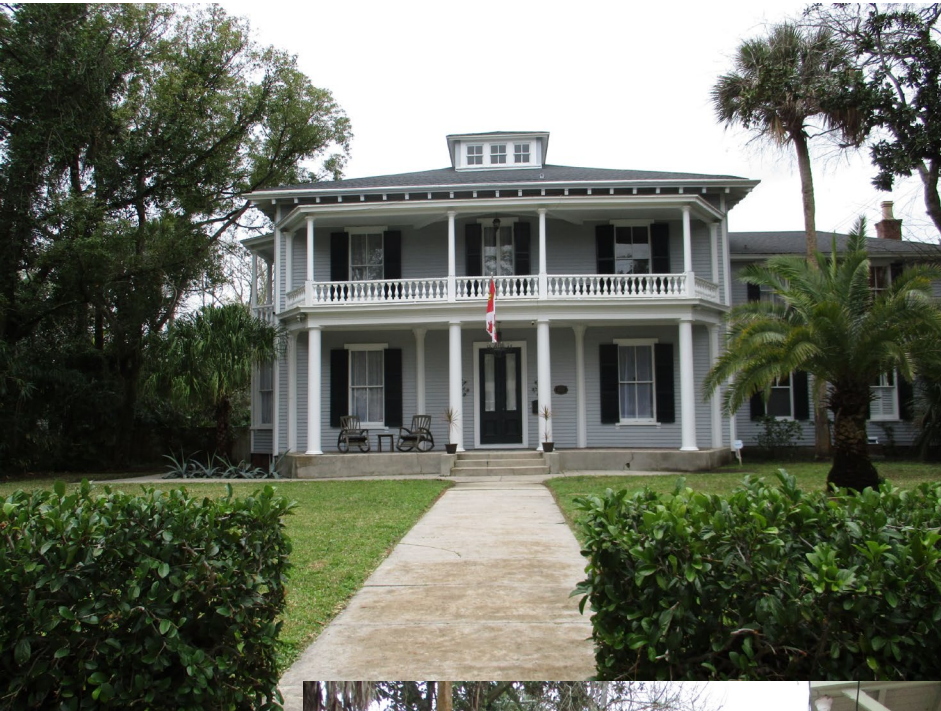
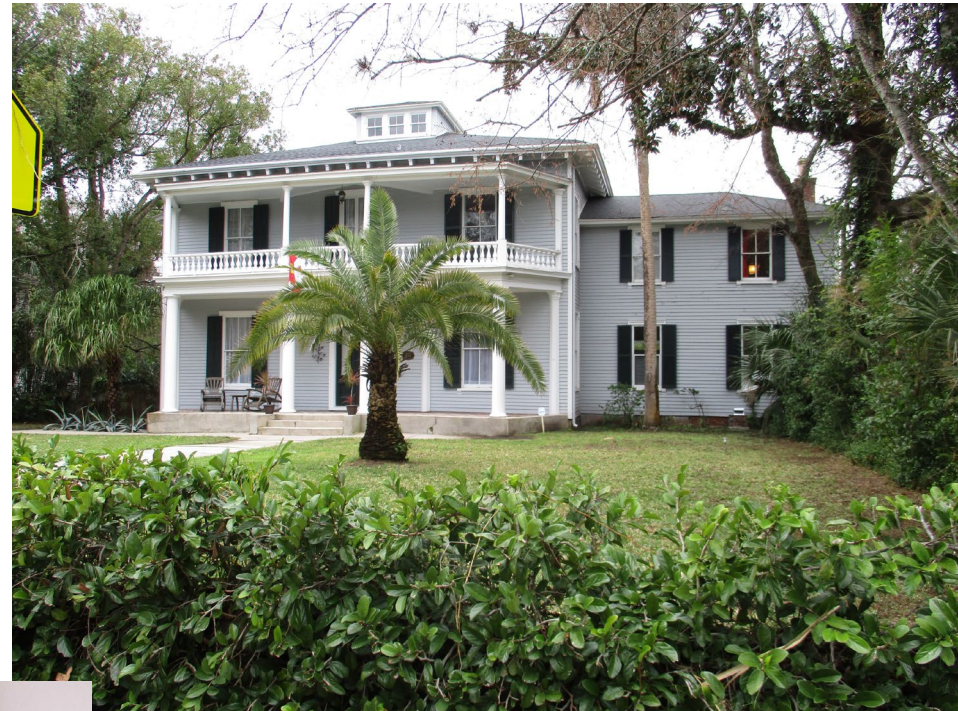
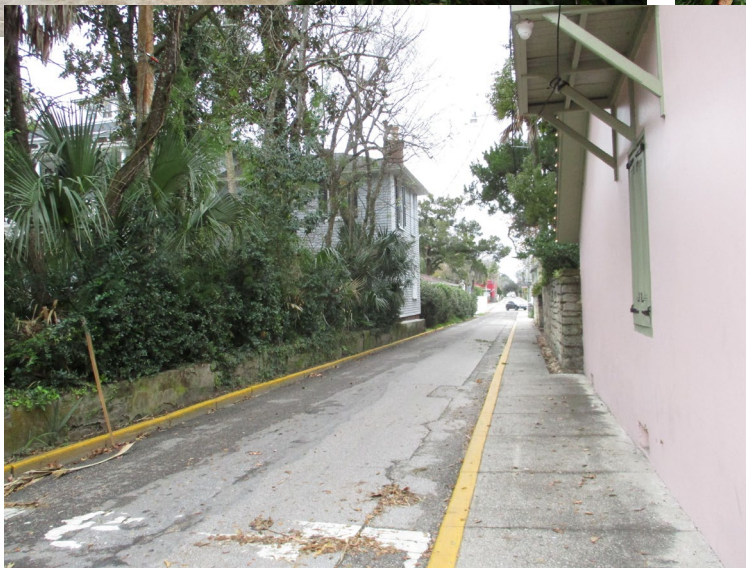
## STAFF PHOTOGRAPHS 252 St. George Street

Front Façade/East Elevation and  
Looking west down Bridge Street

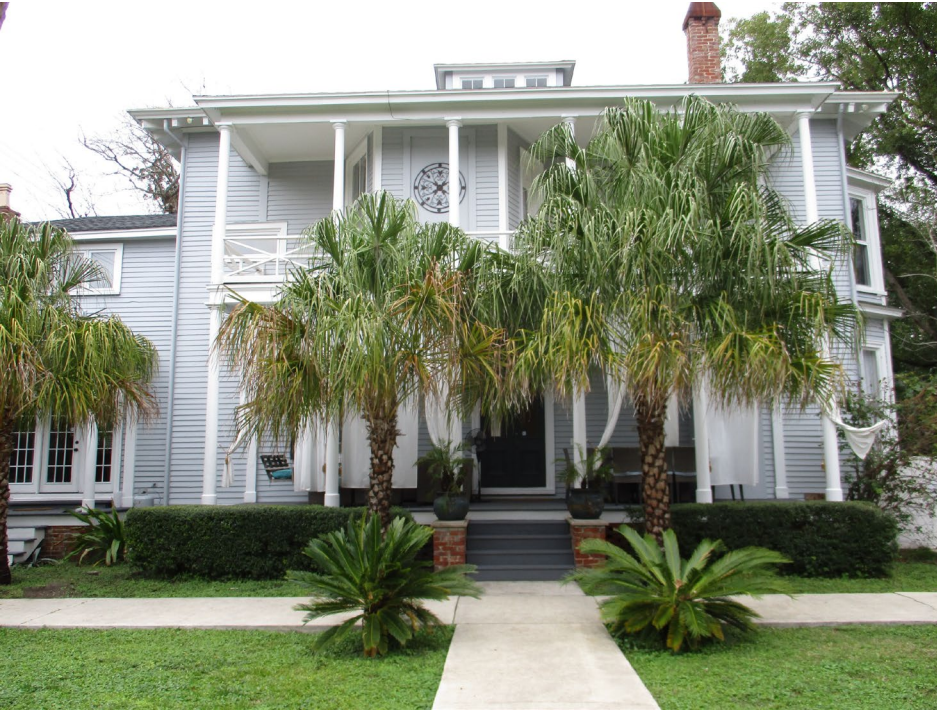
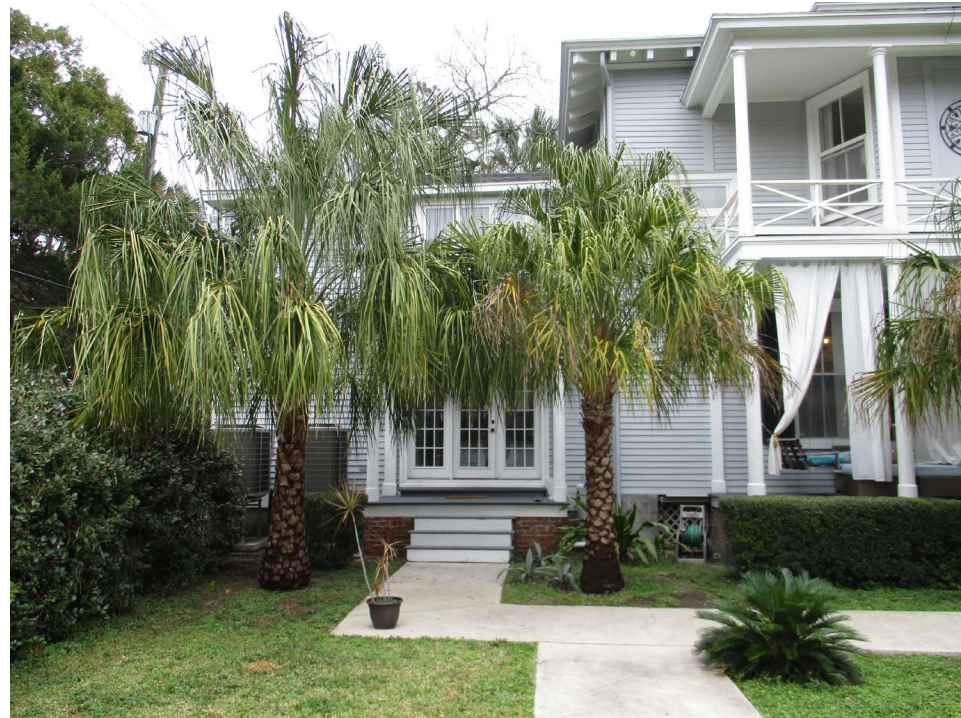
**STAFF PHOTOGRAPHS**  
**252 St. George Street**

Rear/West Elevation with two-story porch on south end and one-story porch on north end:  
looking east at project area for addition

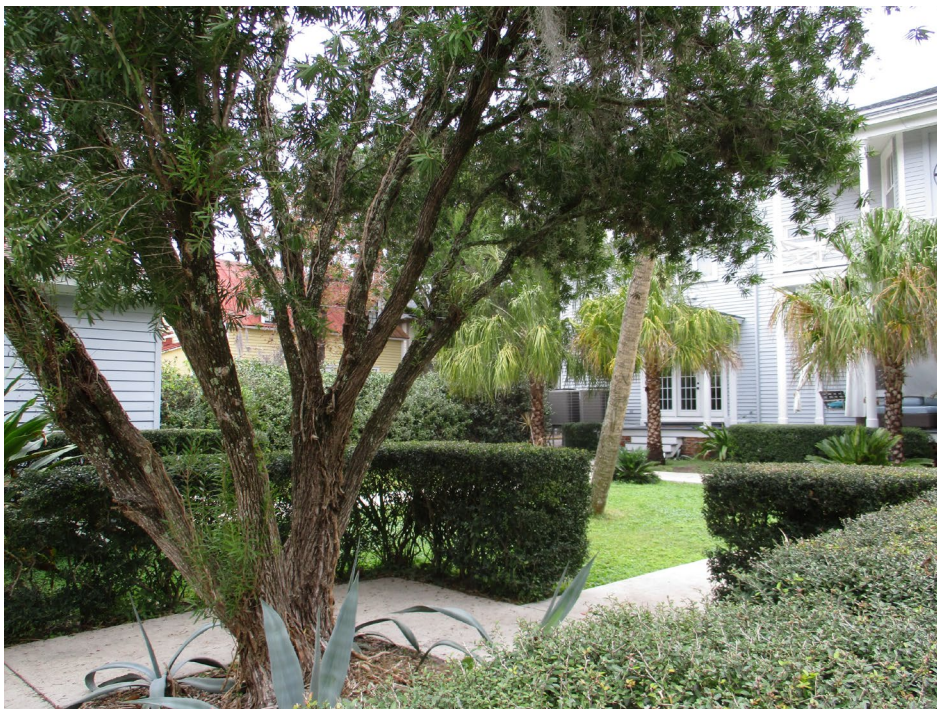
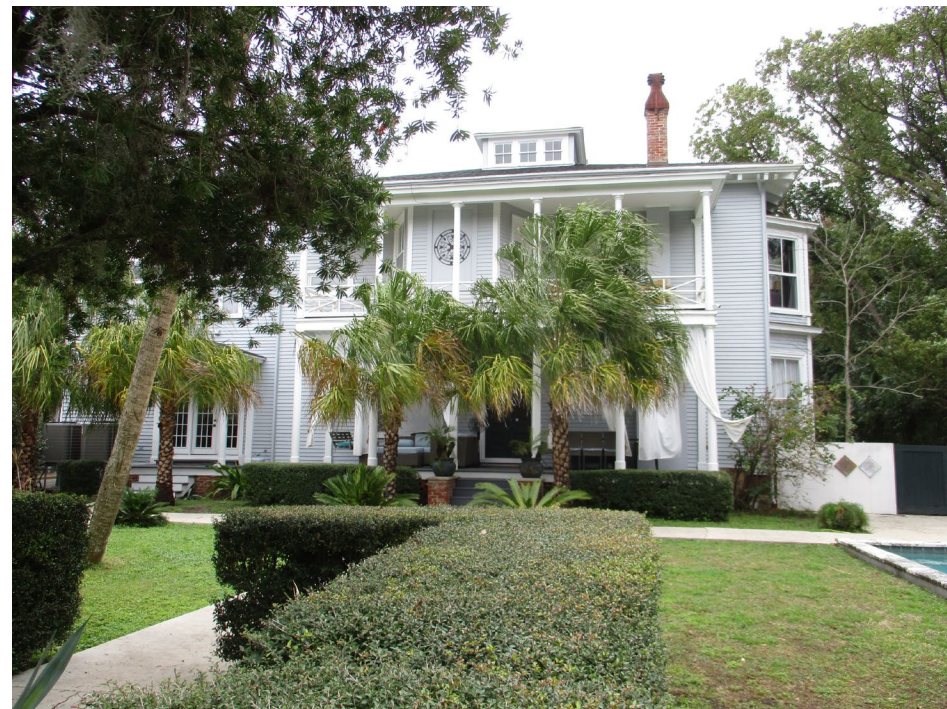
**STAFF PHOTOGRAPHS**  
**252 St. George Street**

Rear/West Elevation with two-story porch on south end and one-story porch on north end:  
looking east at project area for addition

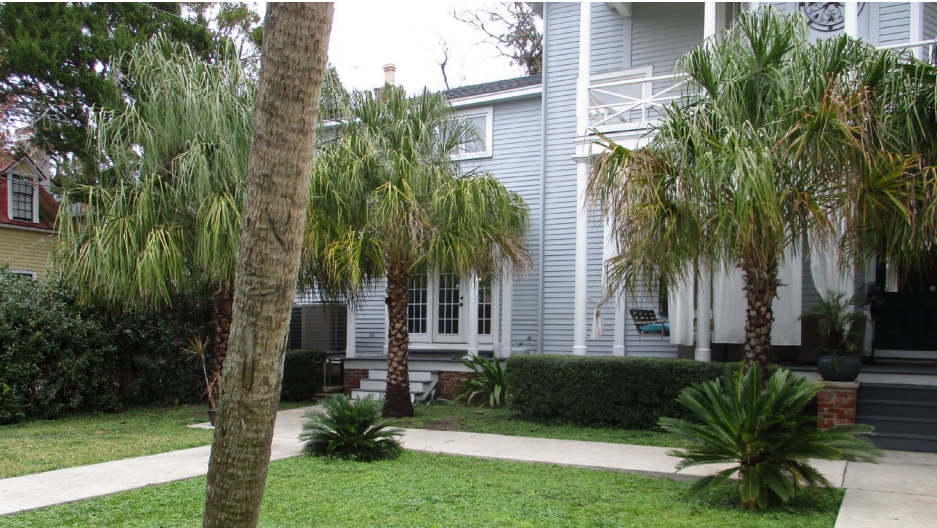
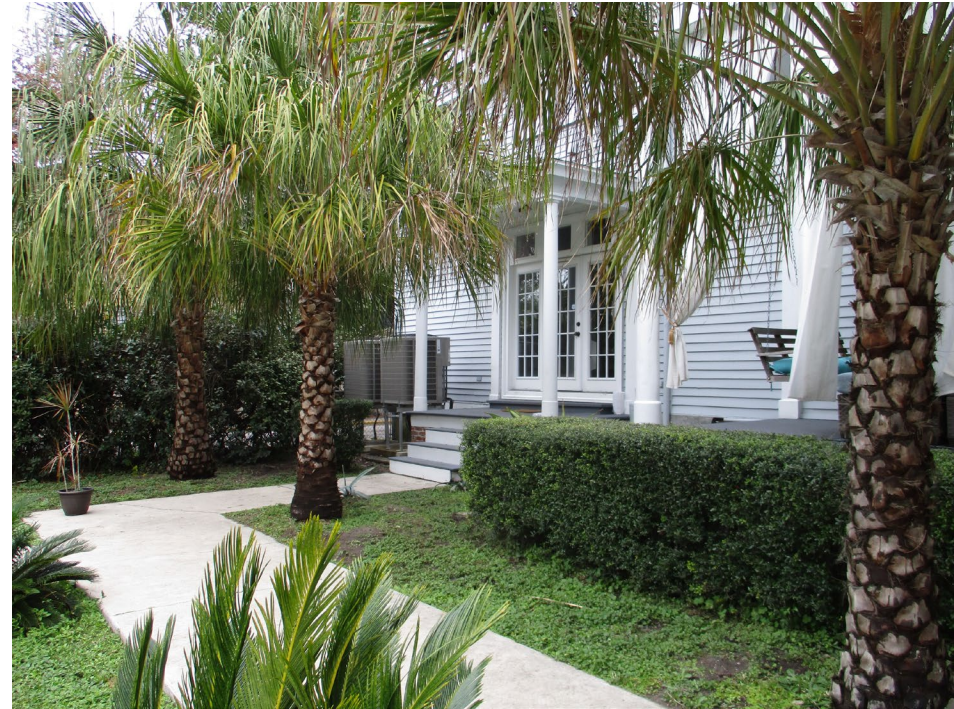
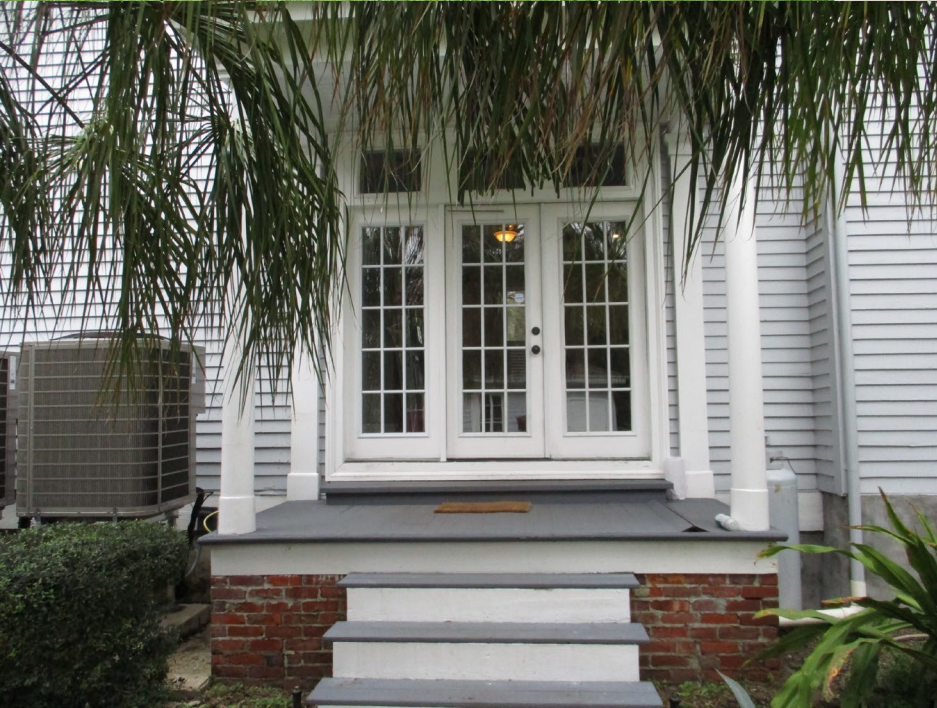
# STAFF PHOTOGRAPHS

Rear/West Elevation with two-story porch on south end  
and one-story porch on north end:  
looking east and north at project area  
for addition  
(elements of one-story porch to be removed for addition)

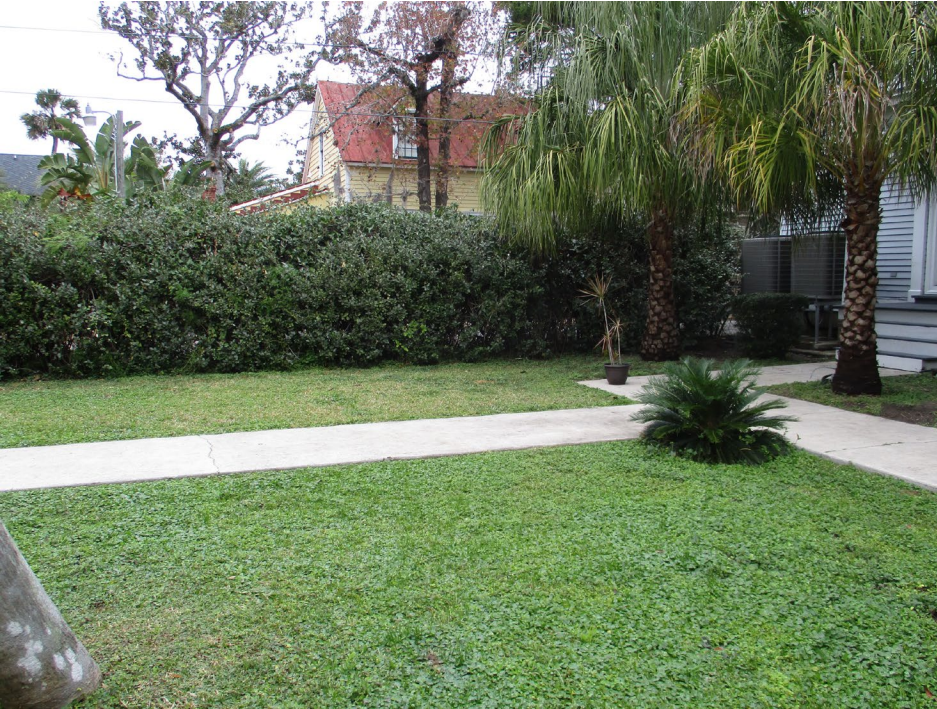
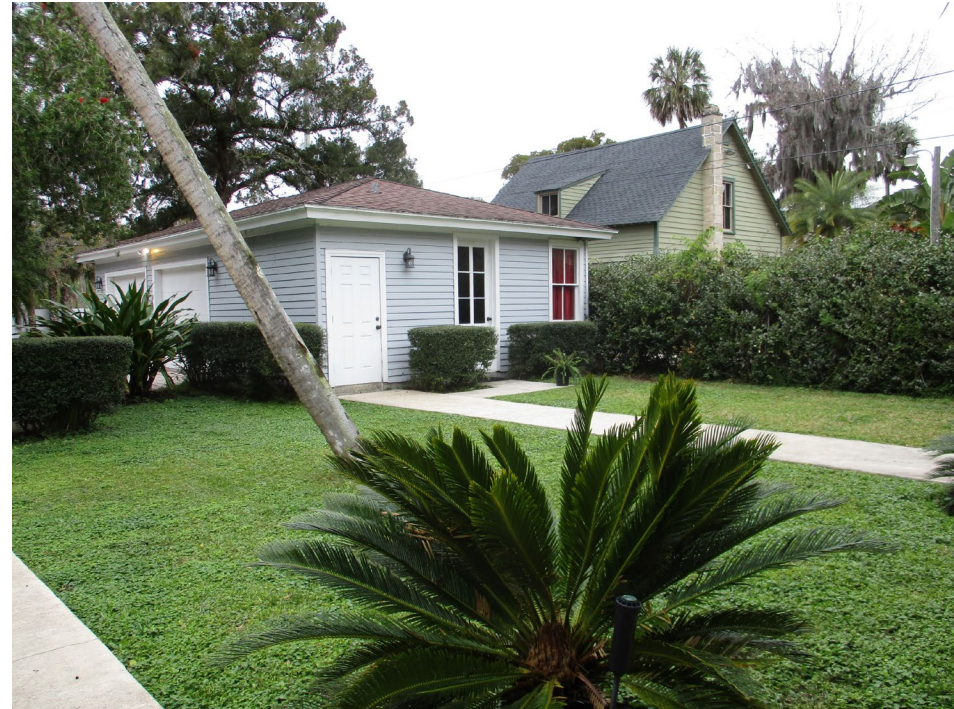
## STAFF PHOTOGRAPHS 252 St. George Street

Looking north and west at project area for addition (existing detached garage to remain)

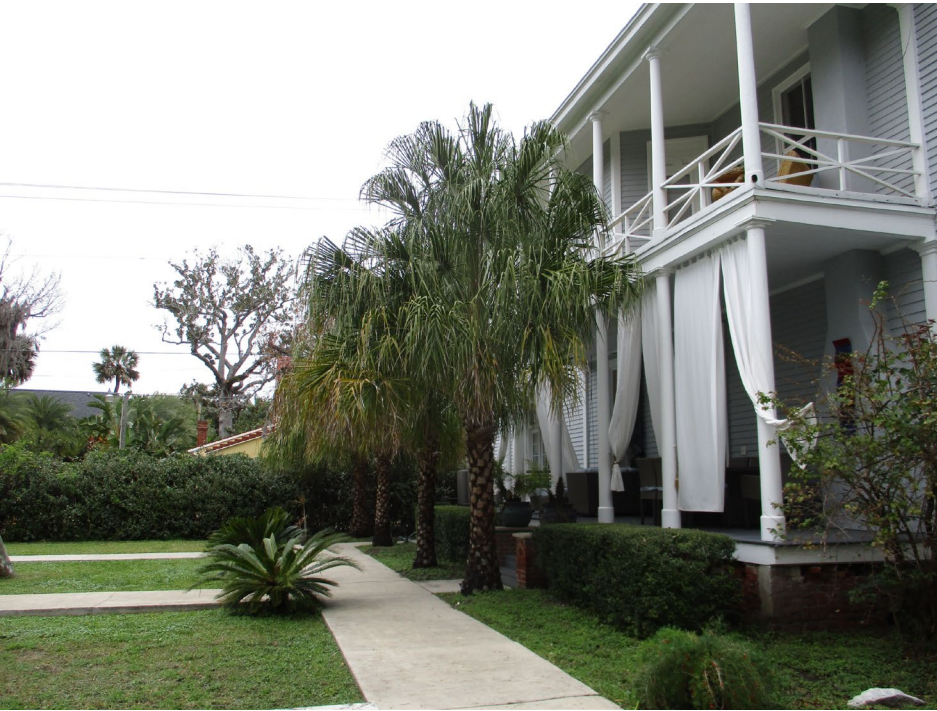
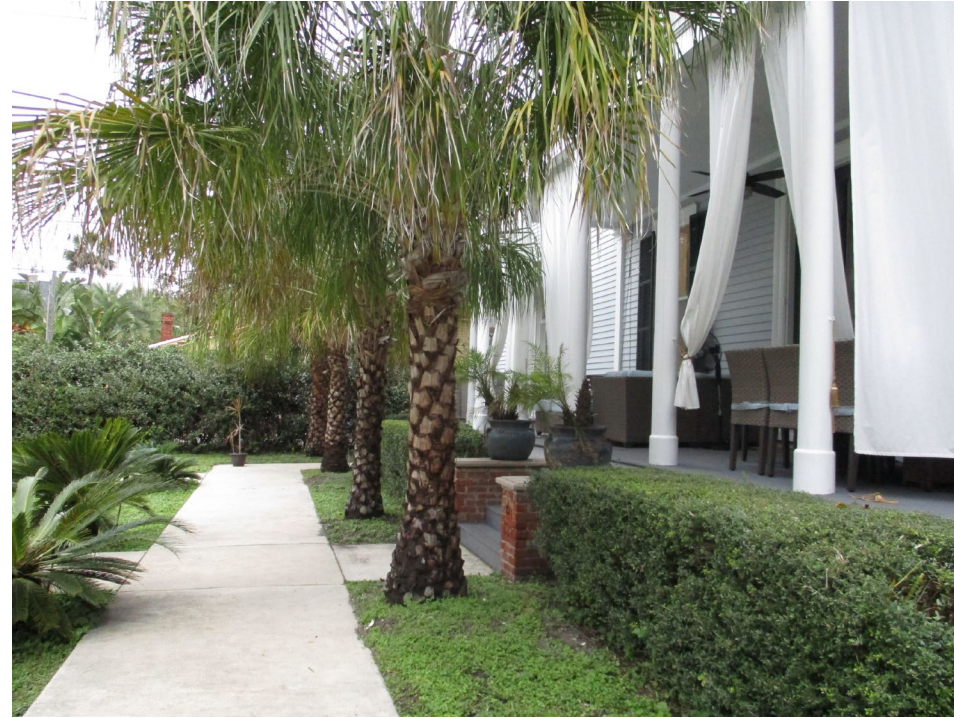
**STAFF PHOTOGRAPHS**  
**252 St. George Street**

Looking north at project area for addition: existing two-story porch to remain
