**CITY OF ST. AUGUSTINE HISTORIC ARCHITECTURAL REVIEW BOARD**

**A G E N D A - AMENDED\***

**THURSDAY, APRIL 15, 2021 - 1:00 PM**

**CITY OF ST. AUGUSTINE HISTORIC ARCHITECTURAL REVIEW BOARD  
STAFF REPORT AND RECOMMENDATION  
Prepared for April 15, 2021 Meeting**

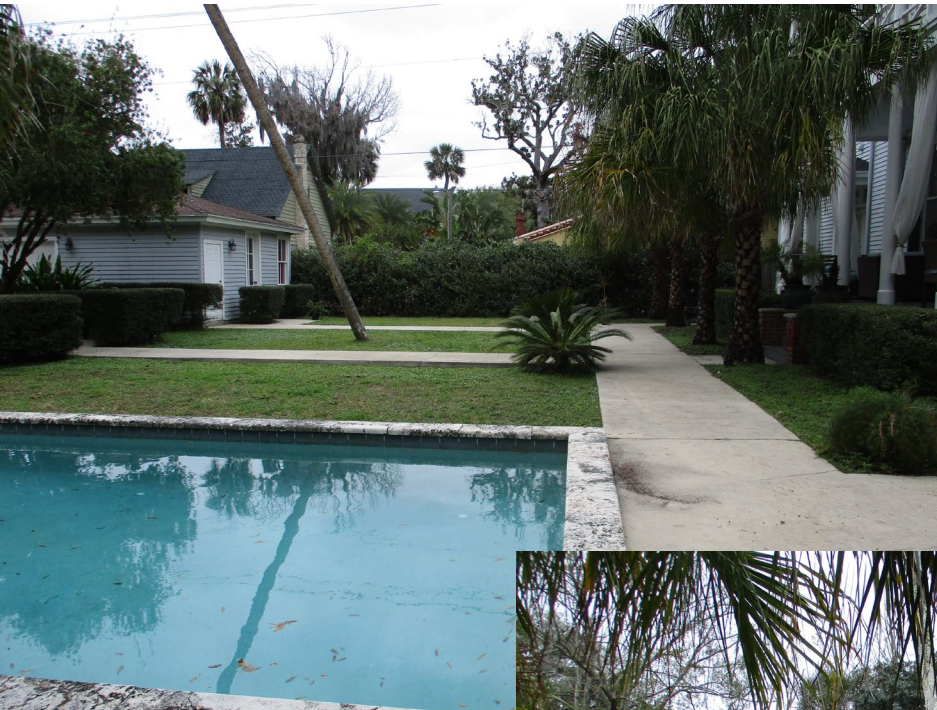
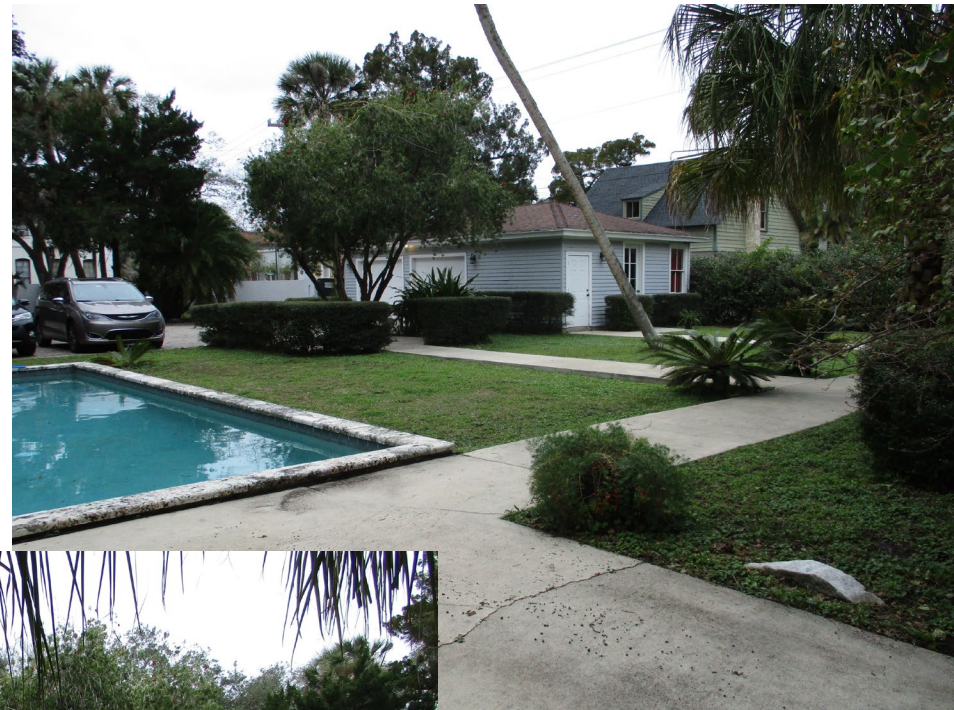
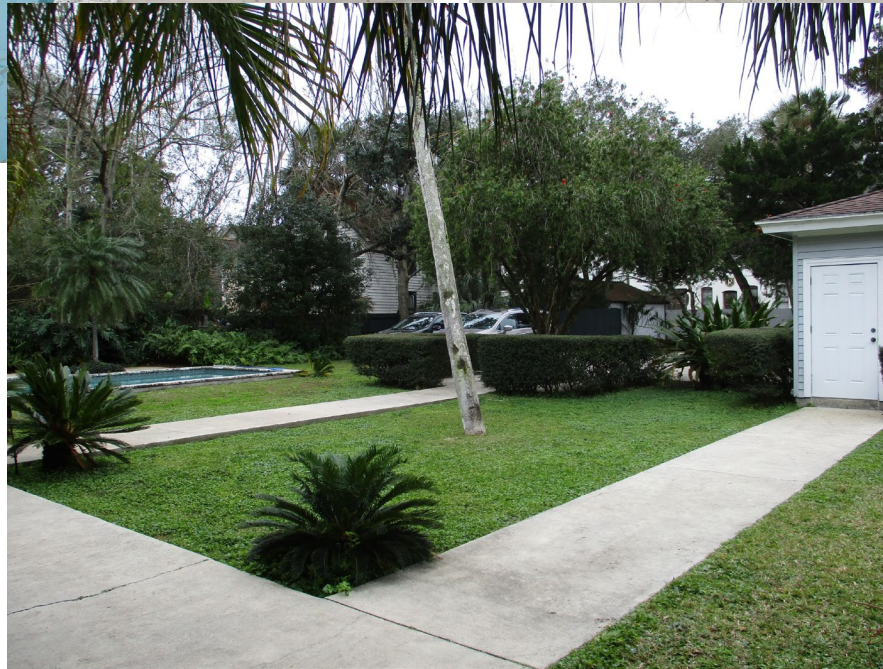
## STAFF PHOTOGRAPHS 252 St. George Street

Looking north,  
northwest, and  
southwest at project  
area for addition

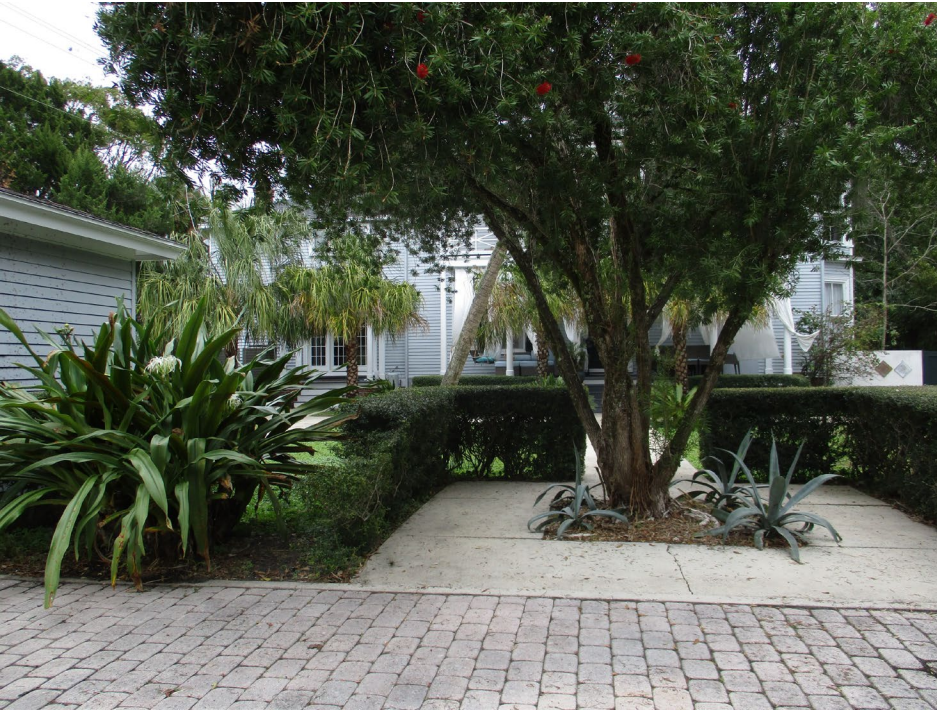
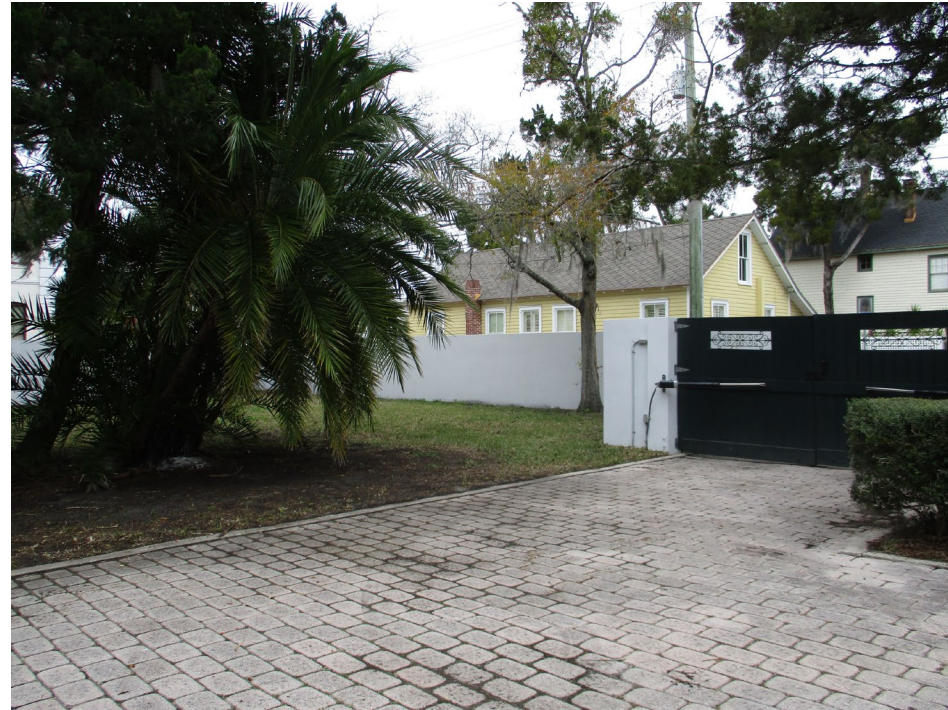
**STAFF PHOTOGRAPHS**  
**252 St. George Street**

Looking east at rear of building and north toward Bridge Street driveway entrance

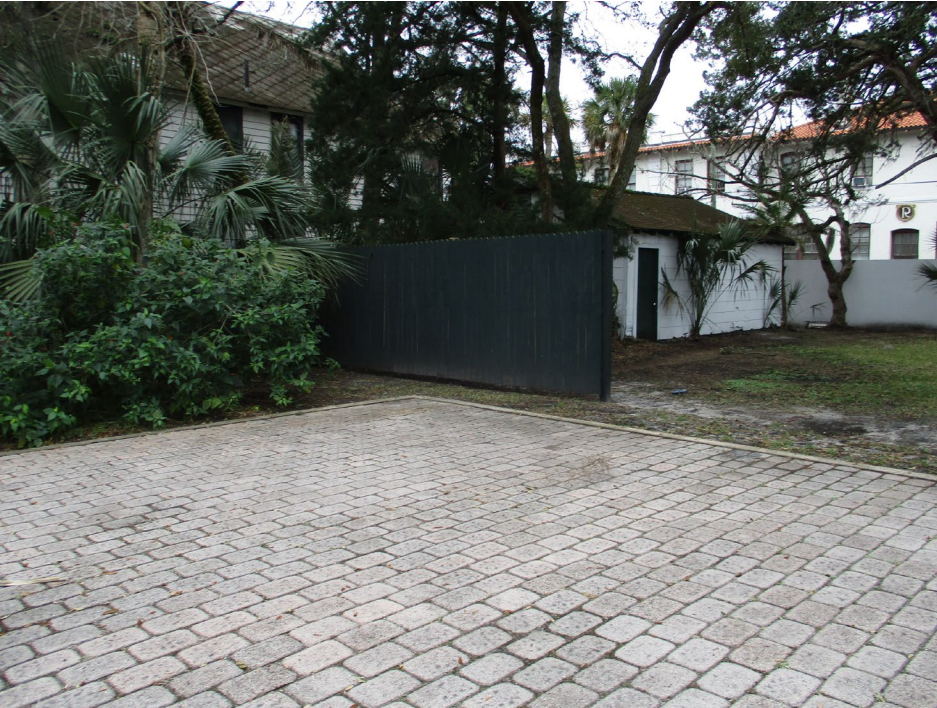
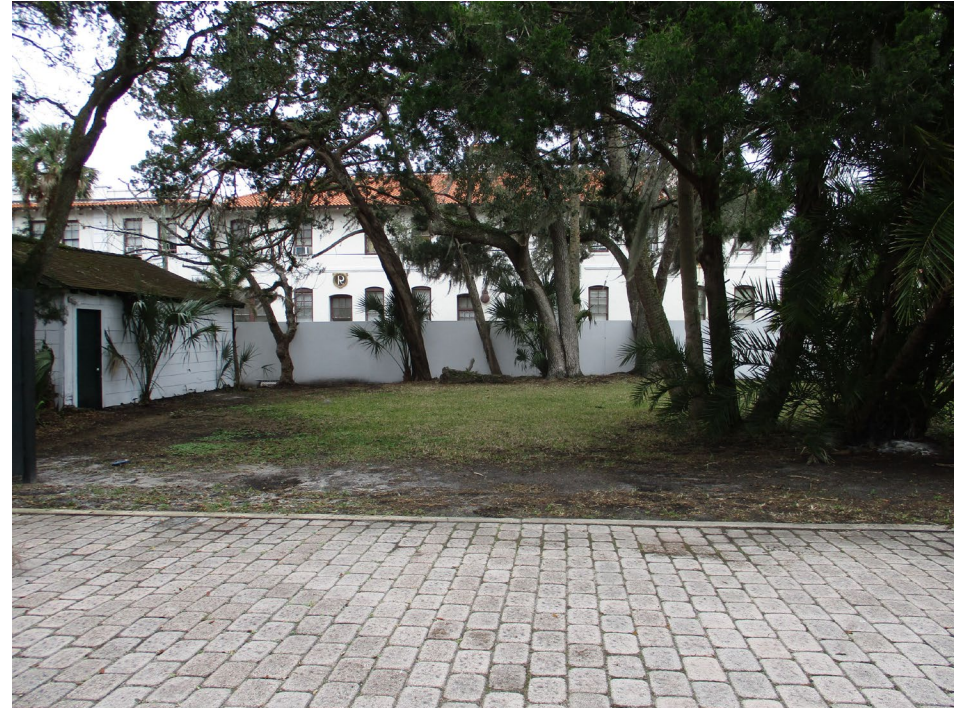
**STAFF PHOTOGRAPHS**  
**252 St. George Street**

Looking west at rear of property toward Cordova Street

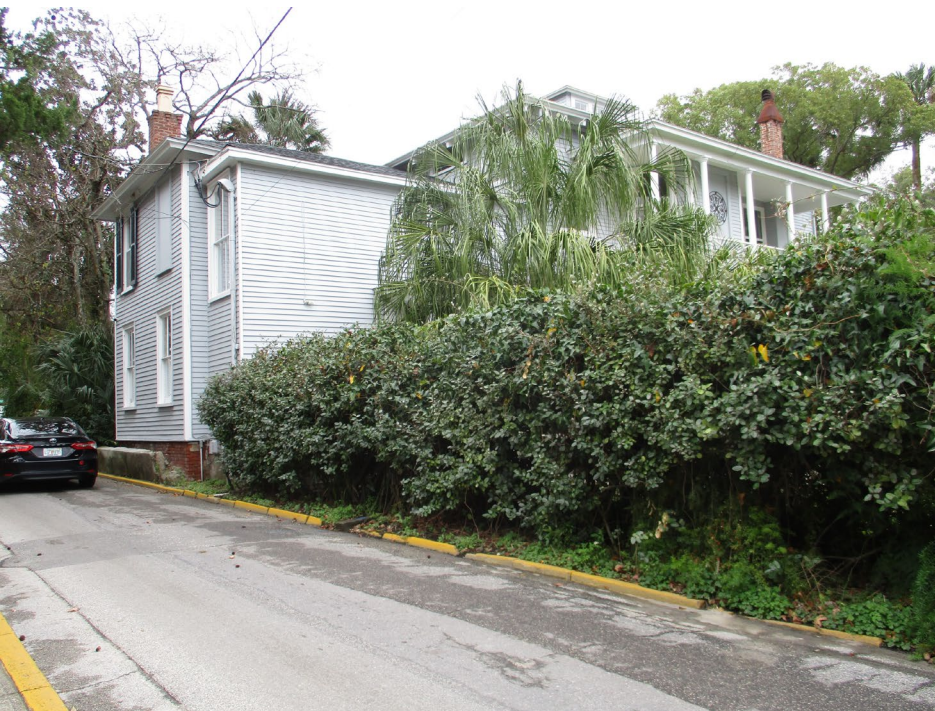
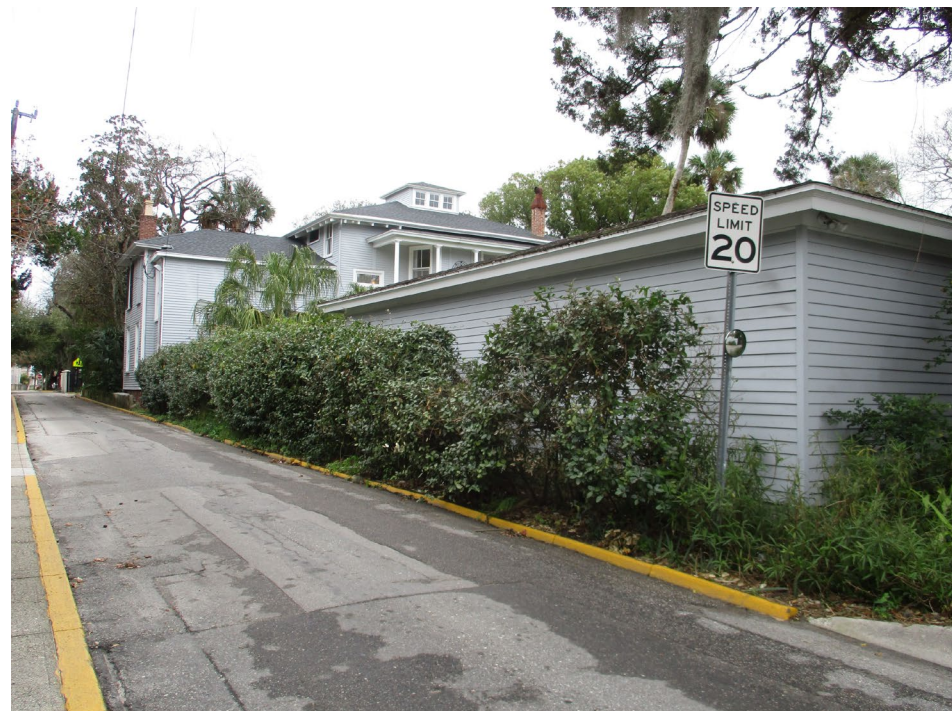
**STAFF PHOTOGRAPHS**  
**252 St. George Street**

Looking east and southeast at rear of building and garage along Bridge Street

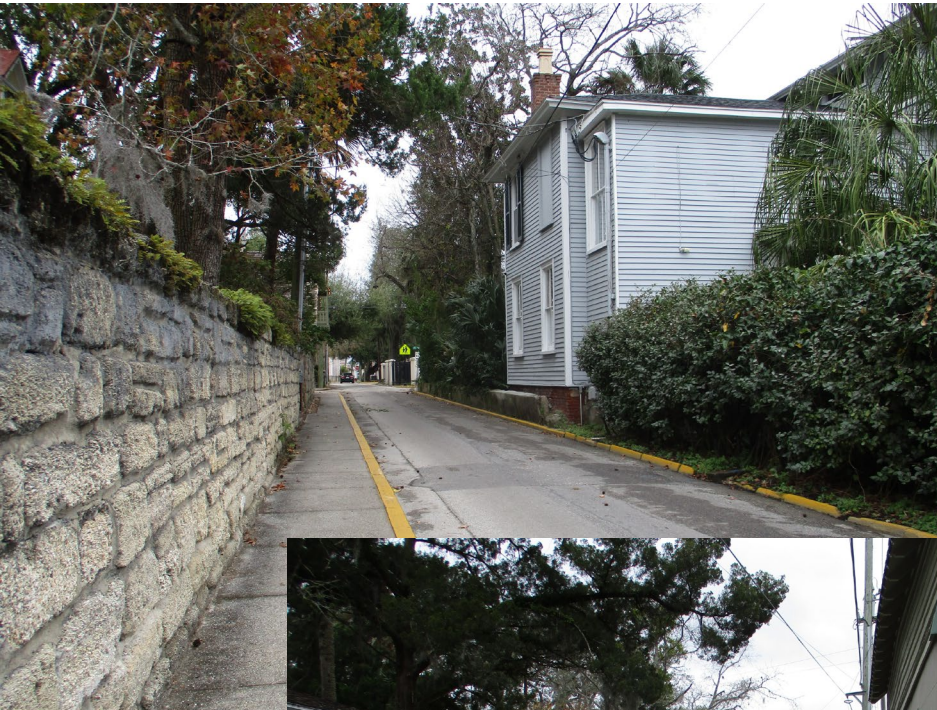
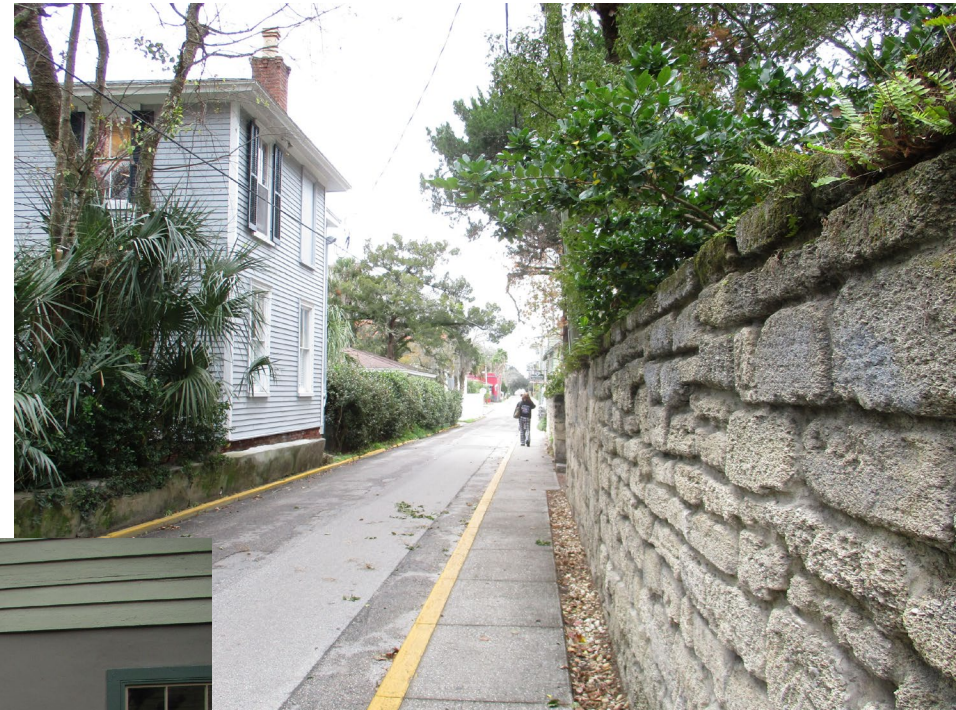
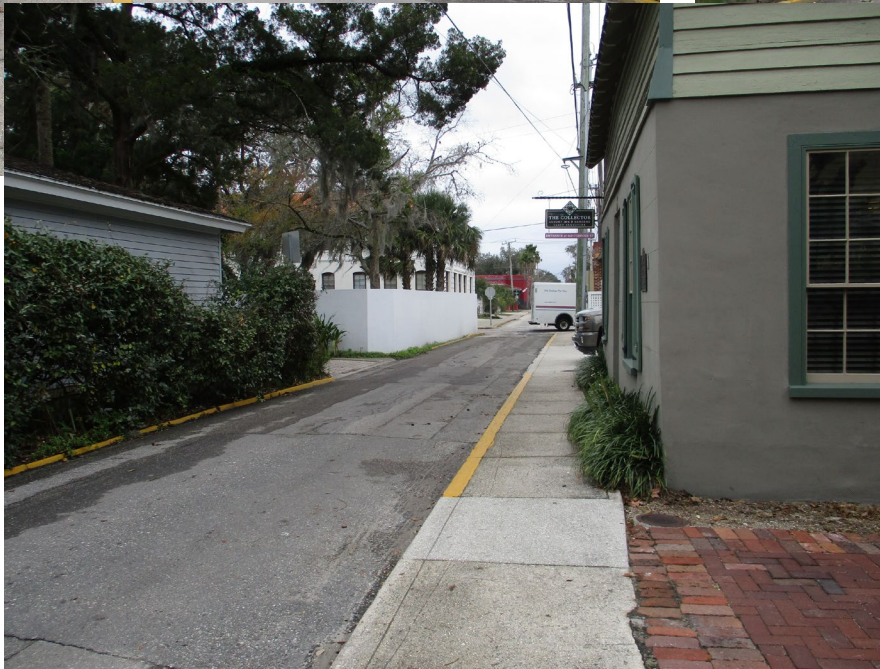
# STAFF PHOTOGRAPHS

Looking east down Bridge Street along  
north property line;  
Looking west down Bridge Street along  
north property line;  
Looking west down Bridge Street at garage  
and rear wall;  
Existing wall with vine hedge to remain

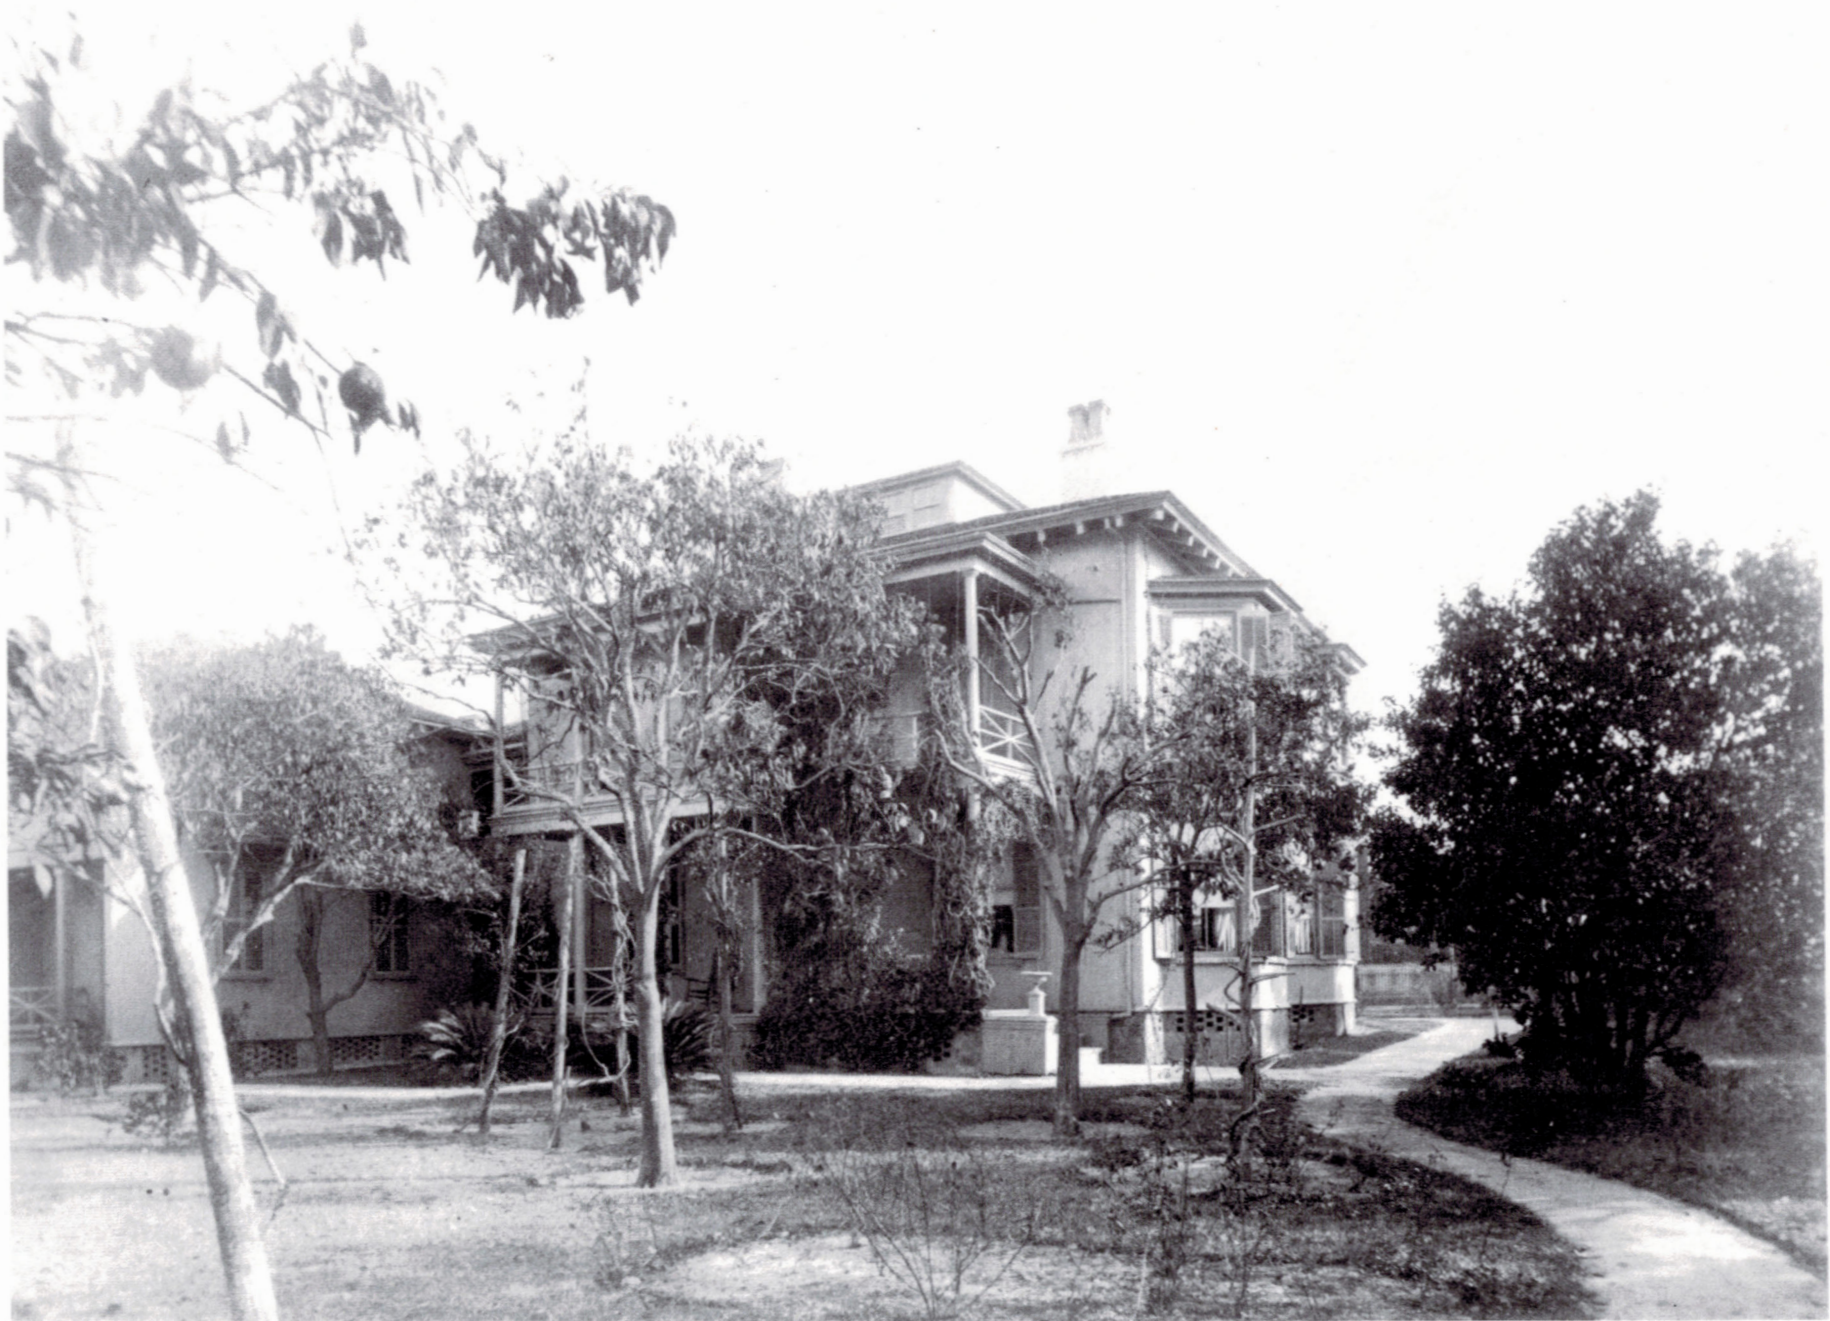
c. 1918: Rear of Bronson Cottage (252 St. George Street) - photo provided by owner, Tara Owen

An examination of the Saborn Fire Insurance maps of St. Augustine between 1884 and 1930 shows some of the alterations that were made to the Bronson Cottage and its outbuildings. Between 1884 and 1888 a long, open one story porch was added to the rear of the house. Between 1893 and 1899 the rear porch was raised to two stories. Between 1917 and 1918 the front porch, originally just one bay wide, was extended the length of the facade. Some of the original porch posts are now used as pilasters. They are octagonal in shape, with capitals--of a type frequently found on Carpenter Gothic houses. The replacements found on the enlarged porch are round, with the ones on the first floor being quite massive. A two-story rear L along the Bridge Street side of the property was removed in recent years.

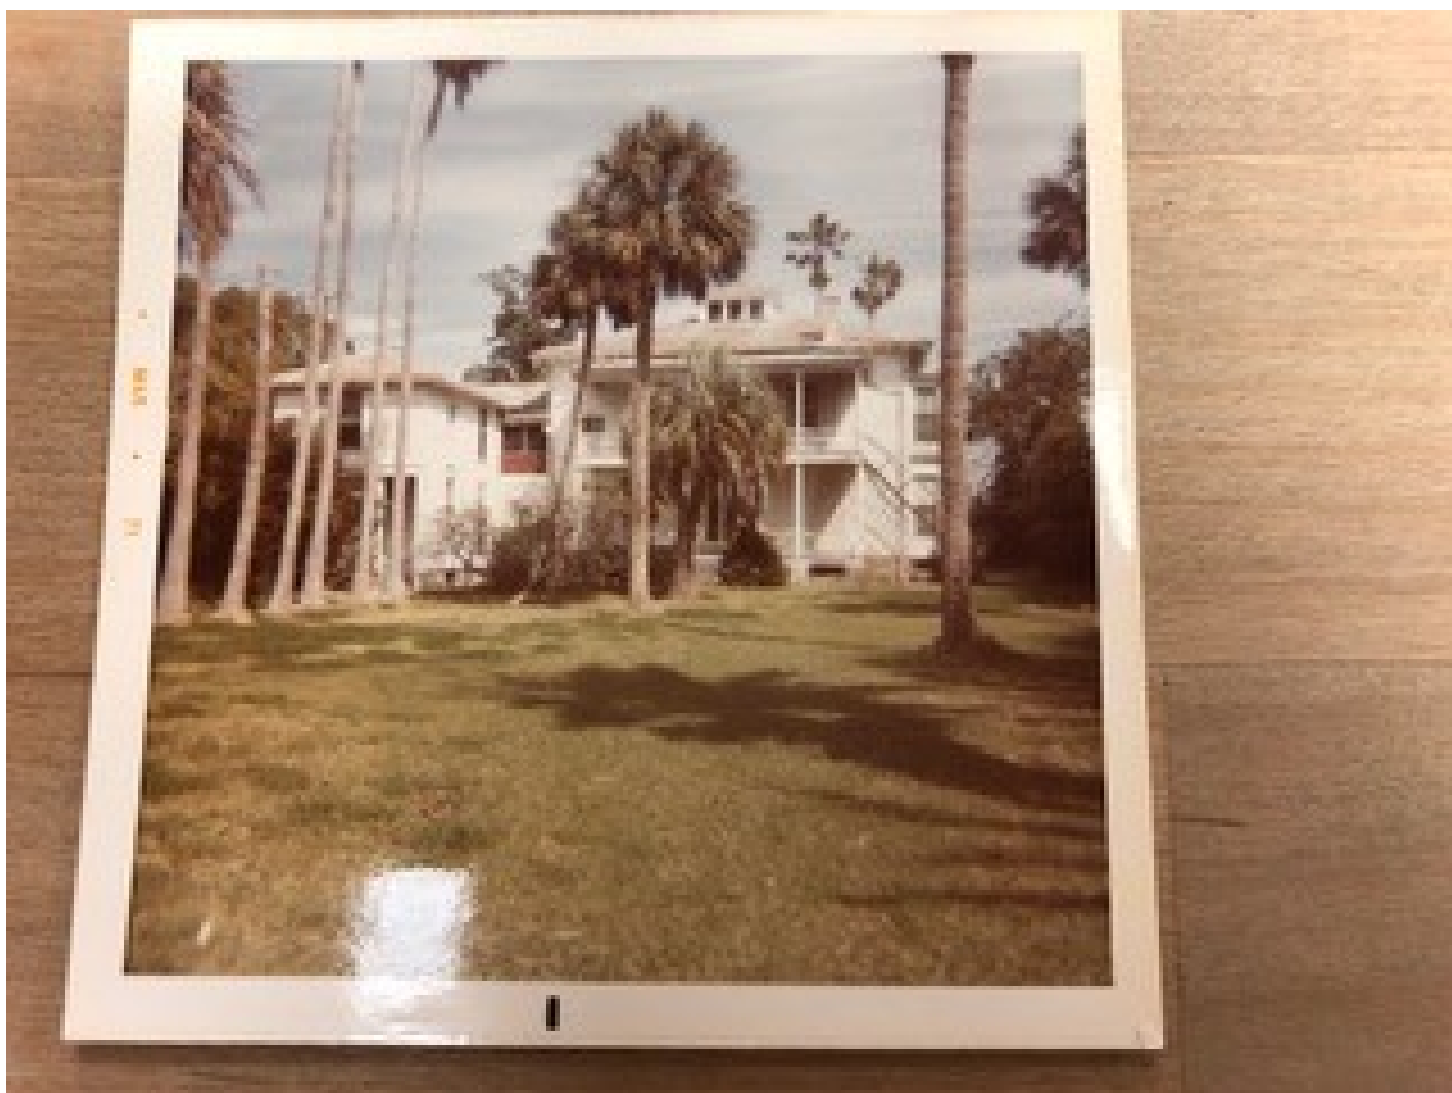
c. 1960: Rear of Bronson Cottage (252 St. George Street) - photo provided by owner, Tara Owen

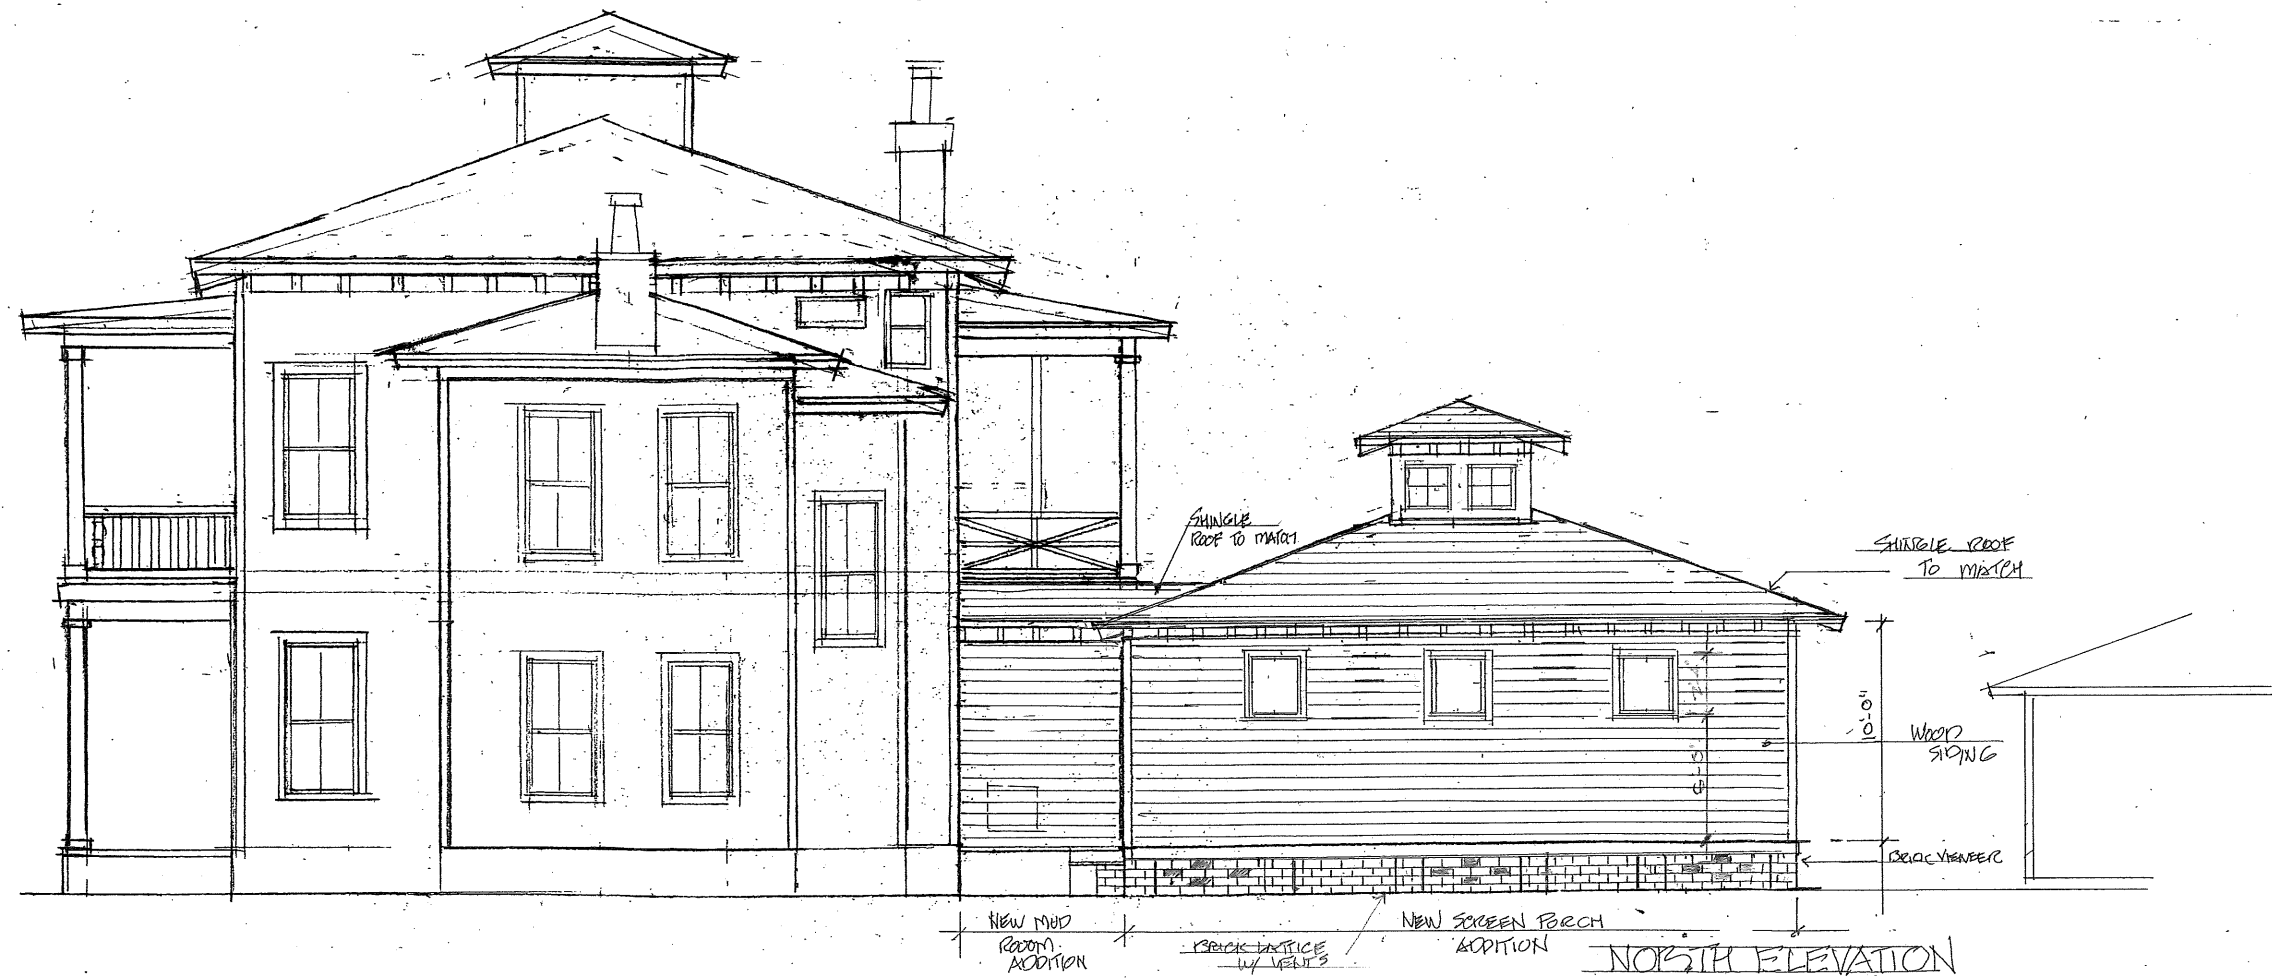
NEW FOYER.  
ROOM ADDITION  
+ EXISTING  
PORCH  
TO BE  
INCORPORATED
