RE: 7 Aviles Street

Re: 7 Aviles Street - Evaluation

AES Project: #326-085

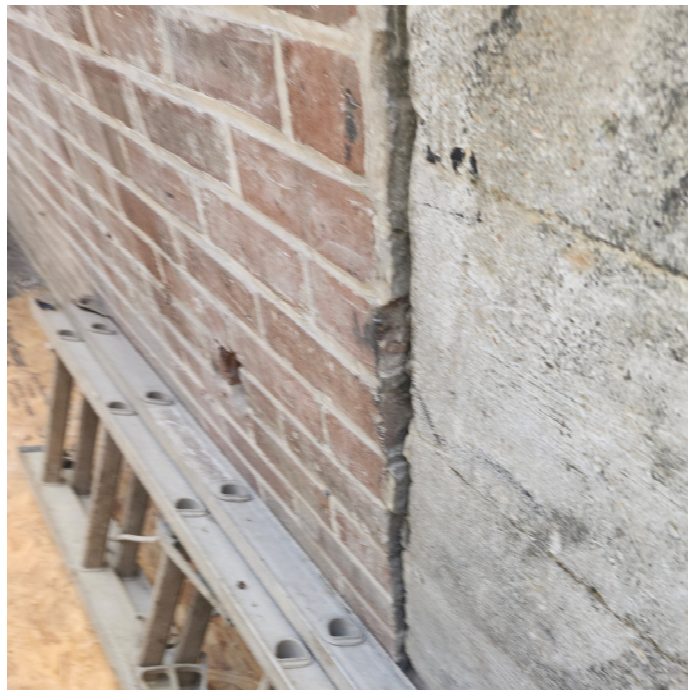
5. The brick veneer at the west addition has no ties anchoring the brick back to the structure. The mortar is severely deteriorated and many of the bricks were loose. The brick is buckling on both the north and south faces of the building. The north face has significant visible movement at the northwest corner of the building (see Photographs 9 and 10).

Photograph 10 - Brick Separating at South Wall

In conclusion, the west addition exterior walls and façade are in poor condition. The brick façade is in poor condition and in danger of failing. These walls are danger to life and property. AES has provided the contractor with a temporary bracing plan to stabilize the brick veneer.

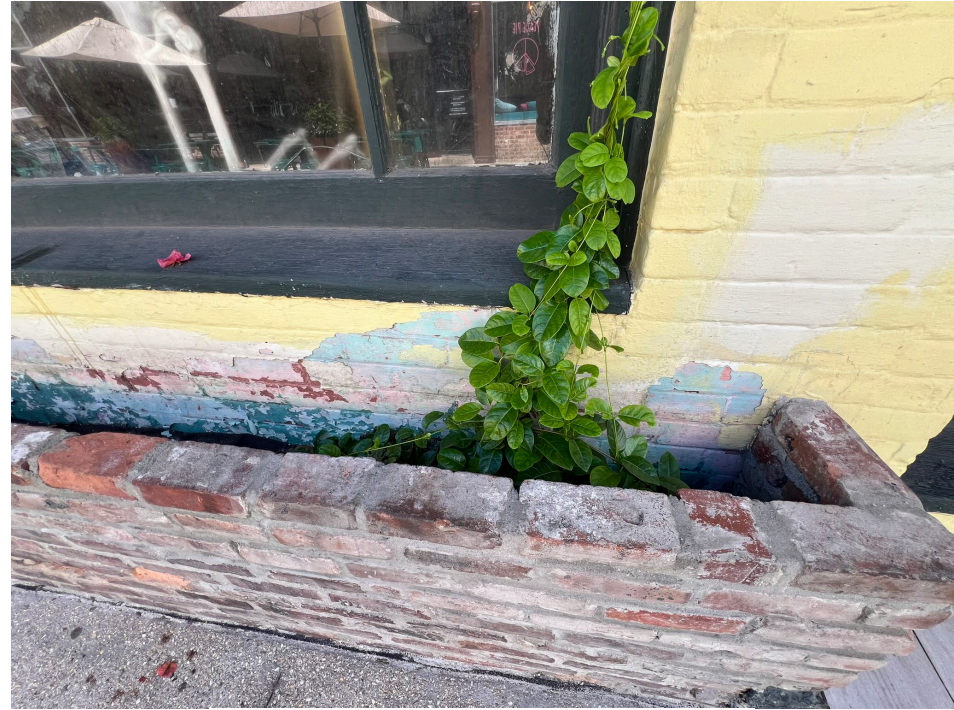
Brick planters to be removed
