# City of St. Augustine

## Historic Architectural Review Board

**Thursday, March 21, 2019 1:00 p.m. \*Amended**

**HISTORIC ARCHITECTURAL REVIEW BOARD**  
**STAFF REPORT AND RECOMMENDATION**  
Prepared for March 21, 2019 Meeting

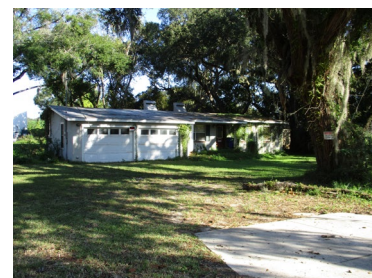
Main Elevation

- No significant historical connection was found.
- The building has no significant architectural features that make it unique.
- A condition assessment was not provided and is not required since the building is not listed on the National Register of Historic Places.

- The area around the home has been developed, and neighboring buildings include Home Depot, a warehouse, and a restaurant. This has caused the building to lose its sense of place and context.

Based on a review of the AGHP and without the support of evidence to the contrary, staff finds that the board can Approve a Certificate of Demolition for 190 Nix Boat Yard Road with the following condition:

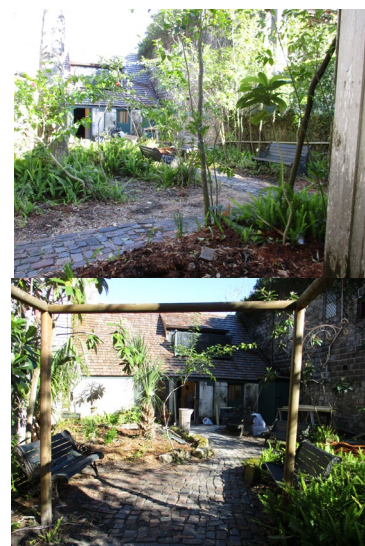
The current rear courtyard

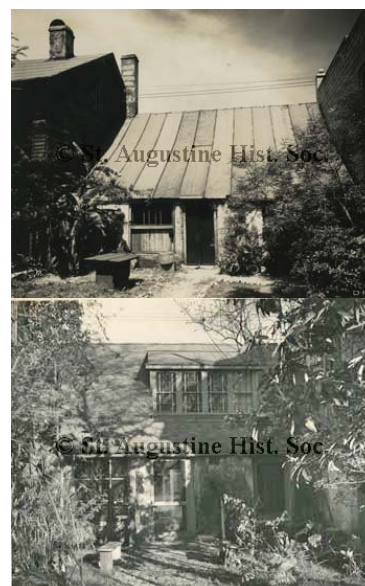
Historic photographs

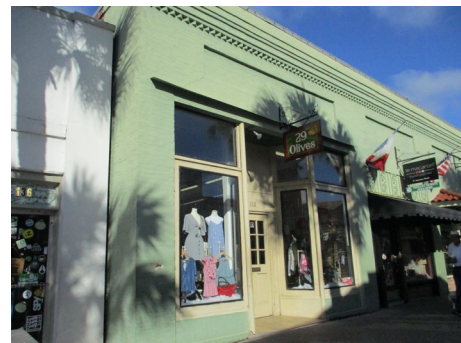
Current Storefront

- The proposed colors are not on the pre-approved color list for the building style but are the same as what is used on the existing sign. The board will need to approve these colors.
- The font is also not on the current approved text list, and there are no similar styles. The board will also need to approve the text style.
- The proposed shape of the sign and the wood material are appropriate.
- The current wall mounted element is appropriate. The applicant should clarify if the same, or a similar, element will be used.

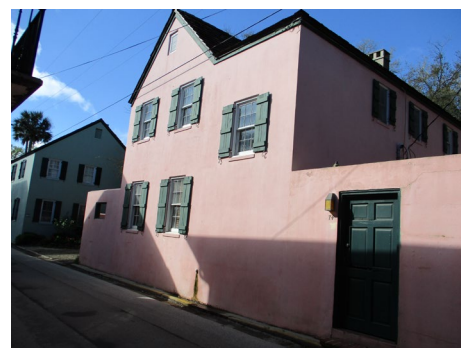
Main Façade

- The home has both six over six and four over four windows. The photographs provided with the application show the proposed windows having the same glazing configuration or pattern.

- The proposed windows have raised muntins that have a similar, but not identical, appearance to those on the existing windows.
- If feasible, the existing windows should be repaired. If the windows cannot be repaired, the new windows should have a compatible appearance and be made from the same or compatible material as the existing windows. Vinyl is typically not considered a compatible material.

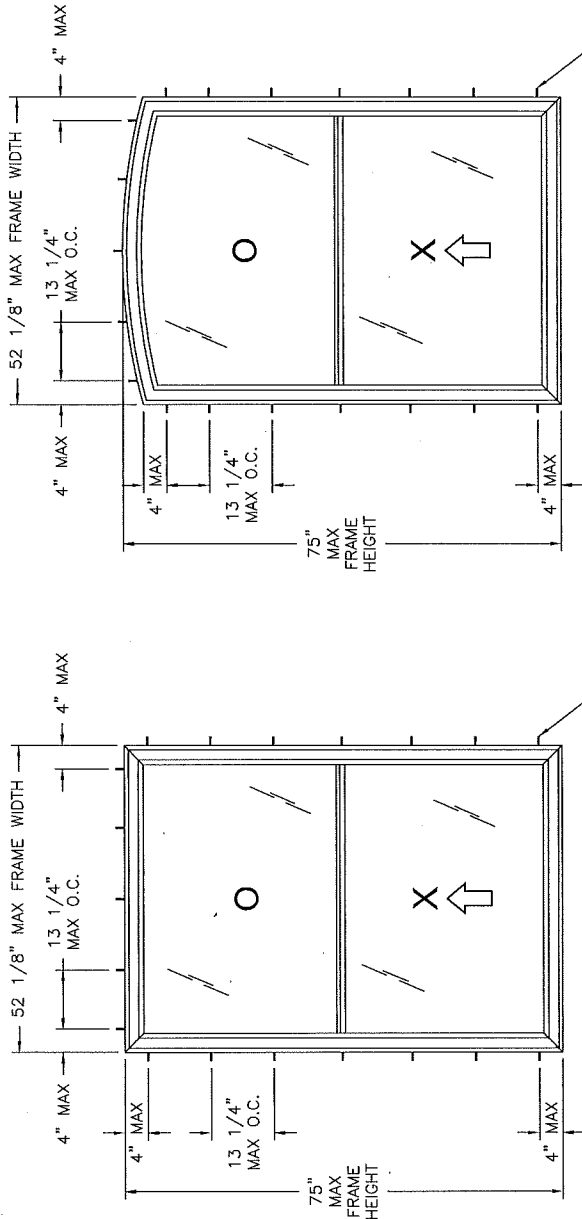
1620 SH REINFORCED  
RECTANGULAR  
EXTERIOR VIEW  
FINLESS & FLANGE INSTALLATION

FOR NUMBER OF ANCHORS REQUIRED SEE CHART #1

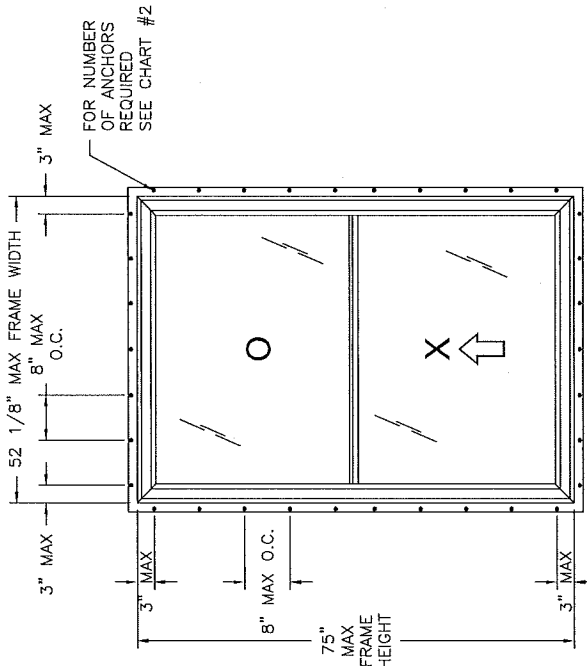
1620 SH REINFORCED  
RECTANGULAR  
EXTERIOR VIEW  
FIN INSTALLATION

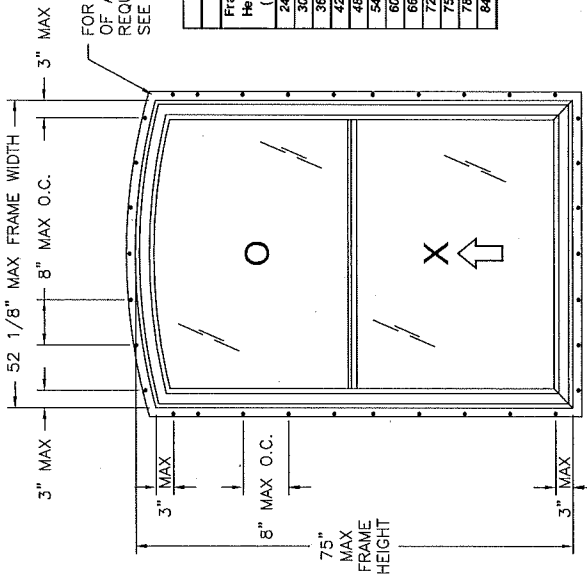
1620 SH REINFORCED  
EXTERIOR VIEW  
FIN INSTALLATION

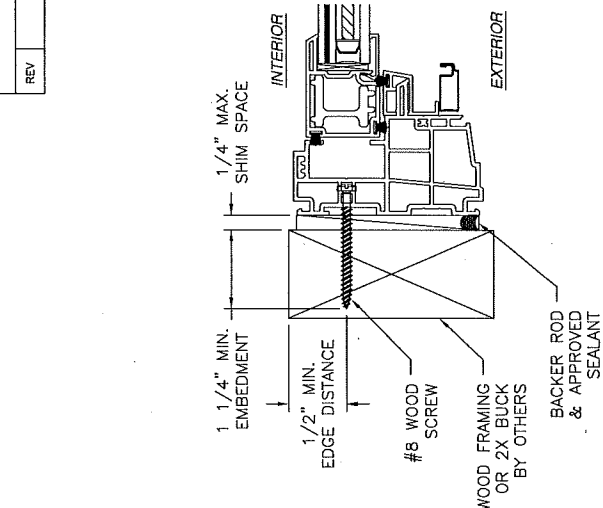
JAMB INSTALLATION DETAIL  
WOOD FRAMING OR 2X BUCK INSTALLATION

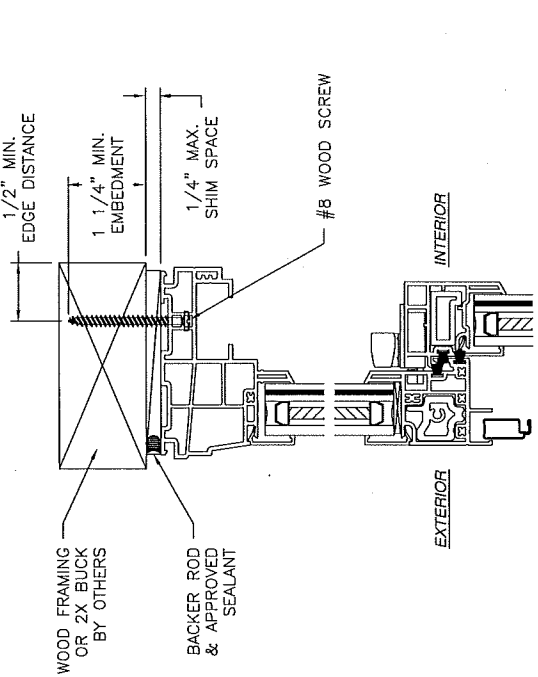
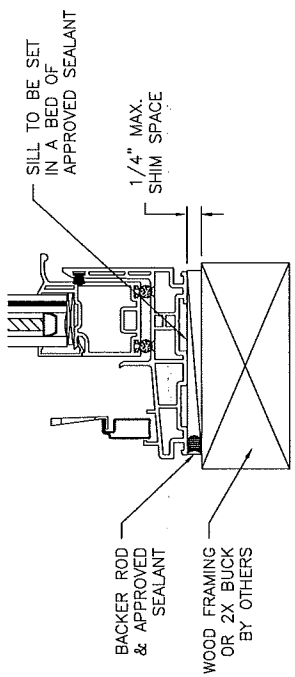
VERTICAL CROSS SECTION  
WOOD FRAMING OR 2X BUCK INSTALLATION

- NOTES:
1. INTERIOR AND EXTERIOR FINISHES, BY OTHERS, NOT SHOWN FOR CLARITY.
  2. PERIMETER AND JOINT SEALANT BY OTHERS TO BE DESIGNED IN ACCORDANCE WITH ASTM E2112

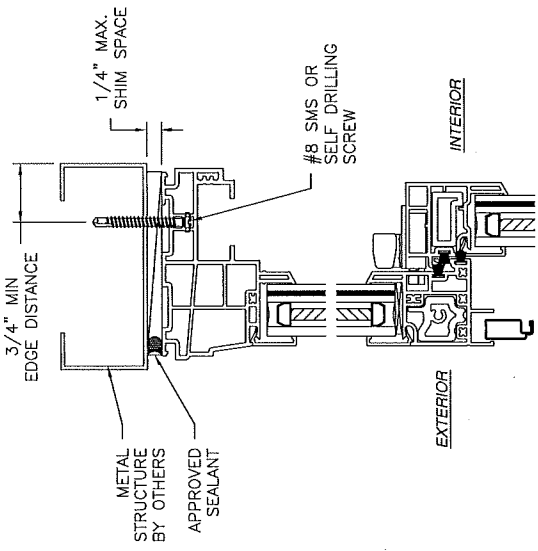
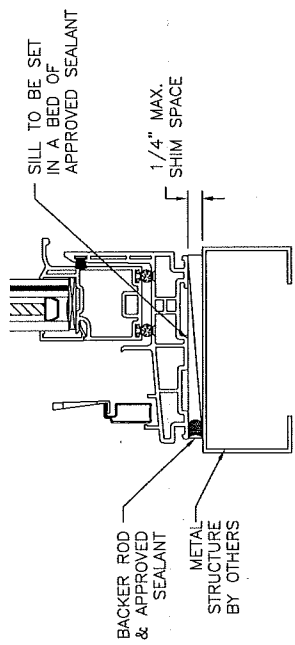
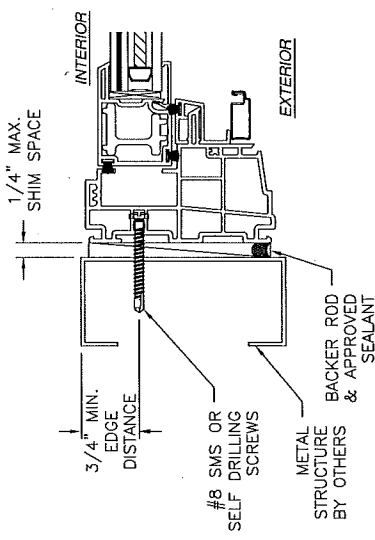
JAMB INSTALLATION DETAIL  
METAL STRUCTURE INSTALLATION

VERTICAL CROSS SECTION  
METAL STRUCTURE INSTALLATION

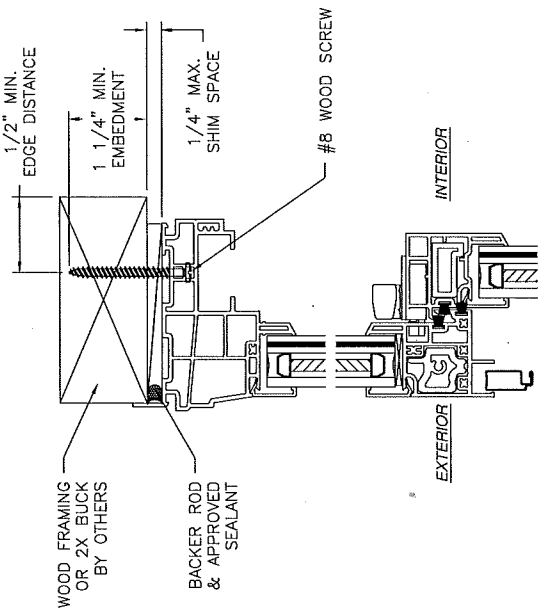
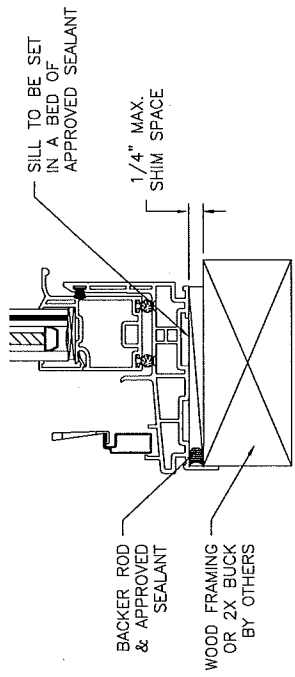
VERTICAL CROSS SECTION  
WOOD FRAMING OR 2X BUCK INSTALLATION

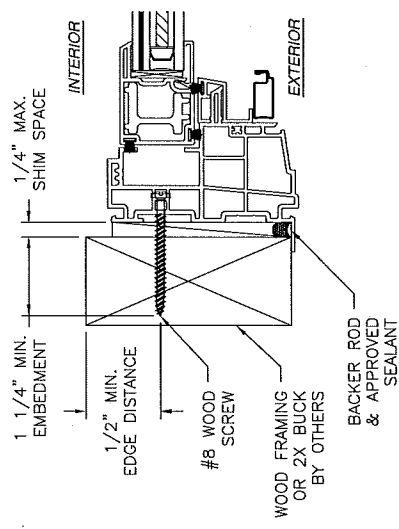
JAMB INSTALLATION DETAIL  
WOOD FRAMING OR 2X BUCK INSTALLATION

- NOTES:
1. INTERIOR AND EXTERIOR FINISHES, BY OTHERS, NOT SHOWN FOR CLARITY.
  2. PERIMETER AND JOINT SEALANT BY OTHERS TO BE DESIGNED IN ACCORDANCE WITH ASTM E2112

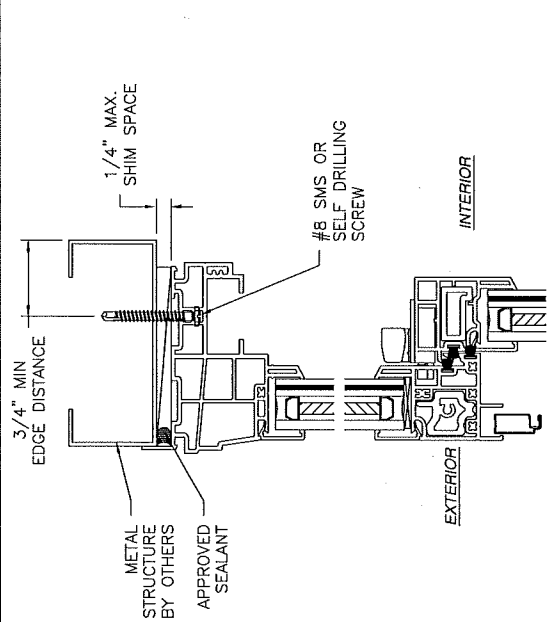
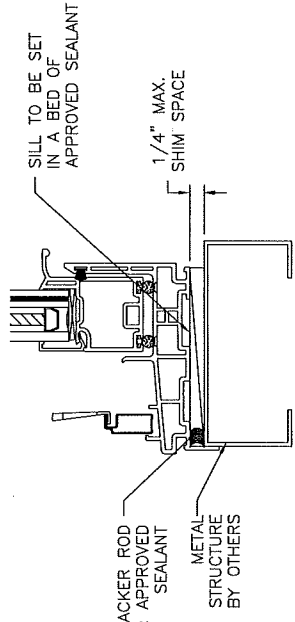
VERTICAL CROSS SECTION  
METAL STRUCTURE INSTALLATION

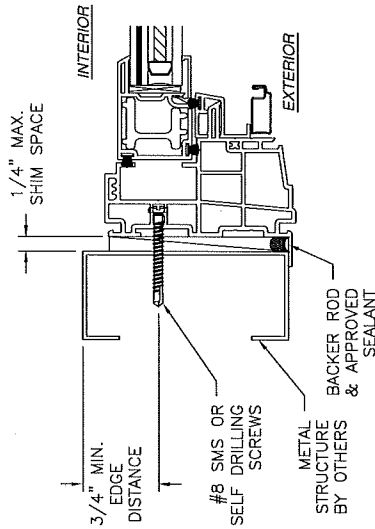
JAMB INSTALLATION DETAIL  
METAL STRUCTURE INSTALLATION

- NOTES:
1. INTERIOR AND EXTERIOR FINISHES, BY OTHERS, NOT SHOWN FOR CLARITY.
  2. PERIMETER AND JOINT SEALANT BY OTHERS TO BE DESIGNED IN ACCORDANCE WITH ASTM E2112

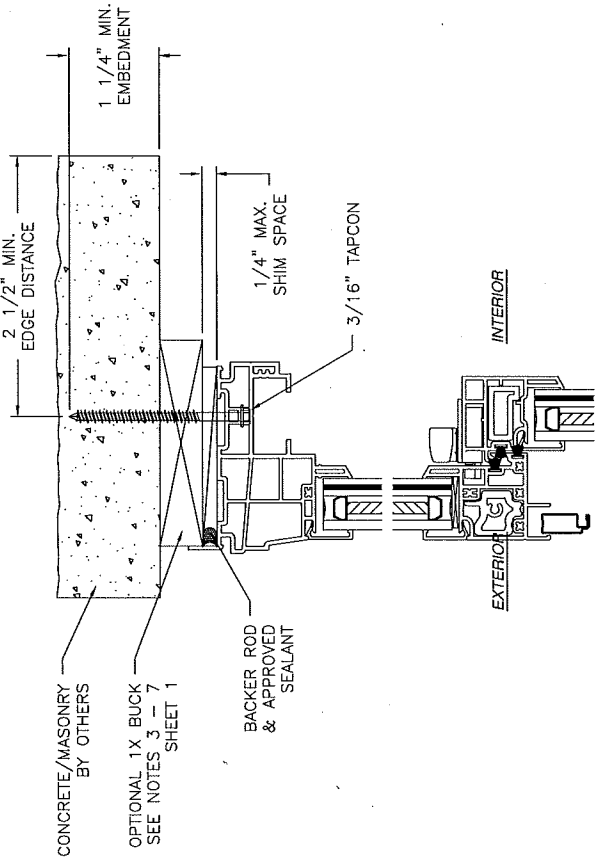
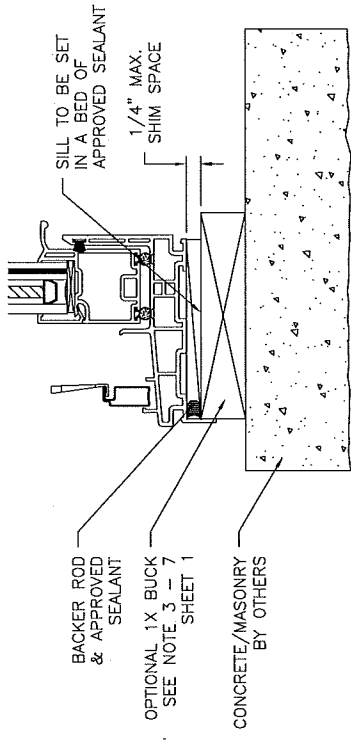
VERTICAL CROSS SECTION  
CONCRETE/MASONRY INSTALLATION

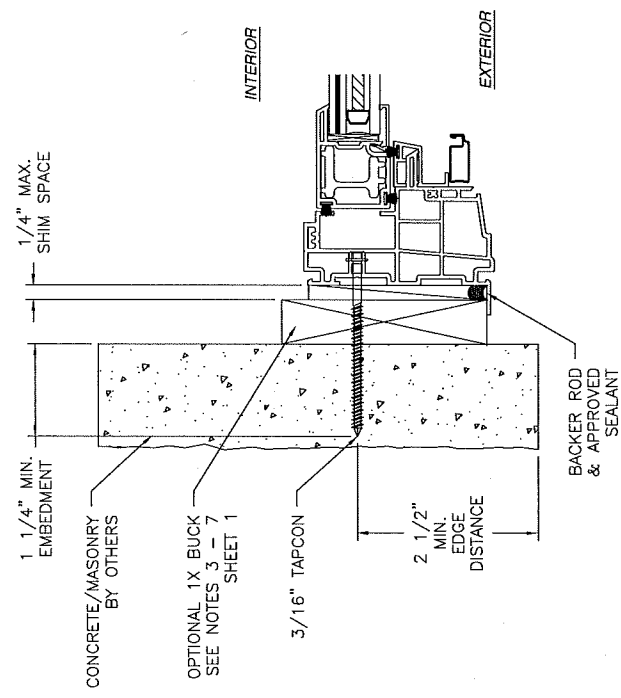
JAMB INSTALLATION DETAIL  
CONCRETE/MASONRY INSTALLATION

- NOTES:
1. INTERIOR AND EXTERIOR FINISHES, BY OTHERS, NOT SHOWN FOR CLARITY.
  2. PERIMETER AND JOINT SEALANT BY OTHERS TO BE DESIGNED IN ACCORDANCE WITH ASTM E212

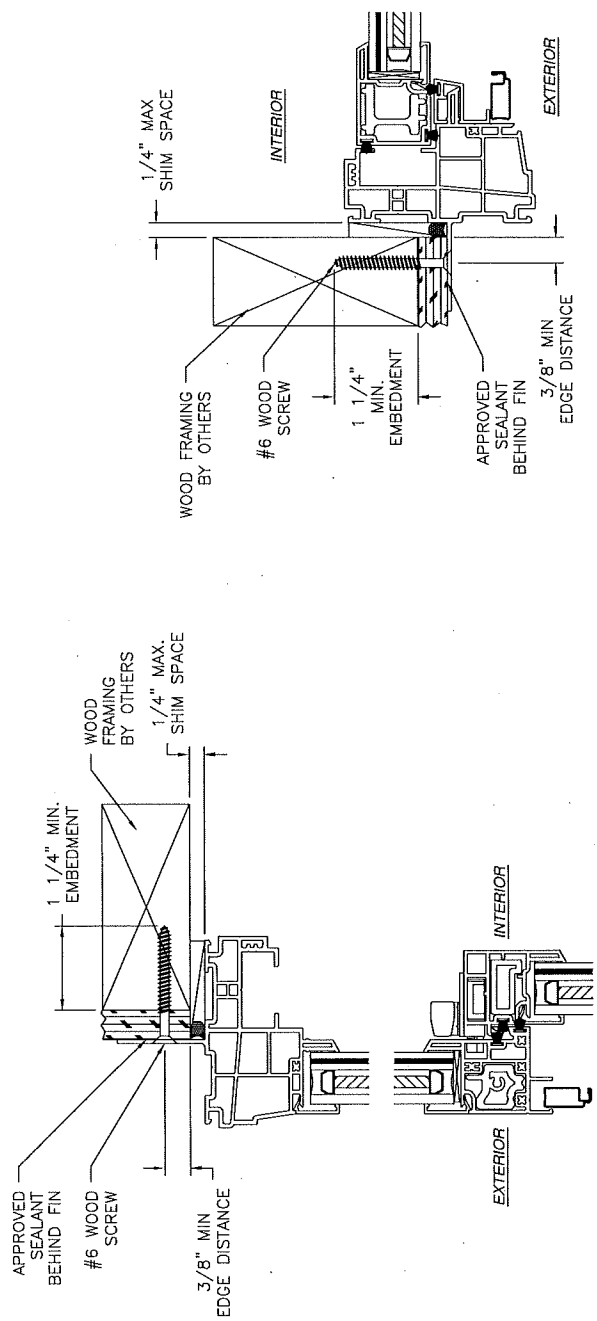
**JAMB INSTALLATION DETAIL**  
WOOD FRAMING OR 2X BUCK INSTALLATION

- NOTES:
1. INTERIOR AND EXTERIOR FINISHES, BY OTHERS, NOT SHOWN FOR CLARITY.
  2. PERIMETER AND JOINT SEALANT BY OTHERS TO BE DESIGNED IN ACCORDANCE WITH ASTM E2112

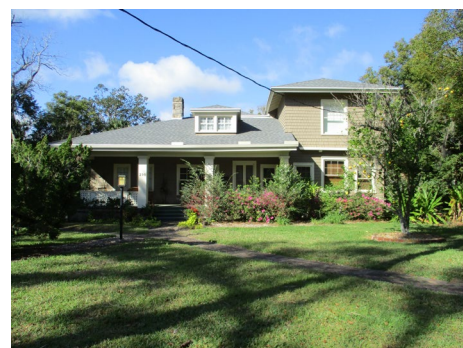
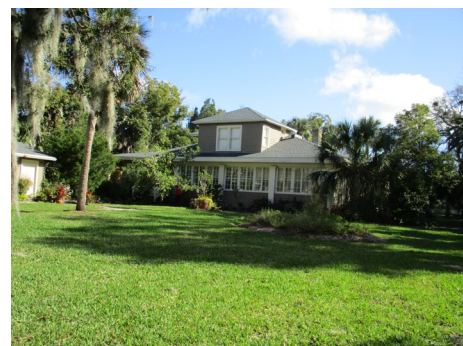
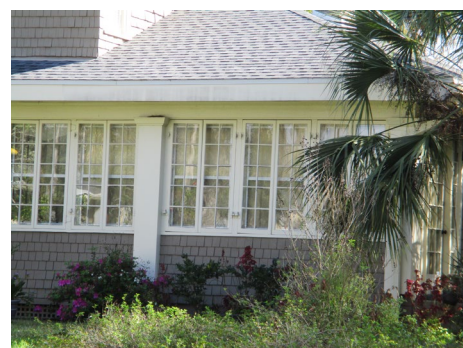
F2019-0024  
298 St. George Street  
March 21, 2019

- The existing front door is a double leaf door, and the applicant is interested in replacing it with a single leaf door made of fiberglass. Doors within this style are typically made of wood.

- It is unclear if the current door is original to the home or is a replacement.

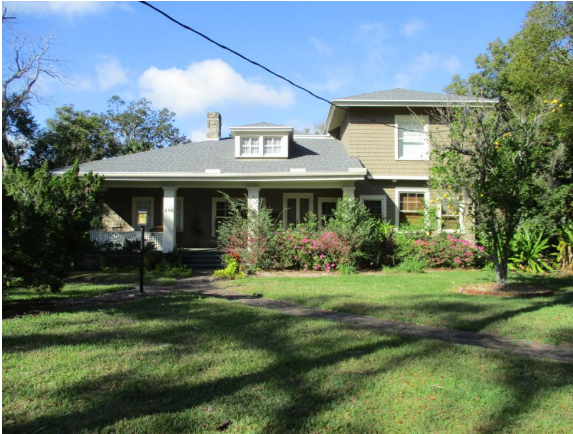
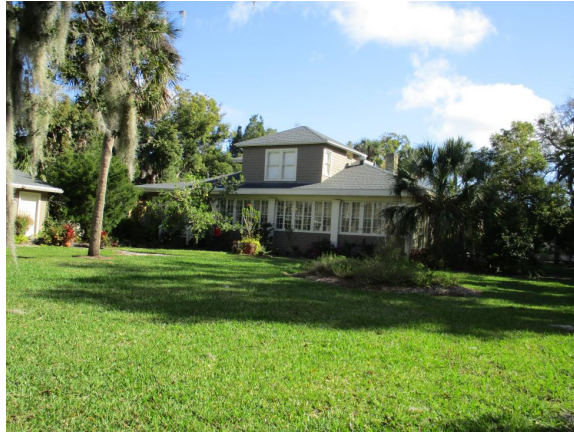
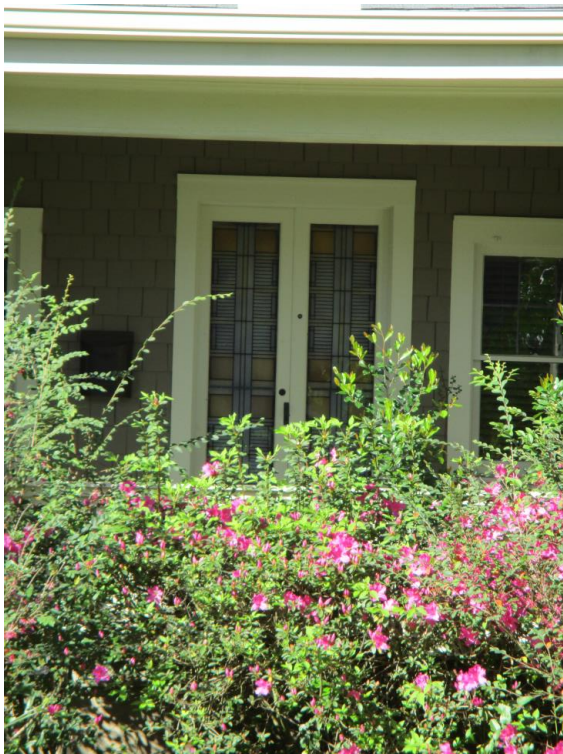
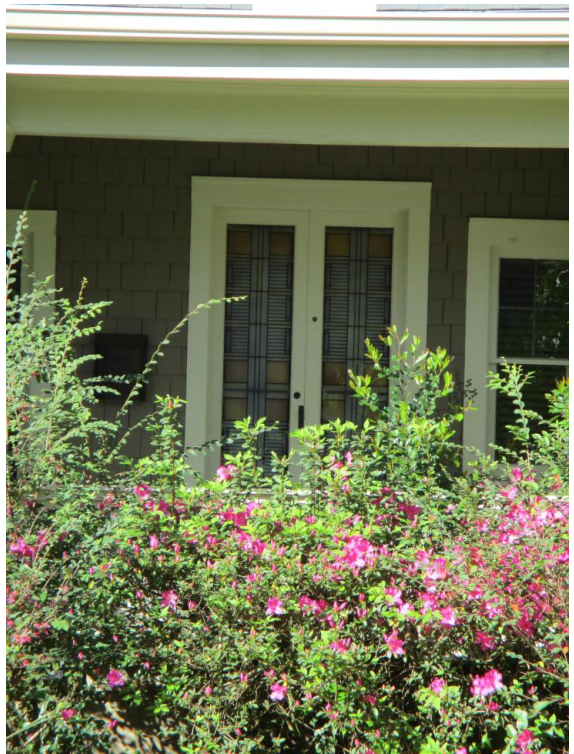
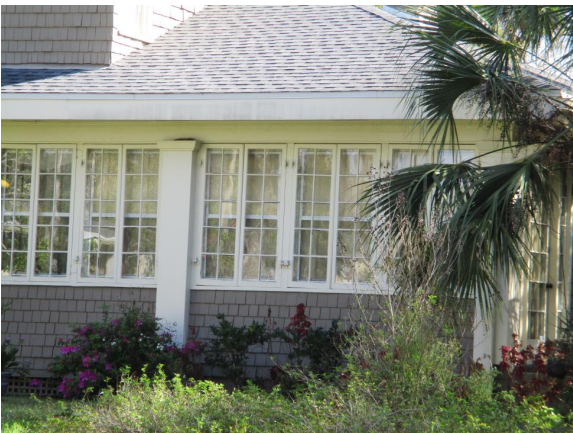
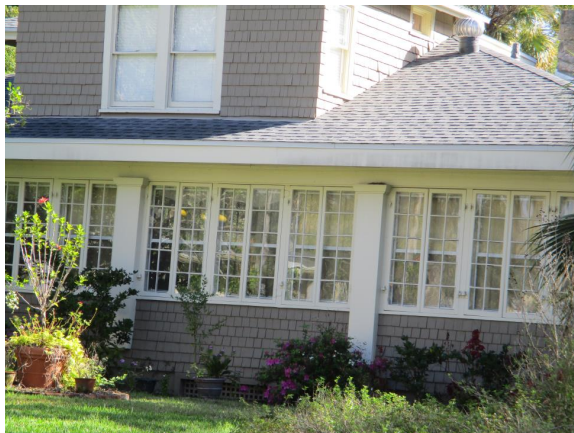
F2019-0024  
298 St. George Street  
March 21, 2019  
STAFF PHOTOGRAPHS:

- According to an assessment provided by Charlie Wild of Mastercraft Window and Door, the existing windows are in poor condition, are falling apart, and are a fire hazard.

1. The existing windows are beyond repair.
2. The replacement windows are compatible.

- Replace existing rear casement windows with wood clad windows
- Replace existing double leaf door with a single leaf, fiberglass door

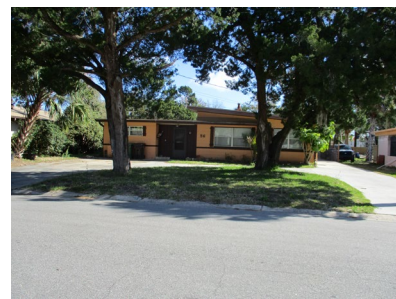
Main Elevation

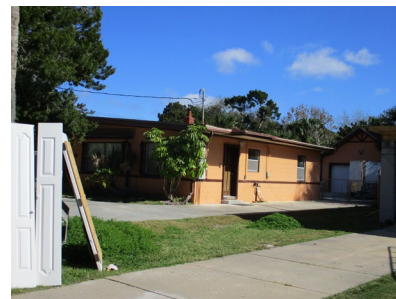
Side Elevation

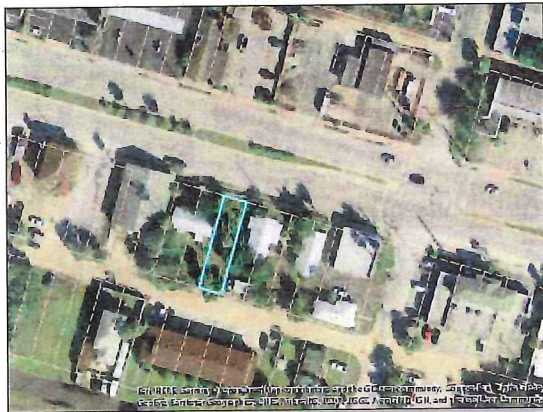
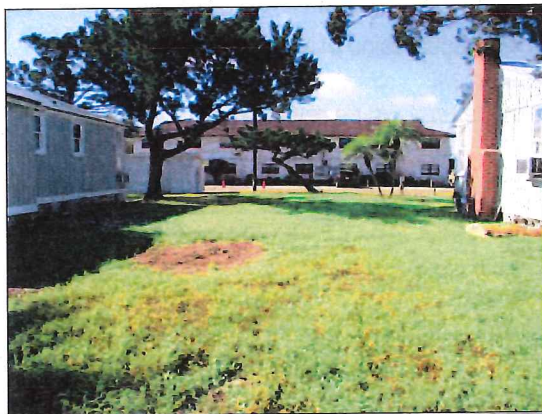
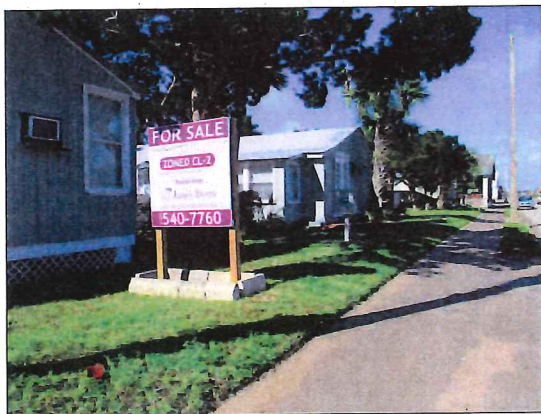
- place a pre-engineered building on the property consistent with the 'tiny-home' movement:
  - steel frame, 140 square feet, measuring 20 feet long, 8 feet wide, and 13 feet high
  - siding includes corrugated metal siding with ribs running in vertical orientation, 1x6 stained cedar siding, and various sizes of vinyl horizontal siding, tinted, windows, and a front residential door with two vertical panels and 6-lite transom
  - foundation and patio/stoop access information not provided at the time of application

Property location and setting:

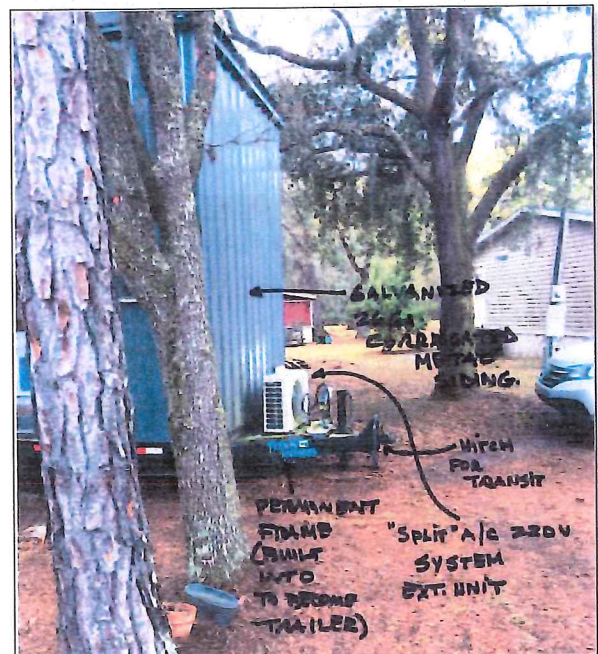
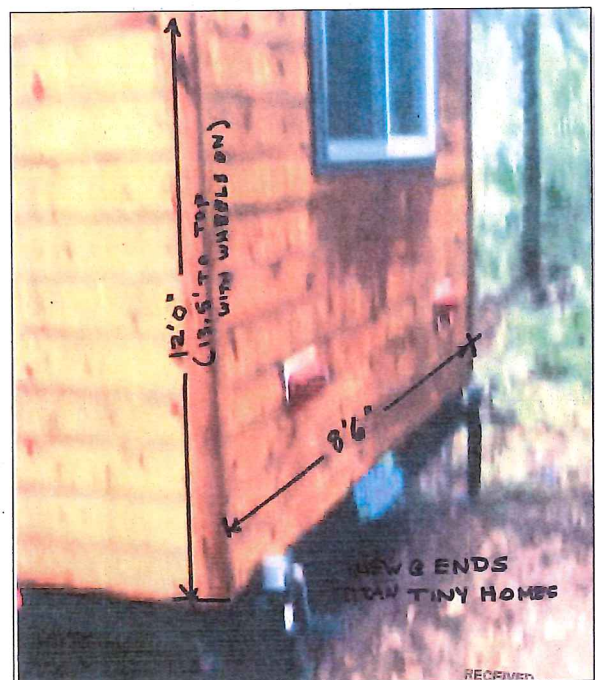
Narrow ends, one will face the street:

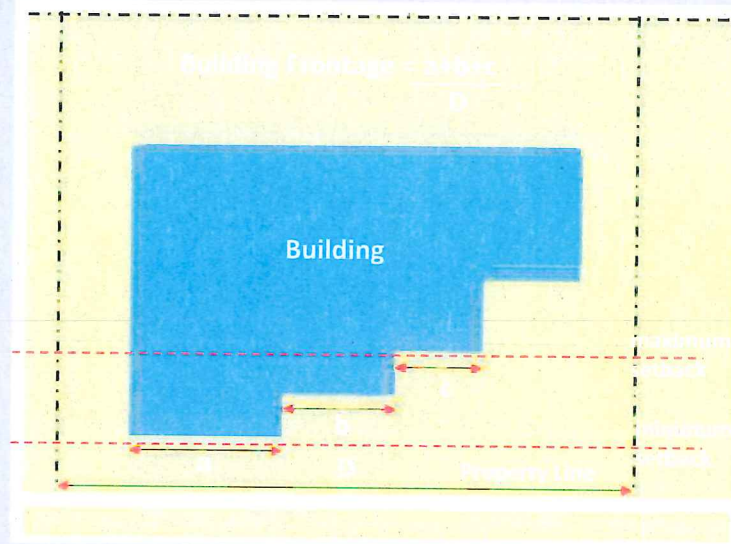
Figure 4. Building Frontage Calculation

- The building frontage ( $a+b+c$ ) shall be a minimum of 50% of the site frontage ( $D$ ).
- Sites with frontages on multiple streets shall be required to meet the minimum required primary frontage along Anastasia Boulevard only.
- Exceptions to the Building Frontage requirements: In the event the proposed building width is too narrow to meet the minimum frontage requirement, the applicant shall have the option of dividing the lot into smaller, narrower lots to meet the dimension requirements, as shown on Figure 5. No replatting will be required, but the site plan shall show the new lots as available for future development.

The purpose of the following building frontage requirements is to ensure façade continuity along Anastasia Boulevard and to avoid large voids between buildings. The building frontage standards are stated as a proportion of the building width within the required building setback relative to the width of the development site measured at the site frontage line. Portions of the building façade outside the required front/street building setback do not count as building frontage (see Figure 4).

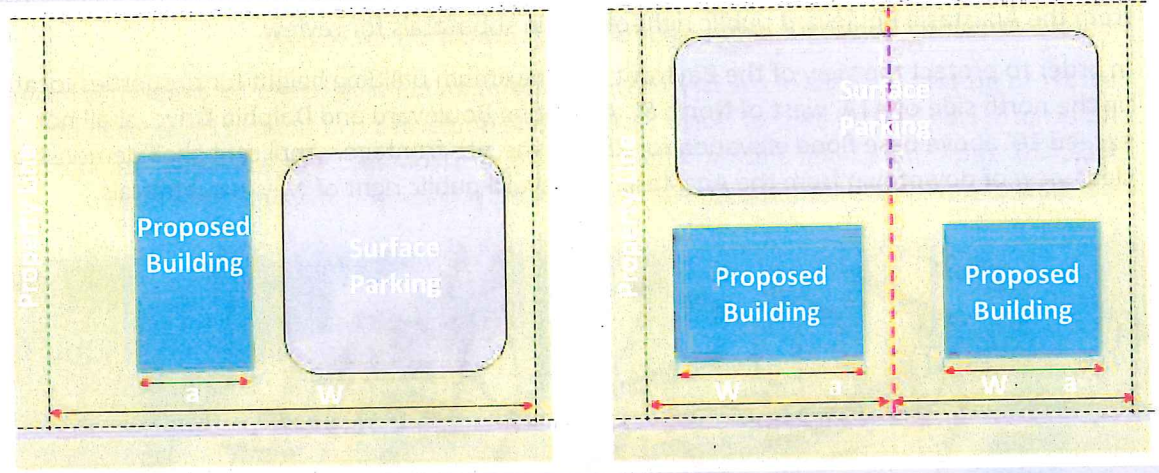
**Figure 5: Exceptions to the Building Frontage**

*Left diagram: Building width (a) is too narrow to meet the minimum building frontage. Right diagram: Subdivide the lot to decrease its width (W) to meet the minimum building frontage.*

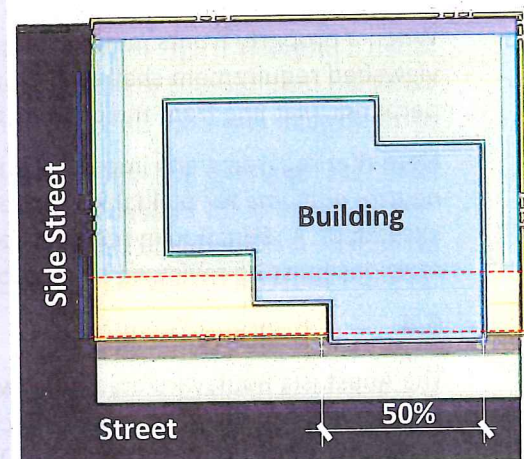
**Figure 6. Zero Lot Line**

- b. The minimum front and side street setbacks (as defined in Section 5.2.a) may be reduced to 0 feet for a maximum of 50 percent of the building façade facing the street. Note: Eaves and overhangs may not project over the property line. See Figure 6.
- c. The maximum front and side street building setback shall only apply to the portion of the building meeting the building frontage requirement. This provision will allow

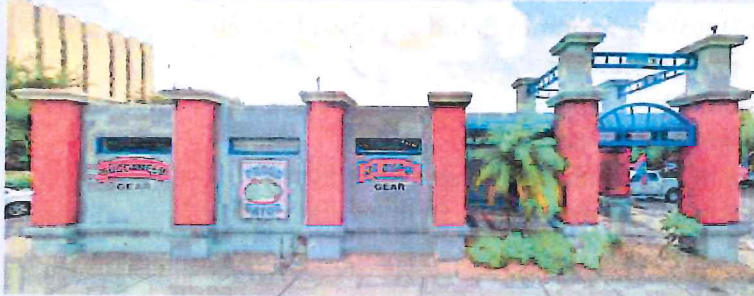
*Figure 21. Examples of Windows*

- a. The size and division of windows shall reflect horizontality.
- b. Multiple pane glass is allowed up to the allowed percentages of glass for any one façade. Windows that abut a right-of-away are to be arranged to enhance the pedestrian's viewing ability into the building.

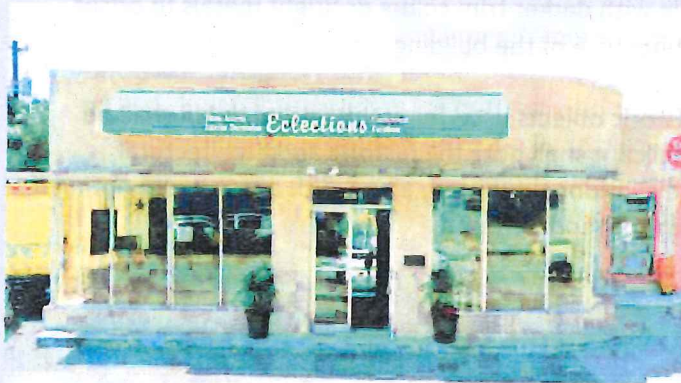
*Prohibited as it does not allow passerby visual access and it does not meet the 30% minimum rule*

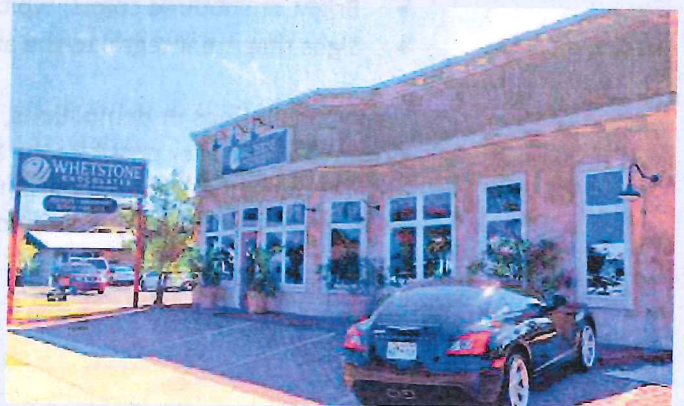
*Allowed as it allows passerby visual access into the building.*

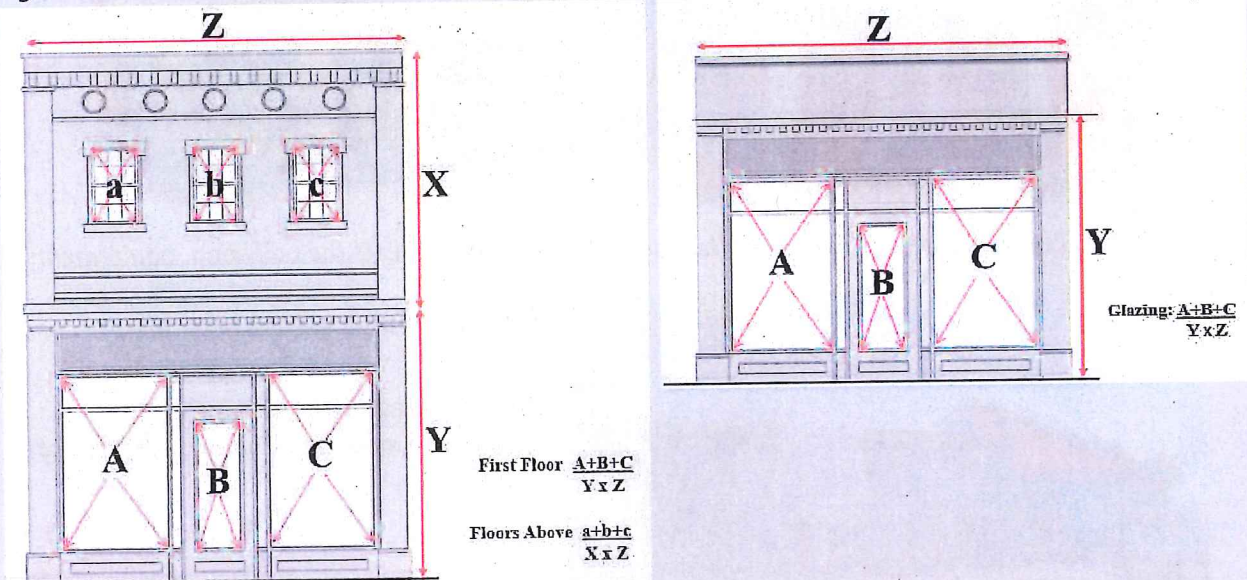
Figure 22. Calculating Glazing

- c. Allowable glazing types are to be clear float, gray light, and solar glazing with 80% minimum transmittance. Reflective glass or film is not allowed.
- d. Glass panes shall not exceed a maximum size of 6 feet by 8 feet.
- e. Windows shall not be obscured or visually blocked by shelves or attachments, but blinds and curtains are allowed to achieve privacy.
- f. The percent of glazing at ground floors abutting rights-of-way shall be 30% minimum and 65% maximum of the ground floor facade area (not including parapet). The percent of glazing on upper floors abutting city rights-of-way shall be 30% minimum and 40% maximum.

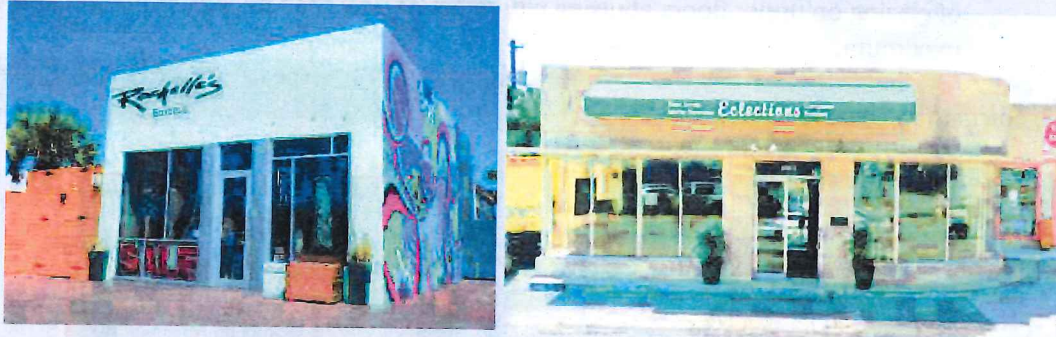
*Figure 24. Bulkheads/Window Sills*

- g. Window sills and bulkheads shall extend a minimum of 12 inches and a maximum of 30 inches above the finished floor (see Figure 24). Bay doors reused as windows are exempt from meeting this requirement (see Figure 25). Buildings that are required to be elevated due to floodplain regulations may measure these distances from the interior finished floor.

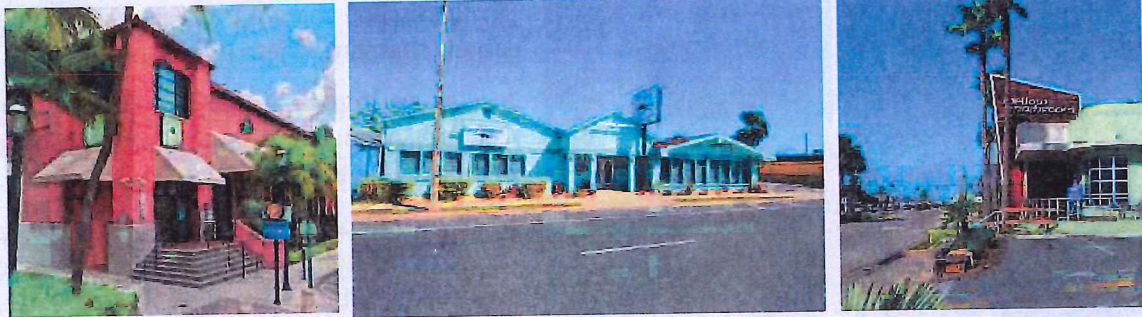
*Figure 26. Pedestrian Transition*

- a. The main entrance of all buildings shall be oriented toward Anastasia Boulevard. Architecture shall reinforce presence of main entrance.
- b. Where parking areas are located behind the building, a secondary pedestrian entrance may be provided from the parking area directly into the building.
- c. Entrances shall be operable, clearly-defined and highly-visible. In order to emphasize entrances, they shall be accented by a change in materials around the door, recessed into the façade (alcove), or accented by an overhang, awning, canopy or similar feature.
- d. Pedestrian connections from the public sidewalk and parking areas to the building entrance shall be provided. Buildings with entrances at a higher elevation than the public sidewalk shall create a transition within the setback (see Figure 26).

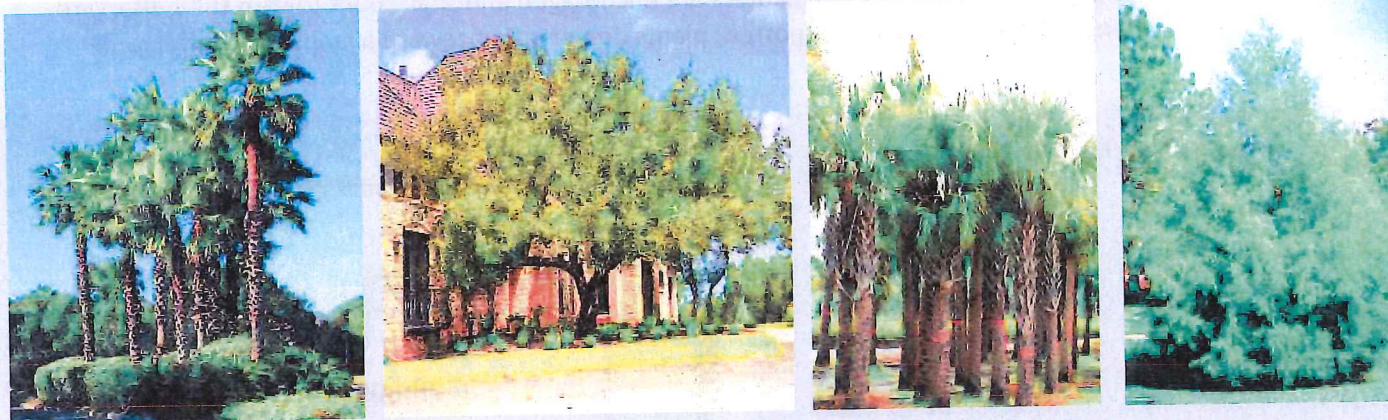
*Figure 31. Tree Plantings*

To maintain the unique appearance of the north and south sections of Anastasia Boulevard, a minimum of 50% (2 trees per 100' of frontage) shall be the following for each section of the corridor:

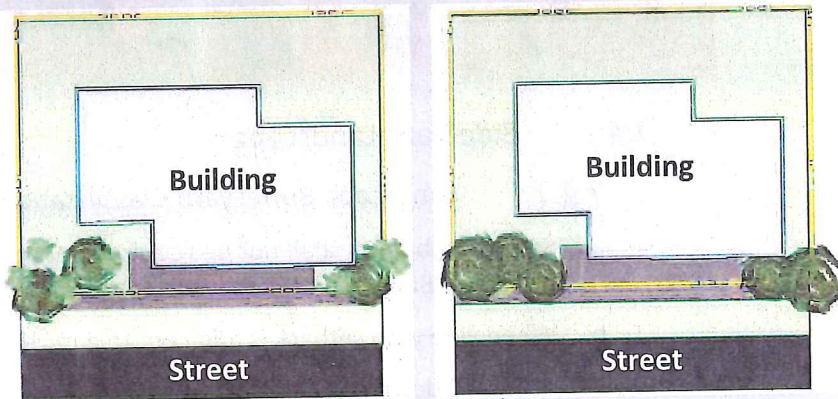
*Figure 32. Tree Compositions*  
 Left | N Zone: Palms and Oaks  
 Right | S Zone: Oaks

Note that for the north zone, 100% of the required trees in the front bufferyard may be palms. If such a planting scheme exceeds the 25% palm maximum for bufferyard trees per City code, this shall be permitted as long as palms are not used as required trees in the other bufferyards. [Note: code only allows 25% max palms for required buffer trees.]

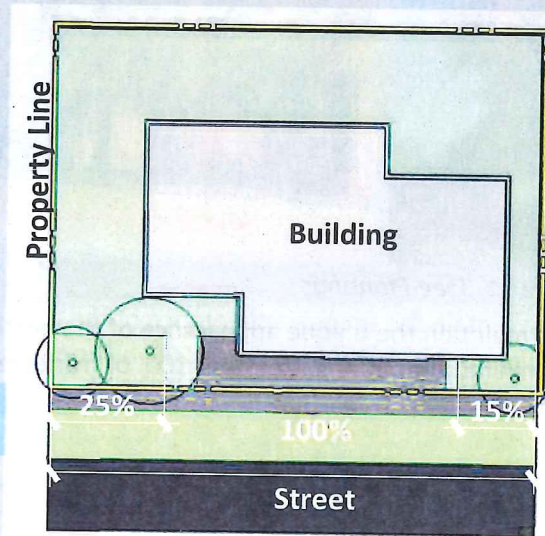
Figure 33. Landscape Percentage

A minimum of 40% of the bufferyard length, inclusive of drives, mechanical equipment, etc., shall be landscape. Raised planters are encouraged and shall count toward the bufferyard length; however, movable (potted) plants do not count toward a landscape bufferyard.

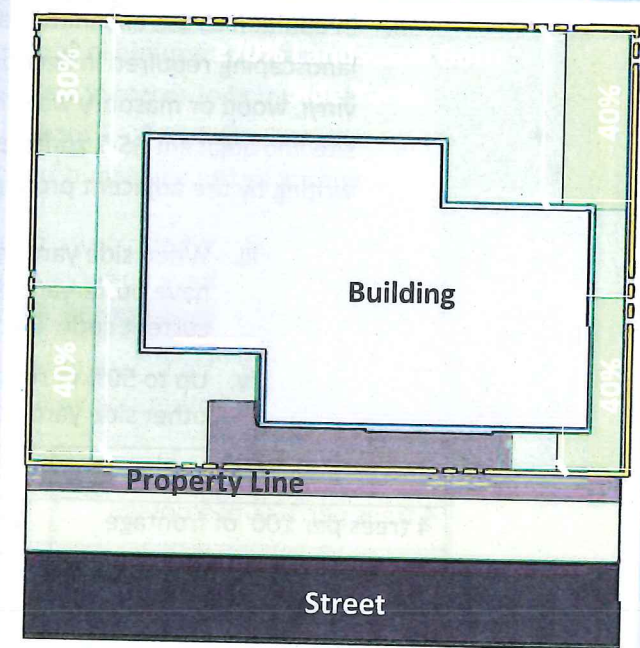
*Figure 35. Side Yard Percentage*

A minimum of 70% of the bufferyard length, inclusive of drives, mechanical equipment, etc., shall be landscape. Modification may be allowed if technically unfeasible.

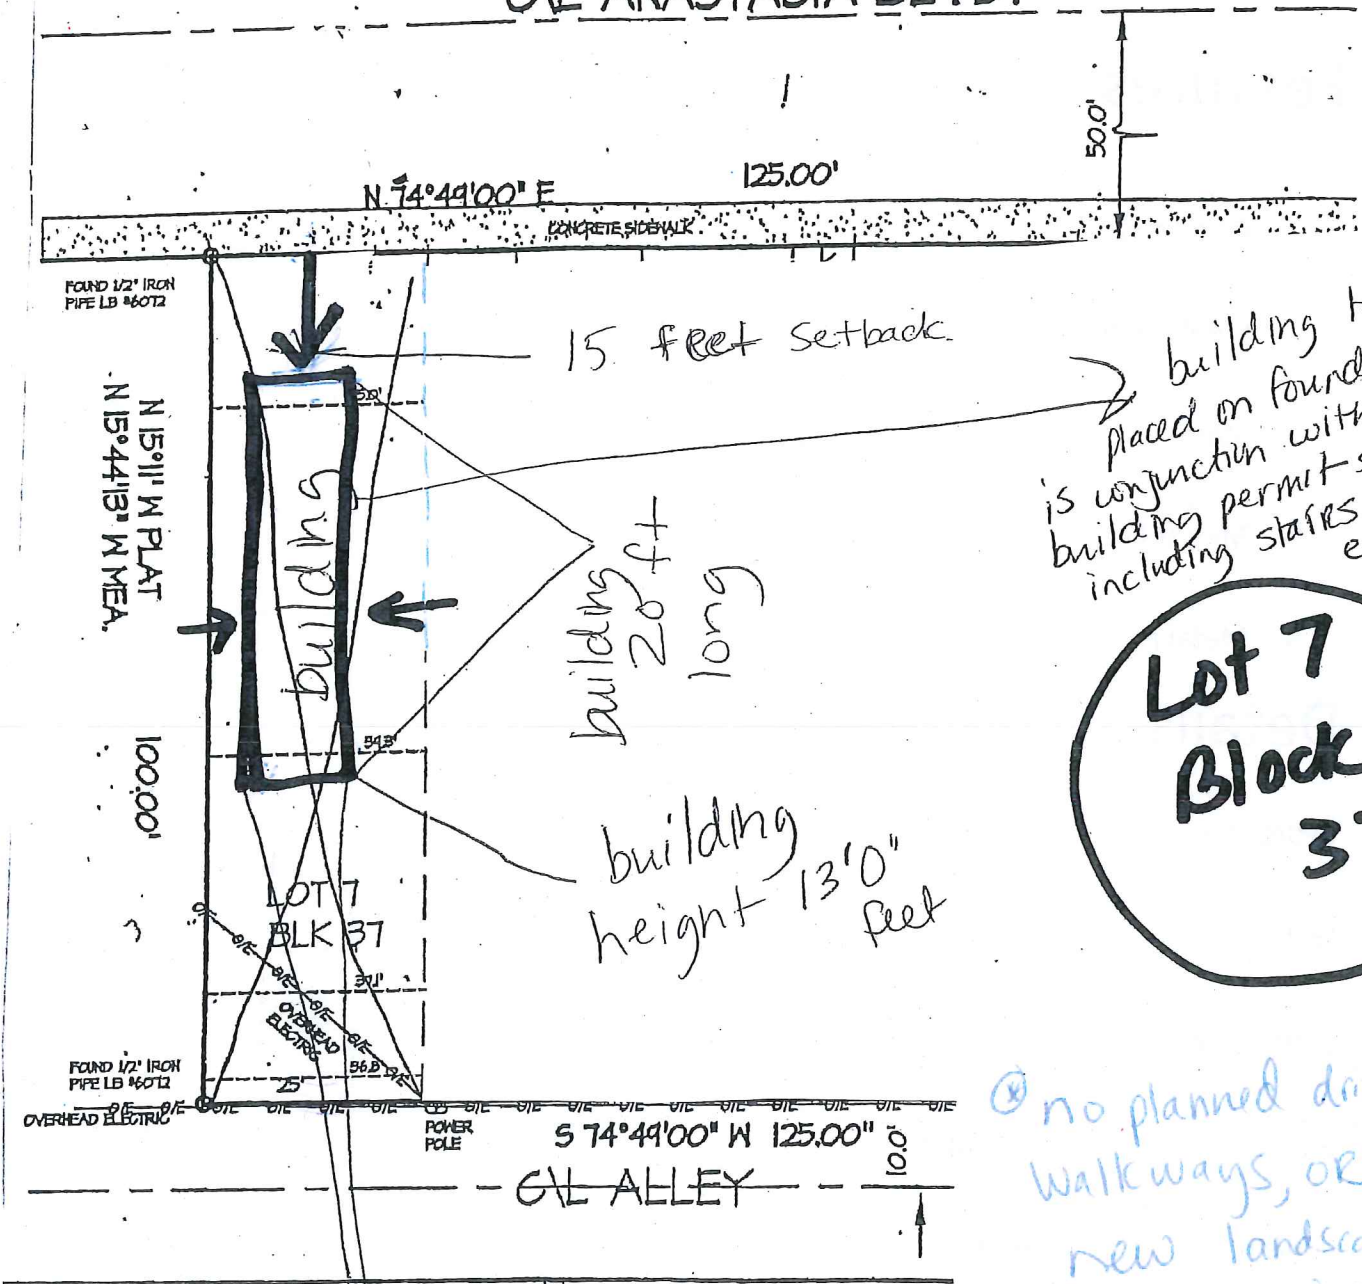
Lot 7  
Block  
37

building to be placed on foundation in conjunction with COSA building permit standards including stairs and elevation.

hookup to existing city sewer & water
