# City of St. Augustine

## Historic Architectural Review Board

**Thursday, March 21, 2019 1:00 p.m. \*Amended**

**HISTORIC ARCHITECTURAL REVIEW BOARD**  
**STAFF REPORT AND RECOMMENDATION**  
Prepared for March 21, 2019 Meeting

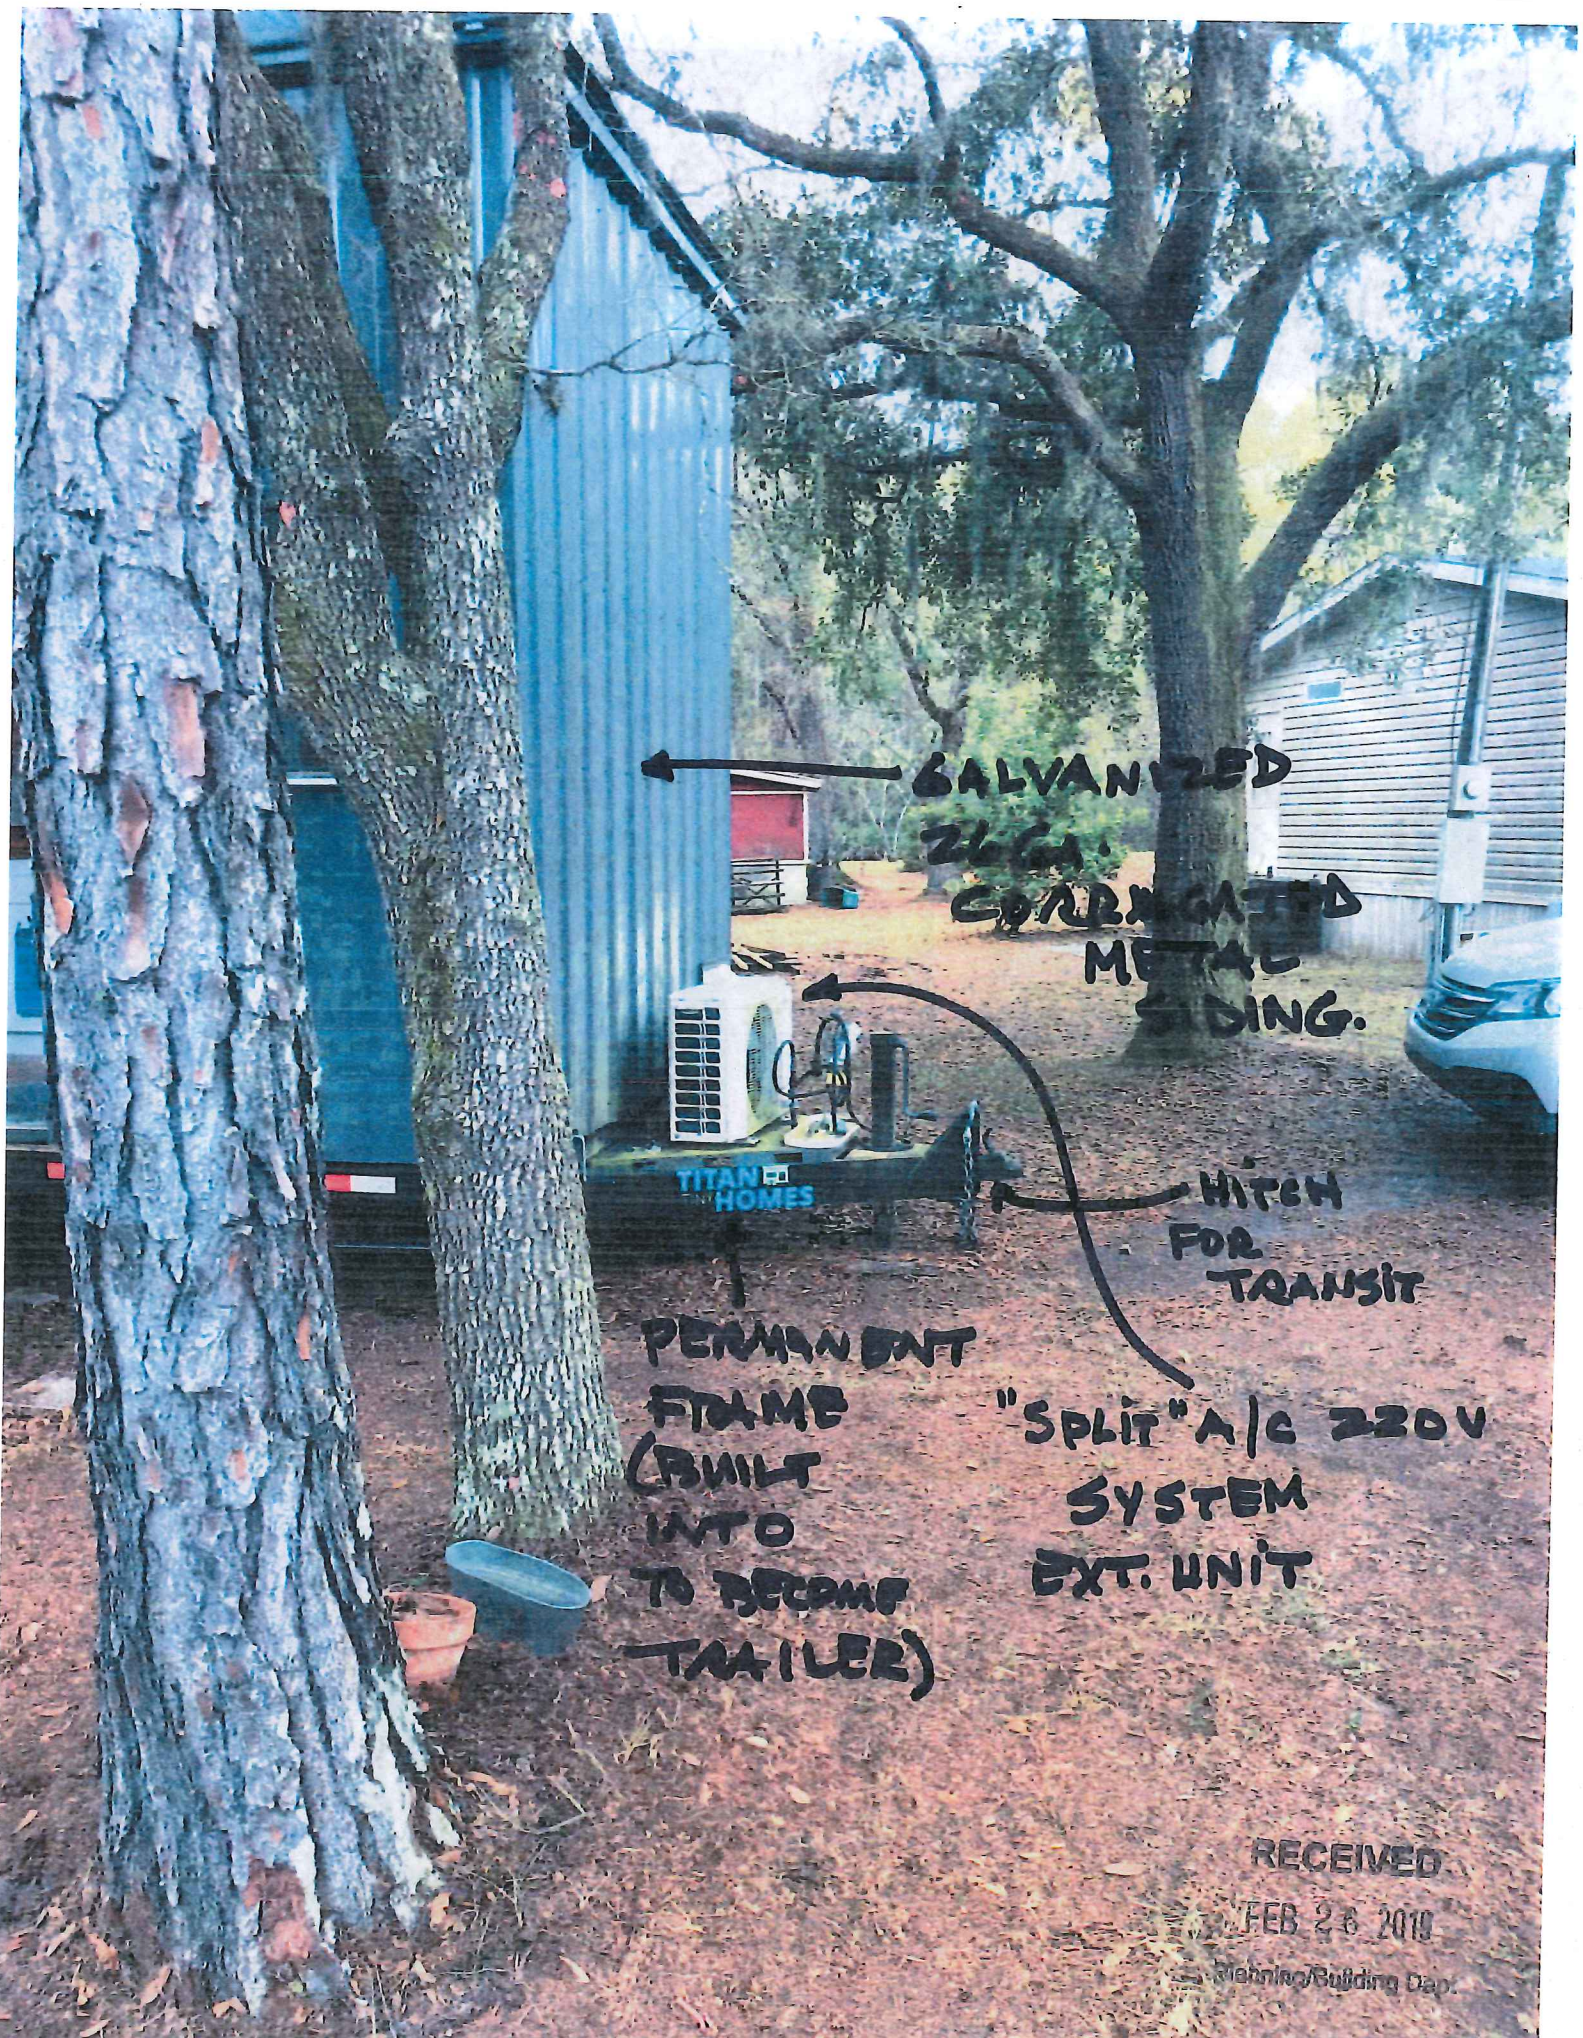
GALVANIZED  
26 GA.  
CORRUGATED  
METAL  
SIDING.

PERMANENT  
FRAME  
(BUILT  
INTO  
TO BECOME  
TRAILER)

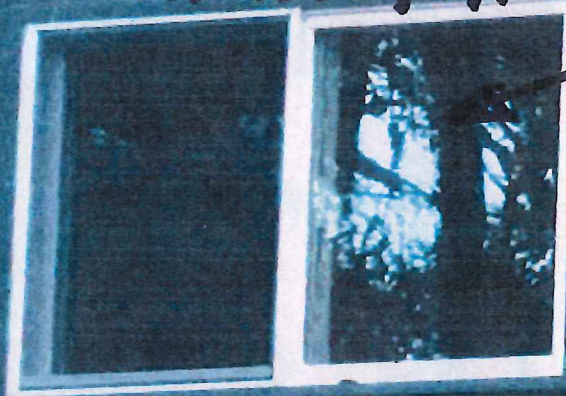
SIDING  
DETAIL

2 PANEL HORIZONTAL SLIDE  
OPERABLE VINYL TINTED  
WINDOW, TYP.

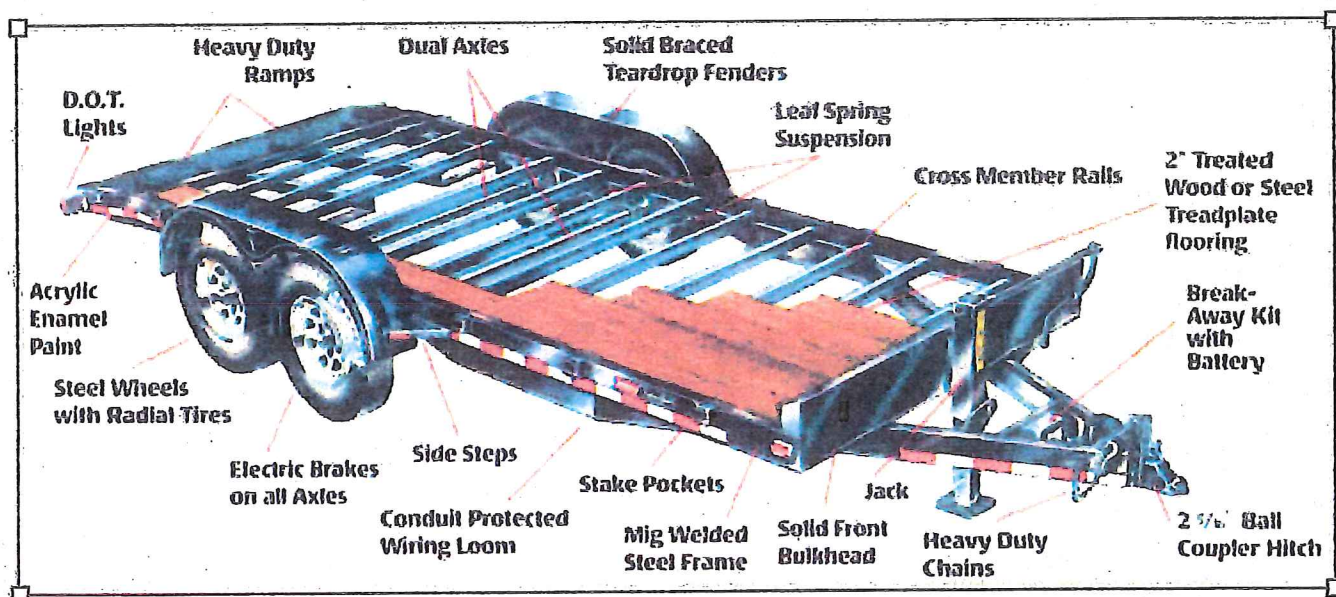
## TITAN TINY HOMES TYPICAL FRAME CONST. DETAIL

### TITAN SPECS:

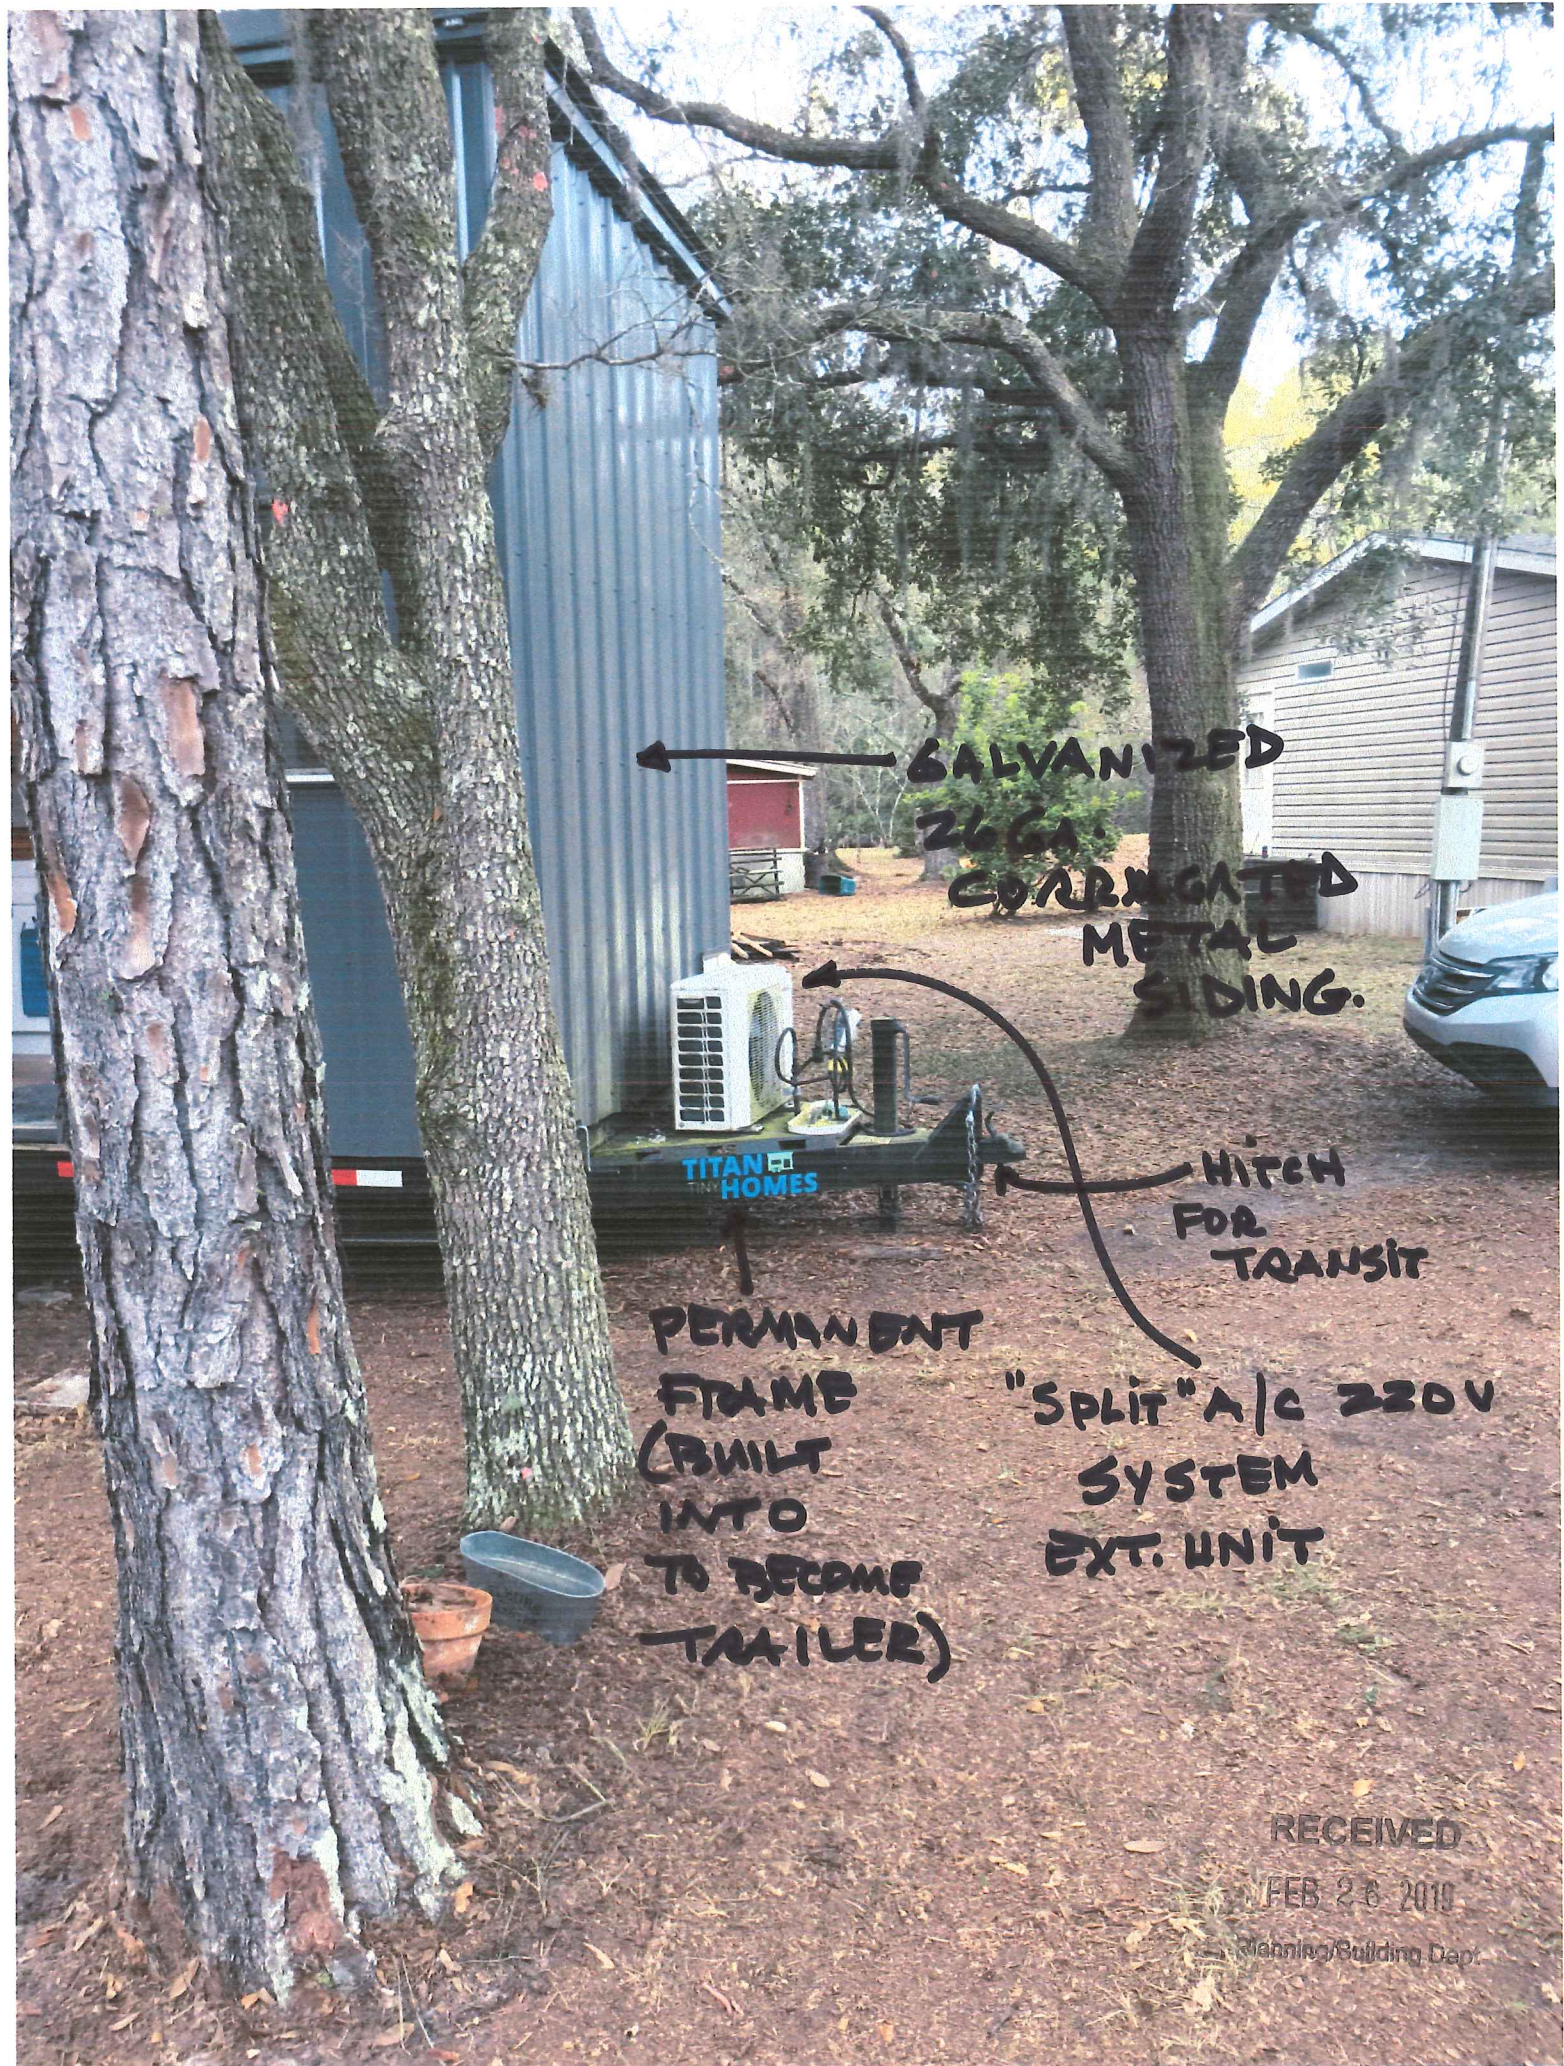
TITAN  
TINY  
HOUSE

← GALVANIZED  
26 GA.  
CORRUGATED  
METAL  
SIDING.

PERMANENT  
FRAME  
(BUILT  
INTO  
TO BECOME  
TRAILER)

1X6 CEDAR, STAINED

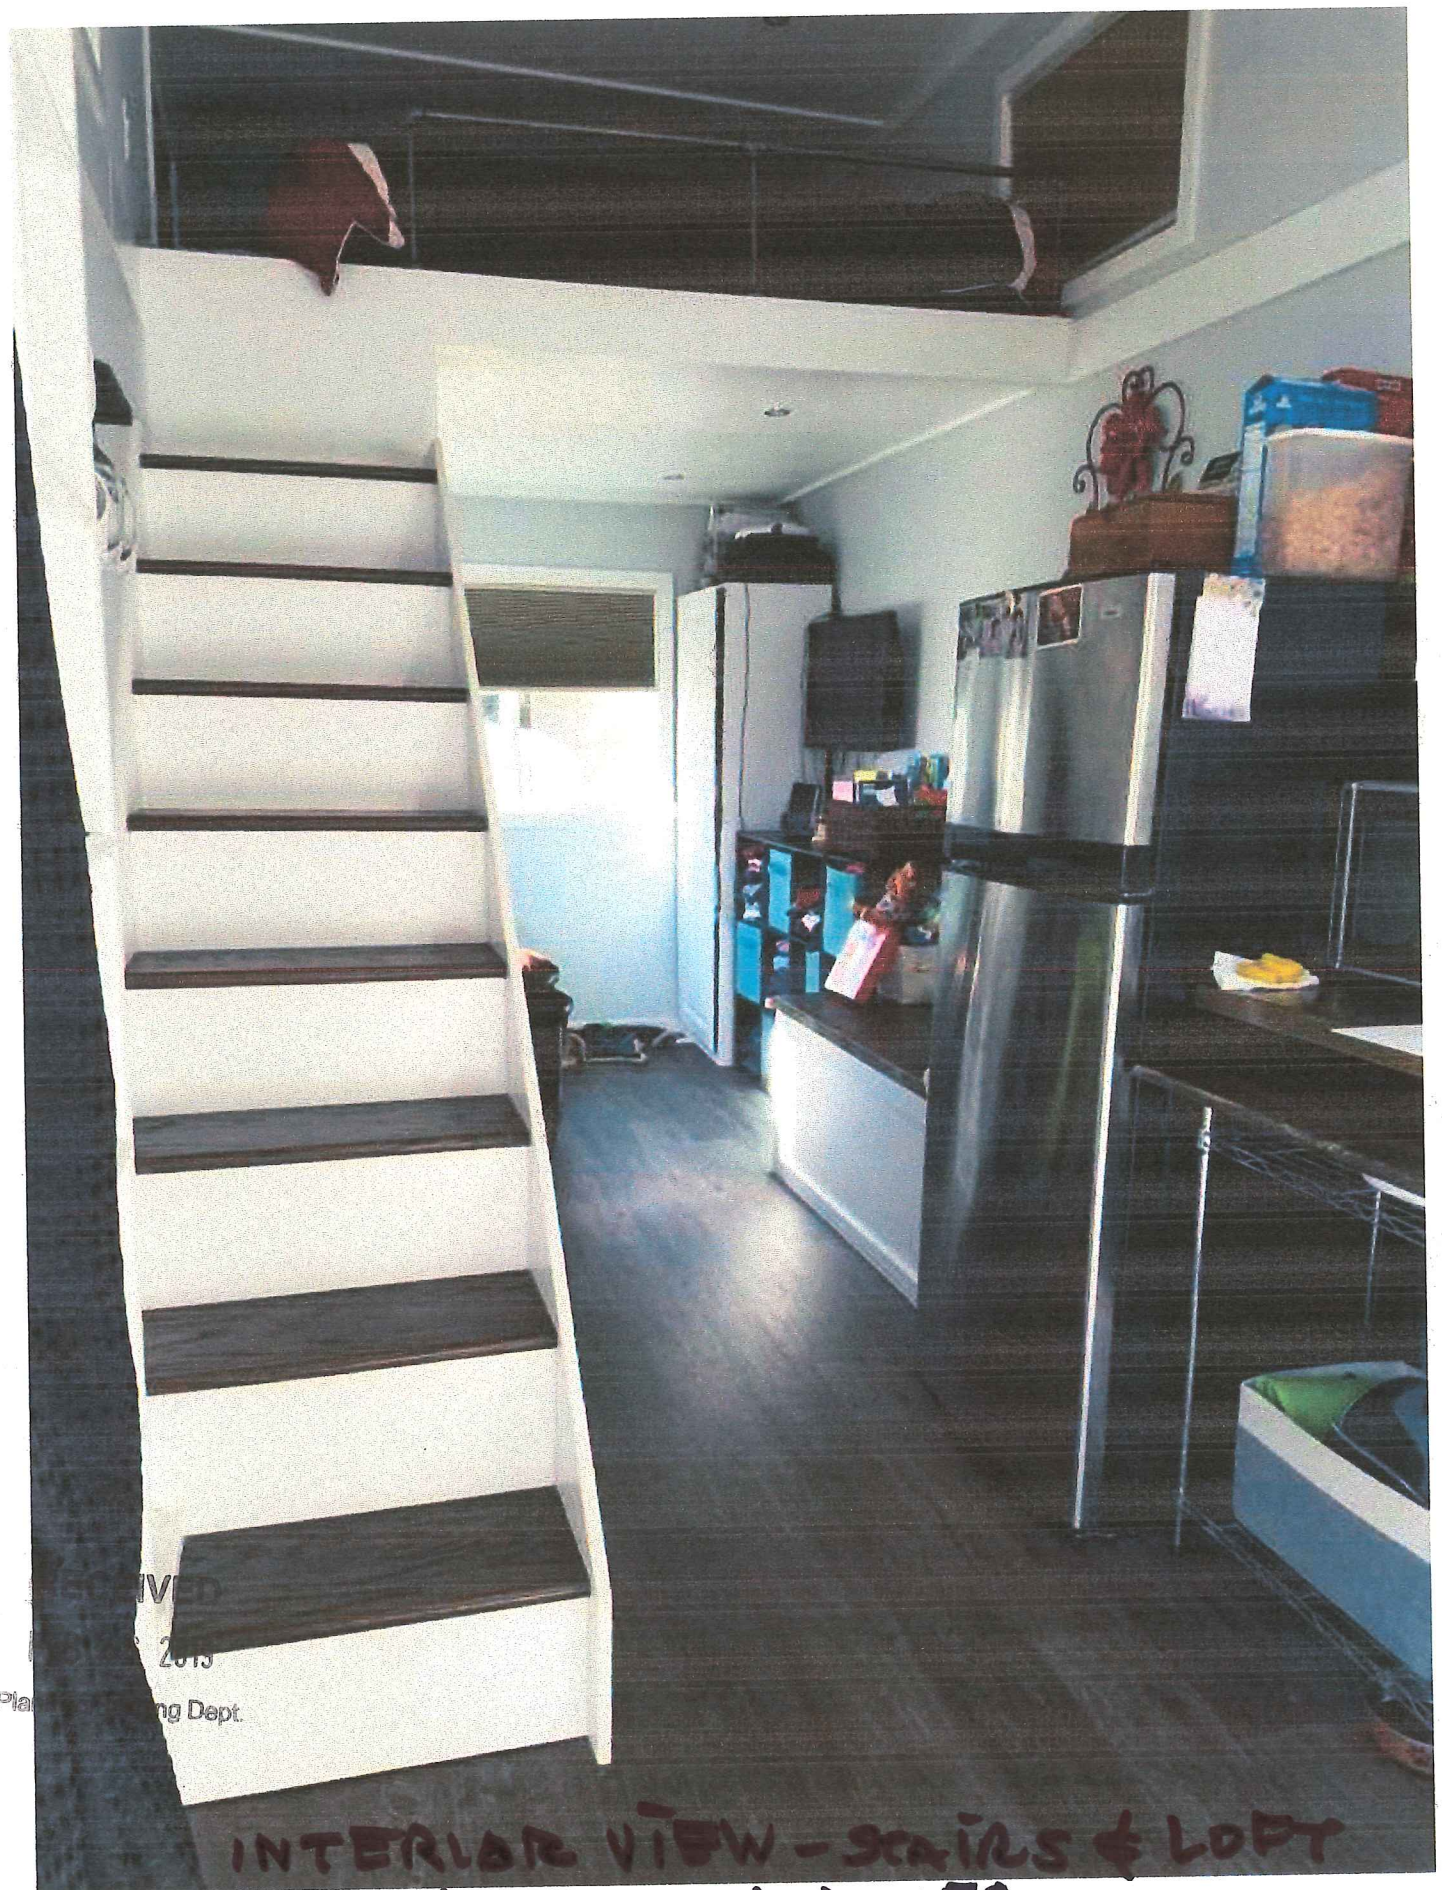
INTERIOR VIEW - STAIRS & LOFT  
E.G. TITAN TINY HOMES.

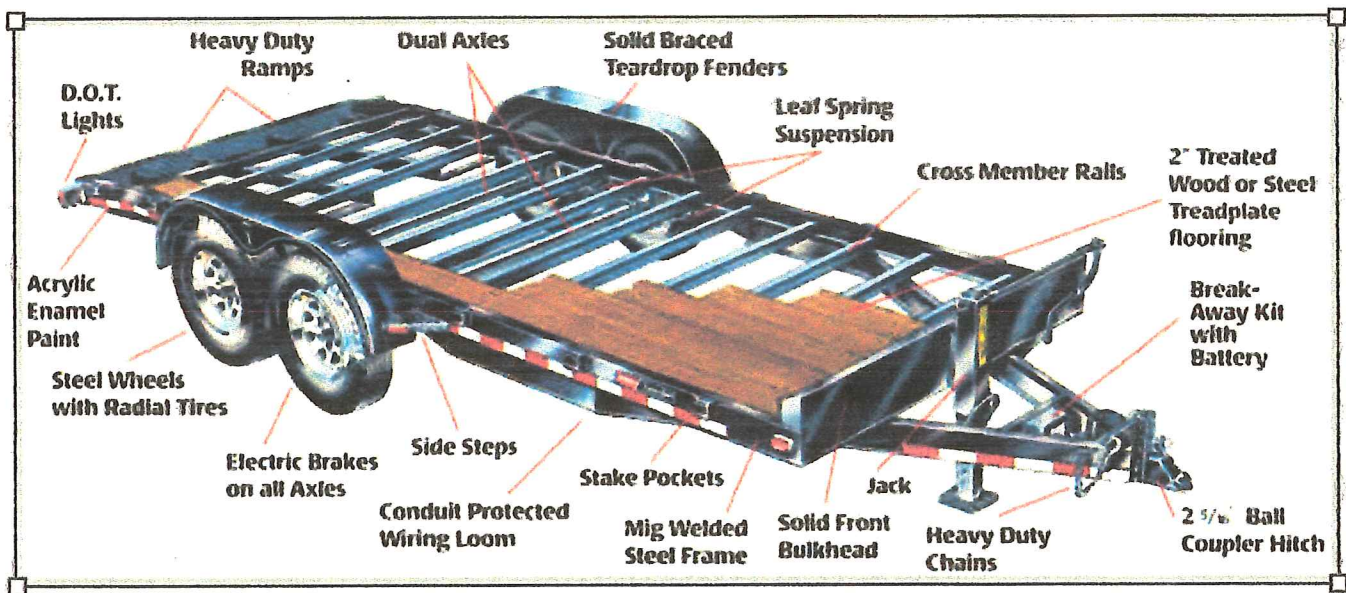
# **TITAN TINY HOMES** **TYPICAL FRAME CONST. DETAIL**

## **TITAN SPECS:**

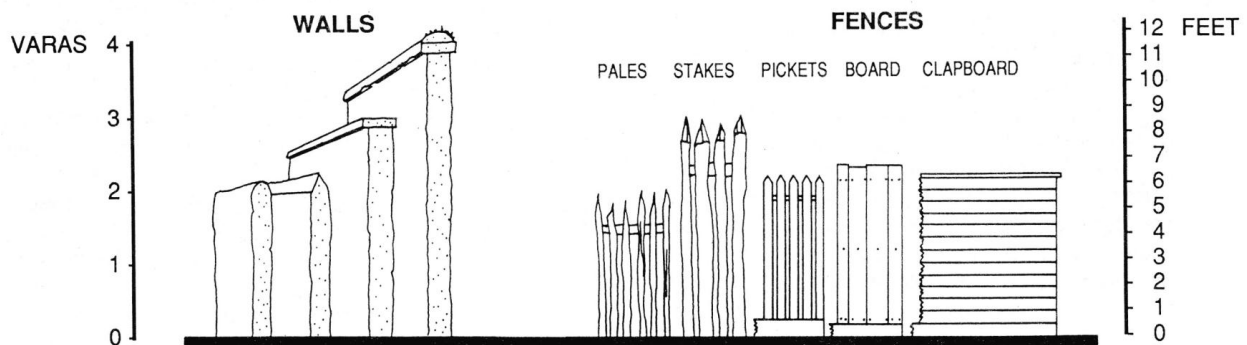
**Figure 16**

### **Pre-1821 Walls and Fences**

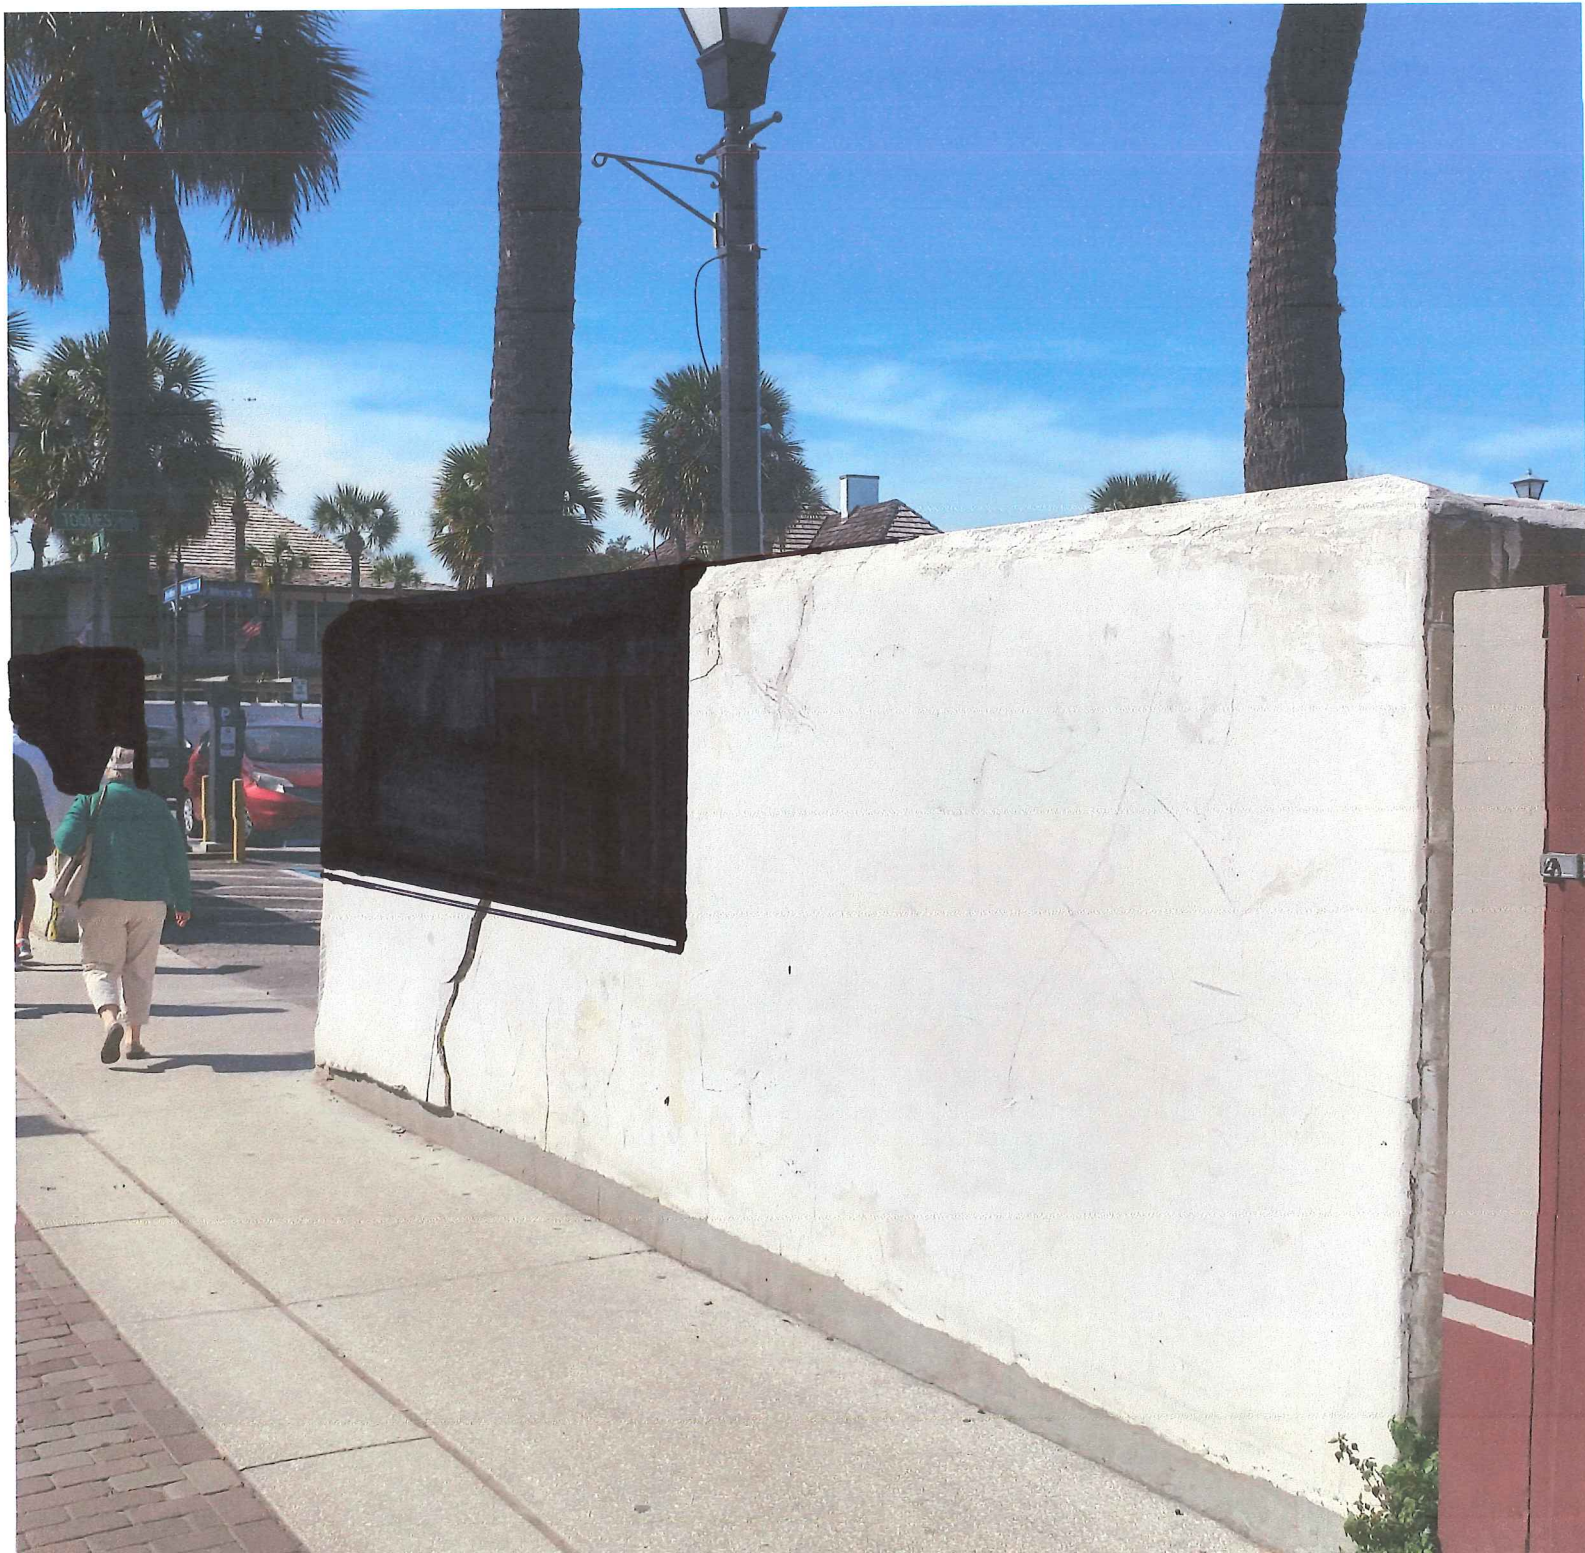
Existing  
MASONRY WALL  
HYPOLITA STREET  
2/22/19
