**CITY OF ST. AUGUSTINE HISTORIC ARCHITECTURAL REVIEW BOARD**  
**SPECIAL MEETING A G E N D A**  
**THURSDAY, OCTOBER 13, 2022 - 9:00 AM**  
**ALCAZAR ROOM**

**Review the Draft Update of the AGHP with consultant, Bender & Associates  
Architects (Jonathan Lammers, Historian)**

# INTRODUCTION TO ST. AUGUSTINE'S DESIGN GUIDELINES

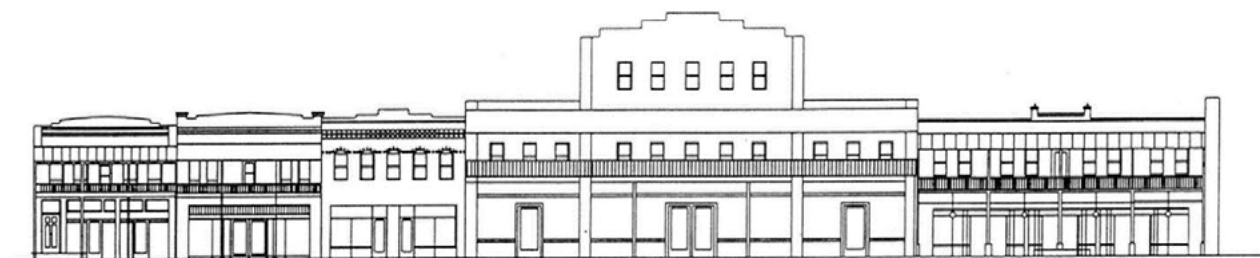
*Example of appropriate infill at center. The massing has been broken up into three bays, and the building height steps up.*

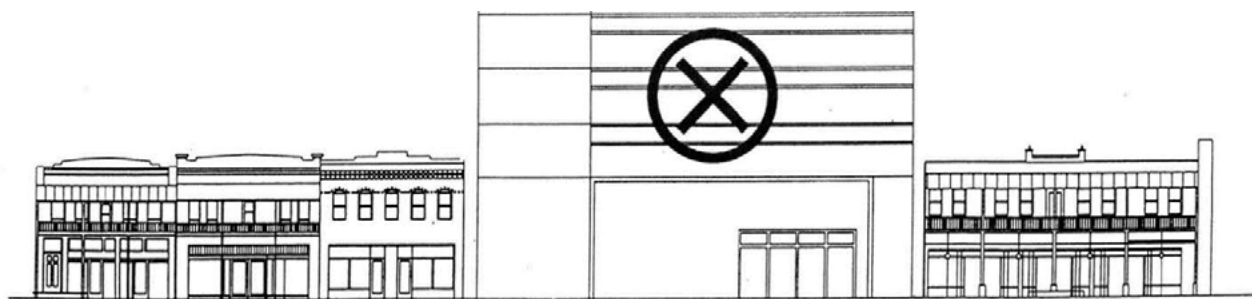
*Example of inappropriate infill. The massing is too blocky and the scale overwhelms its neighbors.*

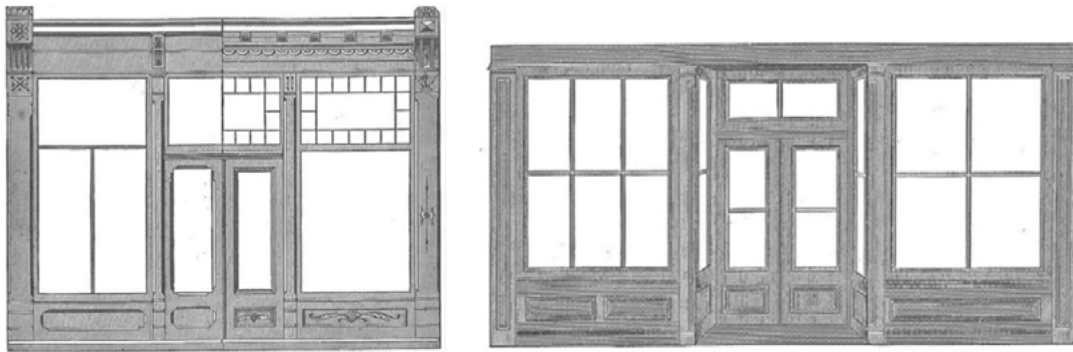
*Circa 1900 examples of wood storefront designs available from building catalogs.*

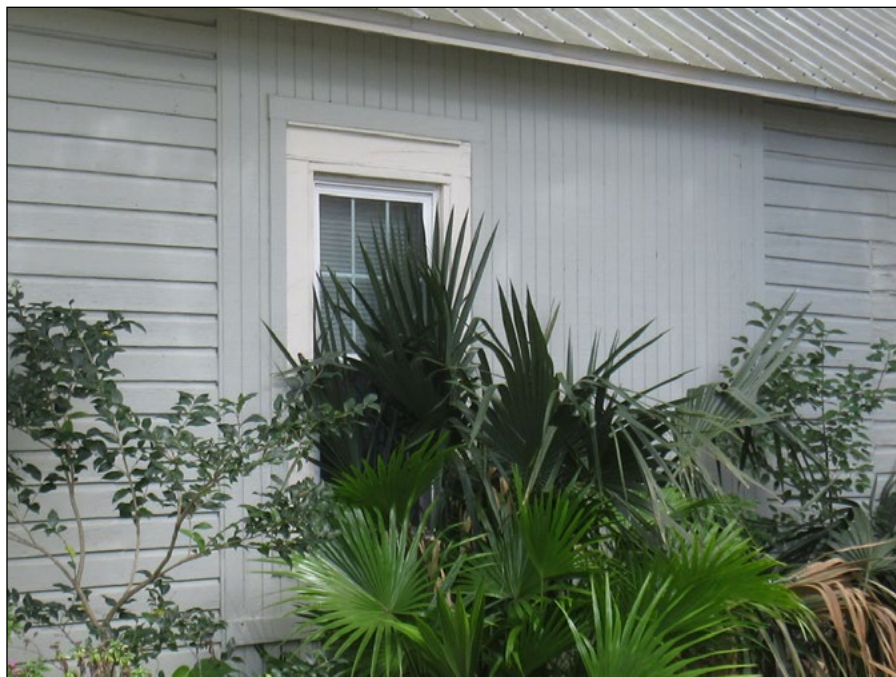
*Repairs should be made with siding that matches the style and dimensions of the original siding.*

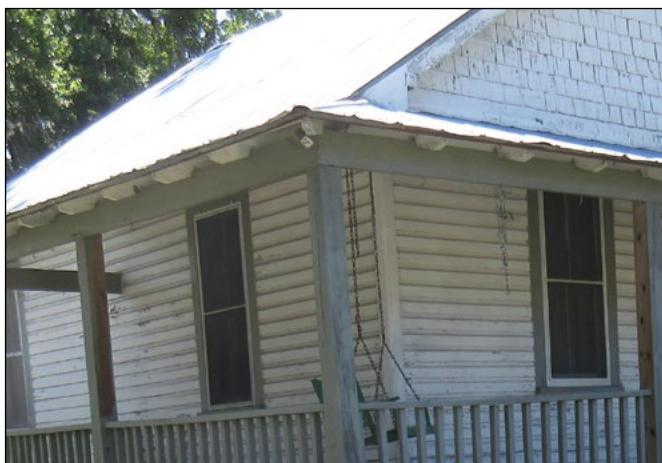
*Wood shingles used in the gable end with novelty siding below.*

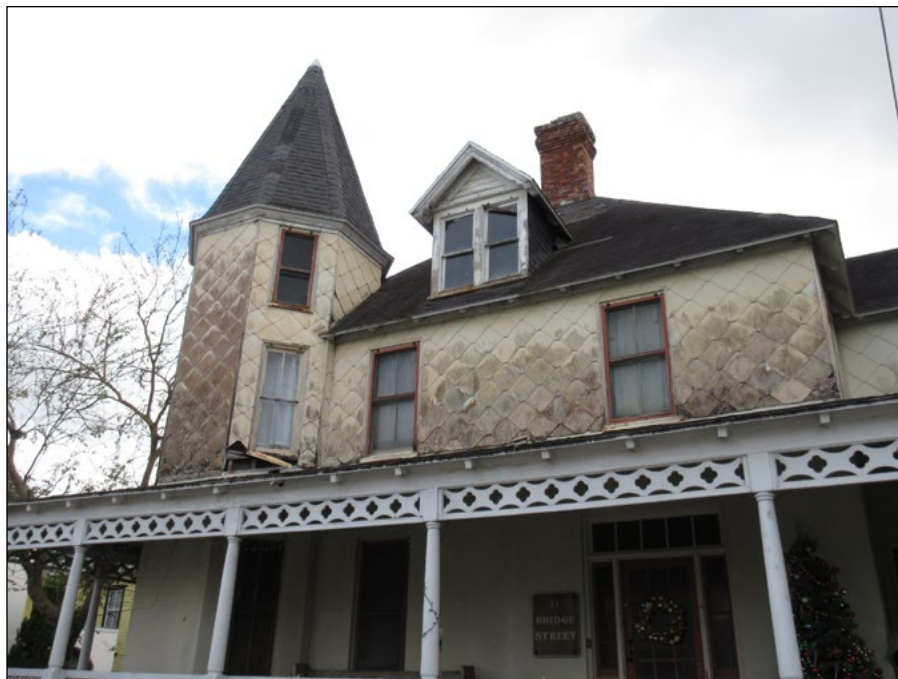
*Asbestos shingles applied in a fish scale pattern to 11 Bridge Street.*

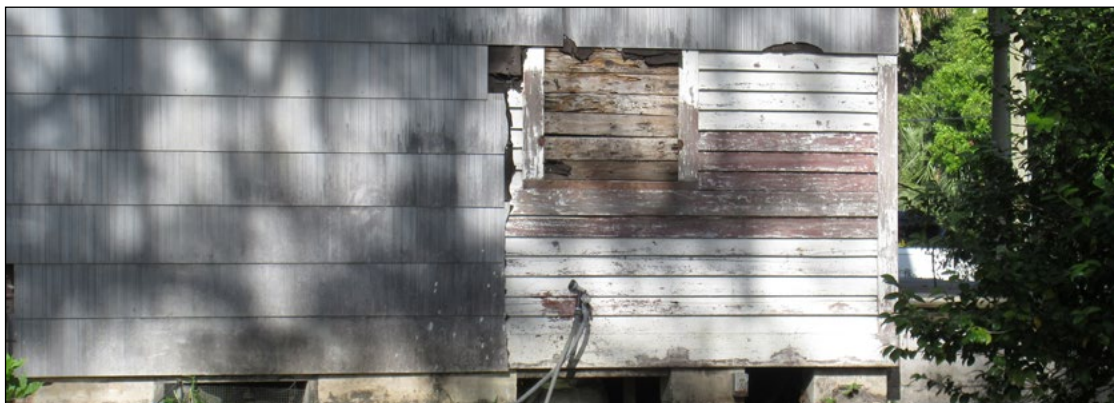
*Missing asbestos singles reveal the historic wood siding underneath, as well as the outline of a window that has been infilled.*

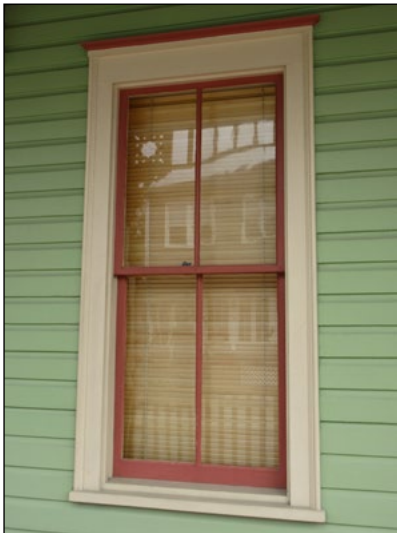
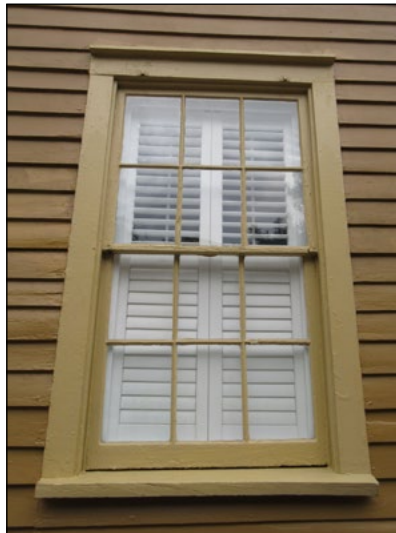
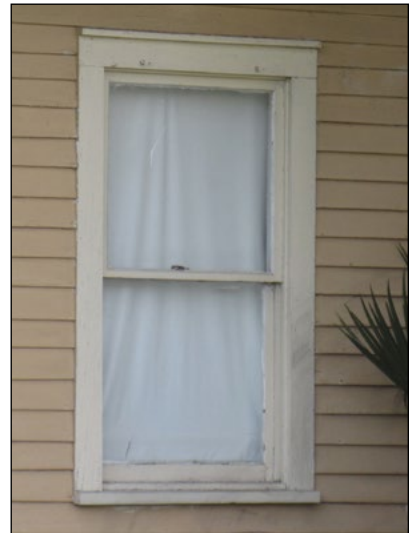
Examples of post-1821 historic wood windows.

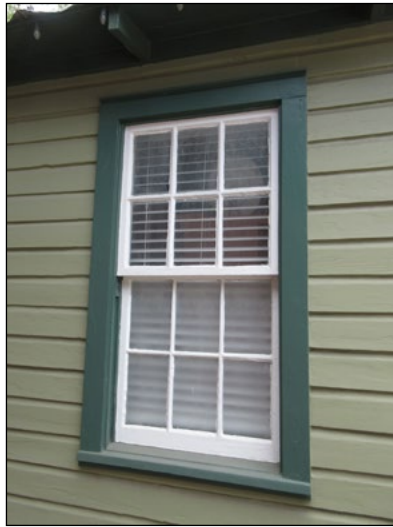
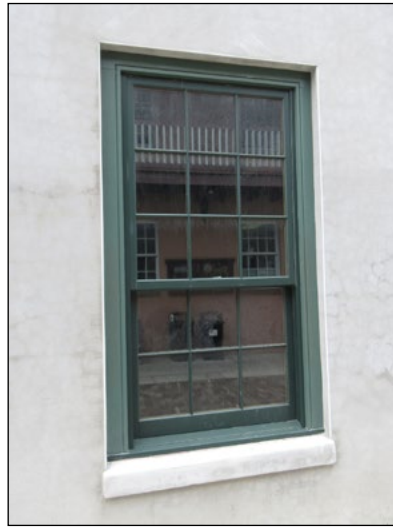
*Historic wood window compared to an aluminum-clad wood window. Although similar, the profiles, depth, and textures of the historic window are more prominent.*

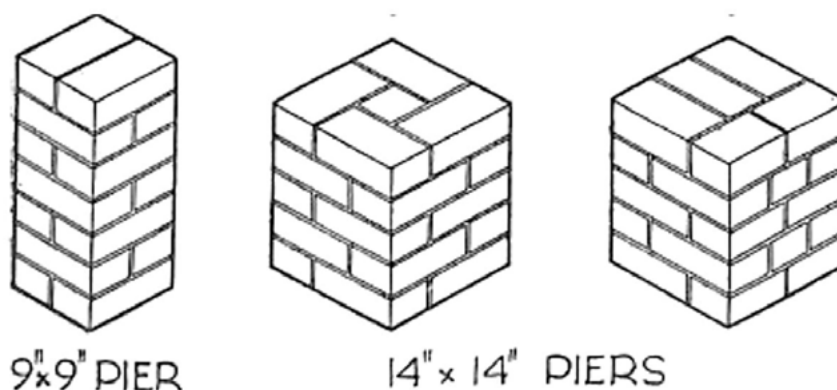
Methods of laying bricks to make various sized foundation piers.

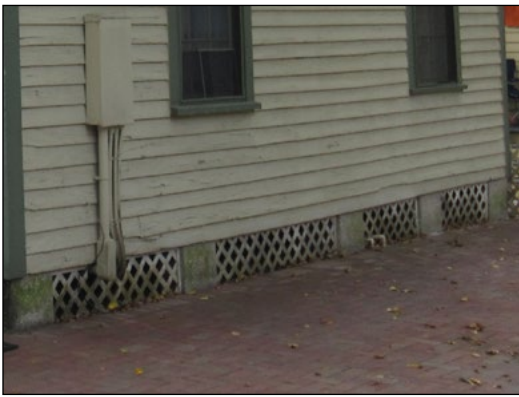
*Lattice should be placed between piers. However, the lattice should also be placed at a 90 degree angle.*

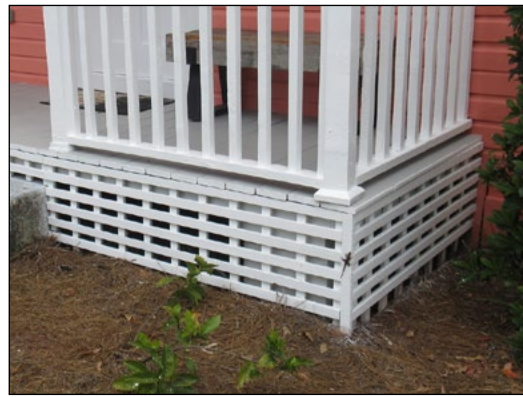
*Do not use foundation screening in such a way that it entirely obscures structural piers.*

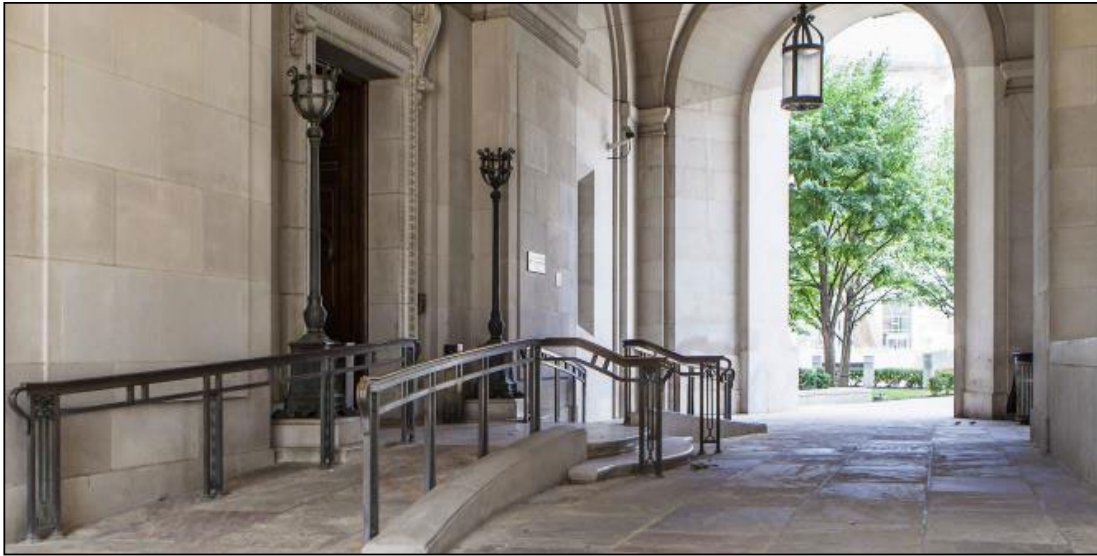
*This accessible ramp uses materials that harmonize with the rest of the building.*

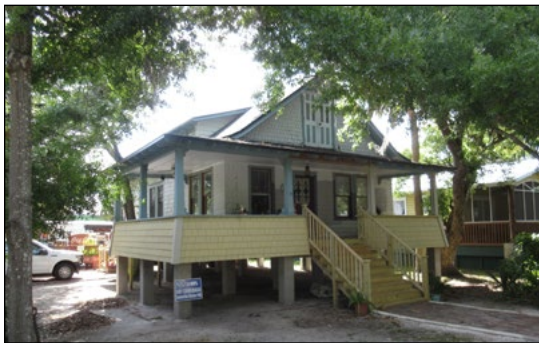
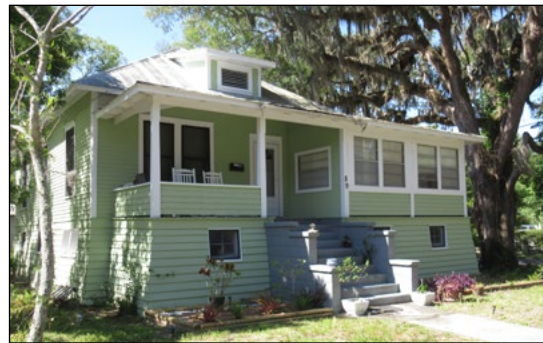
*At left: a building recently lifted for flood mitigation. One method to soften the new proportions is to draw design cues from the historic building at right which will help tie the building to its site.*

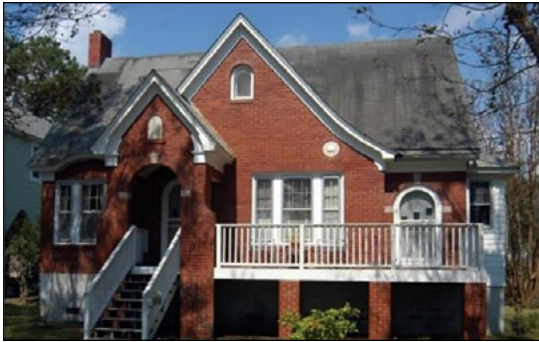
*The front porch and entry were raised on concrete block piers which were veneered with brick. The main portion of the house rests on a new perimeter concrete block foundation. (FEMA)*

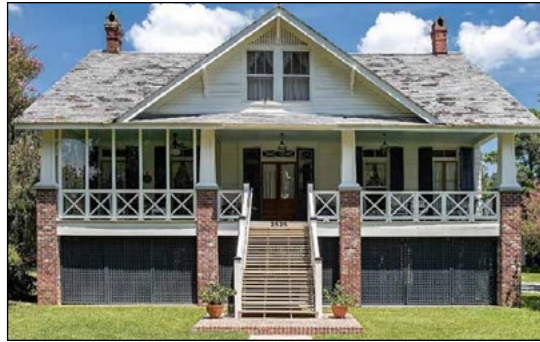
*This house was elevated six feet, necessitating new stairs and piers. The historic porch materials were retained. The dark lattice below helps to visually tie the building to the ground. (National Park Service)*
