RE: 7 Aviles Street

Re: 7 Aviles Street - Evaluation

AES Project: #326-085

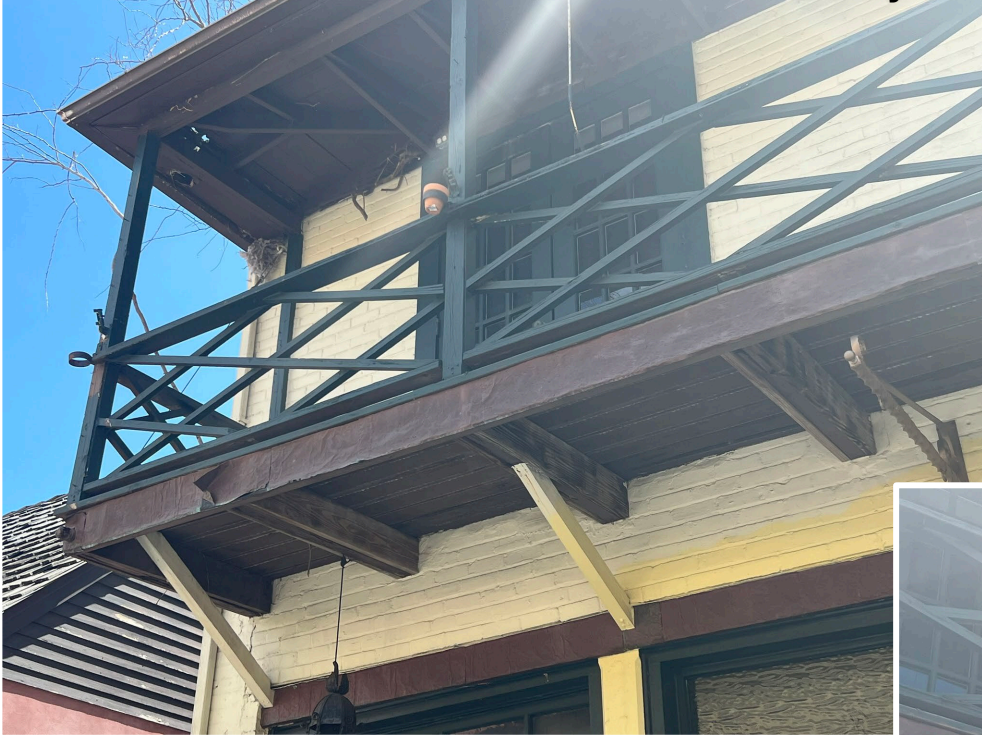
Balcony to be reconstructed
